**MARIN COUNTY HOME PROGRAM PROPOSAL
2014-15**

1. **Project Name: Fairfax Vest Pocket Community**

This Physical Needs Assessment (PNA) is prepared at the request of the Marin Housing Authority (MHA). The purpose of the report is to identify and document the building systems as conditions and to make recommendations for improvements.

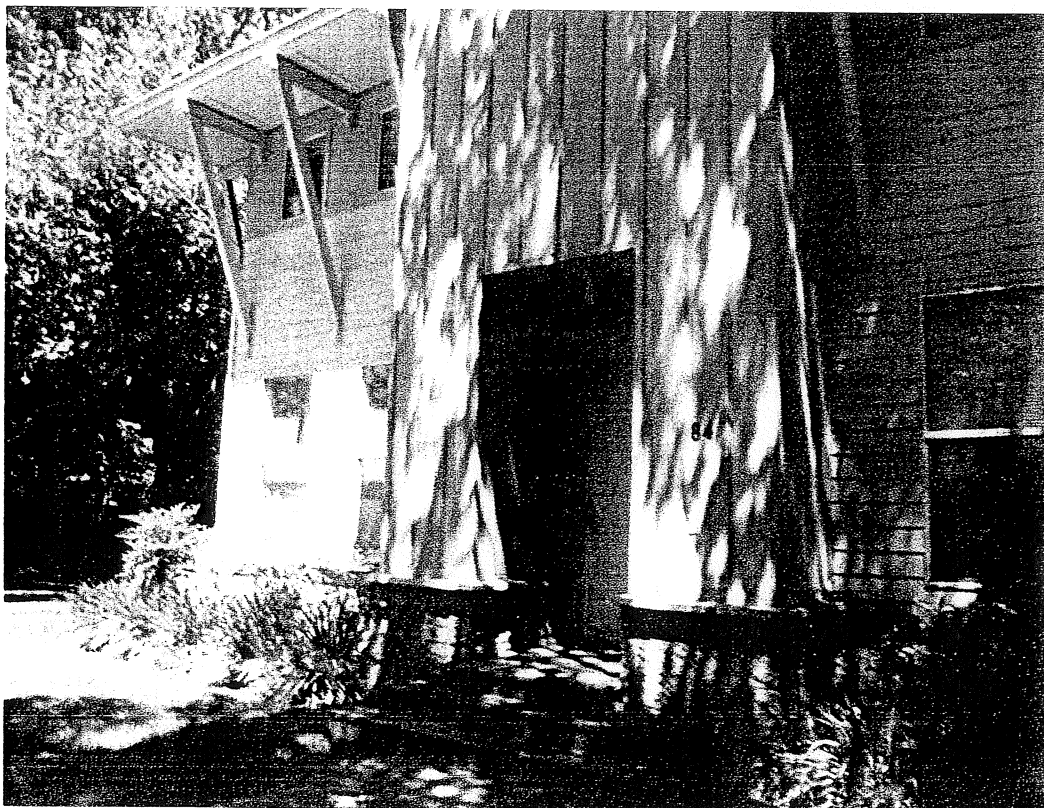
Grass and shrubs at 84 Park Road

- Replace lawns with native grasses and/or drought resistant ground cover.
- All ground cover or earth sloping should be positive – slope away from building footings.
- Remove ivy or other weed ground cover from behind 3 Frustruck. That type of foliage attracts rodents.
- Install rainwater harvesting systems in the below grade areas. Use collected water for irrigation. The harvesting system could include banks of rain collectors along the downspouts for the podium walkways. The harvested water can be used for irrigation.
- Cut back trees that overhang building roofs to prevent leaf debris into roof gutters or install gutter guards. Given the benefits of shade at this location, gutter guards are a much better choice to deal with leaf debris.
- Cure root growth which extends toward or into building bases/foundations.

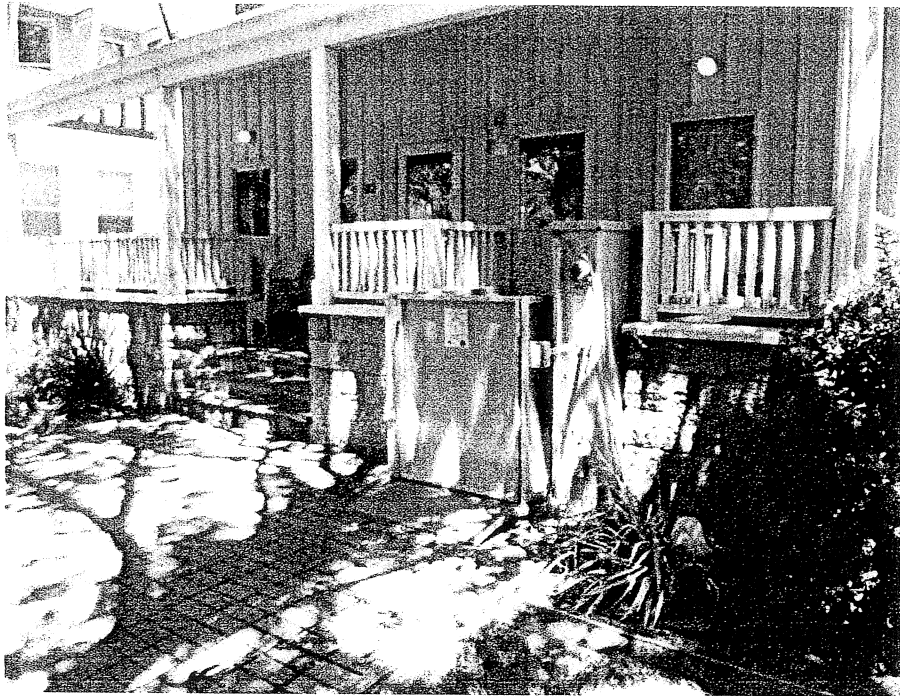
The entry porch at 82 Park is in good condition, but the deck is getting slightly worn.

Entry porch at 82 Park (Community Building)

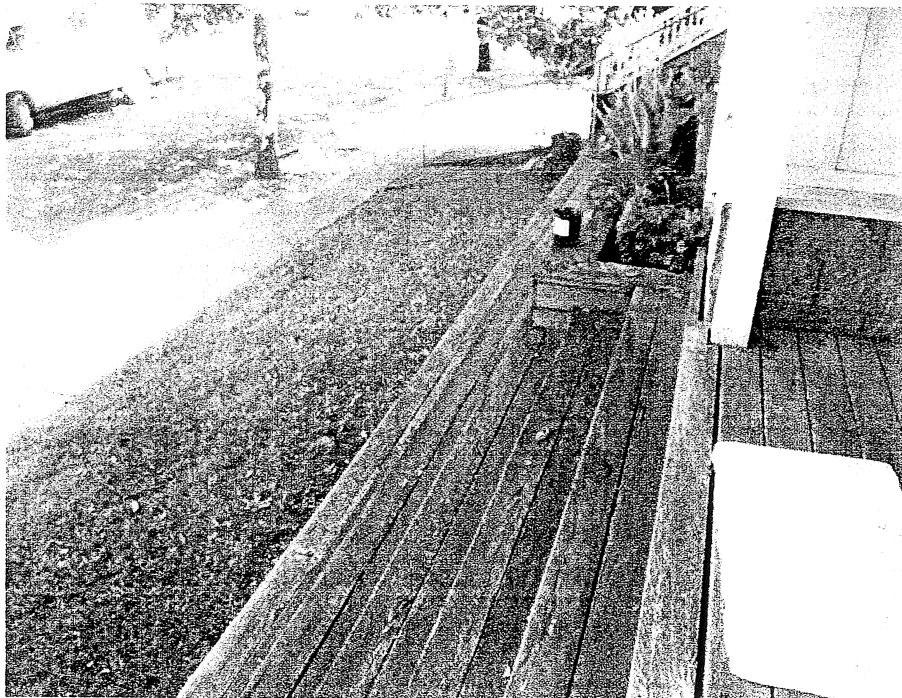
Each building is entered via concrete or wood stairs. The architectural design of the 82 Park, 75 Park and 3 Frustruck buildings included the installation of wood stairs. These stairs, particularly at 75 Park, are in poor condition with loose boards and evidence of dry rot. The wood stairs should be replaced at 75 Park in the immediate scope of work. The use of Trex (though less attractive) may be beneficial and will last longer than wood. Alternatively, the stairs could be replaced with concrete or metal treads.

Entry deck boards at 75 Frustruck. Nosing board is very loose.

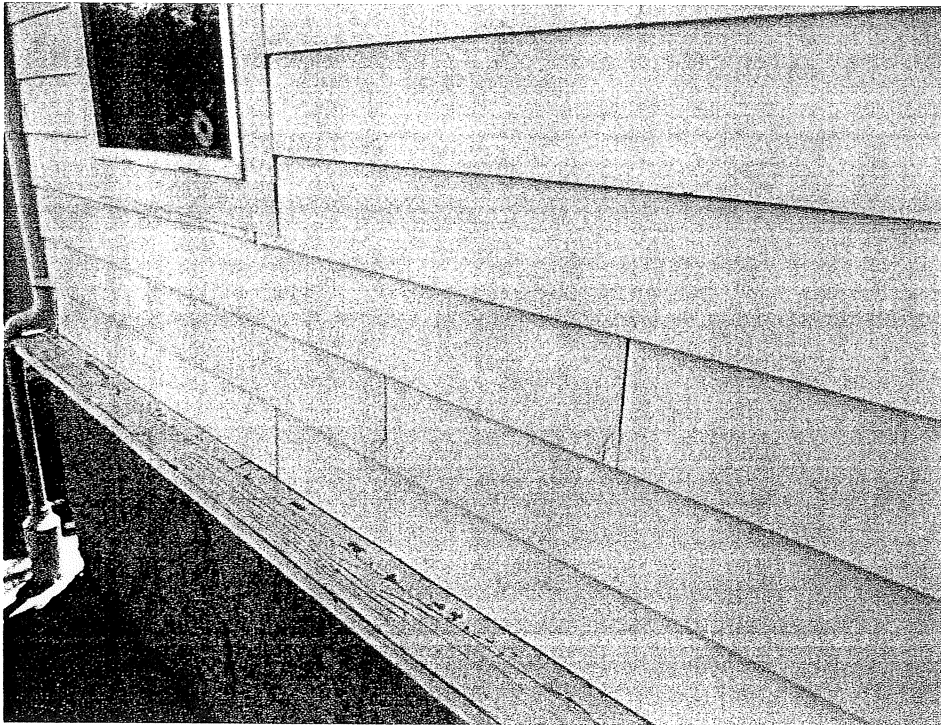
Cracked lap siding at 84 Park Road

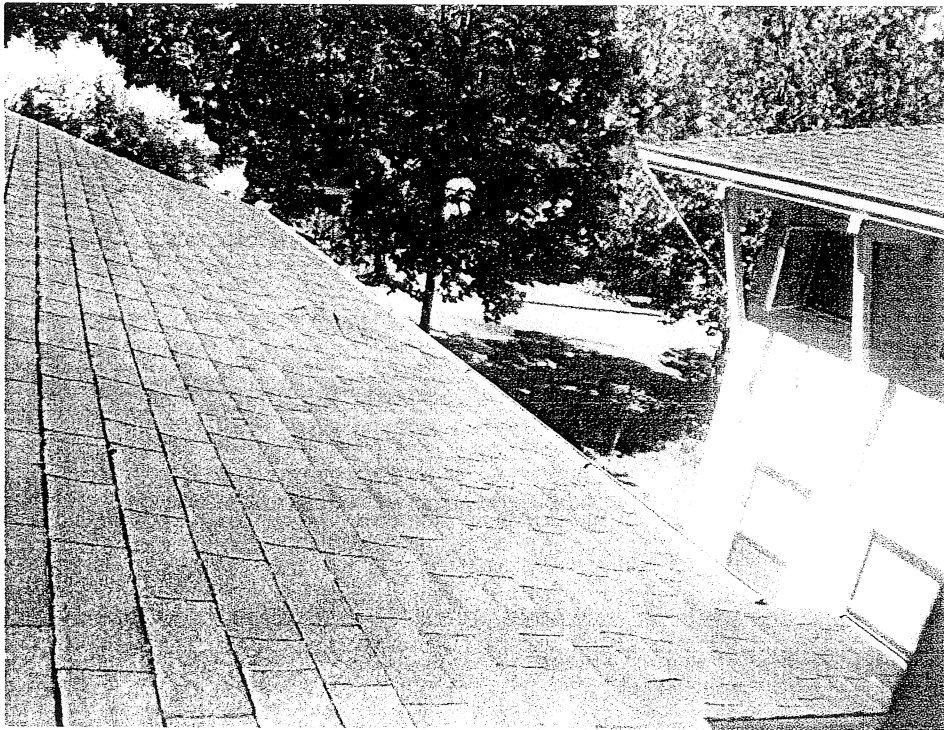
Lump in roof at 5 Frustruck

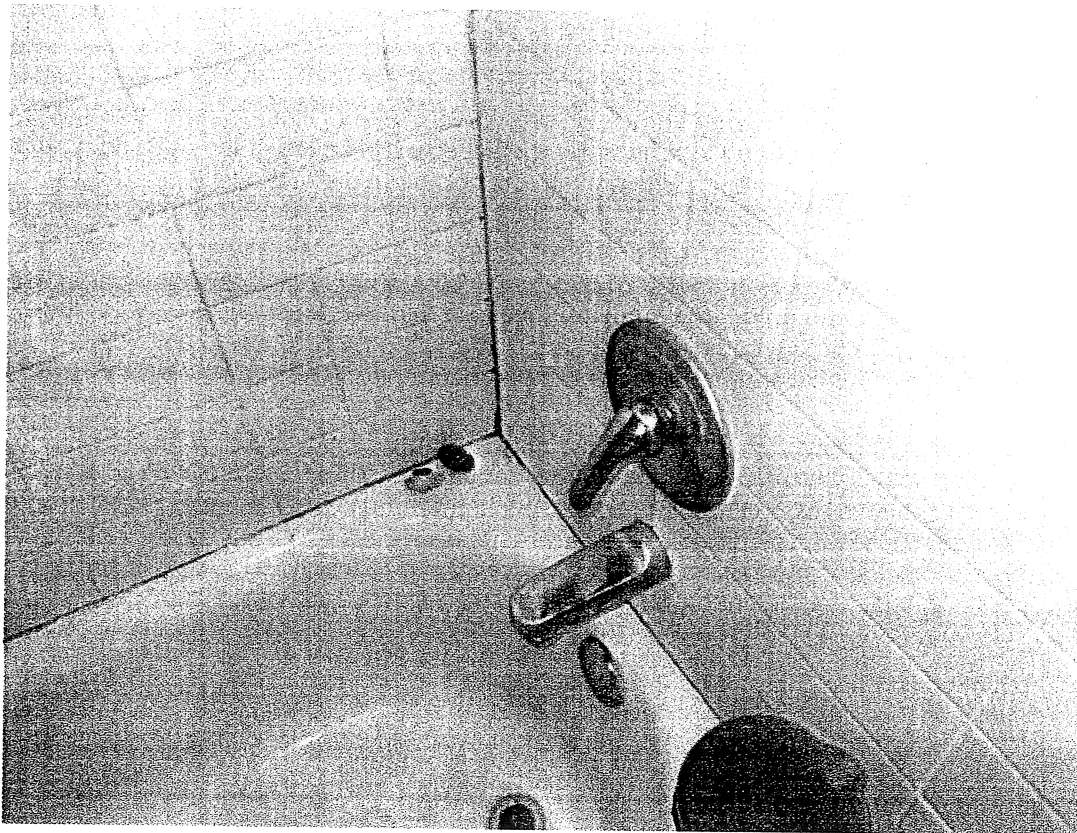
The finishes at the bathrooms with tubs and shower surrounds (the upstairs hallway bathrooms) are typically an enameled steel tub with tile surround. Most were found to be in good condition, however the tub and tile intersections need regular caulking.

Tub surround and tub, mixer and spout. Typical.
