**Subject: Section 106 review for Trench for 49 Cole Drive Water
Main Break Emergency Repair**

Finding of Effect Memorandum

To:	Molly Kron, CDA; Tammy Taylor, CDA
From:	Mike Cutchin, MHA; Adrian Chorley, MHA
Date:	March 3, 2023
Re:	49 Cole Drive Water Main Break Emergency Repair

Project Name: 49 Cole Drive Water Main Break Emergency Repair

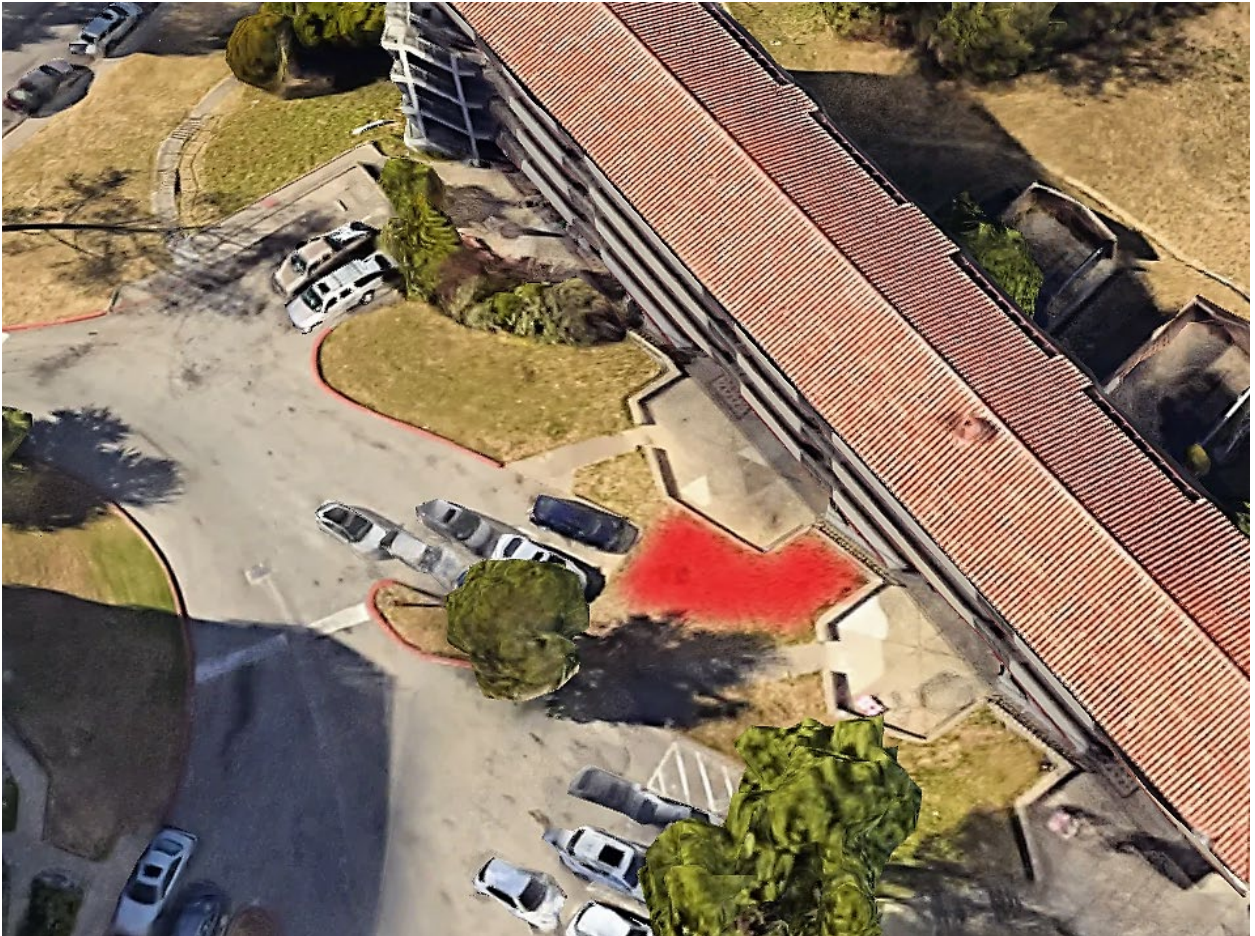
The undertaking included emergency repair of a broken water main found adjacent to 49 Cole Drive, a high-rise building of residential apartments at GGV. The work included excavation of a grassy area southeast of one of the parking lots servicing residents at 49 Cole Drive and the repair of a water main (Figure 1). To fully evaluate direct and indirect effects, the Area of Potential Effect for this undertaking includes the full boundary of the entire historic district because the landscape and the spatial relationships between contributors are character-defining features. However, this analysis focuses on the immediate landscaping and parking area surrounding the broken water main between the two high-rise buildings at 49 and 59 Cole Drive.

Figure 1 Google Maps aerial photo showing 49 Cole Drive. Cole Drive is at the top-left corner. Red shading depicts the immediate work area for this undertaking. Note that excavation was limited to groundcover and did not alter the pentagonal terraces, a character-defining feature of the district. Google Maps 2022 (base map) with shading by ICF 2022.

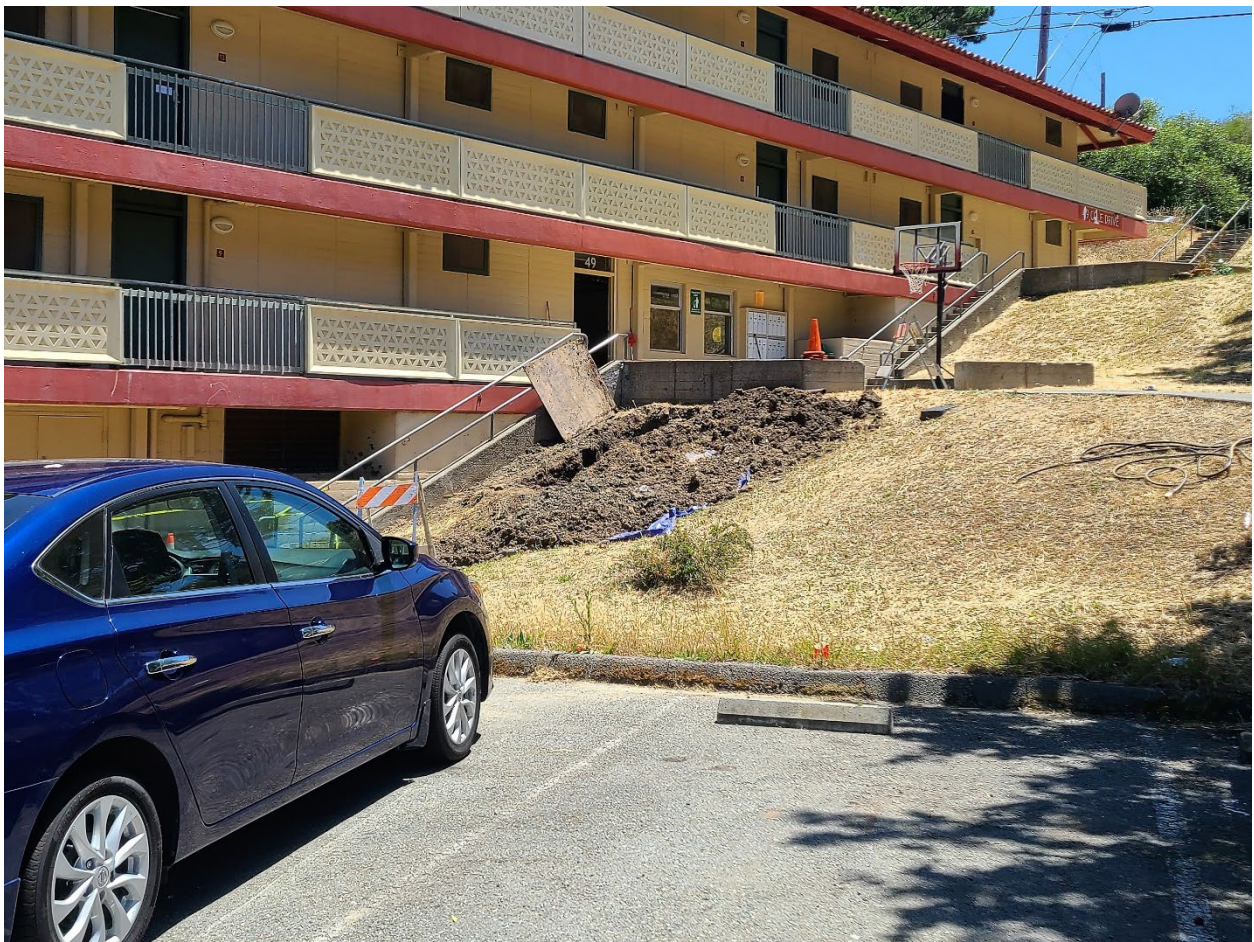
On June 6-9, 2022, MHA discovered and performed an emergency repair on a subterranean broken water main within a grassy area north of a pentagonal terrace near 49 Cole Drive.

Figure 2. The location of excavation work and emergency repair to the broken water main. 49 Cole Drive in background with concrete stairways and pentagonal terraces. Looking southeast.

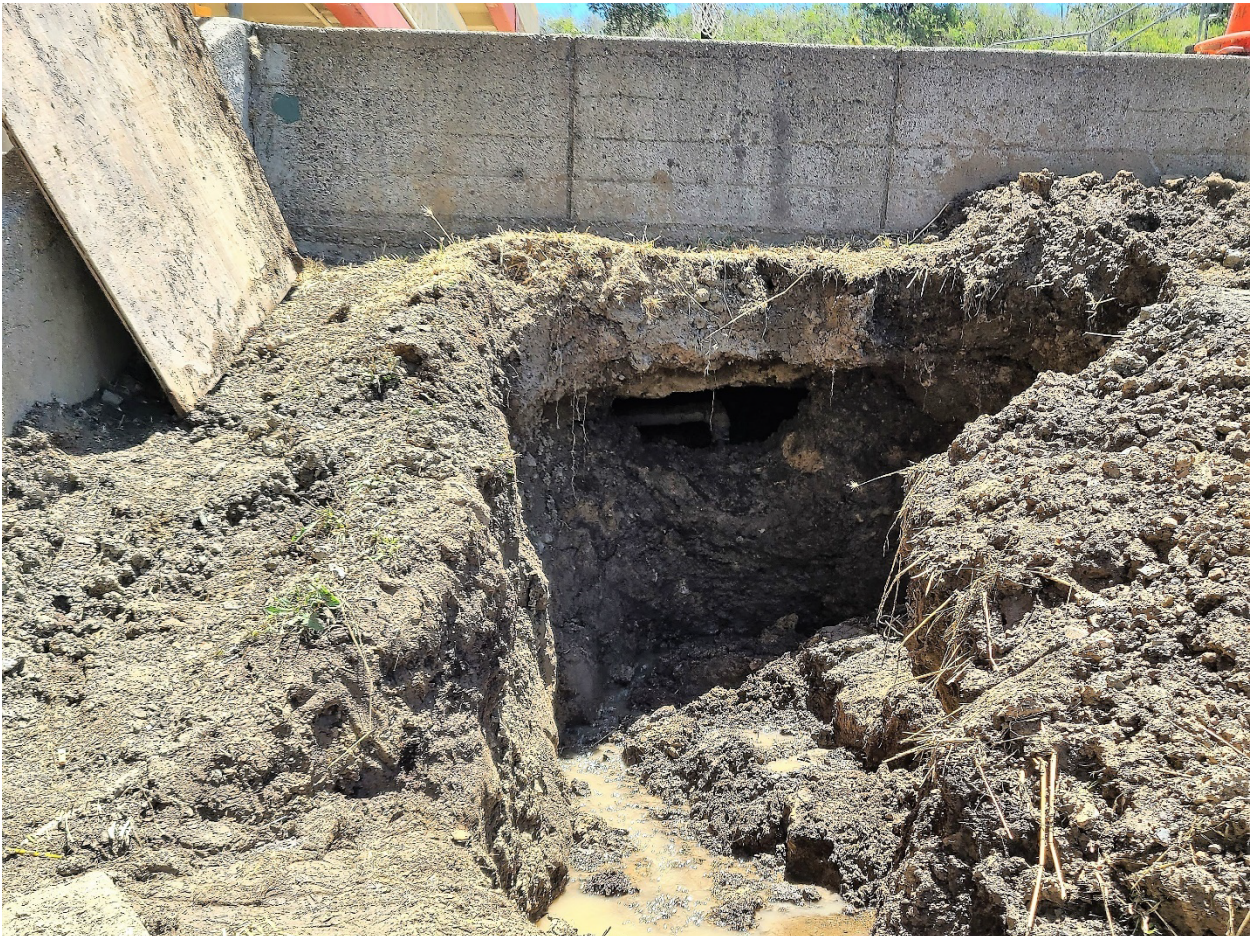
Figure 3. A close-up of the broken water main and the excavated area near 49 Cole Drive. Pentagonal terrace behind the concrete wall and concrete staircases at left behind the plywood and concrete wall. Looking southeast.

To avoid an adverse effect, restoration of the post-excavation groundcover should be in-kind with the rough character of the mixed species groundcover that existed prior to the undertaking to maintain the integrity of this character-defining feature. In addition, also to avoid an adverse effect, the topography surrounding the emergency repair should stay true to the existing steep slopes and be replaced in-kind with its pre-undertaking condition to sustain the integrity of this character-defining feature.

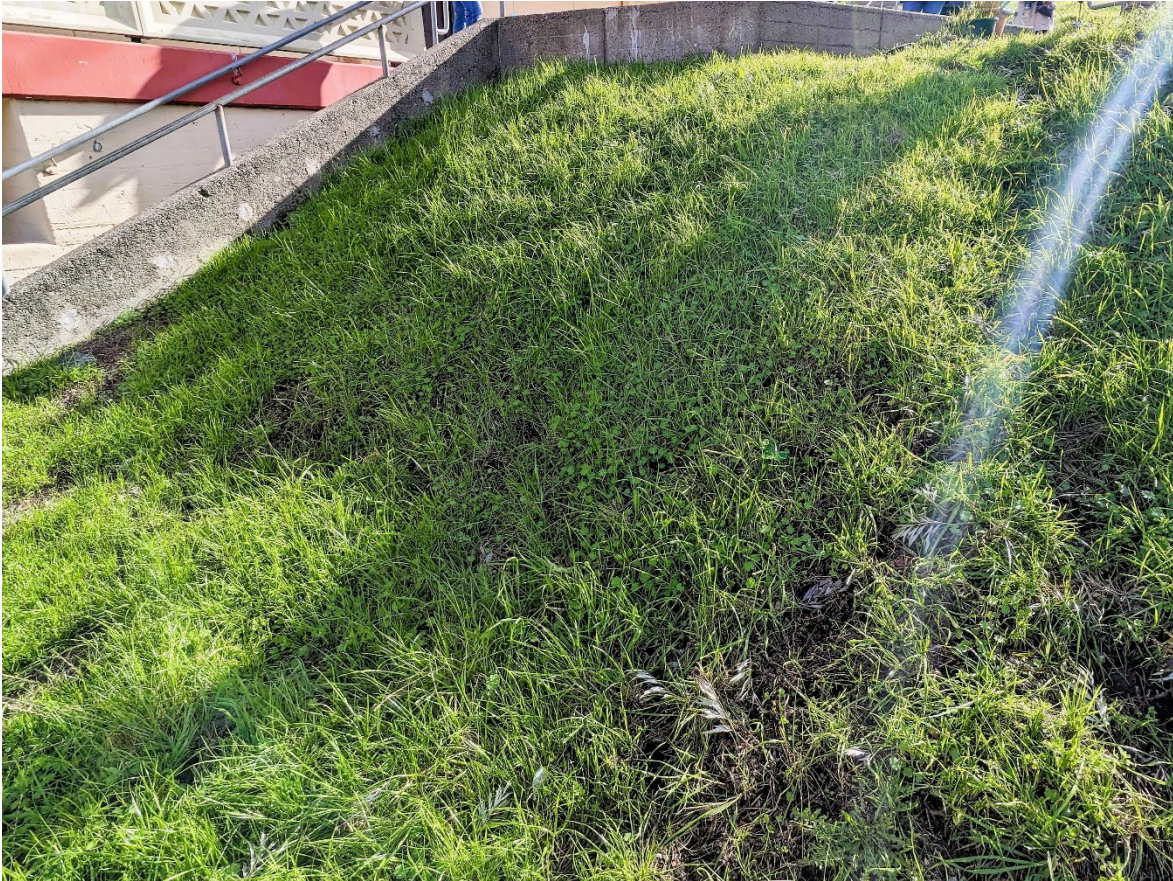
were disturbed but repaired and replaced in-kind and stays true to the area's steep topography with groundcover maintaining the "rough character" called for in Halprin's 1958 landscape planting plan (example i) (Figure 4). The undertaking does not constitute an alteration to the property. The undertaking is better characterized under example i above, damage or destruction to the property. The scope of work does not call for any rehabilitation of the property so conformance with the Secretary's Standards for the Treatment of Historic Properties (36 CFR part 68) is not applicable to this undertaking (example ii). The historic property would not be moved from its location (example iii). The undertaking would not cause a change of the setting within the historic district boundaries as the character-defining topography was repaired in-kind and the groundcover's "rough character" replaced with in-kind materials (example iv). The historic property will maintain its current use (example iv). The property would not be neglected as part of the undertaking (example vi) nor would it be sold, transferred, or leased out of federal ownership or control (example vii).

Figure 4. The location of the broken water main and the excavated area near 49 Cole Drive after work completed as of February 1, 2023. Looking southeast.
