# CHARACTER-DEFINING FEATURE STUDY

## GOLDEN GATE VILLAGE, MARIN CITY, CA

**September 2019**

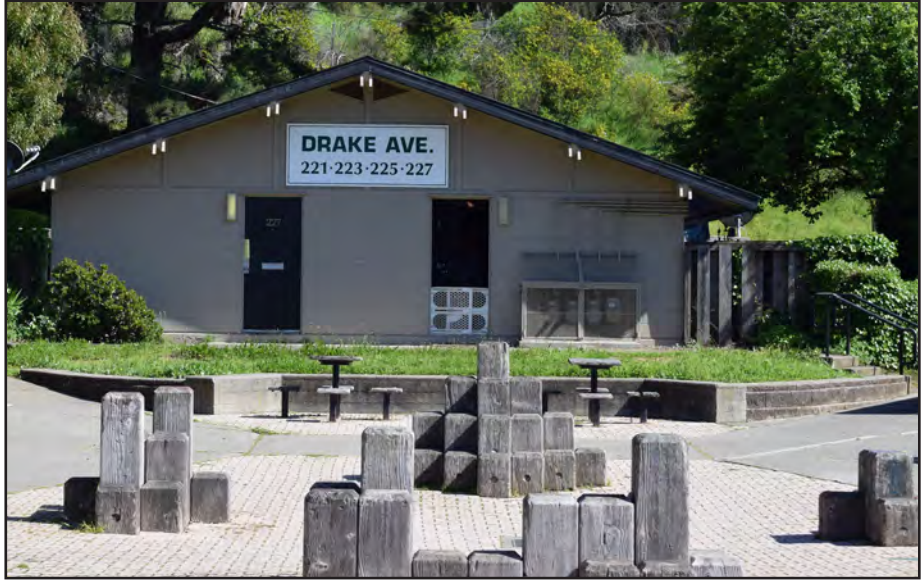
The location and spatial organization of the courtyards is extant, although the furnishings within the courtyards were redesigned in 1984.	1959-1961	Medium	
				Date Altered	Condition	
				1984	Good	
Landscape Characteristic	Feature	Photo	Description	Date Built	Integrity	
Cluster Arrangement	Location of the recreation cluster

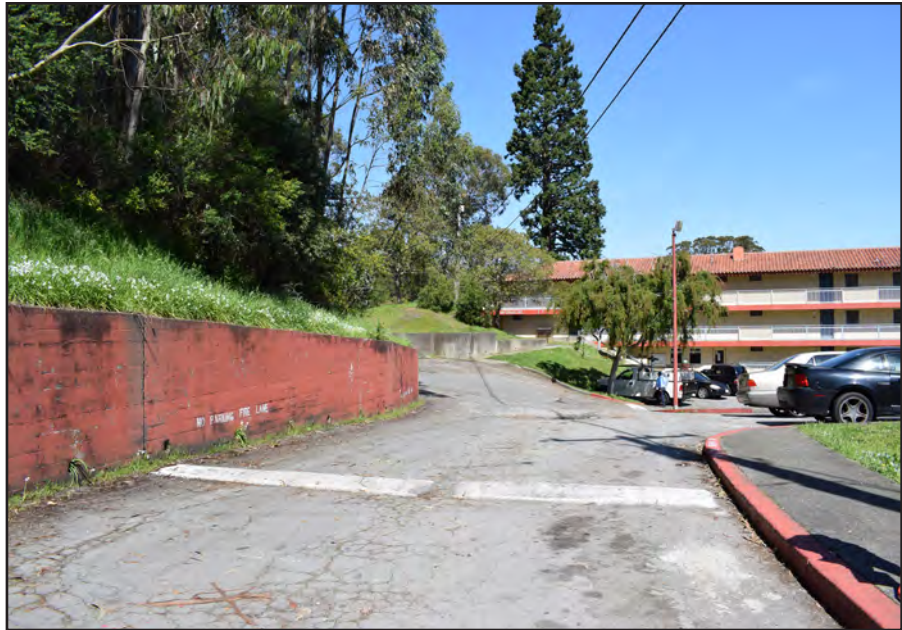
The alignment of the Service Road at the south edge of the property, including the parking terraces.	1959-1961	Medium
				Date Altered	Condition
				1993	Poor
Landscape Characteristic	Feature	Photo	Description	Date Built	Integrity
Circulation	Maintenance Service Road

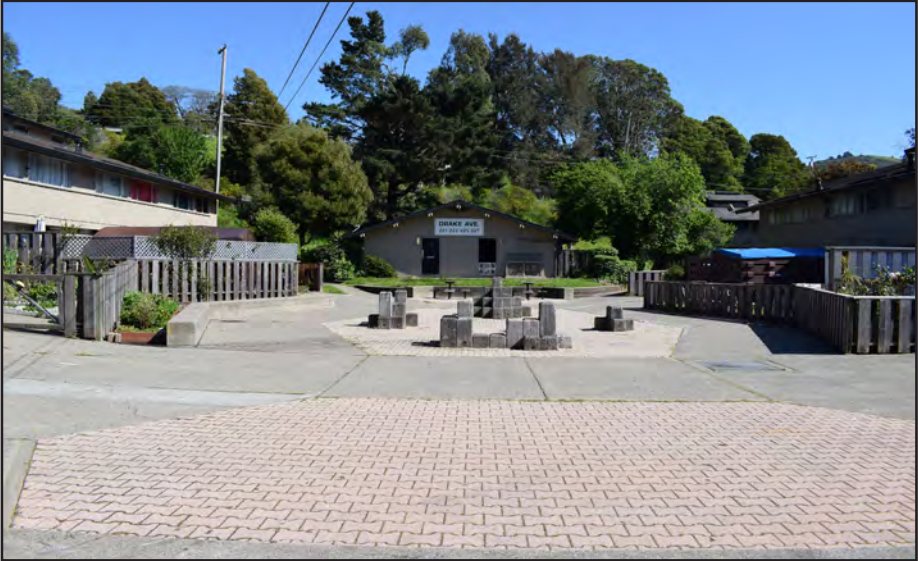
Framed vistas in and out of shared courtyards are extant, but have been altered by changes to small scale features and vegetation in the courtyard areas.	1959-1961	Medium
				Date Altered	Condition
				1974, 1984	Fair
Landscape Characteristic	Feature	Photo	Description	Date Built	Integrity
Views and Vistas	Long view toward high-rise buildings	 	Broad views from the recreation area cluster towards the high-rise cluster.	1959-1961	High
				Date Altered	Condition
				N/A	Good

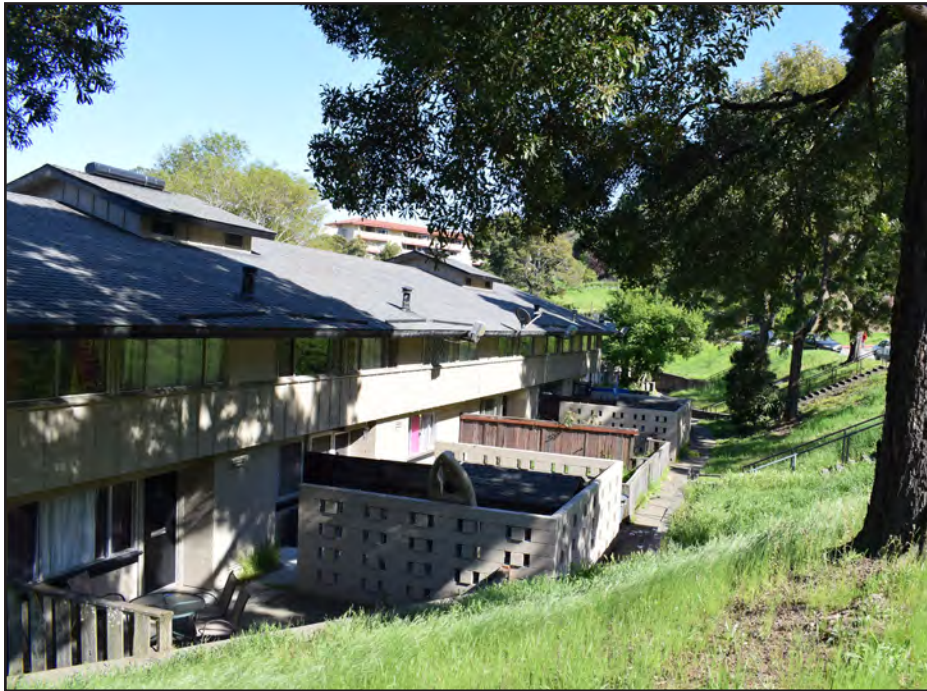
Combination of fence and enclosure types surrounding low-rise buildings, consisting of screen fences, low fences, wood service fences, and concrete block walls.	1959-1961	Medium
				Date Altered	Condition
				N/A	Fair

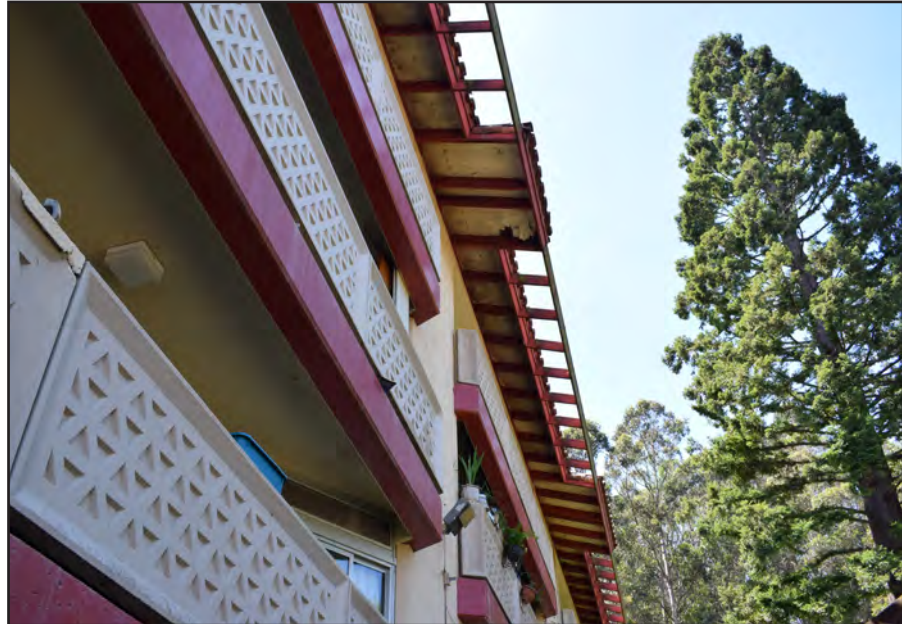
Precast concrete guardrails along open walkways and at private balconies.	1959-1961	Low
				Date Altered	Condition
				2005, On-going	Fair
