Date: April 7, 2021  
 File: 2120009

**RE: DRAPER SEPTIC OBS: 560 PIERCE POINT RD  
 INVERNESS, CA (APN 10—300-10)**

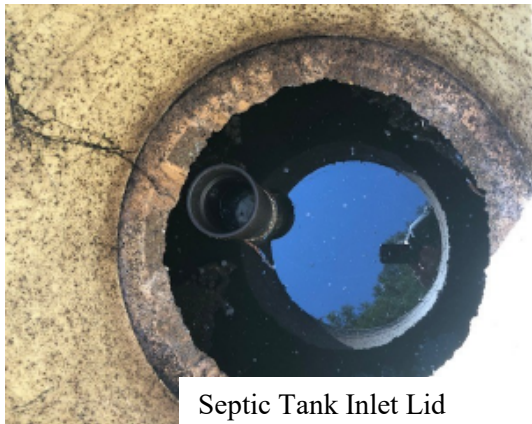
Wastewater from the building sewer flows into two (2) septic tank located below the northeasterly most building corner as indicated in the design plans. The concrete septic tank each had two (2) Orenco plastic risers with bolted-down lids. There was no significant scum or sludge build-up inside the tanks. There was no root intrusions or signs of excessive use within the risers. The septic tank capacities were 1500-gallons. The purpose of these septic tank is to help remove and breakdown solids and chemicals in the wastewater. Upon arrival at the site, wastewater was at the “working” level. The tanks are water tight and the internal baffle appeared to be intact. Plastic tees were visible in all tanks. A Zabel septic tank effluent filter was located in the outlet side of the 2<sup>nd</sup> septic tank. The purpose of this filter is to help remove suspended solids prior from wastewater effluent prior to the sump tank.

Septic Tank Inlet Lid

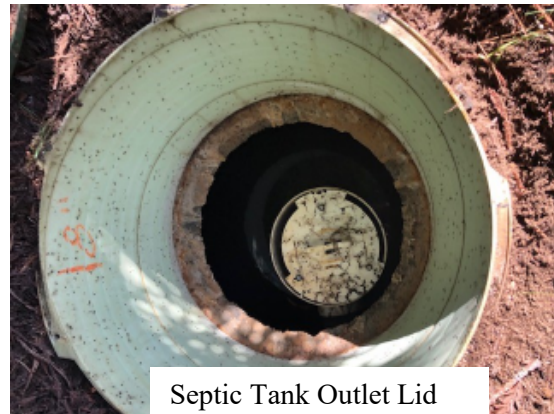
Septic Tank Outlet Lid

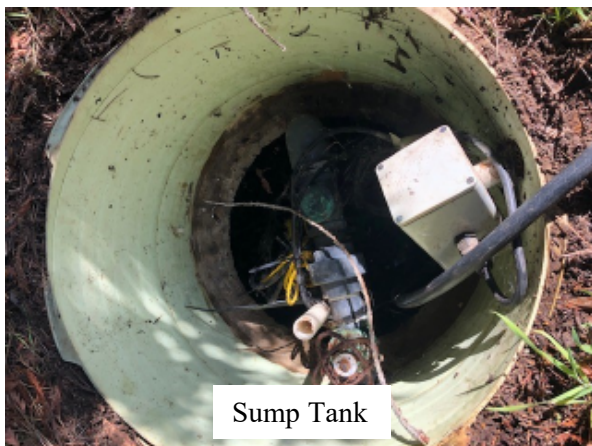
Sump Tank

mounted on a 4x4 wooden post. Excepting the audio high level alarm, the control panel was acceptable. A submersible pump, float switches, splice box, pressurized sewer pipe and appurtenances were visible inside the tank. Access to the tank is provided through a single Orenco plastic riser and bolted down lid. There was no visible root intrusion or signs of high water levels. The pump “on” and “off” float switch operations were acceptable. The high level alarm float switch did not activate the audio/visual alarm in the control panel. Based on observation and the design plans, there is over 1,000 gallons of emergency storage capacity in case of power outage or pump failure.

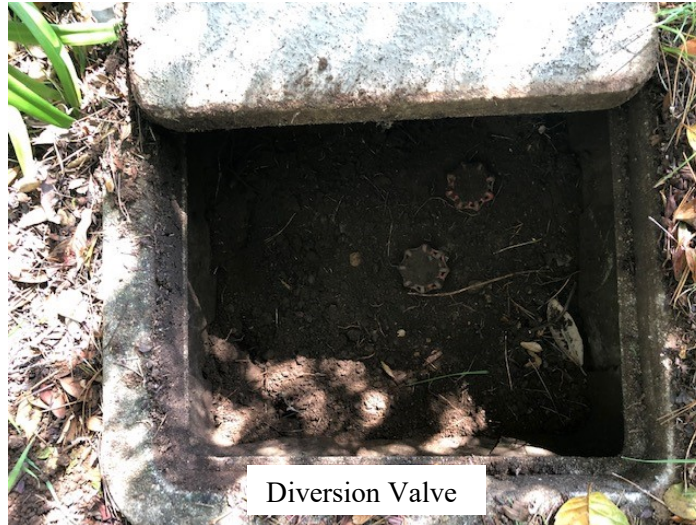
The two (2) brass gate valve were operational. Upon arrival, one (1) valve was open and the other closed. As part of the load test, the valve positions were alternated such that the northerly most field is active.

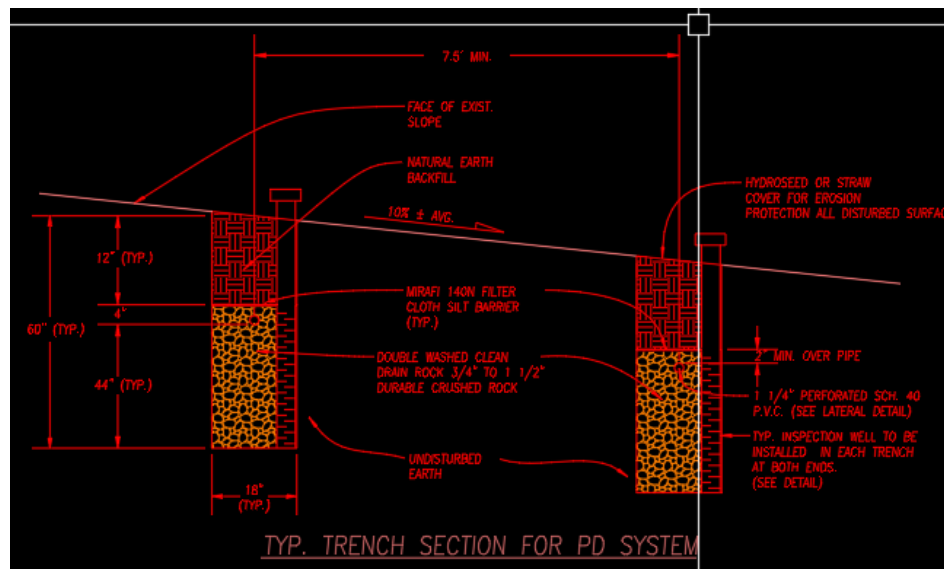
The leach field locations are generally indicated in the design plans. Monitoring wells, gate valves, and boxes for purging are located at the ends of each leach line. There was no “striping” over the leach lines and the ground was firm to the step. Based on the design plans, a typical leach line section is indicated below. There is approximately 100 linear feet of leach line per field.
