Client: Ken Hayes
Project Location: 200 Keith Way, Inverness, CA
Inspection Date: August 25, 2023
Arborist: Ben Anderson

URBAN FORESTRY ASSOCIATES, INC.

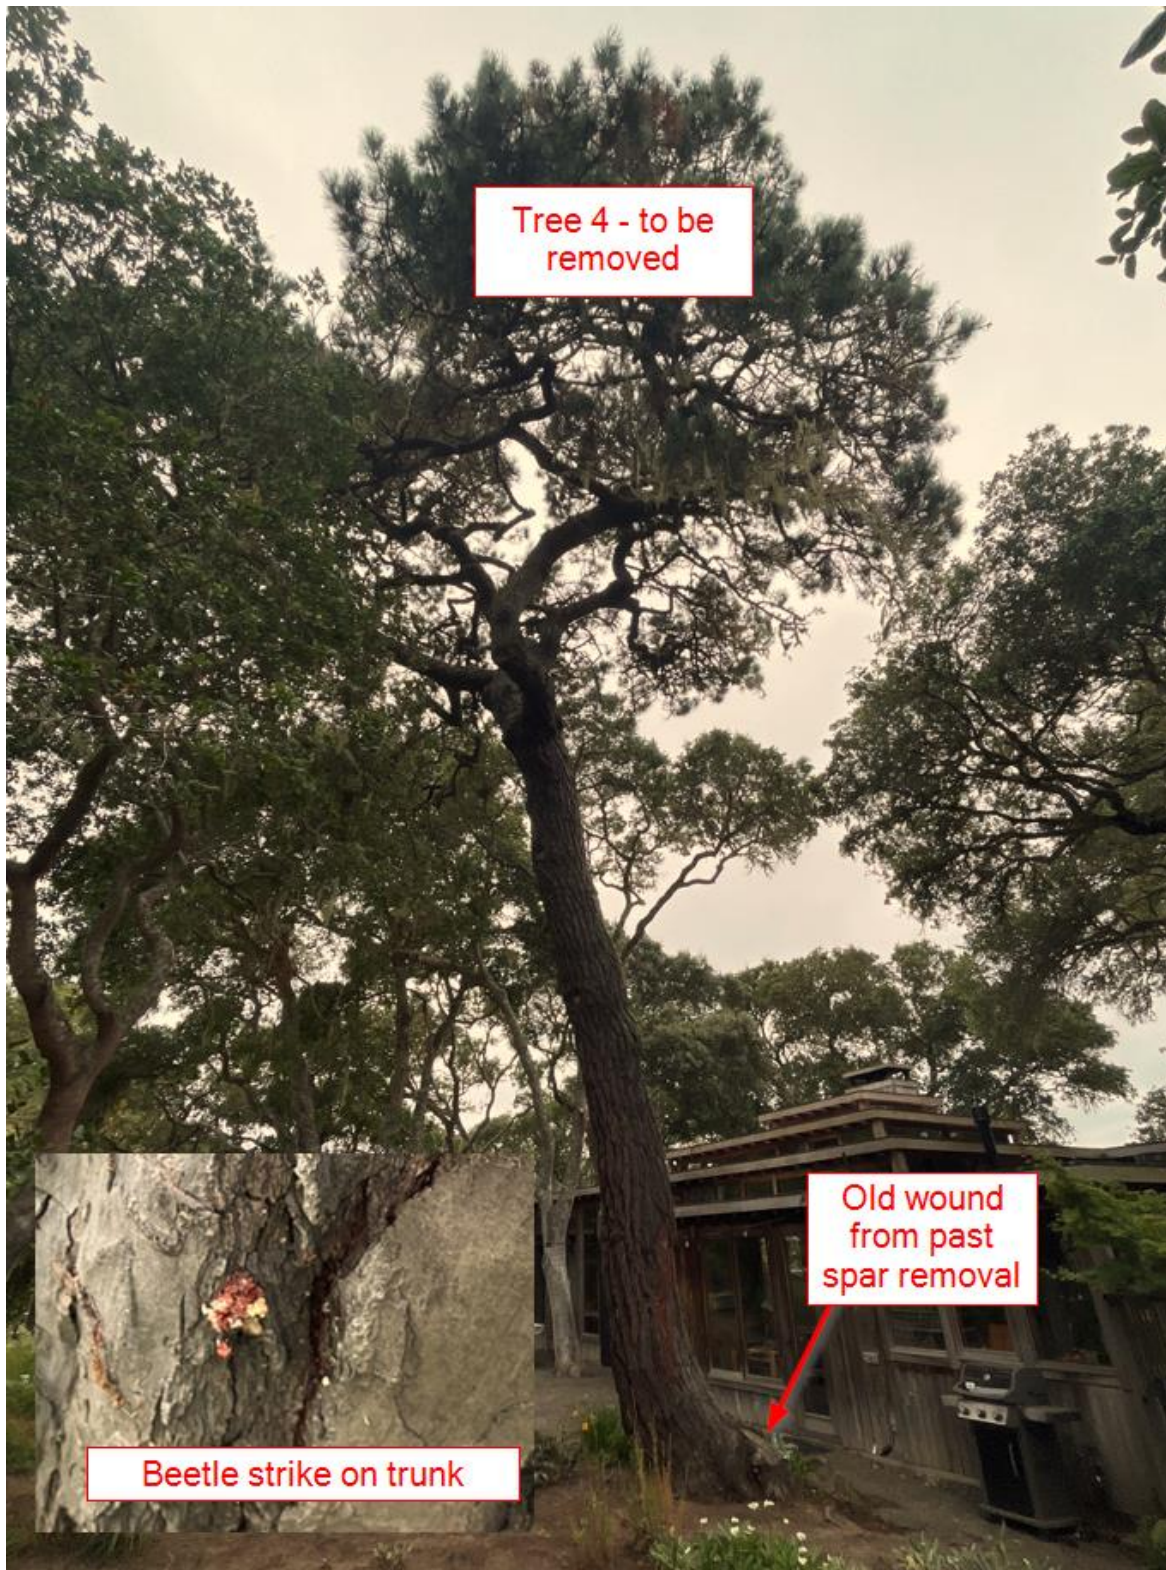
Figure 1. Tree 4 is to be removed to accommodate the proposed addition. This is an unnaturally old Bishop pine with beetle activity in the trunk.

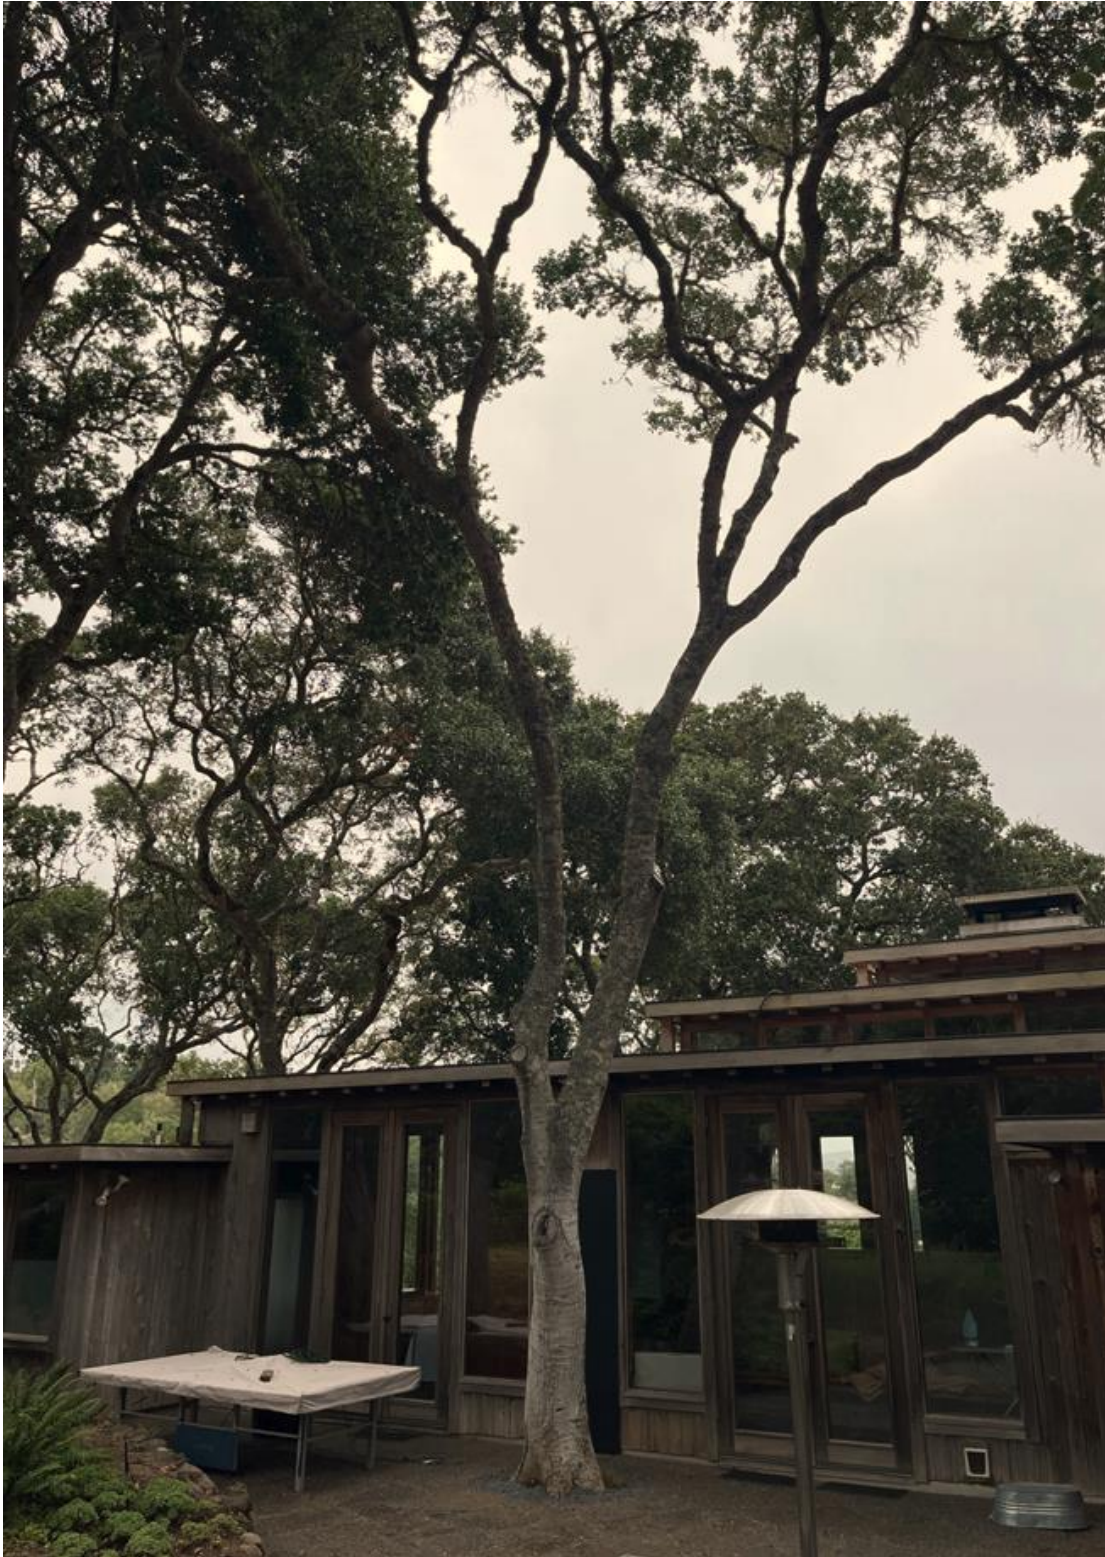
Figure 2. Tree 5 which may be impacted by the replacement of the patio over the root system. The new patio has yet to be designed but will require input from the arborist.

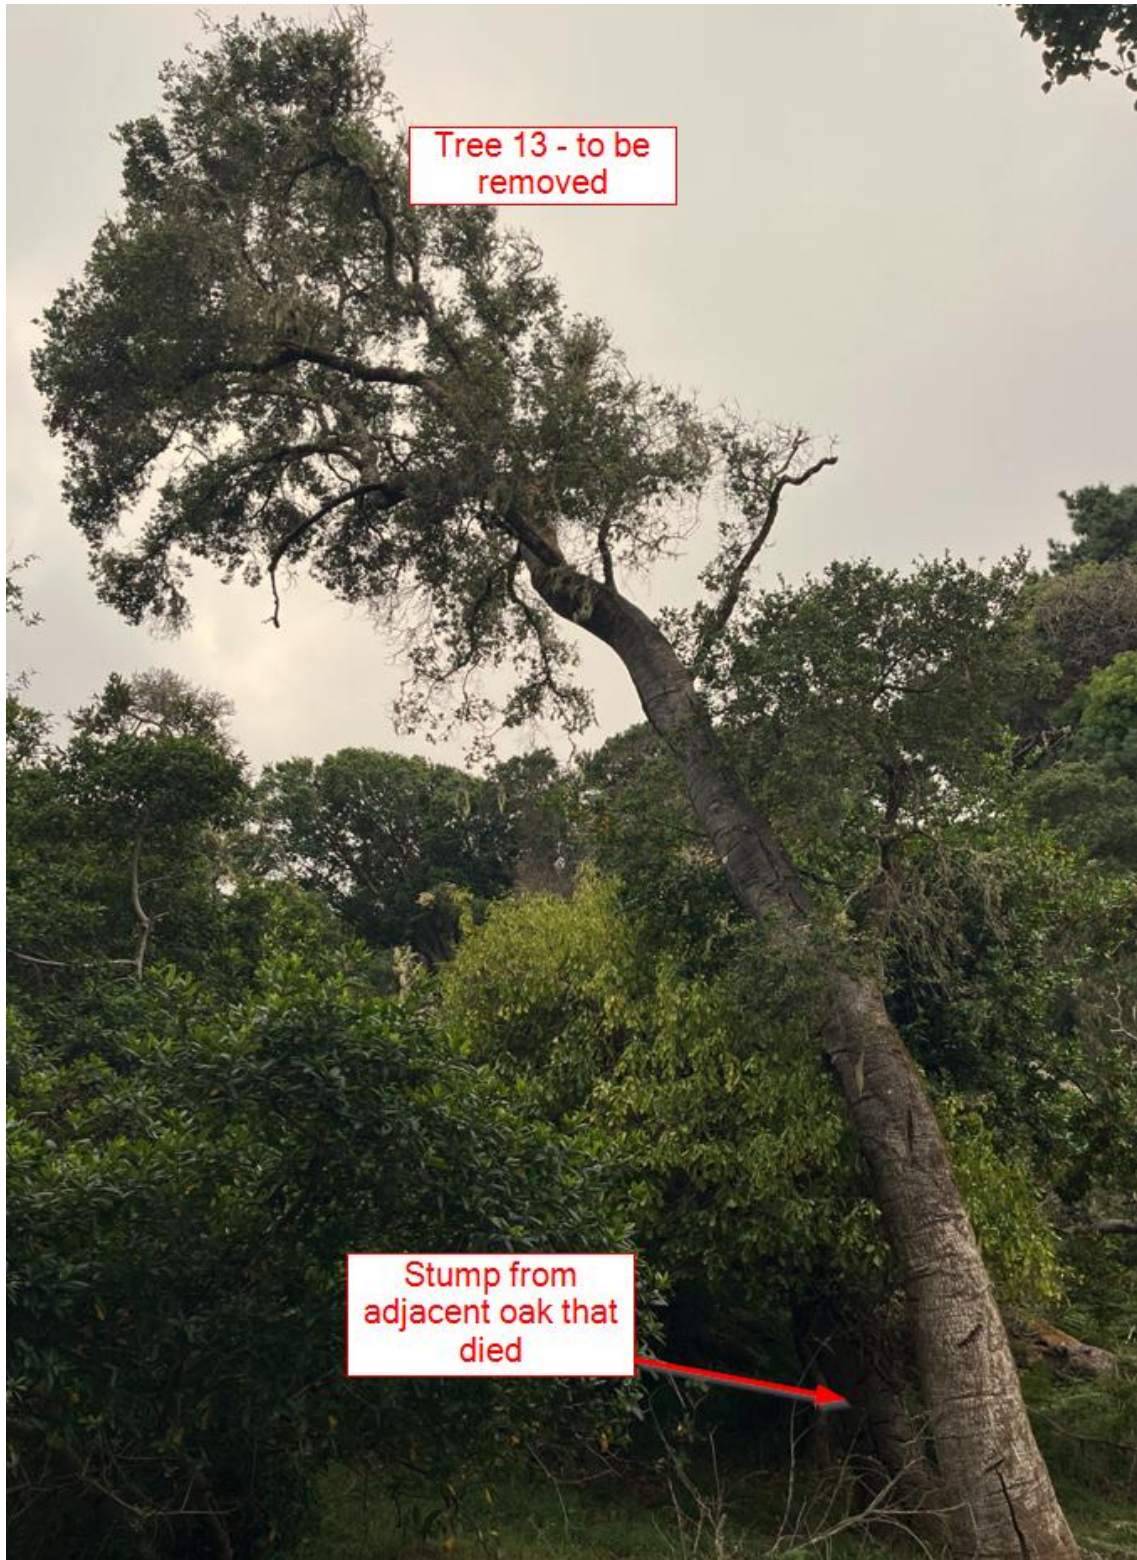
Figure 3. Tree 13 that is to be removed to accommodate the ADU. The tree has an odd form as it used to be an interior tree.

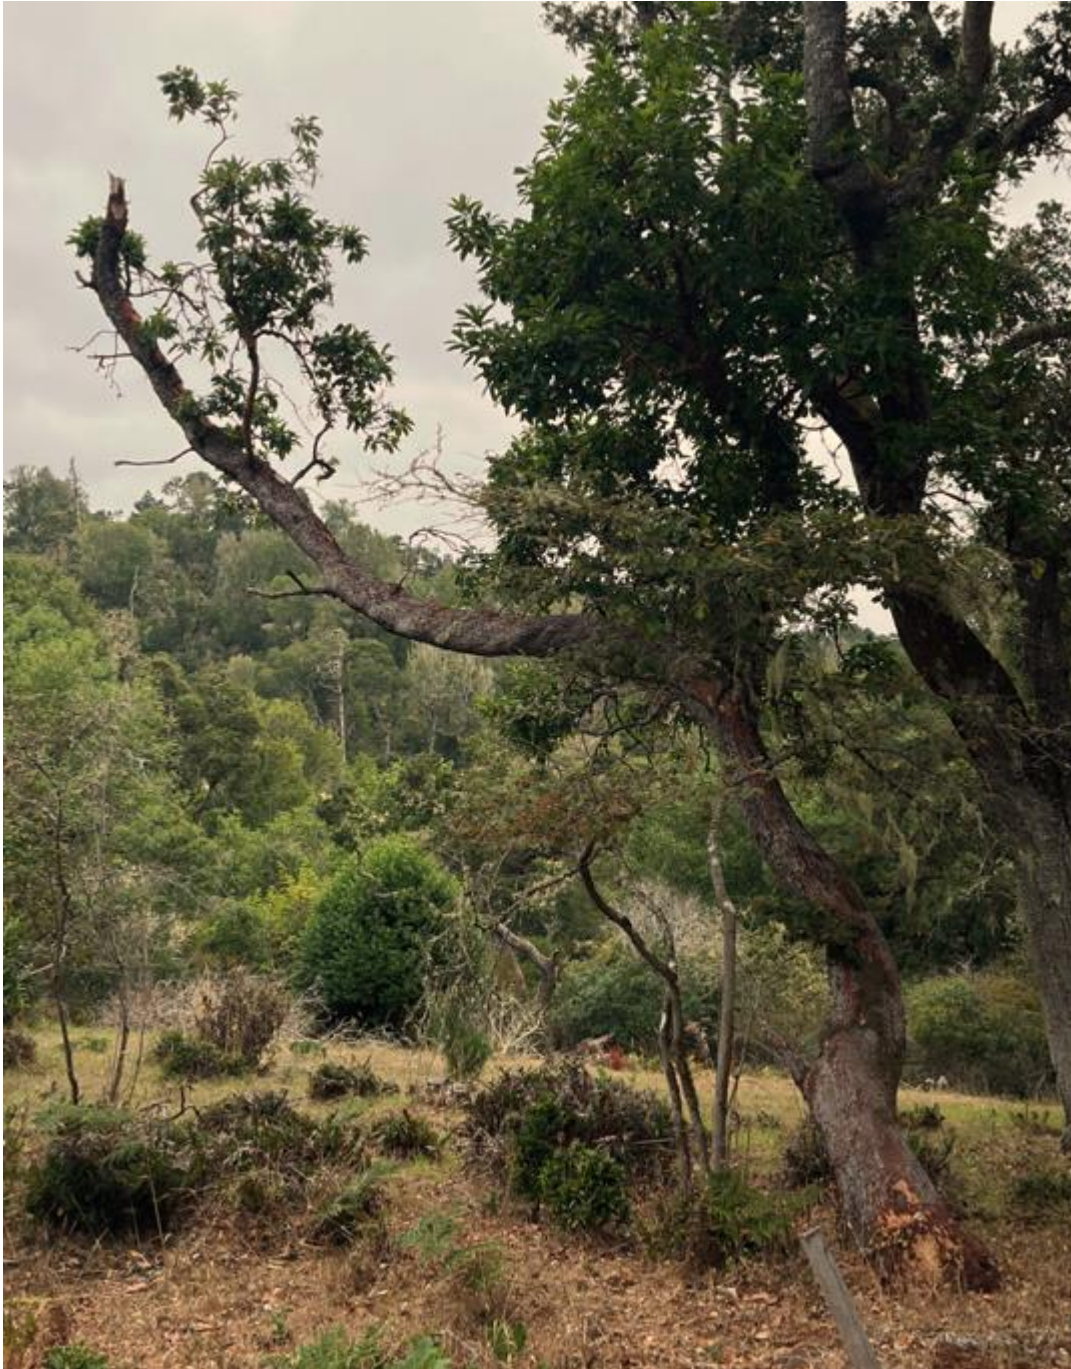
Figure 4. Tree 14 is a madrone in poor condition to be removed to accommodate the ADU. This is not a heritage tree (not major vegetation).

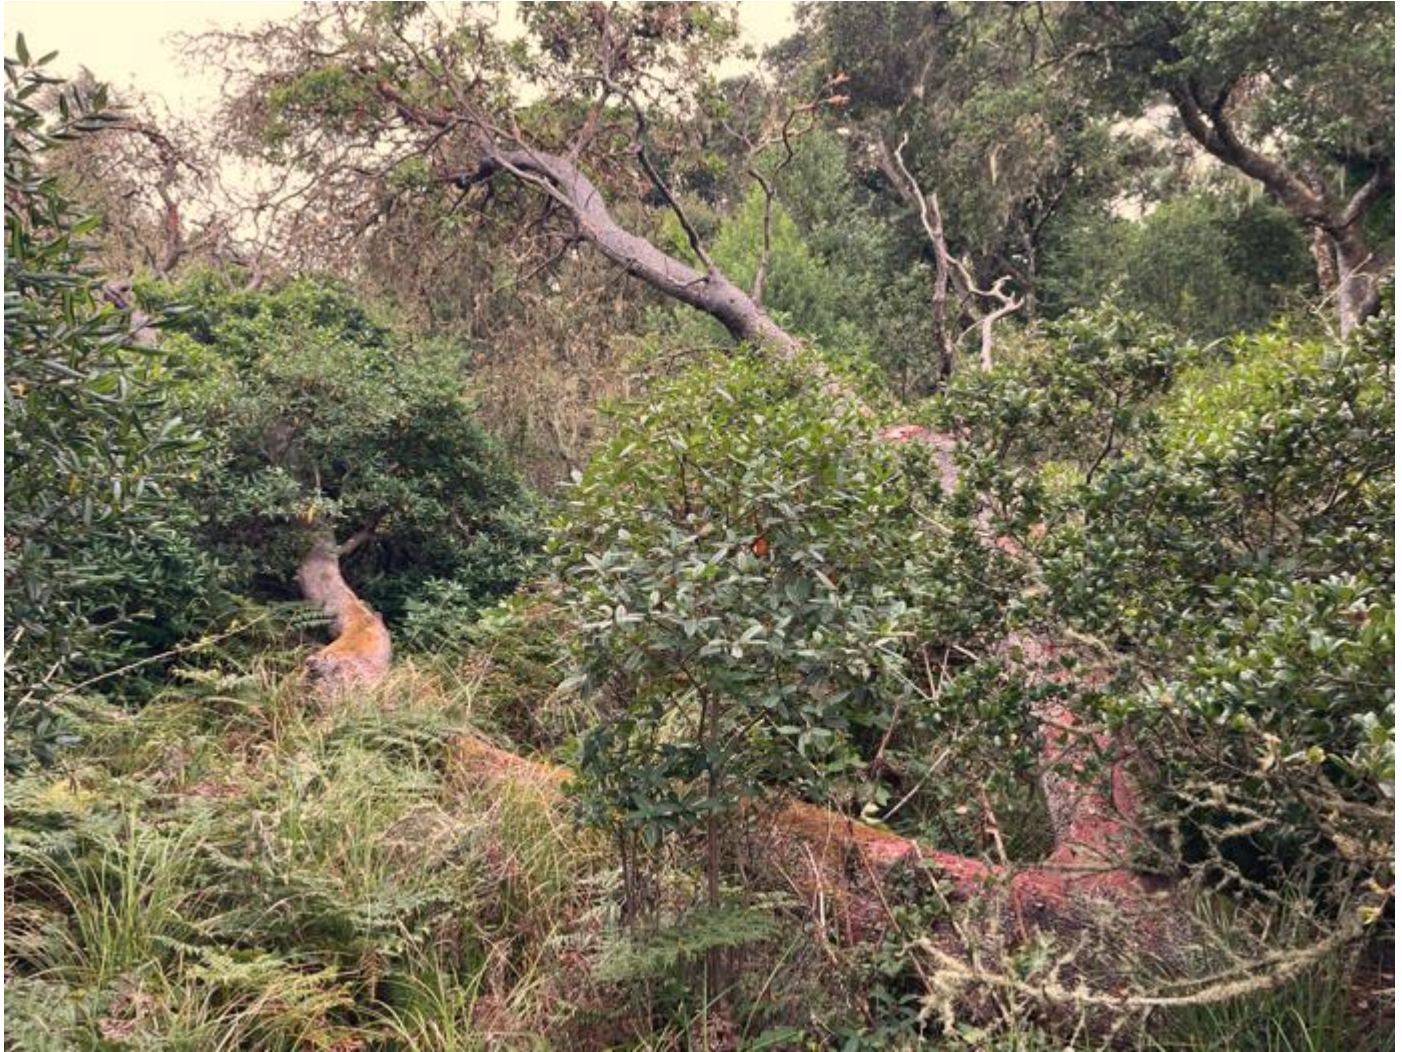
Figure 5. Tree 16 is a madrone that previously failed from the roots and remains barely alive. It is to be removed to accommodate the ADU. This is not a heritage tree (not major vegetation).

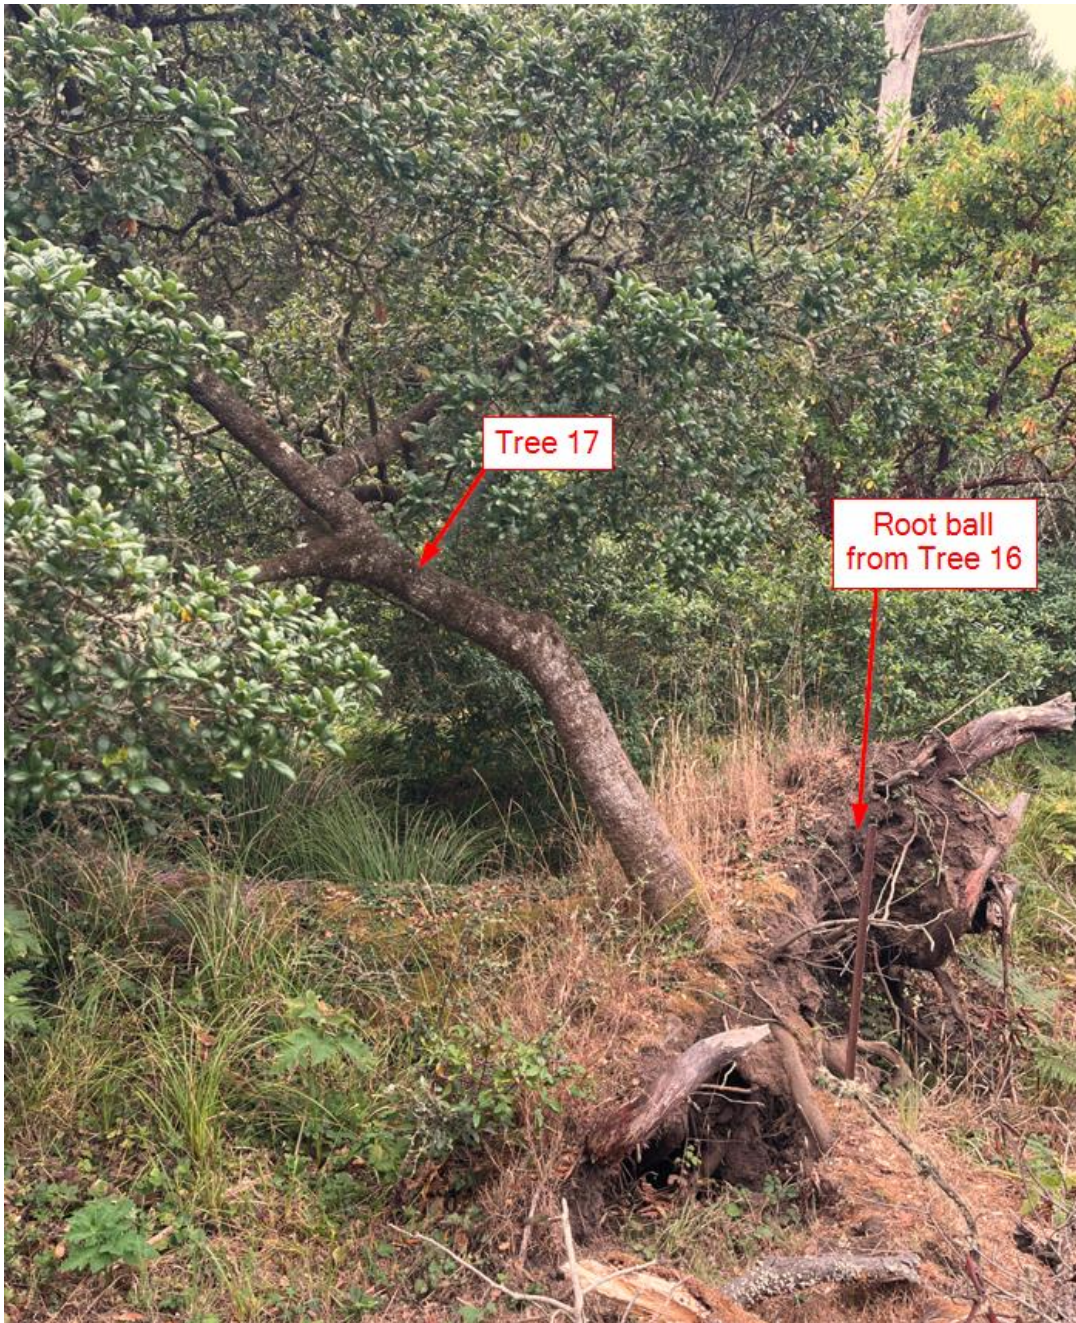
Figure 6. Tree 17 growing out of the root ball of Tree 16. Both are to be removed for the ADU and neither is a heritage tree.
