**COUNTY OF MARIN
COMMUNITY DEVELOPMENT AGENCY
PLANNING DIVISION**

February 5, 2020

RE: The Seminary- Arborist Report Addendum

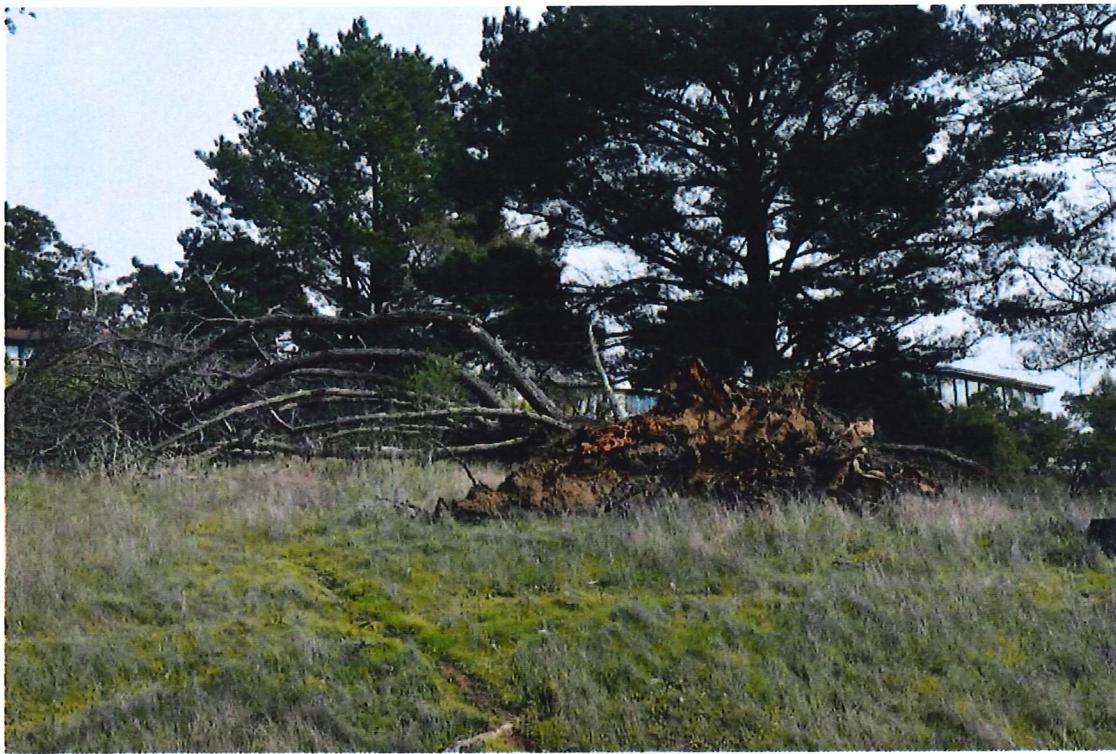
Recent failure near adjacent residences.

The removal of the pines and the area of dense acacia is recommended as soon as practical. Priority for removal should be trees within fall distance of roadways, structures, and other high use areas. It is worth noting that in the pine area west of the Chapel Hill residences, there are vigorous stands of young coast live oaks. These stands should be protected during the pine removal operations and encouraged as the preferred replacement woodland.

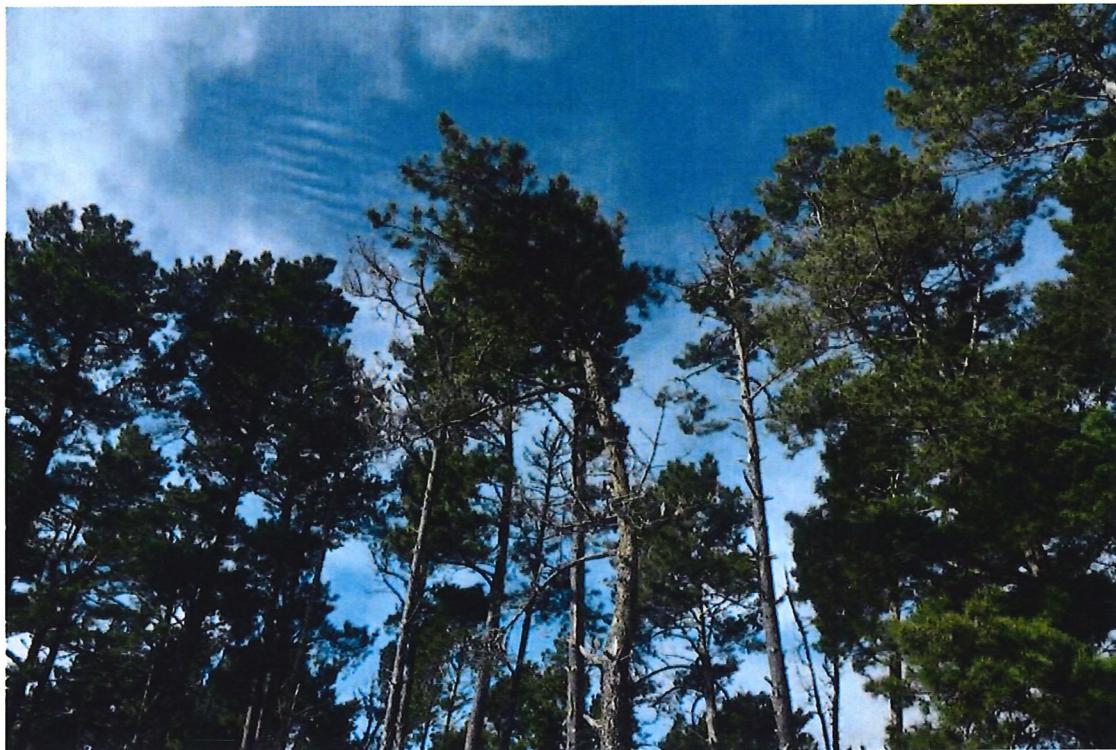
Dead, standing trees near roadway.

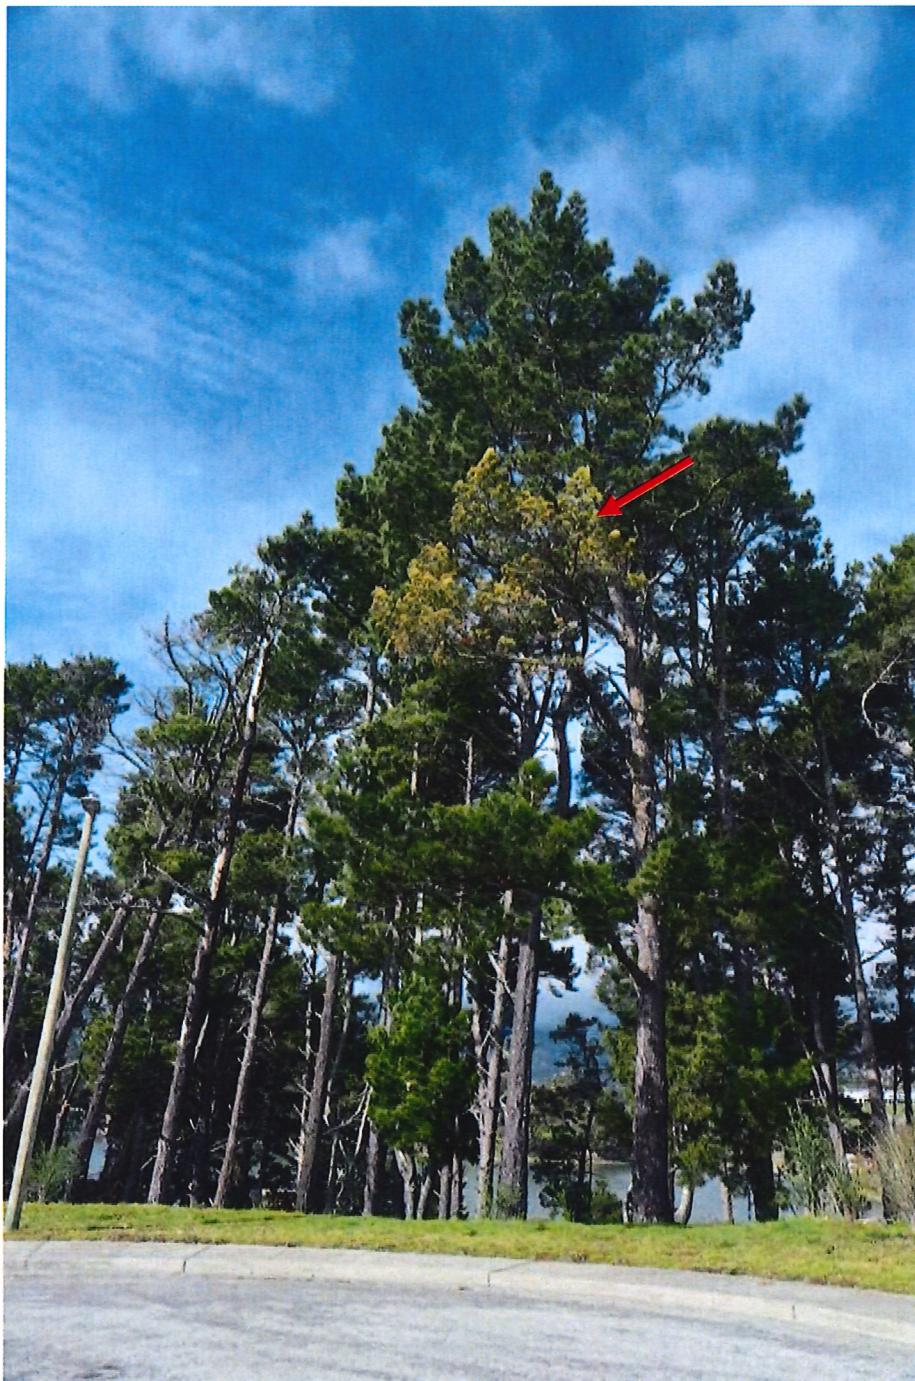
Tree in decline from Ips beetle attack. Other dead trees nearby.

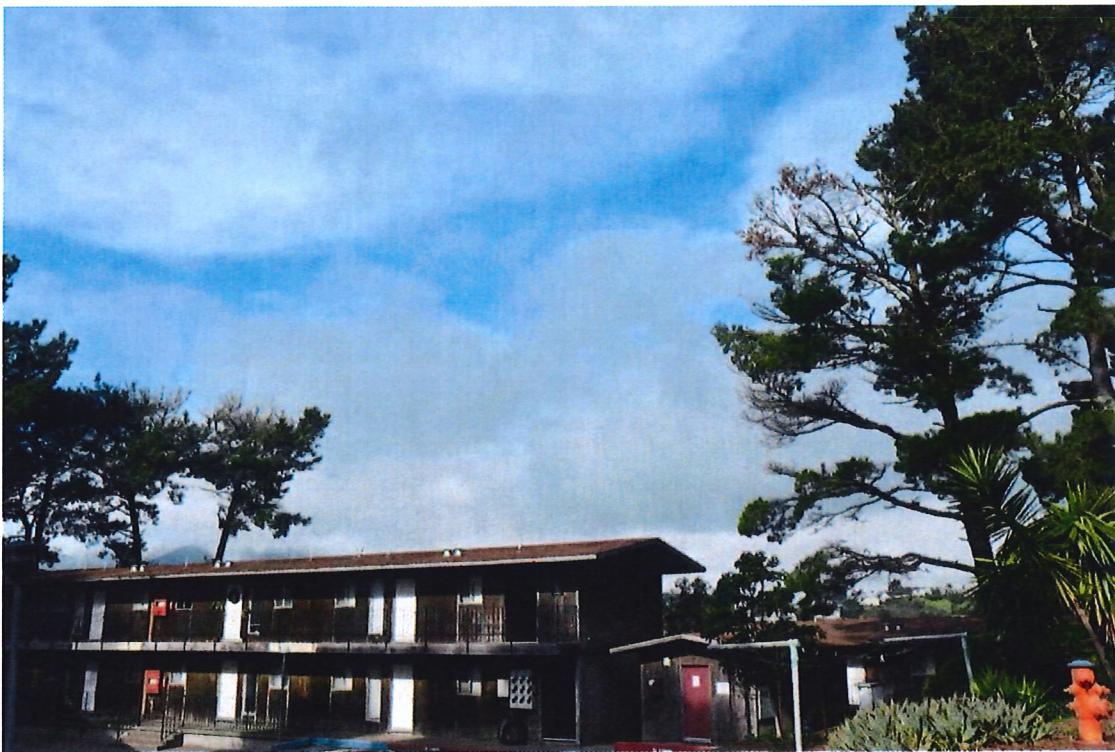
Declining trees near Chapel Hill residences.

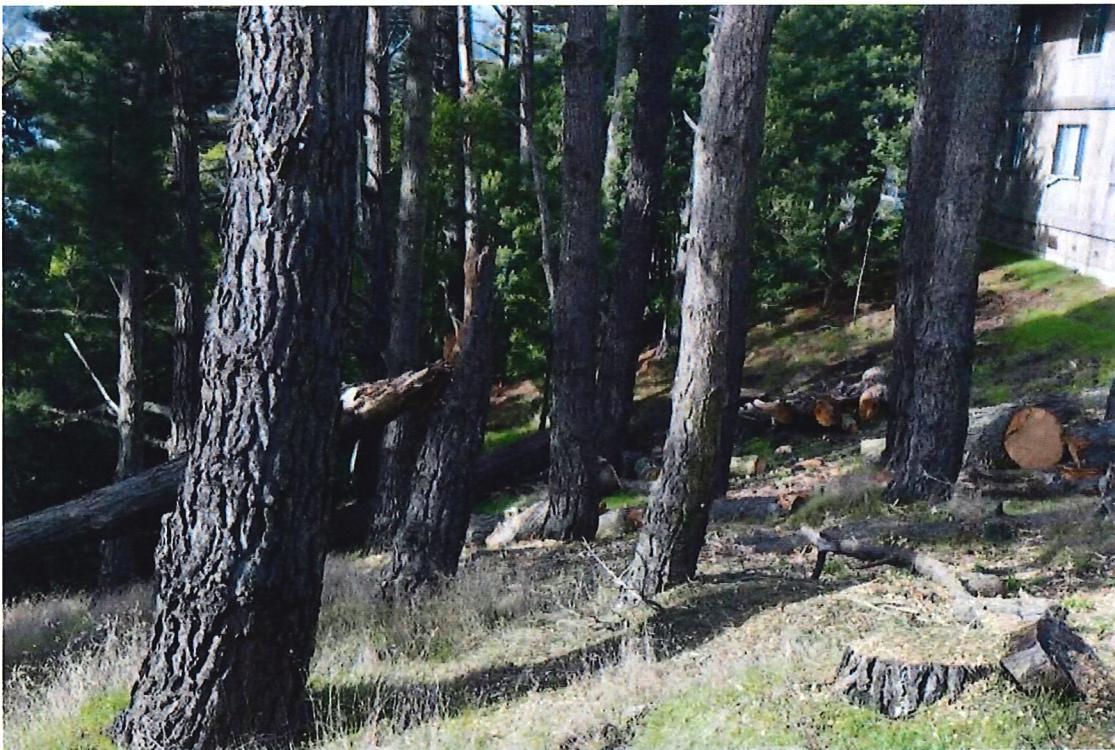
Trunk failure of tree and trunk sections from removed trees at Chapel Hill residences.

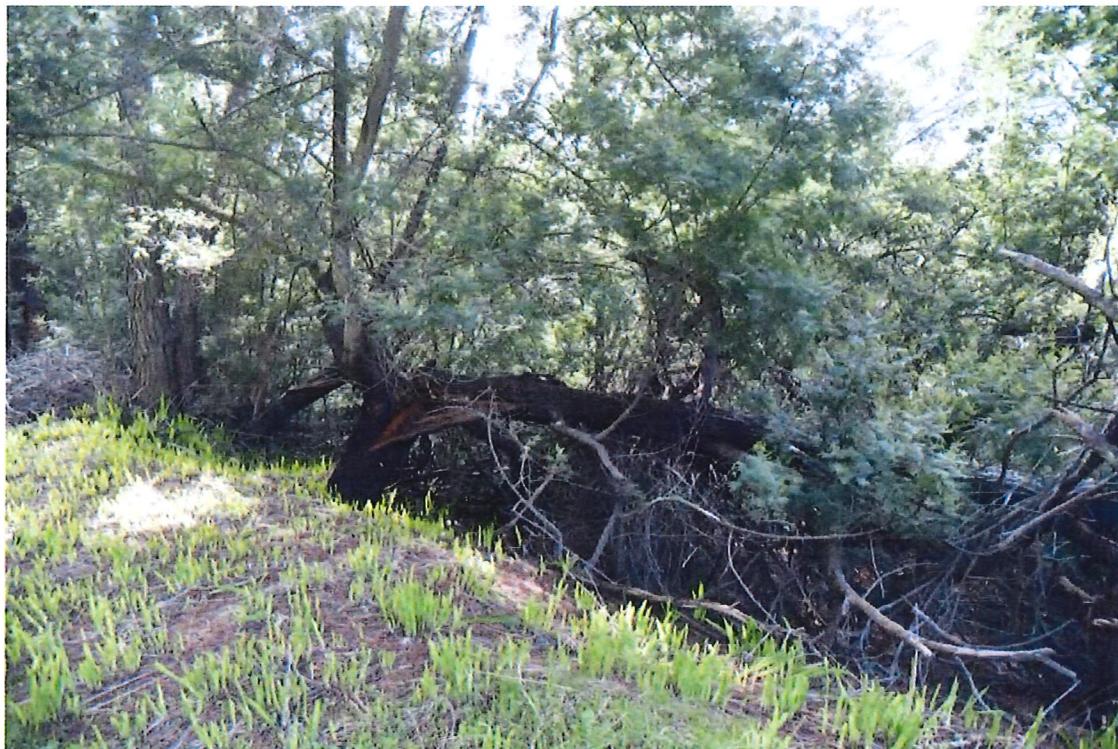
Collapsed pine in area of dense acacia.

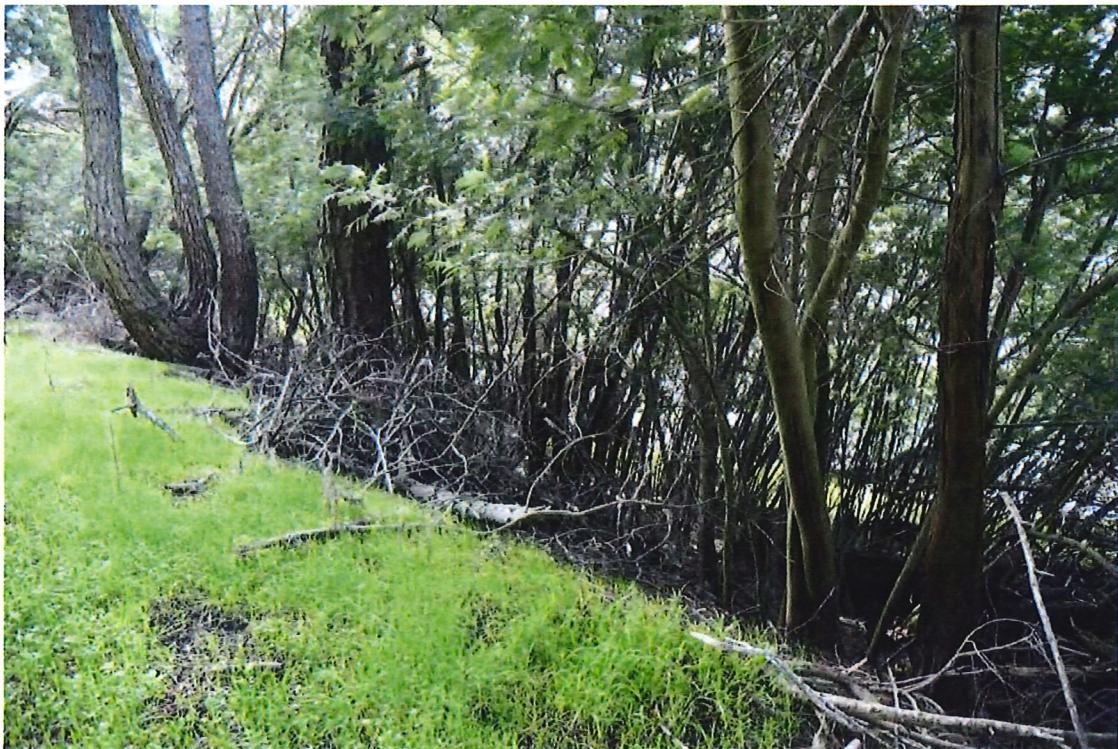
Another critical management issue affecting the pine woodlands is fire safety. These dense and over-mature pine woodlands are pyrophytic and very prone to wildfire ignition due to the type of tree (coniferous with high pitch content), the number of dead limbs, dried foliage litter, and high density of trees. Current defensible space standards would not permit the planting of pine species in the proximity of structures. In the area east of the Chapel Hill residences, dense acacia is growing below declining pines and represents a potentially severe fire hazard.

Dense acacia thickets growing below declining Monterey pines.

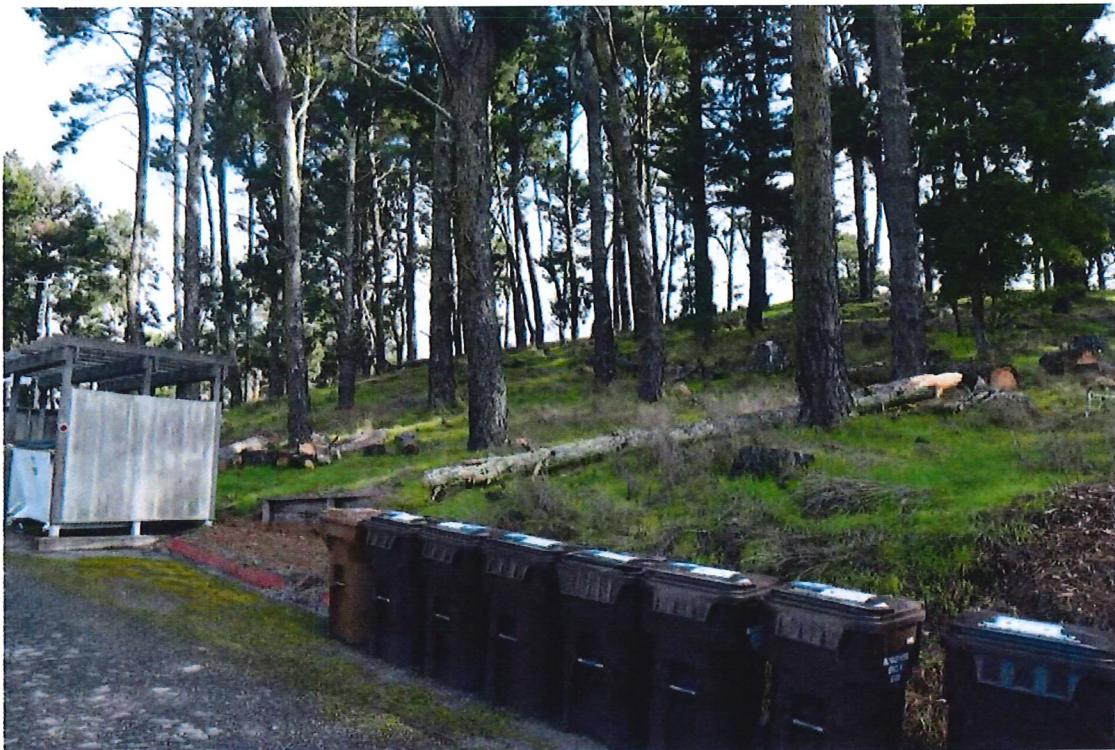
Trunk failure of pine near parking lot.

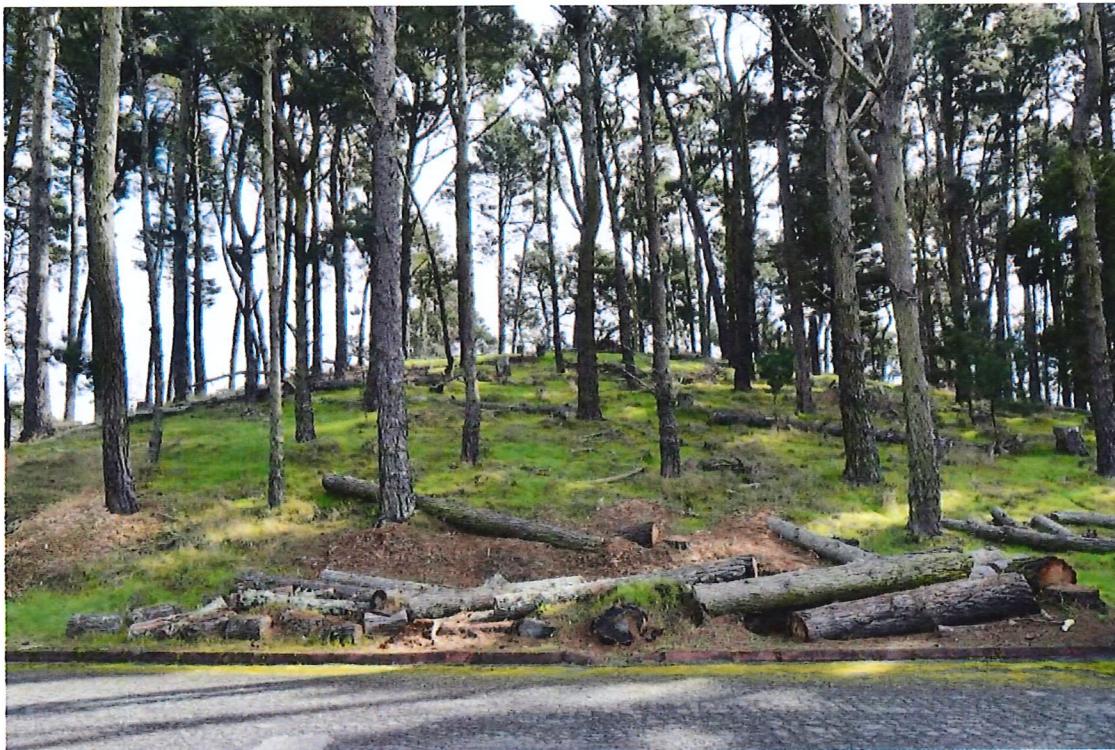
Image depicting the high level of tree mortality and whole tree failures.
