November 27, 2023  
File: 3555.001ltr.doc

Re: Geotechnical Evaluation Report  
20 Oak Road (APN 191-261-21)  
Bolin, California

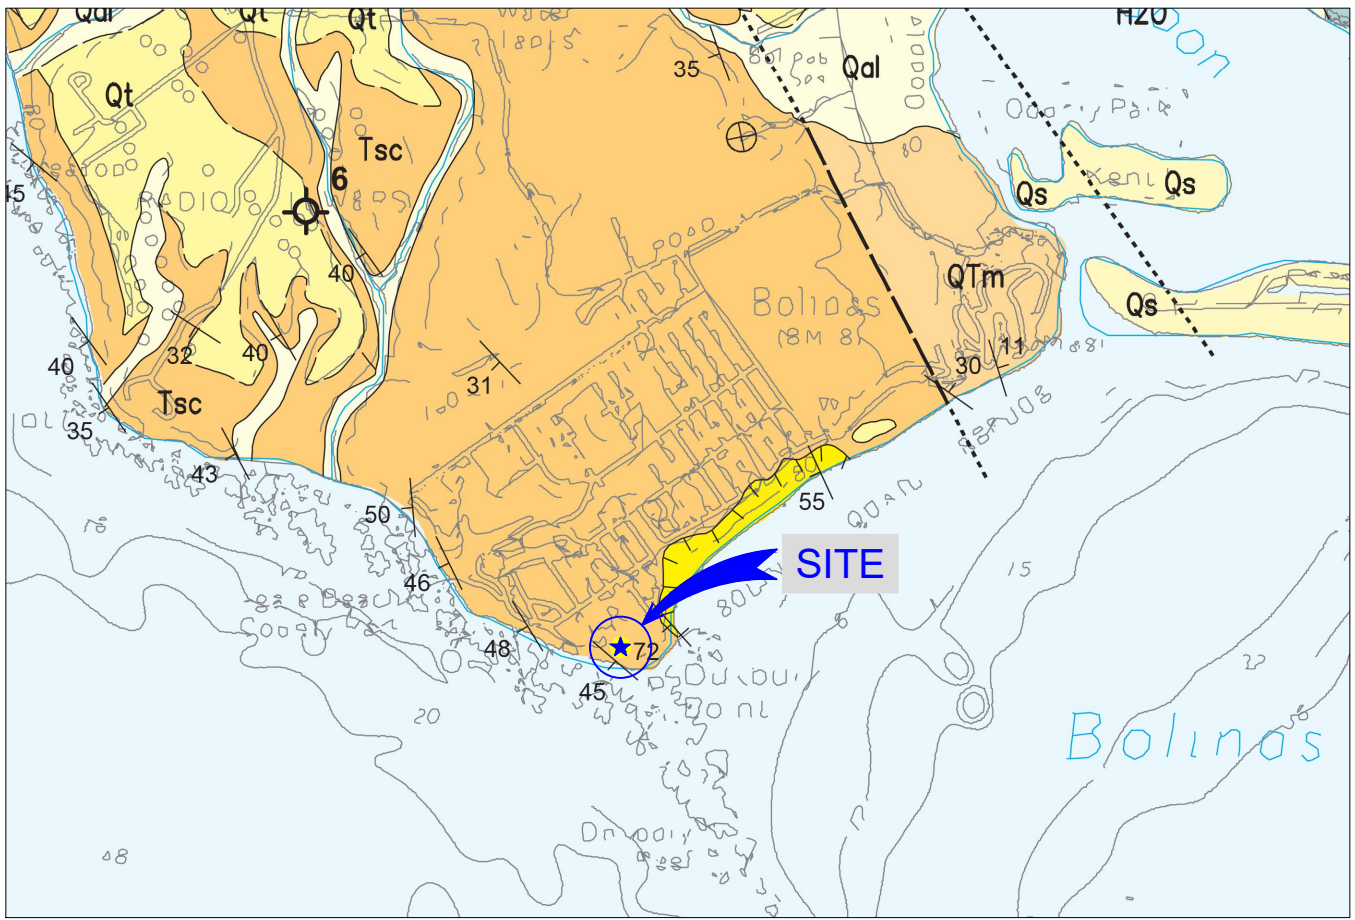
### REGIONAL GEOLOGIC MAP

Regional geologic mapping<sup>1</sup> indicates the site is located at the edge of a coastal bluff and underlain by Miocene-aged Santa Cruz mudstone bedrock. Quaternary-aged landslide deposits are mapped along the bluff to the east of the project site. Quaternary-aged marine terrace deposits are mapped along the bluff edge to the northwest of the project site. Santa Cruz Mudstone bedrock typically consists of thin- to thick-bedded and faintly laminated olive-gray to pale-yellowish-brown siliceous mudstone. Marine terrace soils consist of weakly consolidated, variably sorted sand, silt, and gravel deposited on stream- and wave-cut surfaces. A regional geologic map is shown on Figure 3.

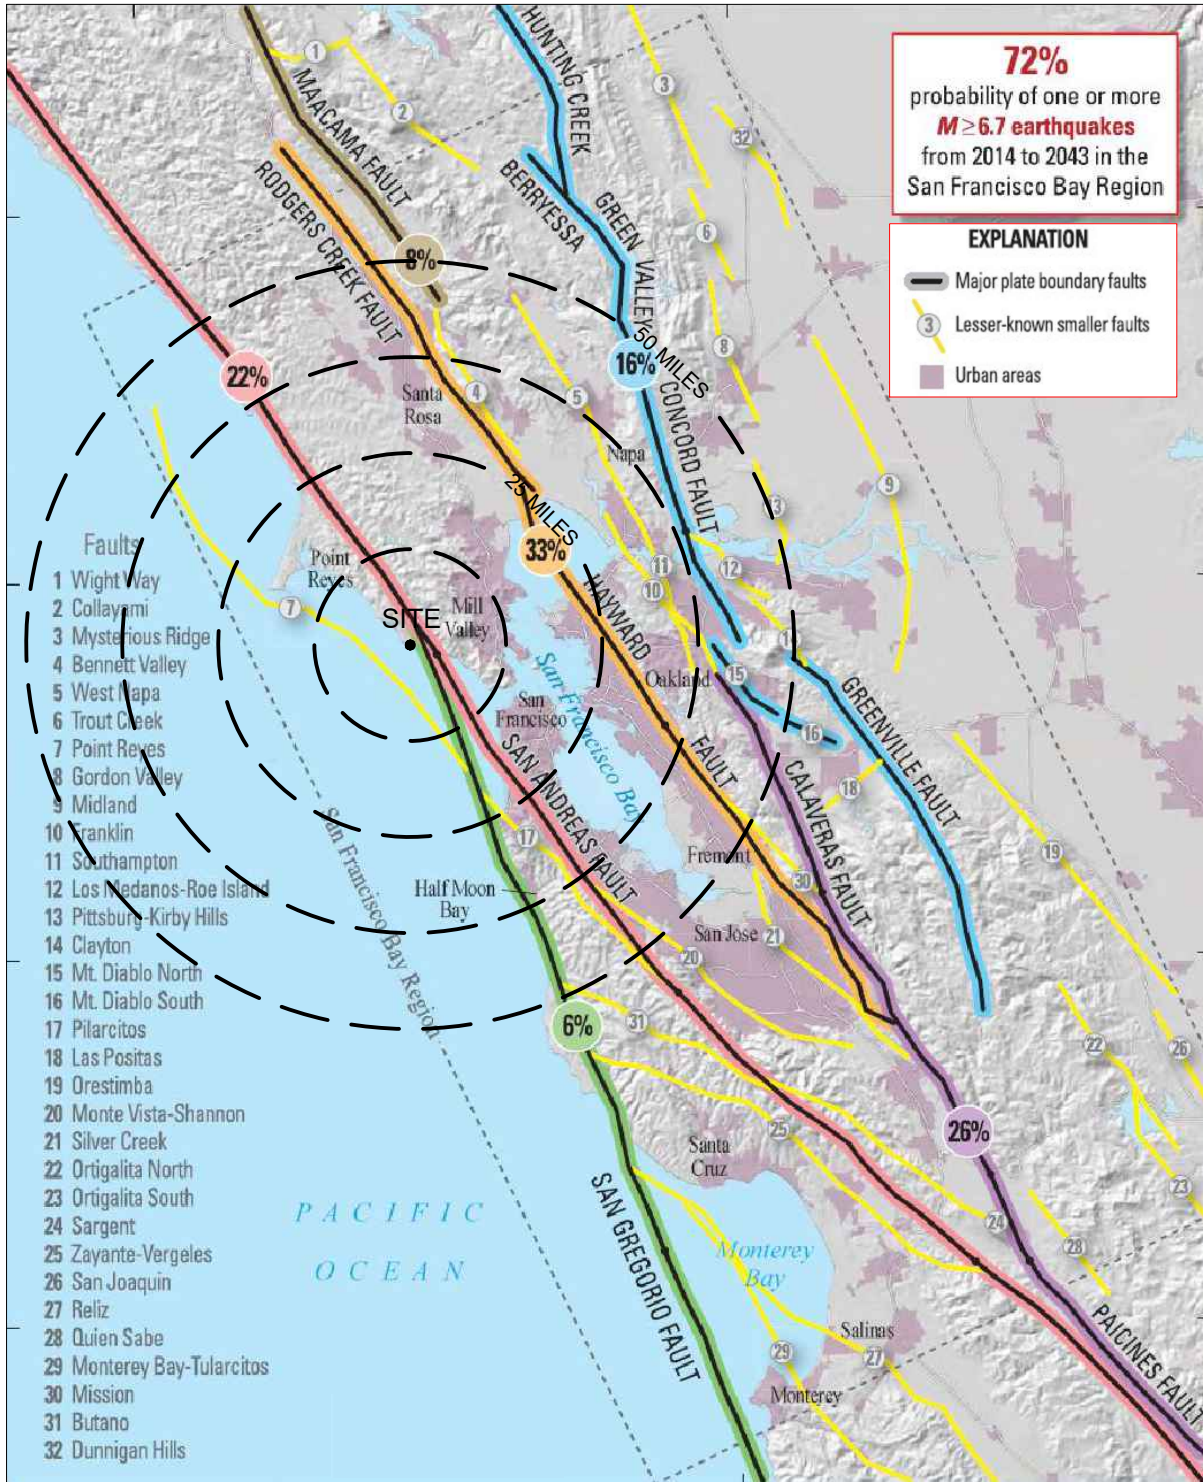
**ACTIVE FAULT MAP**

The site will likely experience seismic ground shaking from future earthquakes in the San Francisco Bay Area. Earthquakes along several active faults in the region, as shown on Figure 4, could cause moderate to strong ground shaking at the site. A map of historic earthquake activity is presented on Figure 5. The intensity of ground shaking will depend on the characteristics of the causative fault, distance from the fault, the earthquake magnitude and duration, and site-specific geologic conditions. Estimates of peak ground accelerations are based on either deterministic or probabilistic methods. For residential developments, deterministic methods are typically used.

The potential for strong seismic shaking at the project site is high. Due to their proximity, the San Andreas and San Gregorio Faults present the highest potential for severe ground shaking. The significant adverse impact associated with strong seismic shaking is potential damage to structures and improvements.

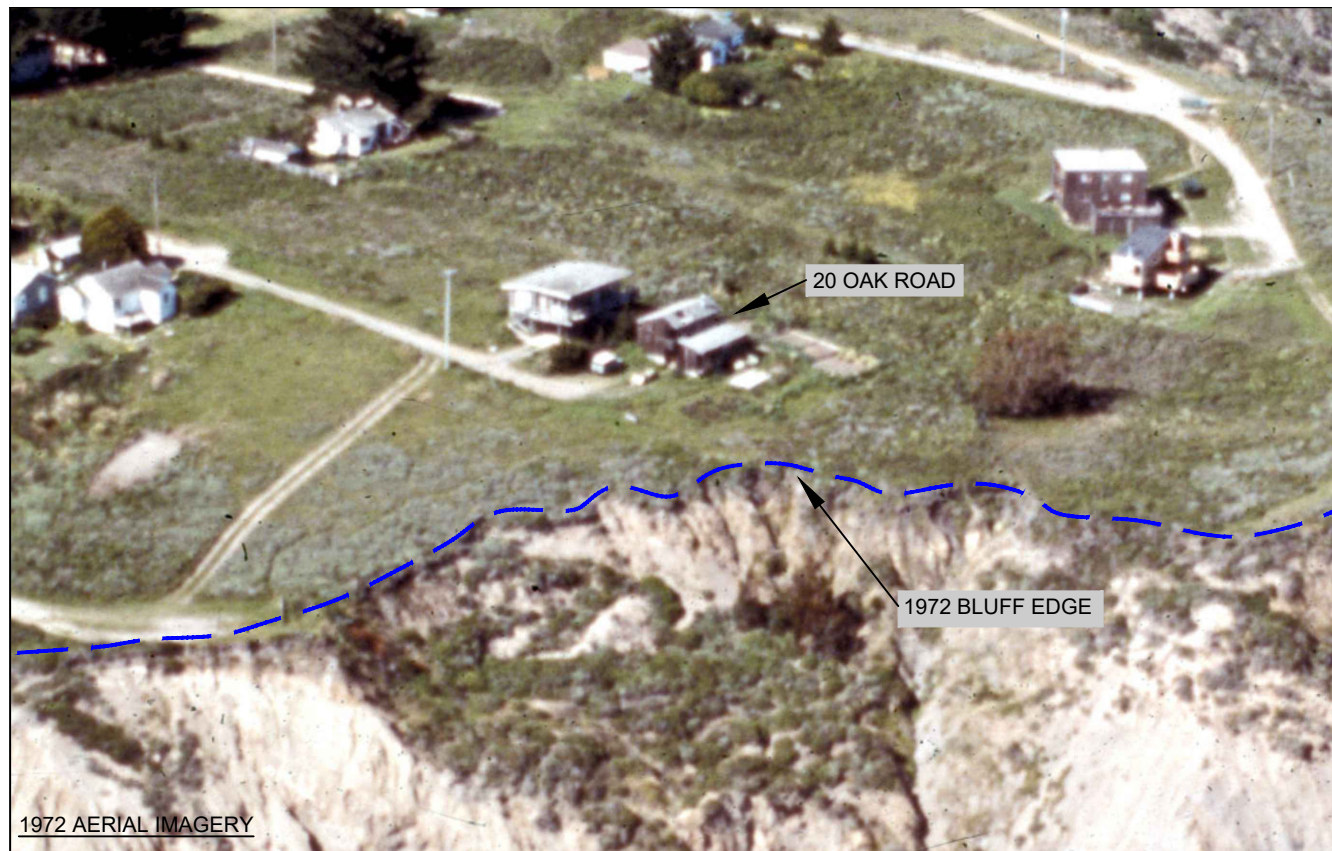
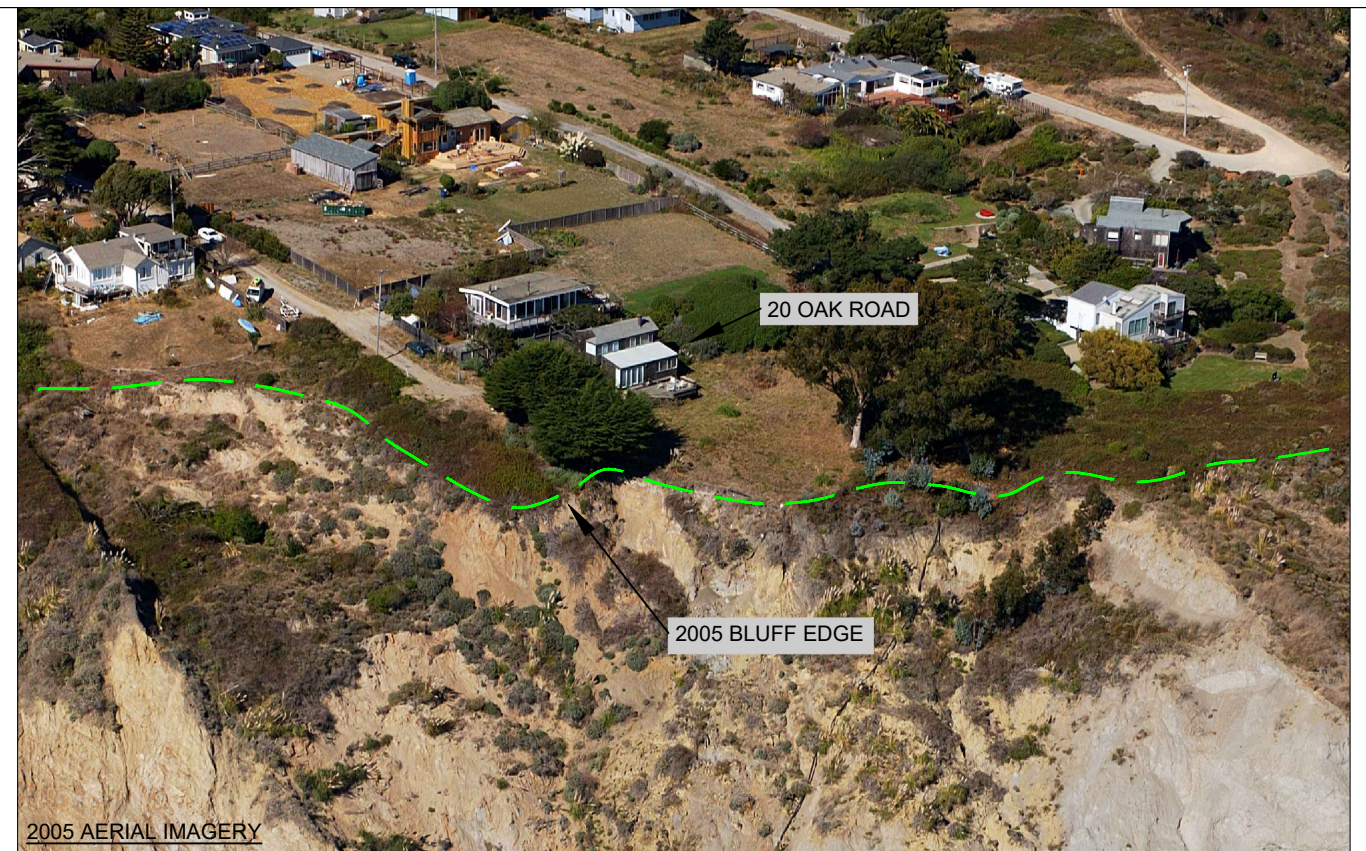
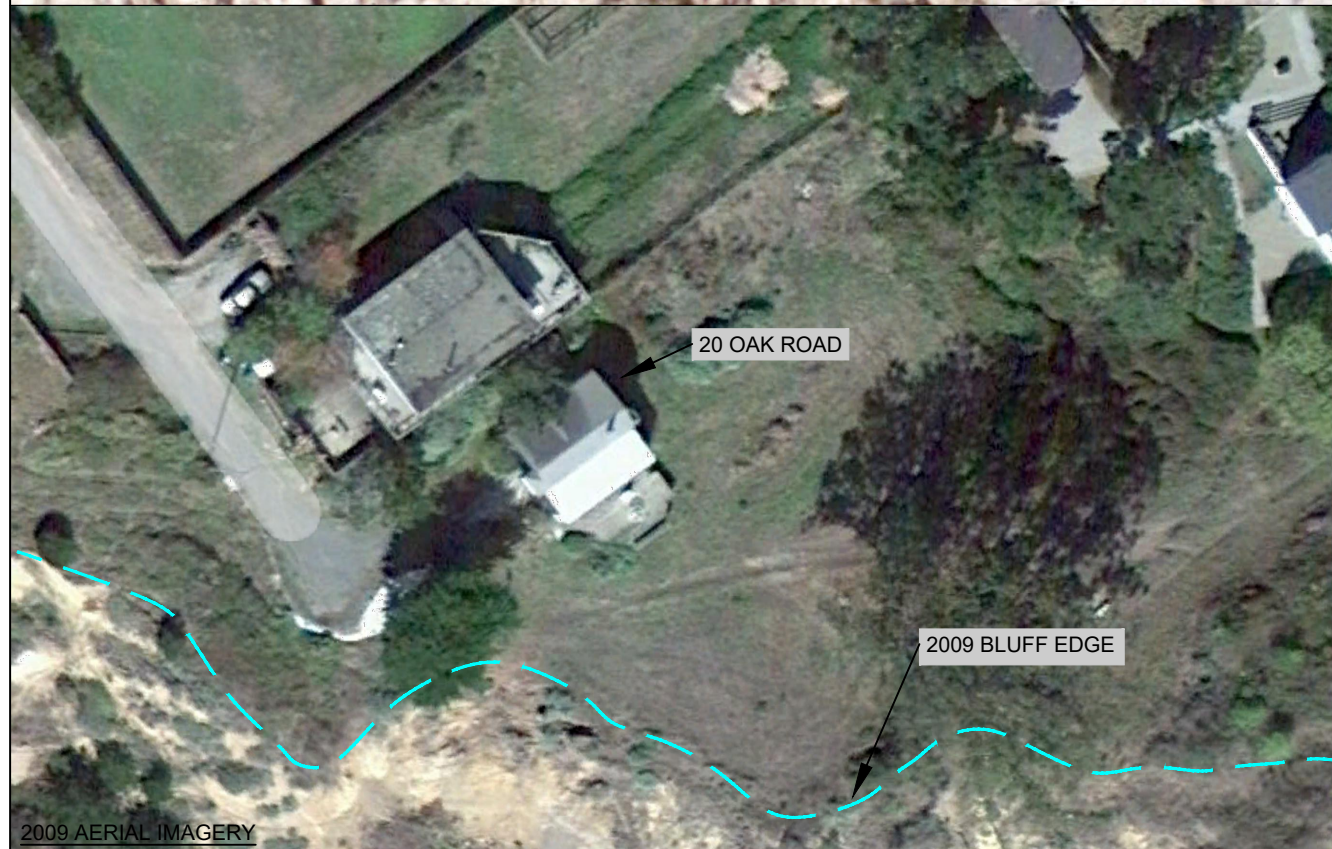
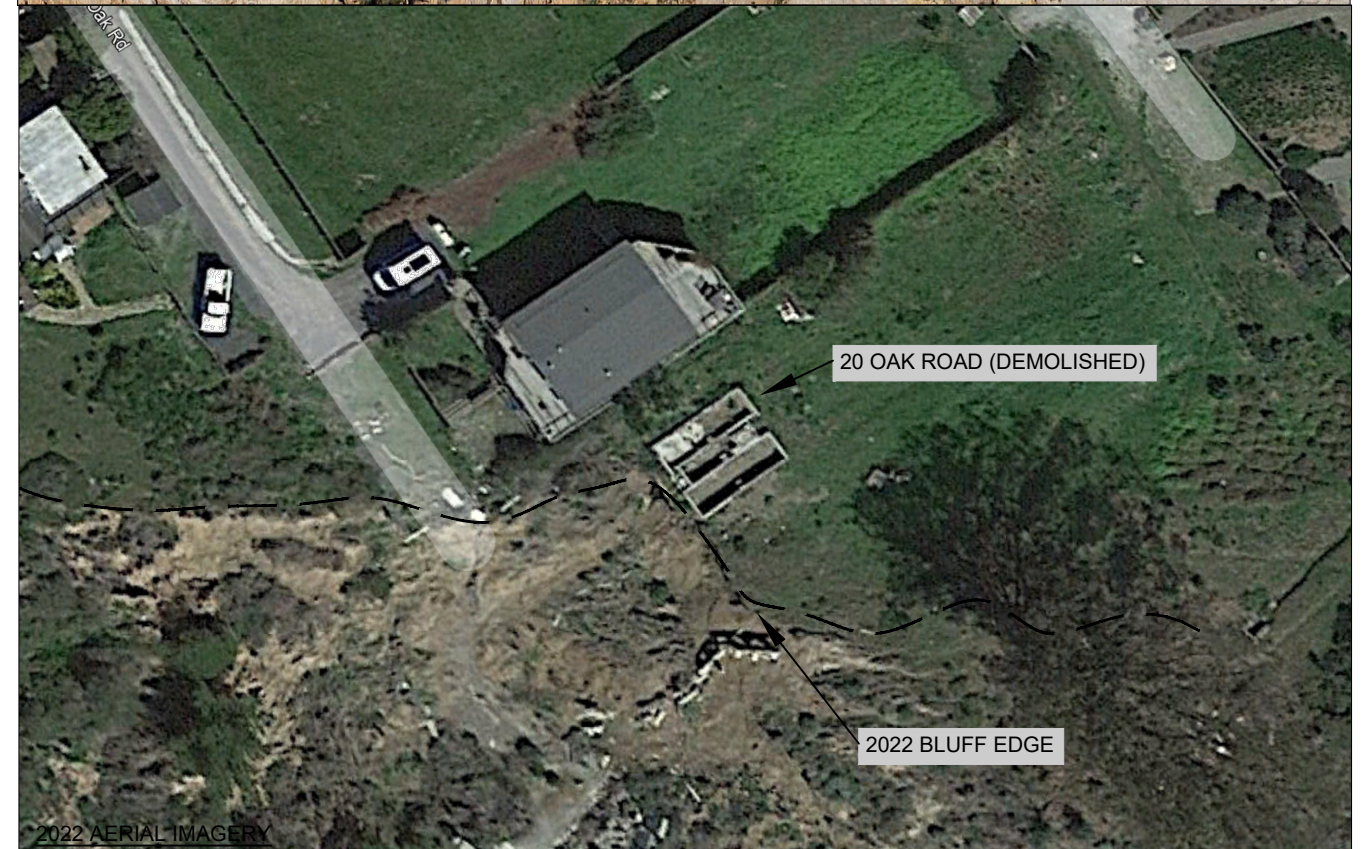
AERIAL IMAGERY 1972-2022

We also reviewed historic aerial photography from the California Coastal Records Project and Google Earth. Oblique-angle color photographs spanned the time period between 1972 and 2022. As shown on Figures 6, significant mass-wasting and bluff retreat has occurred, primarily within the southwest region of the site. More recent site specific rates calculated from bluff edge positions between 2009 and 2022 generally agree with the historic average rate of 2.0-feet per year.

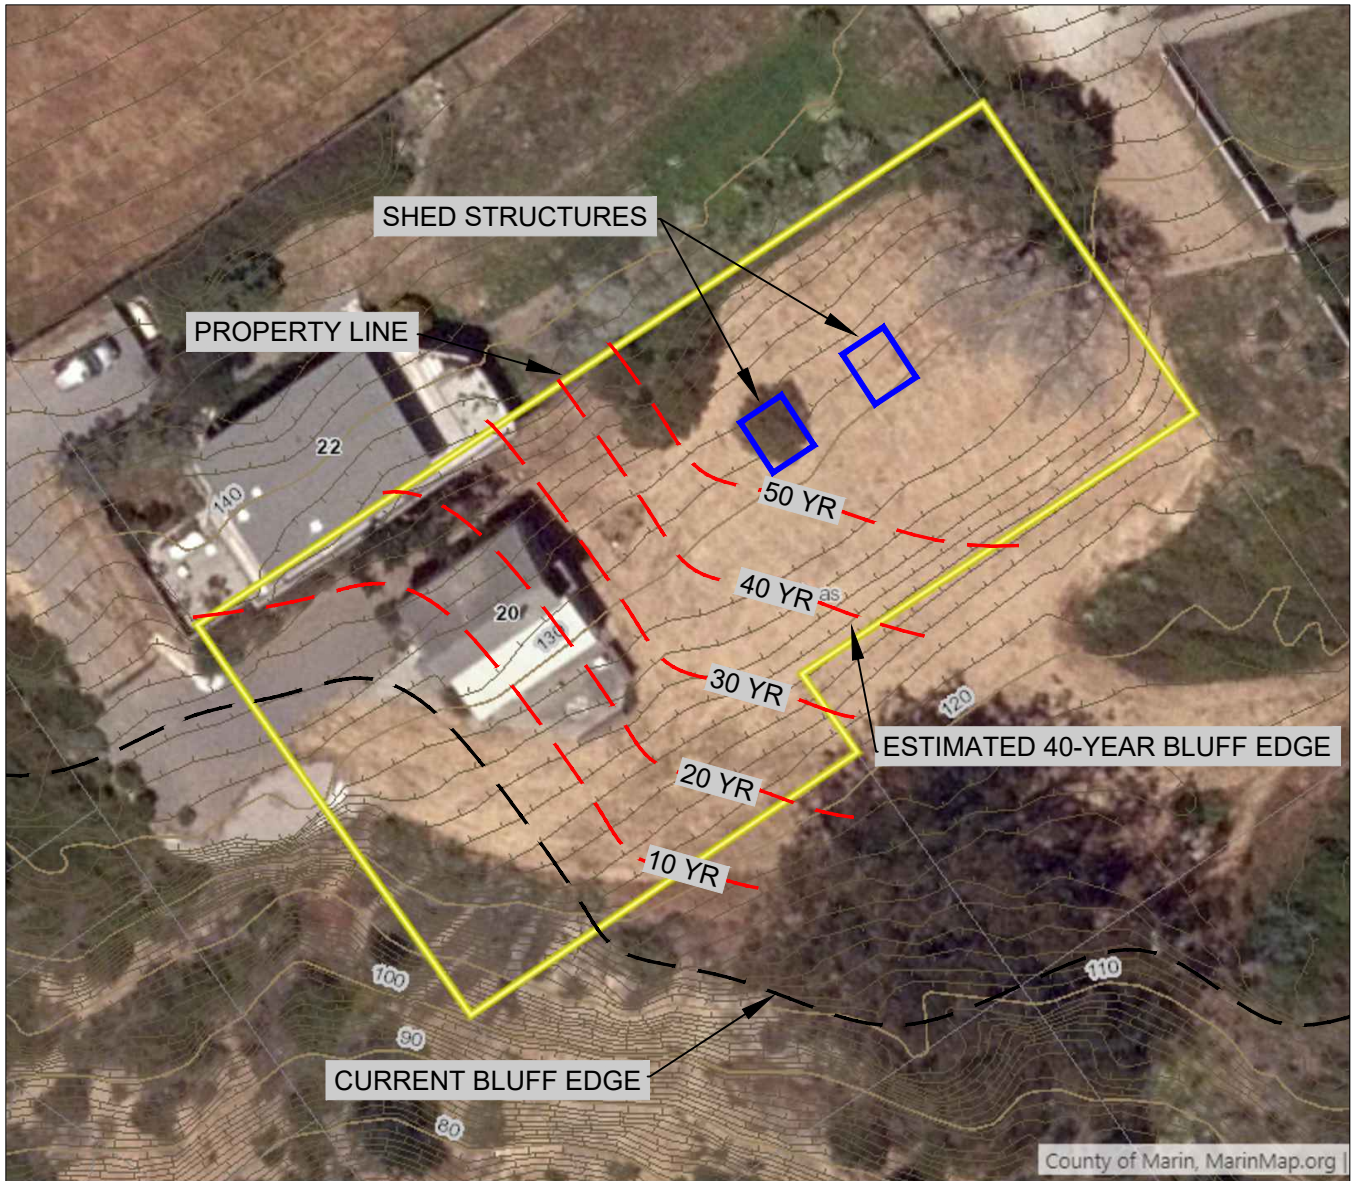
**SITE-SPECIFIC BLUFF RETREAT**

Based on an average annual retreat rate of 2.0-feet (0.6 meters) per year and a reasonable structure-life of 40 years, we estimate that a total of about 80-feet (24.4 meters) of bluff retreat should be anticipated. As shown in Figure 7, the southwestern half of the project site will likely be impacted by bluff retreat in the next 40 years. Slope instability/bluff retreat is considered a significant geologic hazard at the project site, especially in the southwest region of the property.

*Evaluation:* *Less than significant with incorporated recommendations.*  
*Recommendations:* *Recommendations include providing new structures with an 80-foot (24.4 meter) setback for a structure-life of 40 years to reduce the risk of damage or undermining by bluff retreat.*

For a structure-life of 40 years and an average bluff retreat rate of 2.0-feet/year, we recommend providing the sheds with an 80-foot setback from the bluff edge. If a longer structure-life is desired, the setback will need to be increased using the rate of 2.0-feet/year mentioned above.
