## Arborist Report

1495 San Antonio Road  
Marin County, CA

May 28, 2020

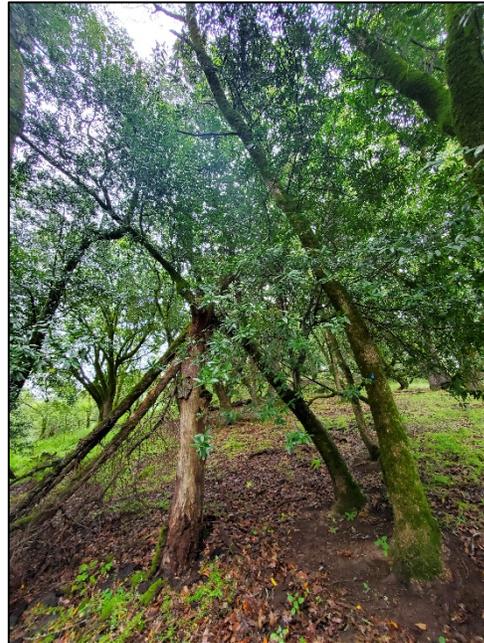
**Photo 1** – California bay #110 was growing in the dense oak woodland forest surrounding the property. The tree was suppressed and developed a significant lean as a result of dense growing conditions.

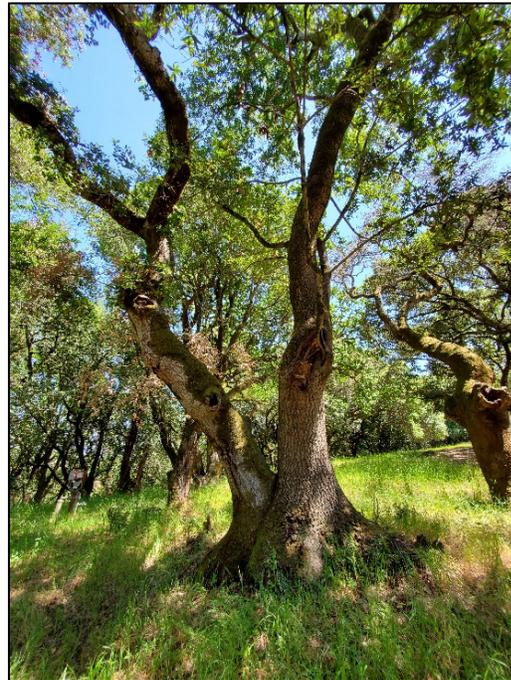
**Photo 2** – Coast live oak #66 and California bay #56 were fused at their bases.

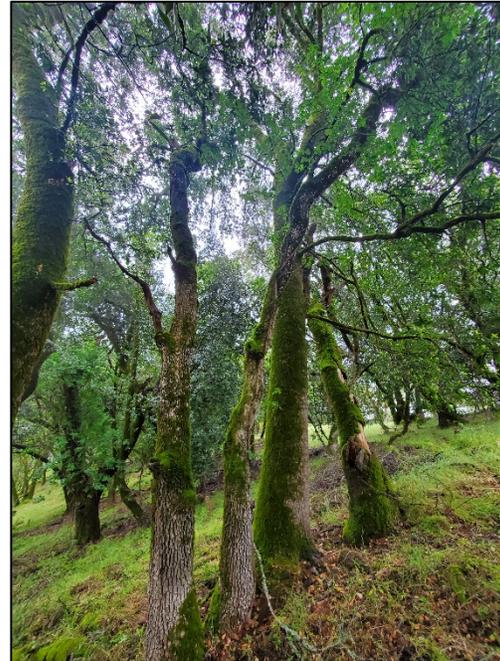
**Photo 3** – Black oak #94 was fused at the base with black oak #93. The two oaks had low live crown ratios with sparse upper canopies.

94	Black oak	11	No	2	Low	3' of fused wood at base with adjacent oak; canopy suppressed by adjacent trees and leans west; vigorous spreading canopy.
95	Coast live oak	11	Protected	3	Moderate	Adjacent to access road; multiple attachments arise at 1'; full vigorous canopy; upright form; multiple codominant stems with included bark present in canopy.
96	Black oak	24	Heritage	4	High	Fused to adjacent oak; extensive decay at base; hollow at base; low live crown ratio, Ganoderma fruiting body on trunk; multiple attachments arise at 2.5'.
97	California bay	9	No	3	Low	Swollen base; codominant fork at 15'; minor lower canopy twig dieback; large spreading canopy; second stem arises from base.
98	Coast live oak	15	No	2	Low	Snag; engulfed in poison oak; no live foliage; extensive decay.
99	California bay	14	Protected	3	Moderate	Snag; extensive decay.
100	Bigleaf maple	23	No	2	Low	All but dead; top down dieback; fruiting bodies present; internal decay.

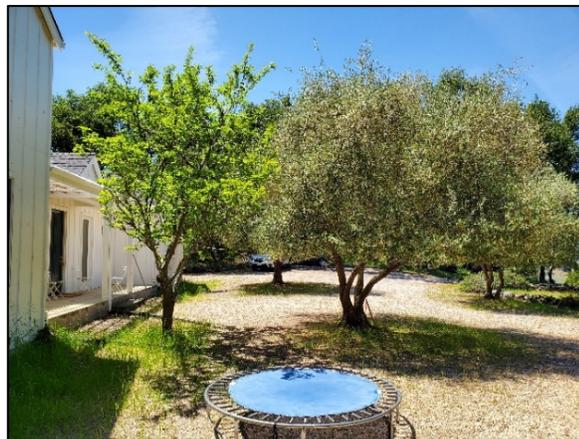
- Three European olives were growing along the driveway outside the existing residence (Photo 4, next page). Olive #70 was in fair condition with decay in its base; whereas, olives #69 and 71 were young, vigorous trees in good condition.

- Fruiting plum #72 was in good condition and grew along the driveway outside the existing residence. It was multi-stemmed with a vase-shaped canopy, which is typical of small, fruiting trees.

**Photo 4** – European olives #69 - 71 and fruiting plum #72 were growing outside the project area, near the existing driveway and private residence.
