115 Woodland Road Arborist Report | April 2020

Arborist Report 115 Woodland Road

John and Susan Brownridge are planning the redevelopment of a residential property, at 115 Woodland Road, in Kentfield CA. Currently the project area consists of a single family home with trees in the back and front yards. Trees were assessed on October 8, 2019. The assessment included all trees 6" and greater in diameter, located on the property. No off-site trees had canopy overhanging the property.

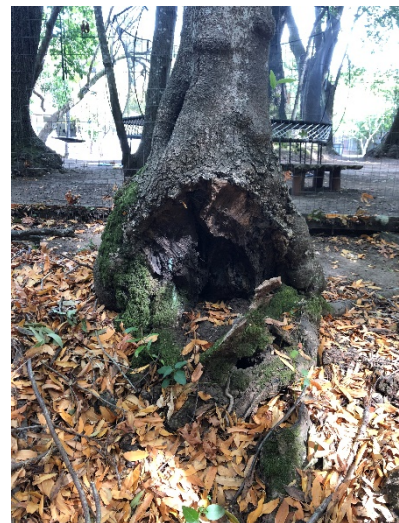
Photo 1 – California bay #46 with cavity and significant decay at root collar. Trees with destabilizing defects to this degree should be removed before the demo stage of the project begins.

At the rear of 115 Woodland Road there are a number of native trees that are not directly within the grading footprint. Some of these trees have attained “over-mature” status, and are near the end of their useful lifespan. A number of these trees have serious defects that have compromised their structural integrity (Photo 1.) These trees should be removed before the demo stage of the project begins.

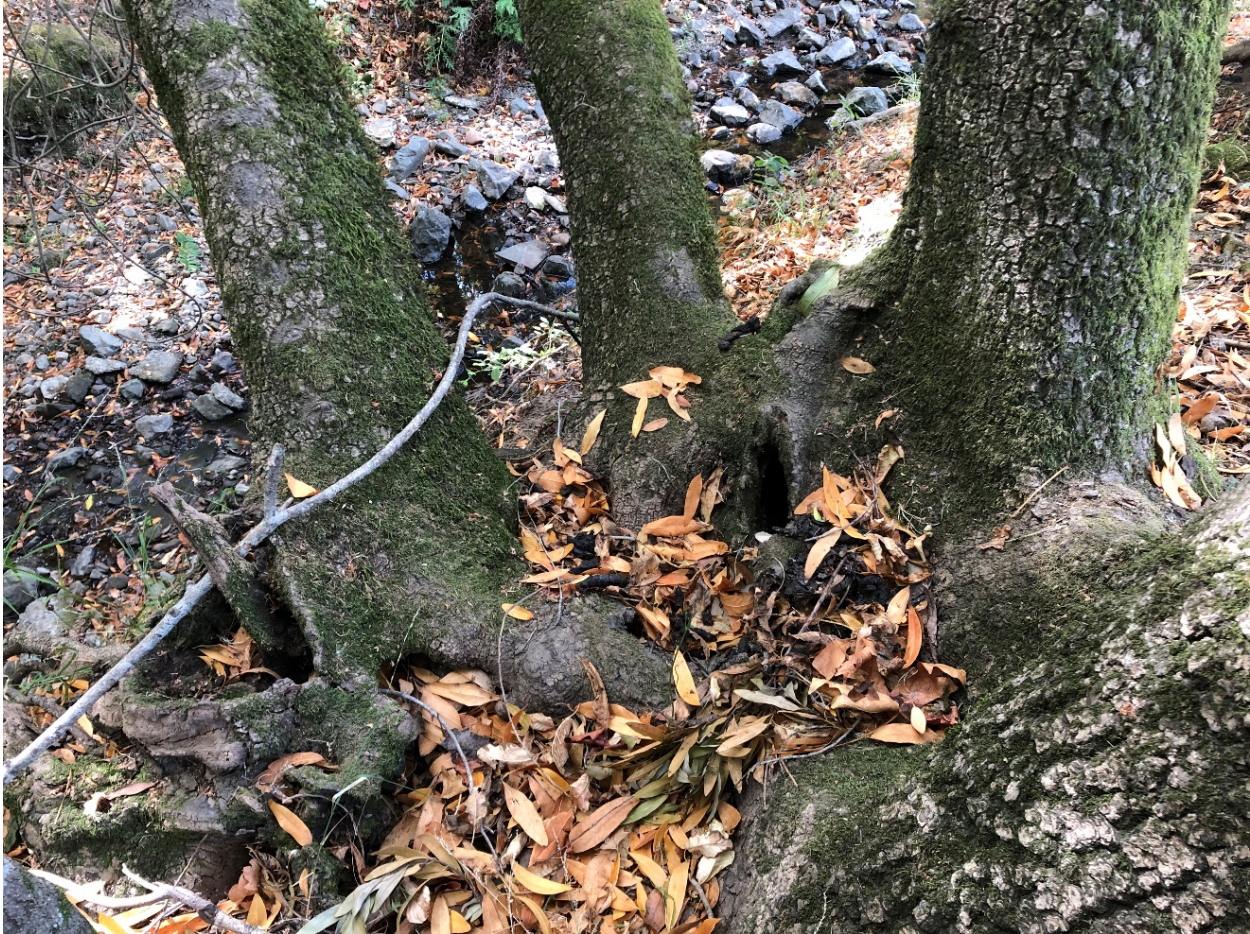
Maintaining stands of trees within these riparian zones is important for maintaining the integrity of creek boundaries, mitigating the impact of erosion during months of seasonal rains and greater storm events. Often these trees are imperfect or structurally suspect, but lack targets that deem them an unacceptable risk. (Photo 2.)

Photo 2 – California bay #51 with multiple stems and basal cavities. While imperfect, and possibly unstable, there are no significant targets within striking distance, so associated risk is not elevated. The benefits to the riparian zone out-weigh the structural imperfections.
