GEOLOGY & GEOLOGIC HAZARD UPDATE & PRELIMINARY GEOTECHNICAL STUDY

BOLINAS MARINE FIELD STATION FACILITY

Geosphere Project No. 91-55182-PW
23 September 2020

MARIN COMMUNITY COLLEGE DISTRICT
835 College Avenue
Kentfield, CA 94904

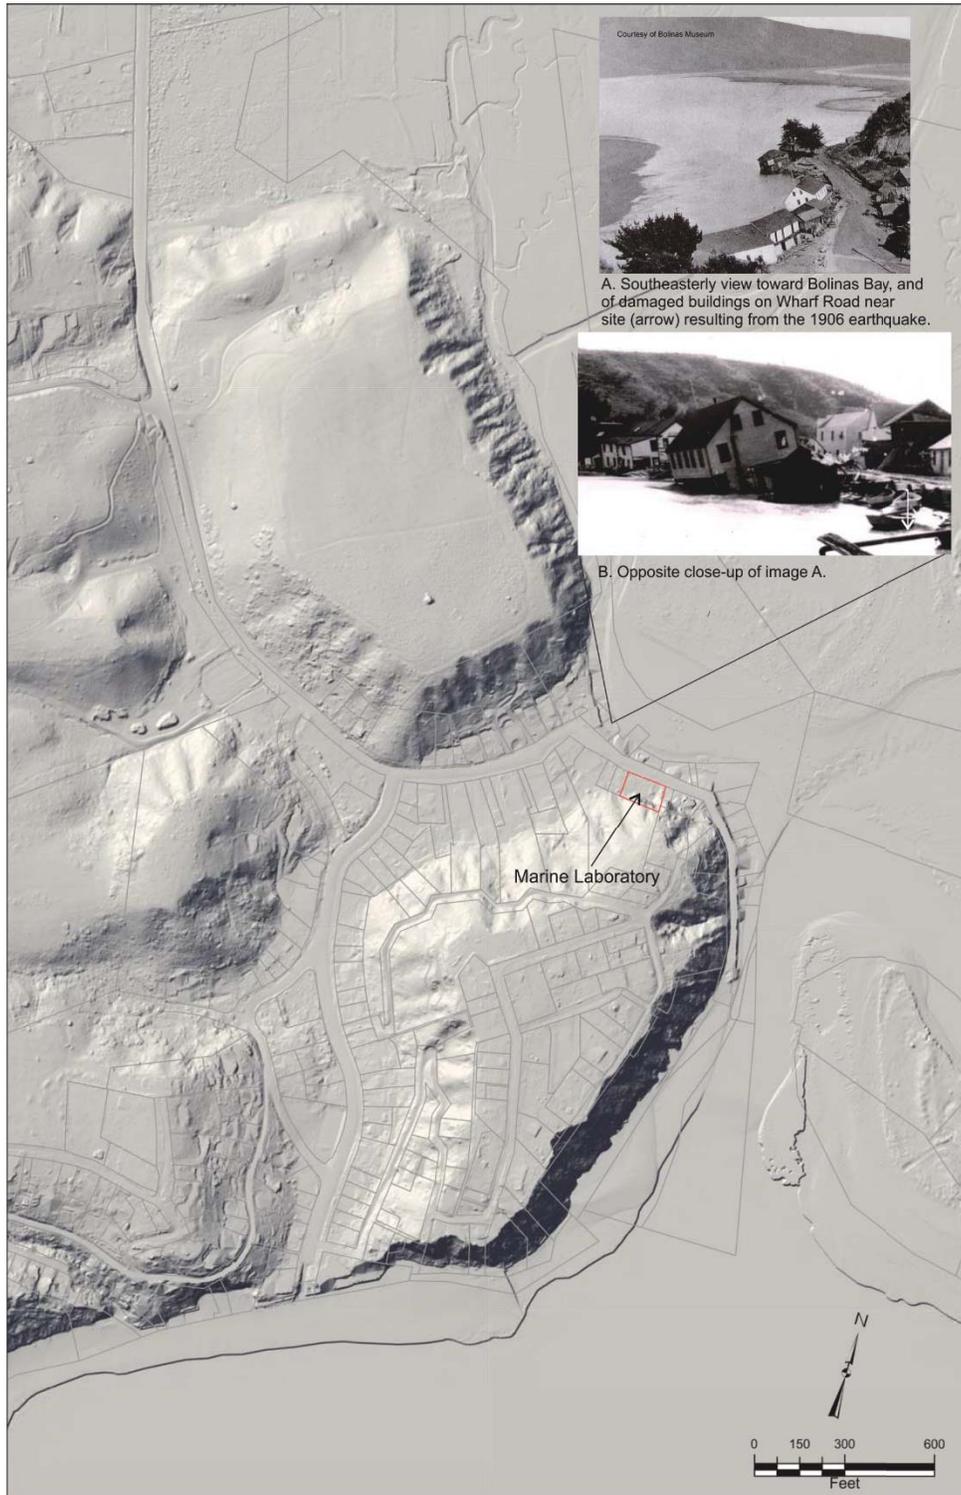
“Along the main street of Bolinas stand most of the houses. Of these about two-thirds were heaved, slid, tipped, and shattered into uninhabitable condition. Along the bay shore were 7 buildings. Of these 6 went over or down. At the Flagg Staff (sic) Inn the tipping of the house has thrown it so far east into the bay that one may sit along the upper floor and fish in 4 feet of water along the upper edge of the same room” (Figure 1).

Figure 1. Effects of 1906 earthquake along Wharf Road in site area. (Photos courtesy of A, Bolinas Museum and B, Marin County Free Library)

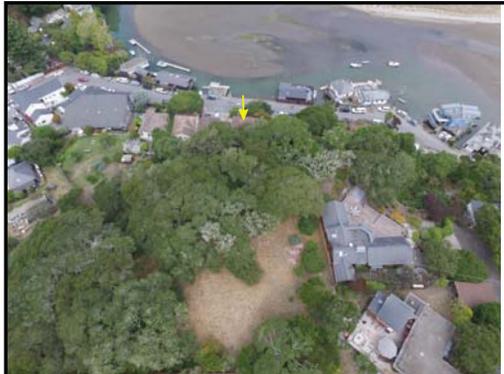
Photo 1. North aerial drone view across residential development at west end of Cresente Ave. contributing concentrated runoff to slope above project site (arrow).

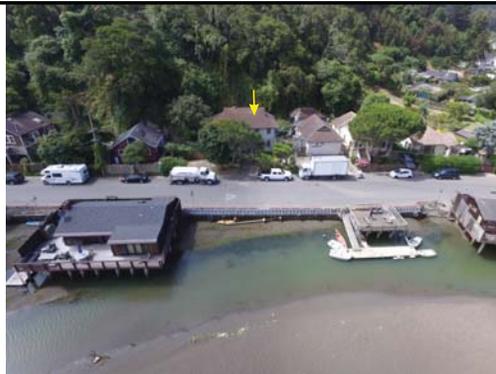
Photo 2. Southerly aerial drone view of project site from across channel on margin of Bolinas Lagoon (arrow). Note approximate 6-foot high steel sheet pile/whaler seawall support to edge of Wharf Road.

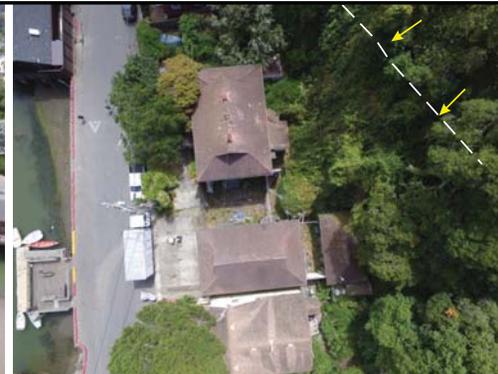
Photo 3. Westerly aerial drone view across project site. Top of cut slope approximately defined by white dashed line. Arrows are in principal swales that direct runoff and debris flows to the site.

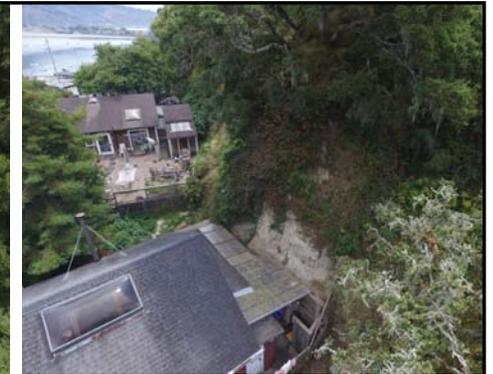
Photo 4. Southwest aerial drone view of exposure of Merced Formation in cut slope on adjoining property.

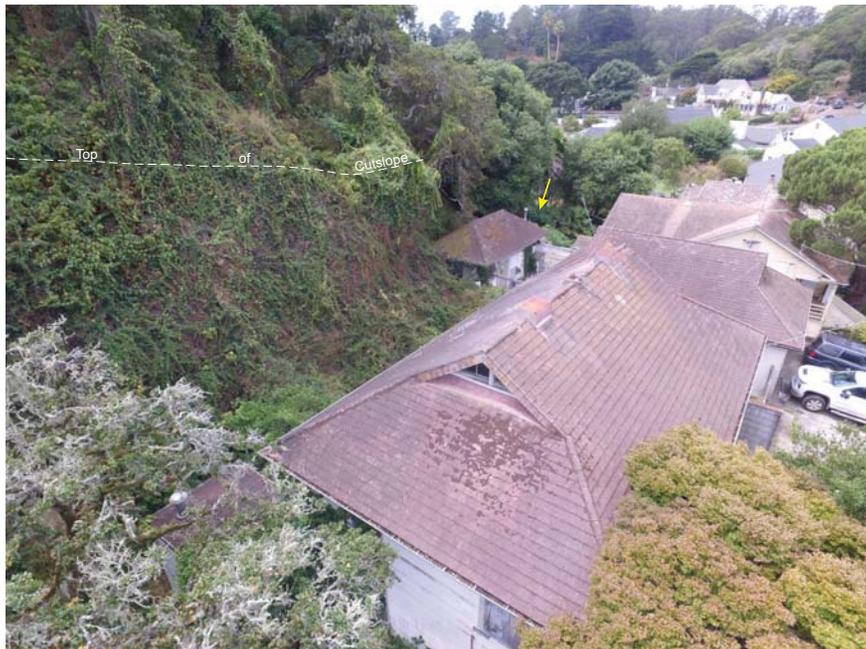
Photo 5. Westerly aerial drone view of existing structures on project site. Arrow points to exposure of Merced Fm. comprising a landslide block detached from cut slope at the eastern swale re-entrant depicted in Photo 3 & locale of Photos 6 and 7.

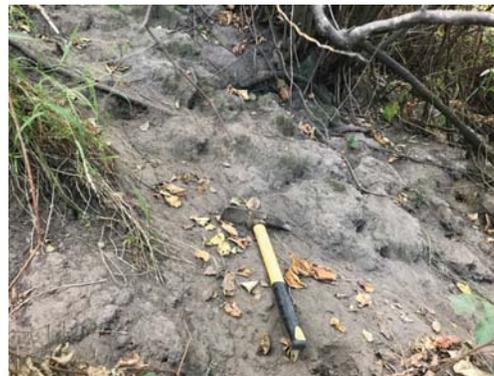
Photo 6. Westerly view of pervasive rodent burrowing in erodible Clayey Silty SAND colluvium exposed in the flank of the debris slide scar at the swale re-entrant at the southeast corner of the project site.

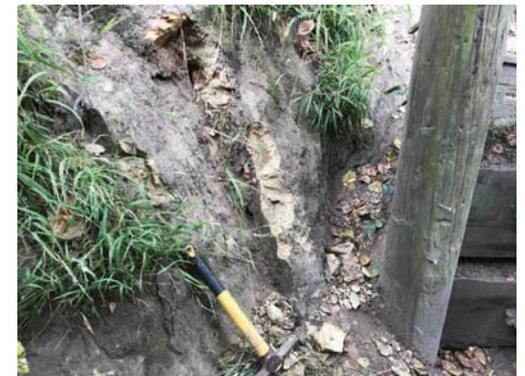
Stability of Adjacent Ascending Slope – It is our opinion the steep slope on the north side of the property is highly susceptible to slope failure. The cut slope is oversteepened relative to the lithologic strength and pervasive adverse discontinuities (i.e. jointing) that historically has resulted in relatively shallow landsliding in the form of block glides and rock fall. Concentrated runoff from residential development at the top of the native hillside contributes to the potential for long runout of debris flow confined in the three swales that intersect the top of the cut slope on the southern margin of the site. Elsewhere, there is a perceived high risk for episodic debris slides and rock fall/avalanche from the face of the cut slope during rainfall. Given the accounts from the 1906 earthquake, the weathered and thoroughly jointed Merced Formation has high propensity for seismically-induced landsliding, which we judge would be more significant than under static conditions.

Photo 7. Westerly view of steep, adverse joints in the Merced Fm. landslide block at the base of the cutslope depicted in Photo 5.

It is our opinion comprehensive landslide mitigation is warranted. Given the limited space, we anticipate steel mesh anchored to the ascending slope behind the new building with soil-nails could offer sufficient resistance to slough of surficial soil and weathered rock and rock fall while offering structural reinforcement to resist potentially deeper seismically-induced slope failure. We note that the portion of upper slope overlooking the District's property is owned by others (i.e., is part of the 52 Wharf Road property) and therefore stabilization of this portion of slope may be more problematic.
