**Project Address:** 206 Grandview Avenue, Novato

**Inspection Date:** November 4, 2019

## Assignment

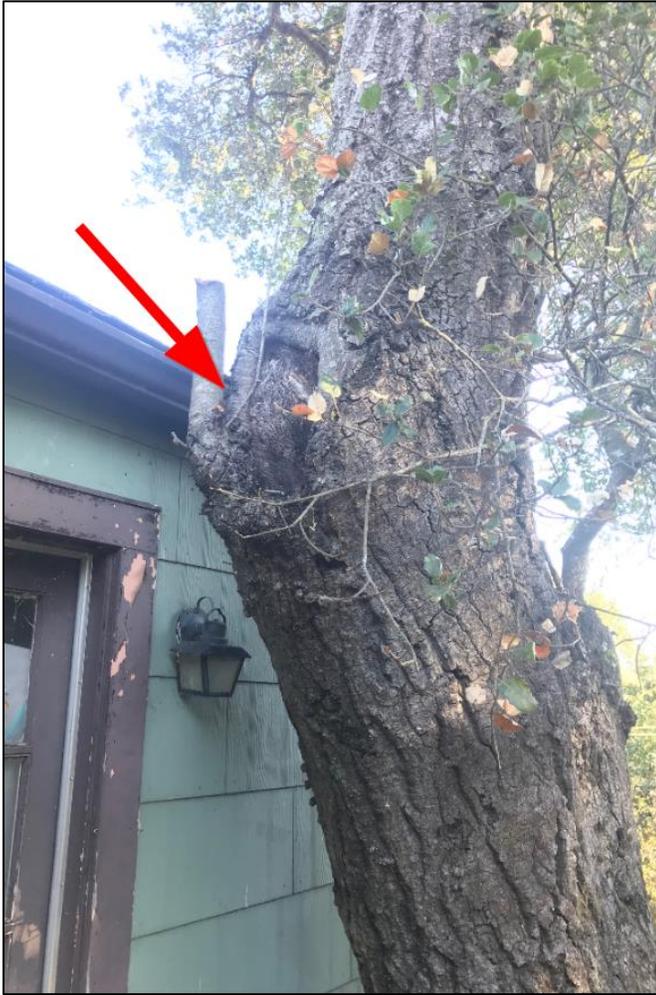
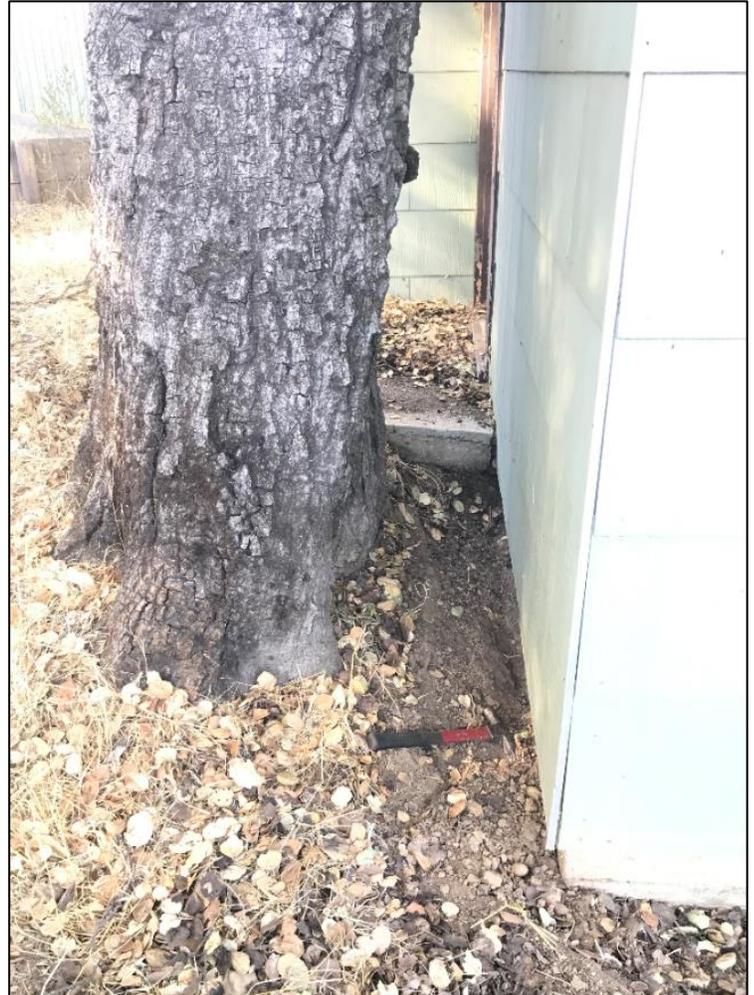
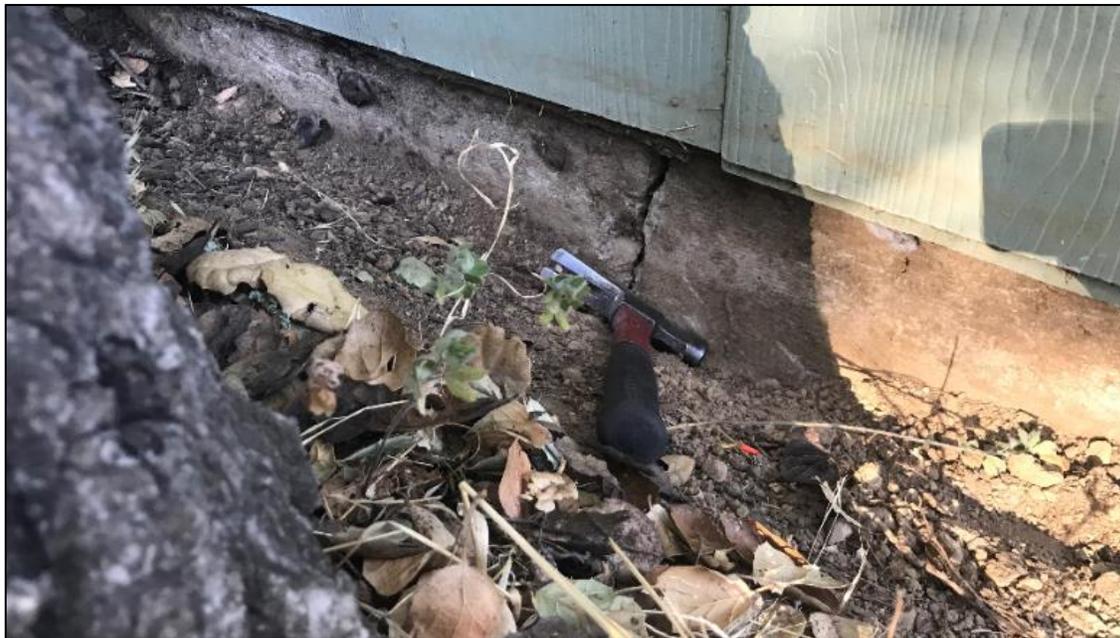
Location South corner of the home. The trunk is less than one foot from the foundation and the canopy extends over the home (Figure 3). There is a crack in the foundation immediately adjacent to the trunk.

Structure Fair. At approximately six and eight feet above grade, two large stems were removed from the tree in the past. Decay cavities have formed at these aging pruning wounds (Figure 3). The tree became top heavy as a result of the stems being removed.

Tree-1 possesses two significant issues. First, the trunk and structural roots are within one foot of the home foundation where a crack was identified. Considering the size of the tree and proximity to the foundation it is very likely the tree is contributing to the crack. The foundation stands within the zone where large roots responsible for the overall stability of the tree are likely to be found. Large root can be thought of as anything three inches in diameter or larger. Such roots have a higher likelihood of causing damage when conflicts with infrastructure occur as the root increases in diameter. In some cases, selective root pruning is an option to mitigate damage but in this situation the foundation is so close to the tree that impacts to tree stability are likely if more than one 3-inch root were severed.

The second issue with Tree-1 is the two large pruning wounds on the trunk. Each of the cuts is actively decaying and there is no accepted method of halting the decay. As each of the wounds continues to decay the trunk will weaken, and the whole tree will be less stable. Currently the cavities are contributing to an elevated risk of trunk failure which will only increase with time. For these reasons Tree-1 is scheduled for removal as a part of the project.

Figure 3. (Upper left) Proximity of the trunk of Tree-1 to the existing house. (Upper right) Proximity of the lower trunk to the existing foundation (hammer for scale). (Below) Hammer laid near the foundation crack.

1. Tree-1 is exempt from removal permit requirements per exemption D of the Tree Removal Permit Fact Sheet.  
*D. The tree is a public nuisance by causing damage to improvements, such as building foundations, retaining walls, roadways/driveways, patios, sidewalks and decks, or interfering with the operation, repair, or maintenance of public utilities;*
2. Tree-2 has a poor suitability for preservation due to its suboptimal structural condition and form. It should be removed as it will be left in a precarious structural condition after the removal of Tree-1.

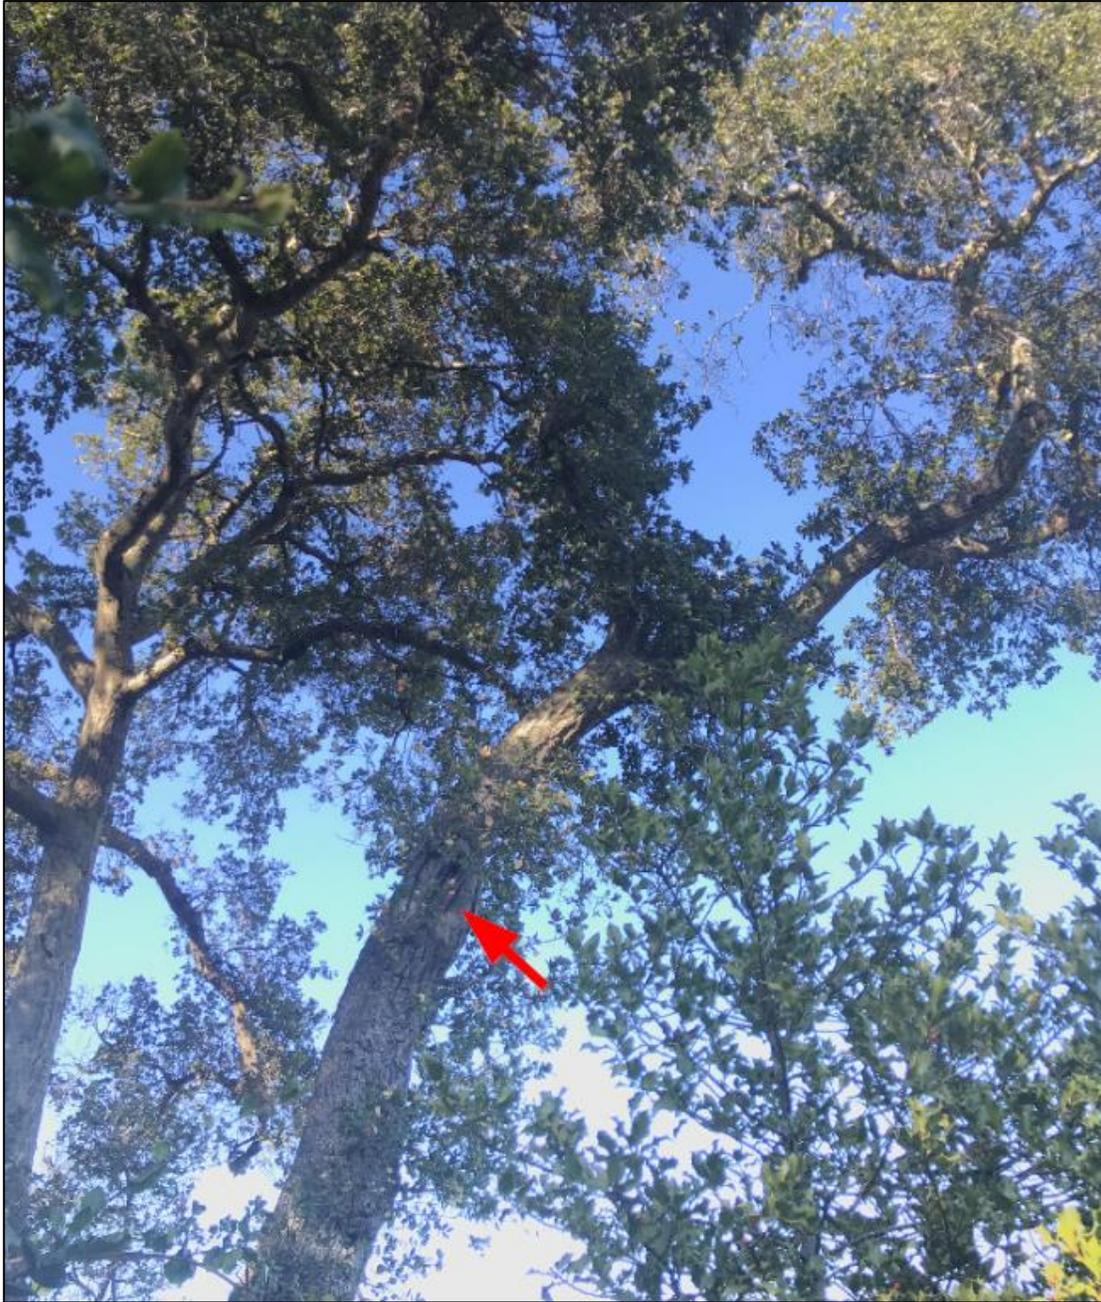
Structure Fair. The tree possesses a moderate trunk lean east. There is a cavity, at approximately 15 feet above grade on the trunk at where a branch failure occurred in the past (See Figure 4).

Form Poor. The canopy is markedly asymmetric to the east (See Figure 4).

Tree-2 is generally in fair overall condition. Grown near Tree-1 for many years both trees share canopy space which has influenced the strong bow and asymmetry in the canopy of Tree-2. The lean in the main stem and strong canopy asymmetry along with a cavity in the trunk are the most notable structural problems. As it now stands Tree-2 is not particularly concerning in terms of overall risk if it were to fail, however if Tree-1 were removed, Tree-2 would be left exposed, and subjected to different wind patterns which could elevate the likelihood of failure.

**Figure 4. View into the canopy of Tree-2. Red arrow indicates the location of a cavity in the trunk.**
