Kosmowski Residence Arborist Report | 2020

Eron Kosmowski
15 Poplar Drive
Kentfield, CA 94904

**Lee Nachtrieb, Regional Inventory
and Consulting Arborist**
ISA Certified Arborist #WE-0533A
ISA Tree Risk Assessment Qualified

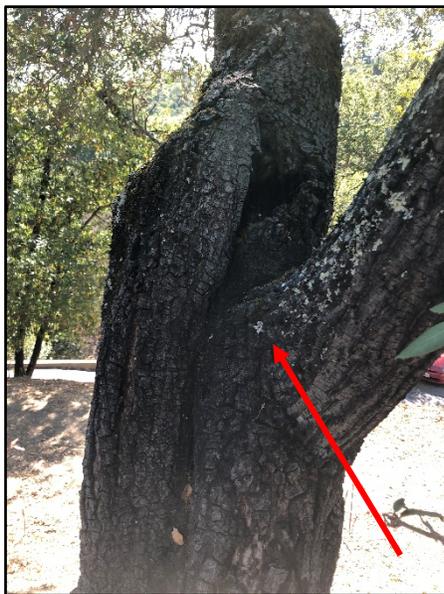
Photo 1: Coast live oak #17 had included bark and a stem cavity.

Fourteen (14) coast live oaks (67% of trees assessed) comprised the majority of trees on site. One tree was dead (#13), while three were in poor condition (#16, 17 & 18). Six of the 14 were in fair condition (#1, 5, 6, 10, 14, 21), and four were good condition (#2, 4, 7 & 8). They ranged in age from semi mature (13" trunk diameter) to mature (24" trunk diameter). There were examples of good form and structure within the group (#1, 4, 8), and most exhibited moderate vigor. There were defects of note among the coast live oaks such as the stem cavity and included bark of tree #17 (photo 1), as well as pest and disease occurrence, such as the borer infestation of tree #18 (photo 2).

Of the seven trees to be removed, trees #16 and 17 will be removed to complete construction, both trees were in poor condition. I recommend removing five additional trees because they are in poor condition.

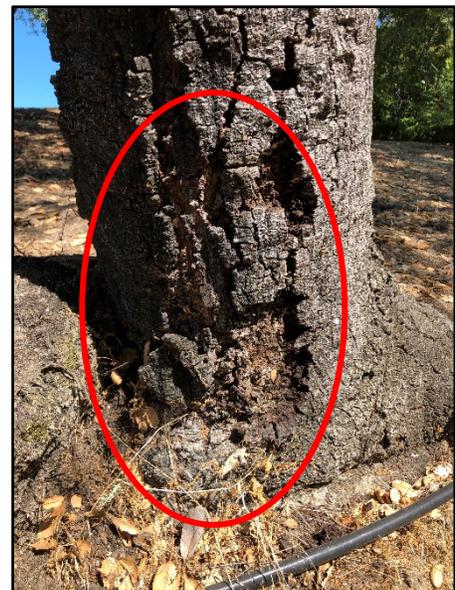
Photo 2: Coast live oak #18 had roughened bark from borer activity.

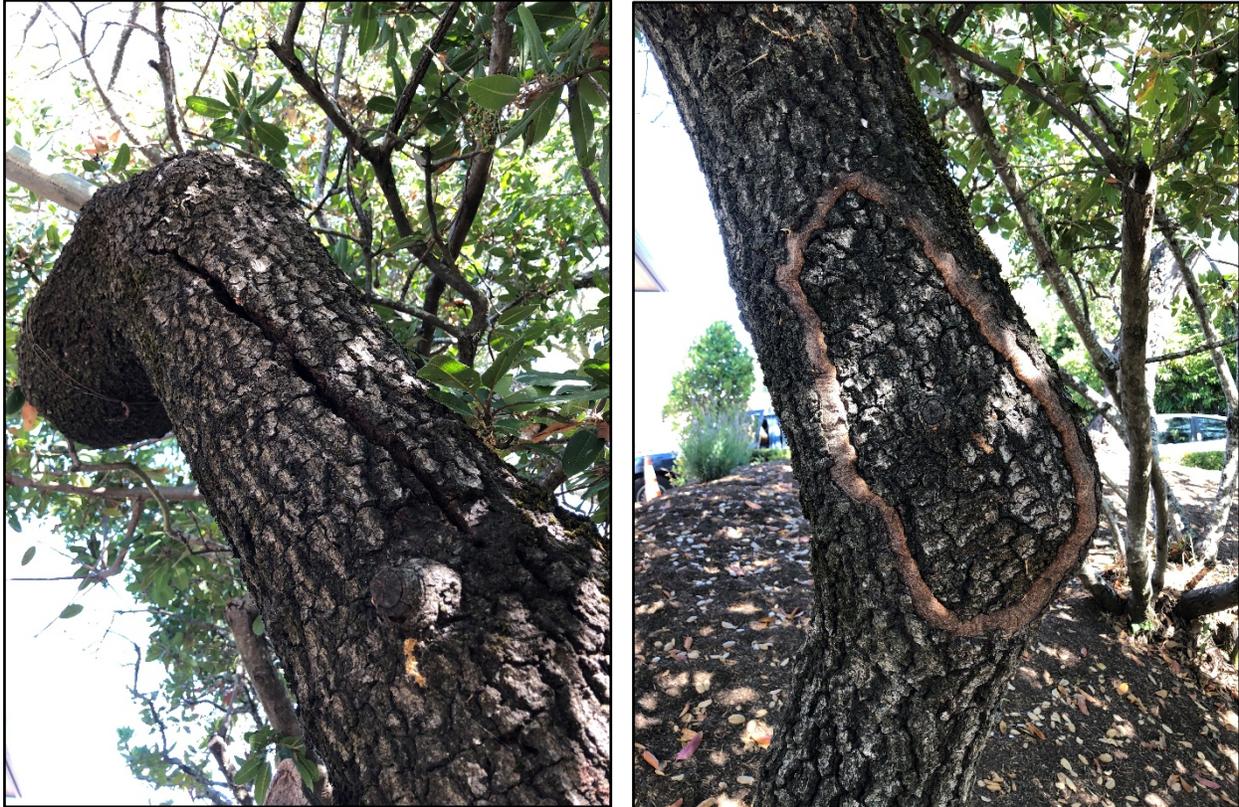
Two California black oaks (trees #15 and 19) measuring 14”/9” and 10”, respectively comprised 10% of trees assessed. Tree #15 was in good condition, form, and structure, while tree #19 was in poor condition with significant structural defects and disease presence in the form of canopy dieback, stem crack and stem canker (Photos 3 & 4, below).

Photos 3 & 4: California black oak #19 live oak had an included stem crack (left), and stem canker (right).

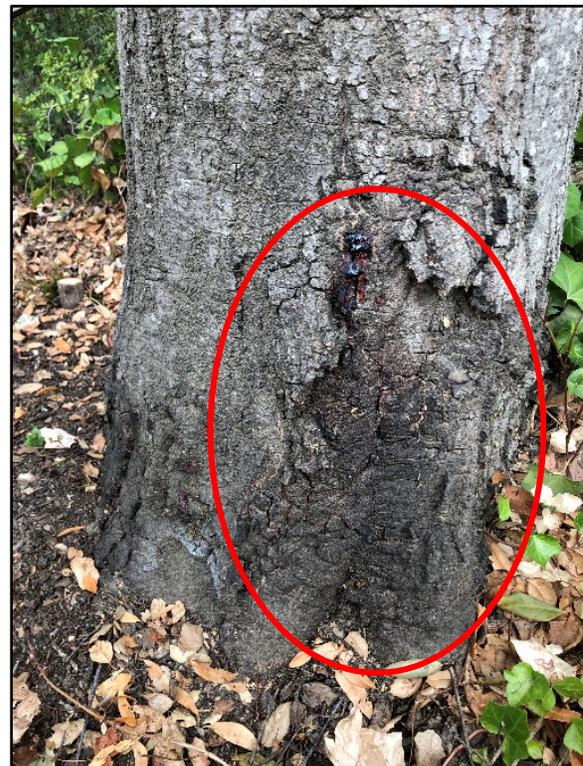
Coast live oak #5 is listed as Potentially Preserve. This tree was in fair condition, because of a suspected *Phytophthora ramorum* canker. If tree #5 has Sudden Oak Death, it would be ill equipped to manage additional stressors (Photo 3). Root loss through excavation, grade changes, or compaction may compromise the health of this and other trees inventoried with potentially preserve disposition status (Trees #3 and 4). Coast live oak #5 also exhibits moderate canopy dieback; soil and plant health care measures should be taken post project to mitigate impacts of construction activity if the tree is to be preserved.

Photo 3: Coast live oak #5 with suspected *Phytophthora ramorum* trunk canker.

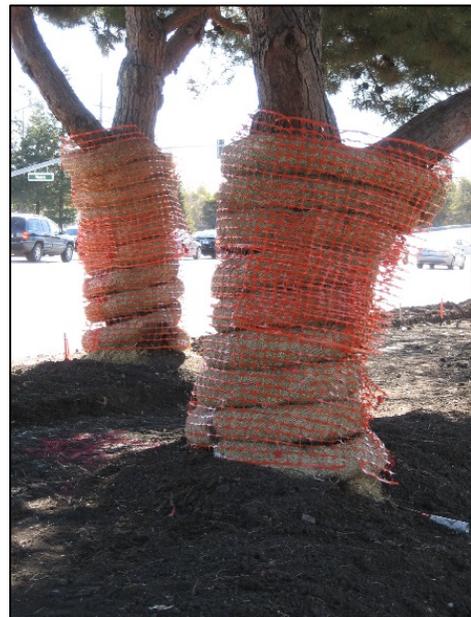
Photo 4: Trunk protection devices (straw wattling) used to protect trees within established TPZs.

3. Fences are to remain until all grading and construction is completed. Where demolition must occur close to trees, such as removing curb and pavement, install trunk protection devices such as winding silt sock wattling around trunks or stacking hay bales around tree trunks.
