Client: Meadow Club

Project Address: 1001 Bolinas Rd., Fairfax

Inspection Dates: 2/6/20; 8/13/21

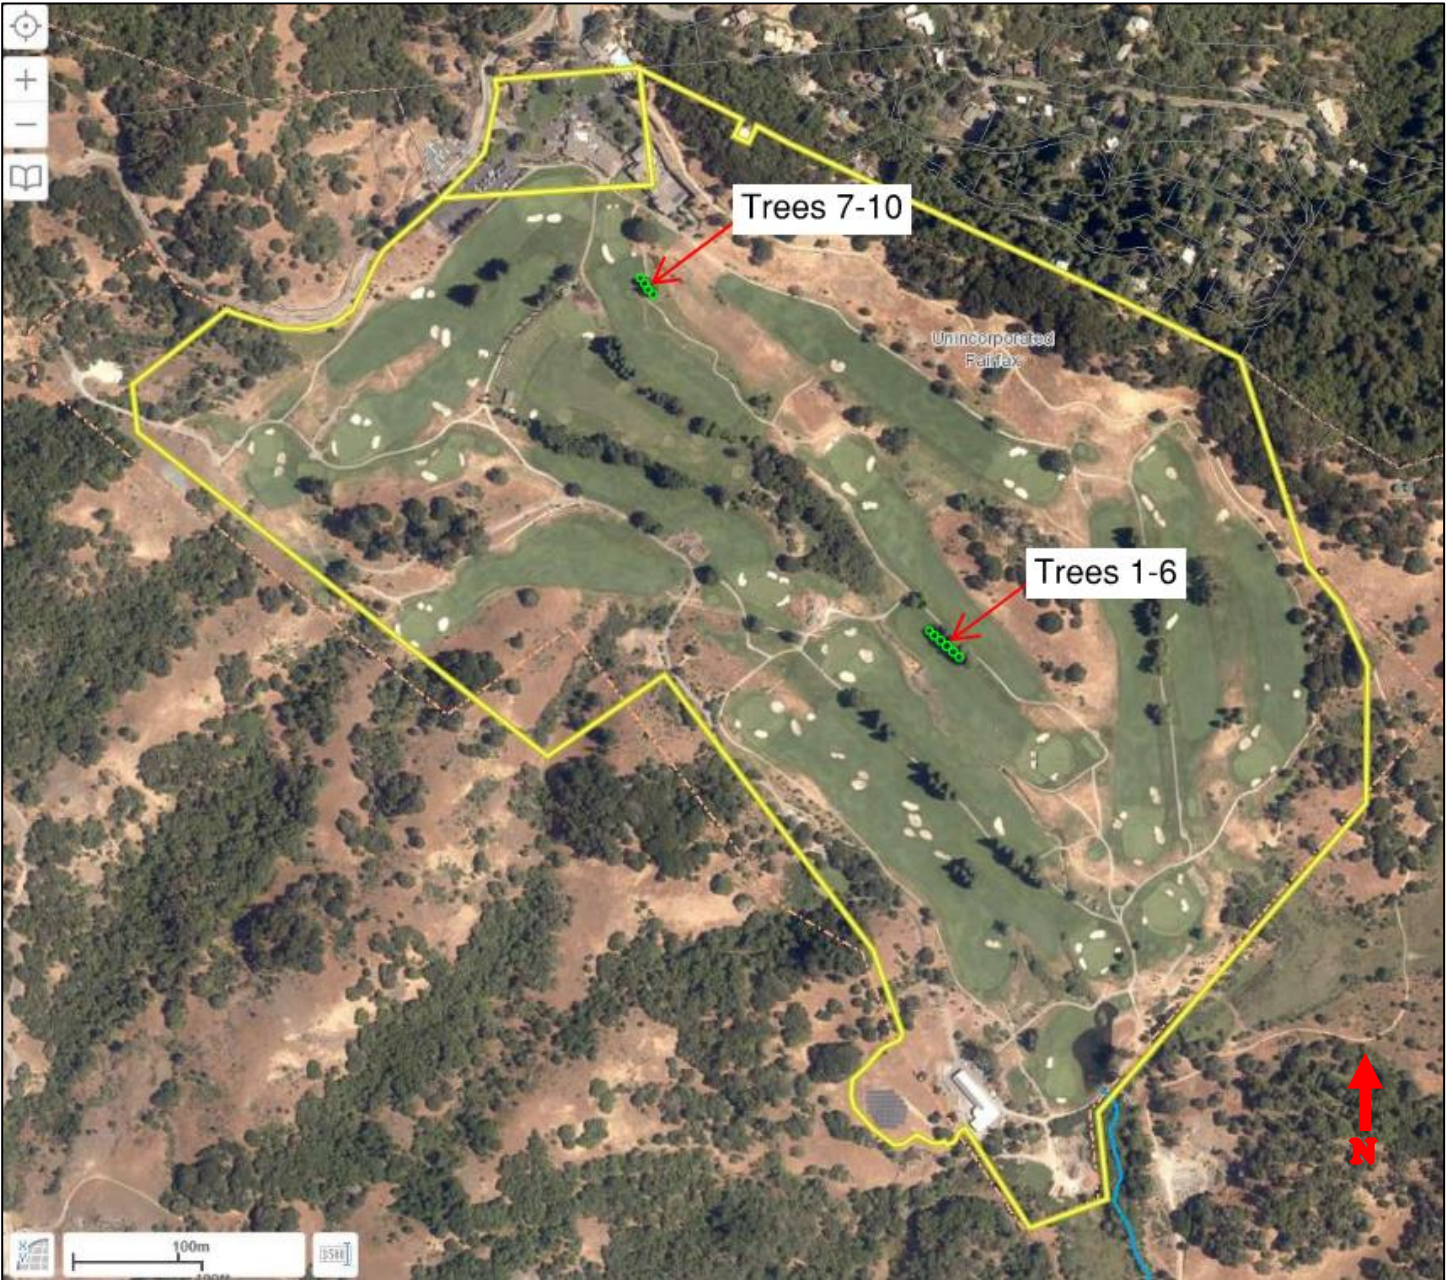
HOLE 16/17 Redwood Removal: See Site plan on Page 6. The (6) subject trees are coast redwood (*Sequoia sempervirens*) ranging in height from approximately 100 to 120 feet. All the trees qualify as Heritage based on the definition in the Marin County Municipal Code. The trees stand in a staggered line parallel with the cart path which separates hole number sixteen and hole seventeen (See Figure 2). The trees are spaced closely and share canopy space. The appearance of the tree canopies was normal at the time of my inspection. The top of Tree-2 (the most suppressed of the six trees) was somewhat brown. The tops of the trees appeared normal, and no obvious indications of decay, disease, or pest activity were observed in their lower trunks and or canopies.

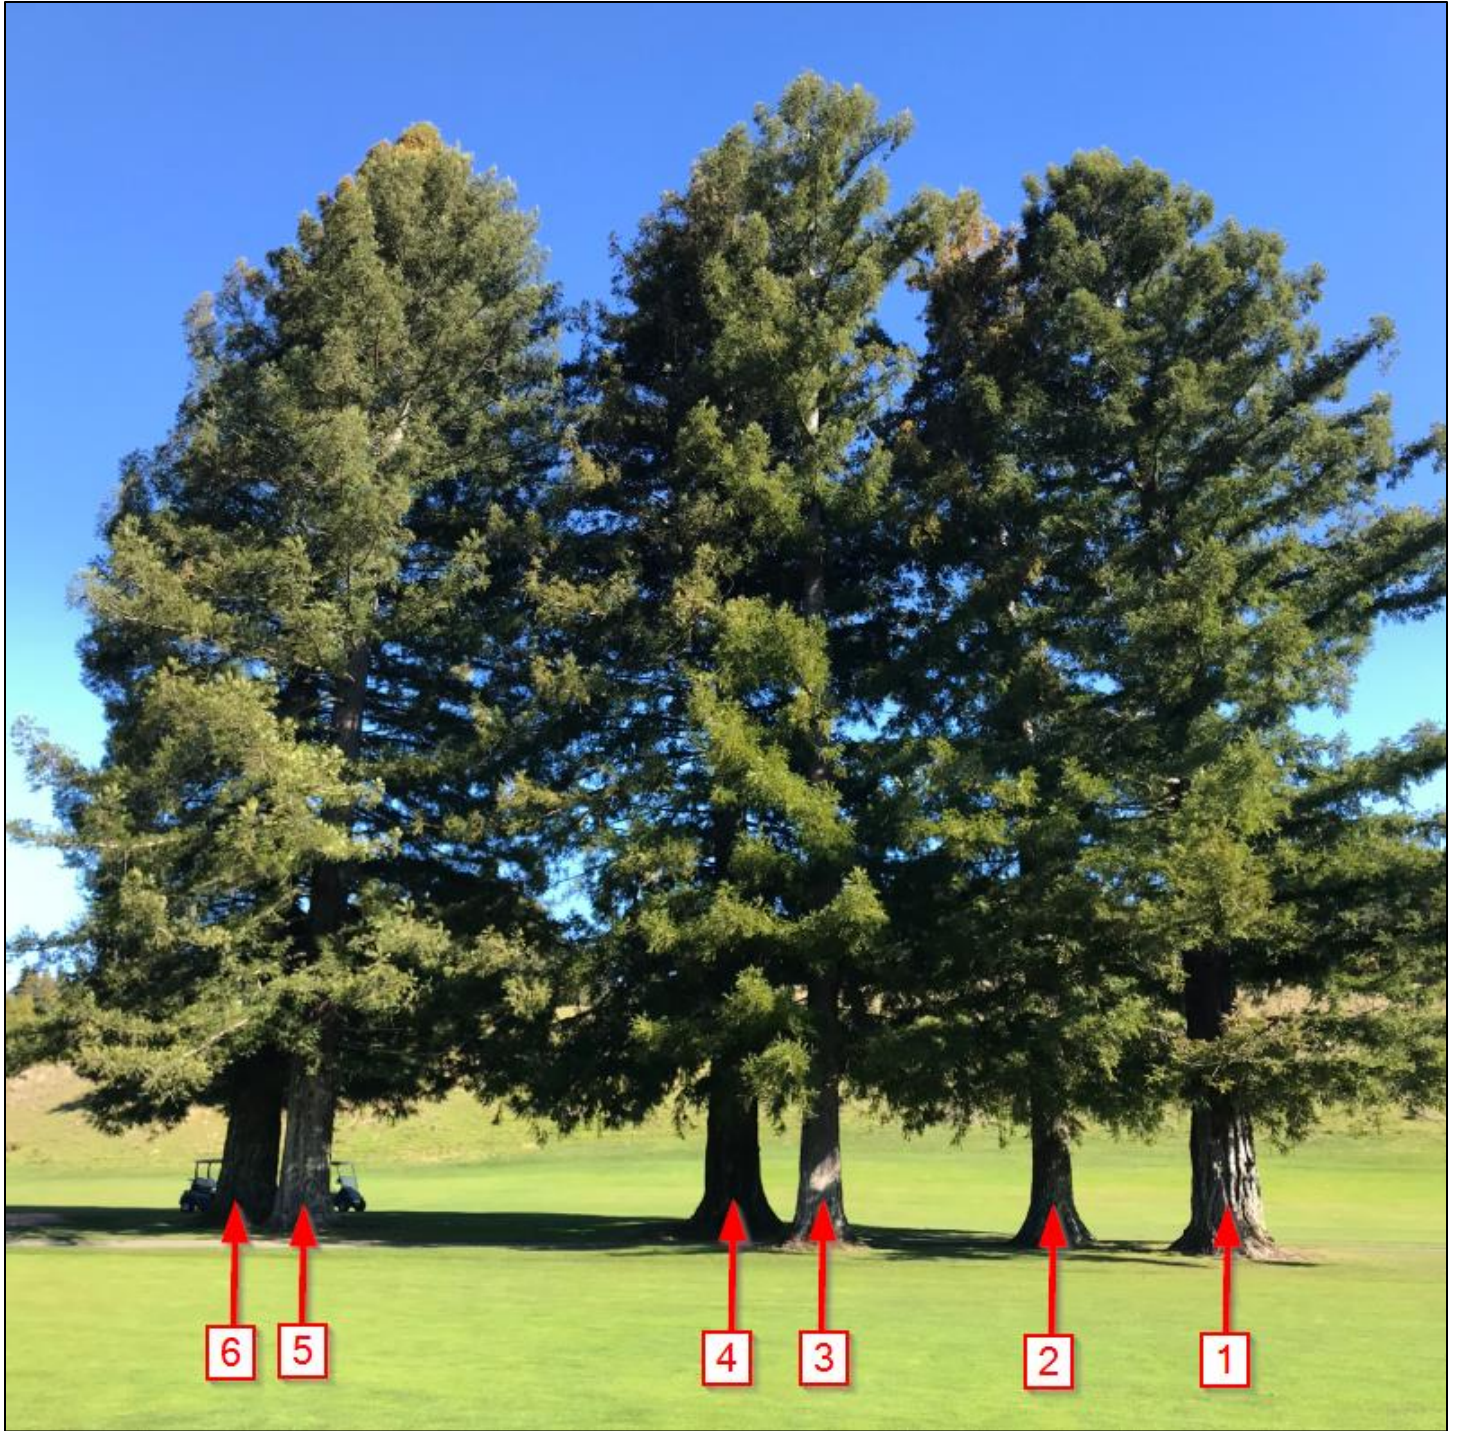
Figure 1. Trees 1-6 as viewed from the 16th fairway looking north.

The subject trees exhibit good health, good structure, and fair to good form (See Table 1 for tree condition descriptions) and appear to be performing well onsite. The form rating was reduced slightly due to the canopy asymmetry caused by the trees being planted too closely.

Removal of the subject trees is necessary to achieve the course's desired use of the property. Removing the subject trees will reduce water use, allow for installation of drought tolerant Bermuda grass, and achieve the desired aesthetic and functional outcomes desired by Meadow Club. If the permit is granted, tree replacement will have to be addressed; either through replanting (3:1 ratio) or in lieu of fees.

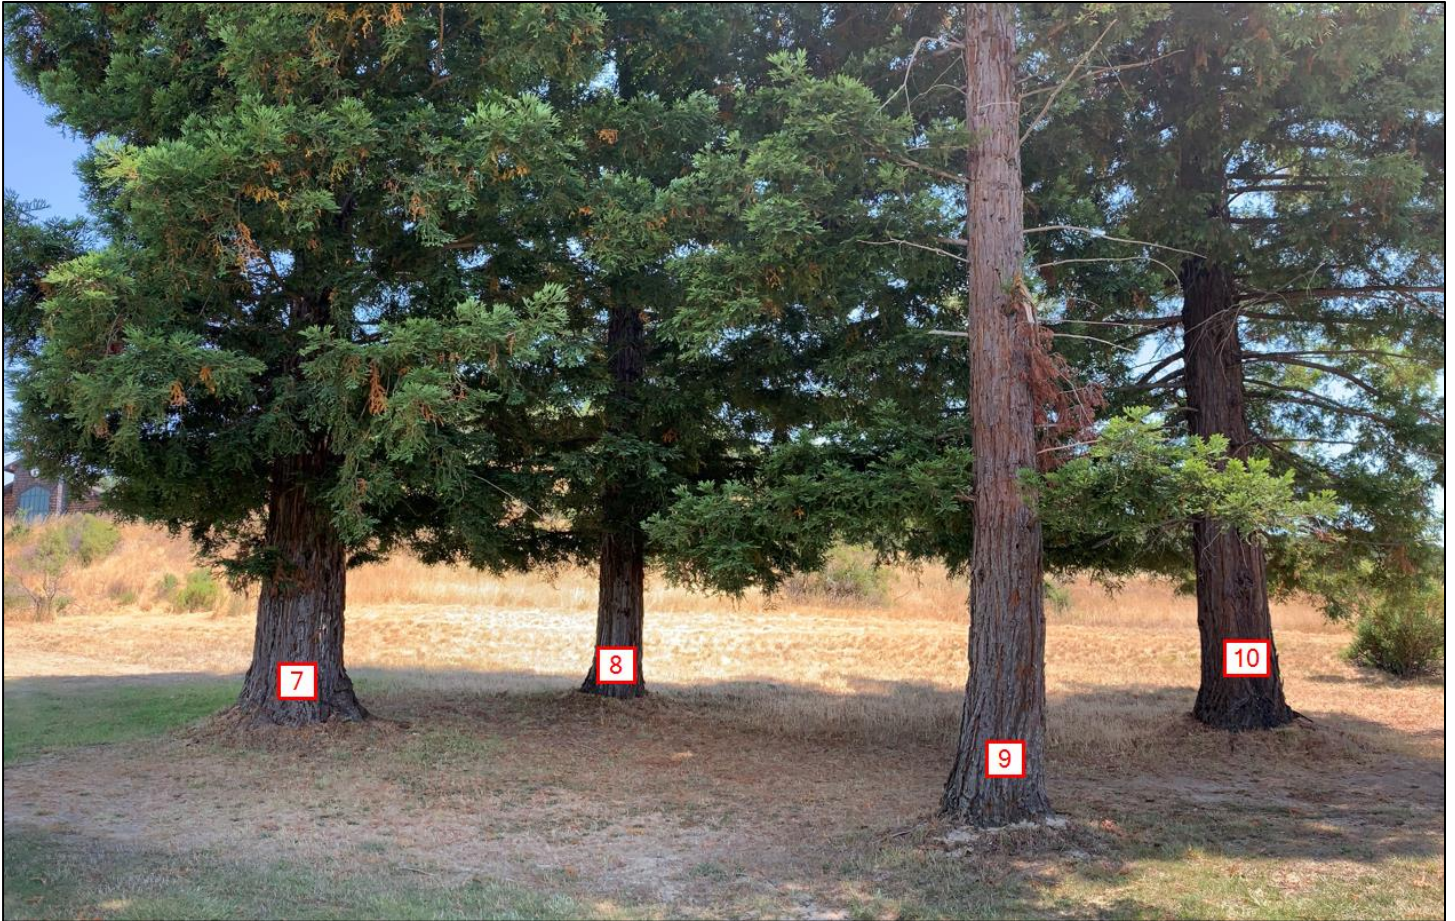
Figure 2. Trees 7-10 as viewed from the 18th fairway

HOLE 18 Redwood Removal: The (4) subject trees are coast redwood ranging in height from approximately

60 to 90 feet (See Figure 3). Of the four trees (2) trees qualify as Heritage based on the definition in the Marin County Municipal Code. The trees are spaced closely and share canopy space. The appearance of the tree canopies was normal at the time of my inspection and no notable structural defects were observed.

Of the four trees on the 18th hole, two would be removed under the annual two trees allowed as they are protected trees. The other two trees (Tree-7 and Tree-10) are heritage trees.
