# Fairfax Branch

## Marin County Free Library

# Inspection Report

Report Number:  
**150909.1**

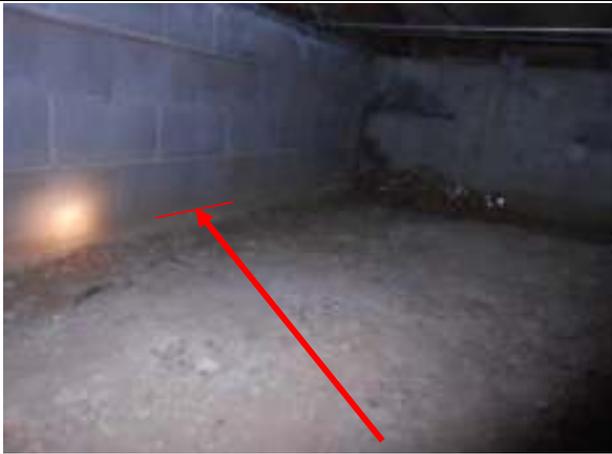
- 2. Watermarks and stains on vertical surfaces in the basement see pic 1.1 and in the return air duct, see pic 21.6 indicate water entry has occurred in this area during periods of heavy rain. However, no significant damage was observed. This area should be monitored during the rainy season to determine if excess moisture accumulates. If water entry occurs, then installation of a ground water mitigation system may be required. Re-inspection of the return air duct after heavy rains would be highly recommended. If moisture is allowed in return air duct serious health issues such as legionnaires or other diseases can occur.**

1.1 Correct crawl space flooding, high water mark

**Watermarks and stains on vertical surfaces in the basement see pic 1.1 and in the return air duct, see pic 21.6 indicate water entry has occurred in this area during periods of heavy rain. However, no significant damage was observed. This area should be monitored during the rainy season to determine if excess moisture accumulates. If water entry occurs, then installation of a ground water mitigation system may be required. Re-Inspection of the return air duct after heavy rains is highly recommended. If moisture is allowed in return air duct serious health issues such as legionnaires or other diseases can occur.**

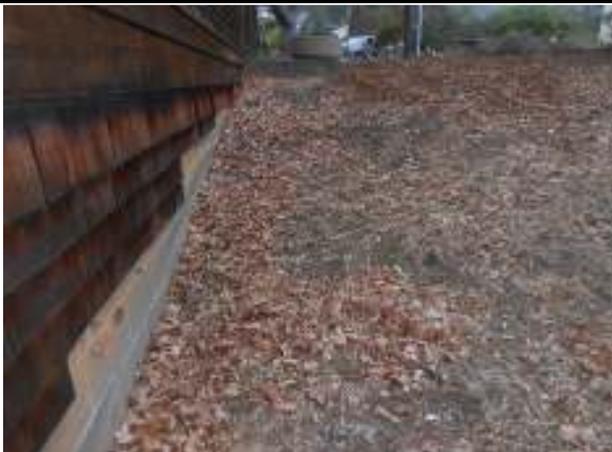
1.3 Correct grade wrong pitch, h2o should drain away

**Grading left side sloped toward the foundation. This condition promotes water accumulation at the building, which could result in deterioration of the foundation and water penetration into the basement or crawl space.**

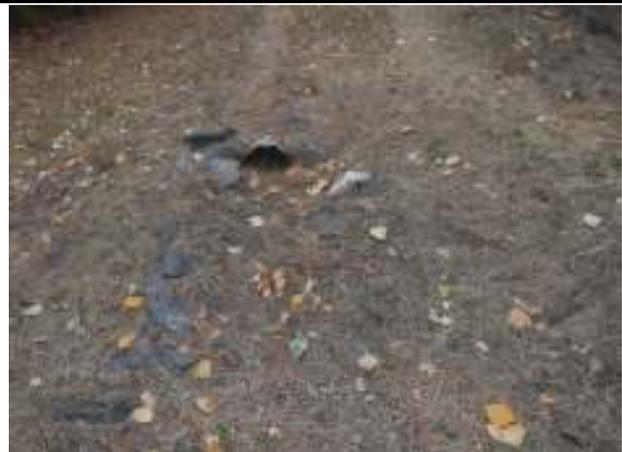
1.4 correct open drainage pipe hazard add grate

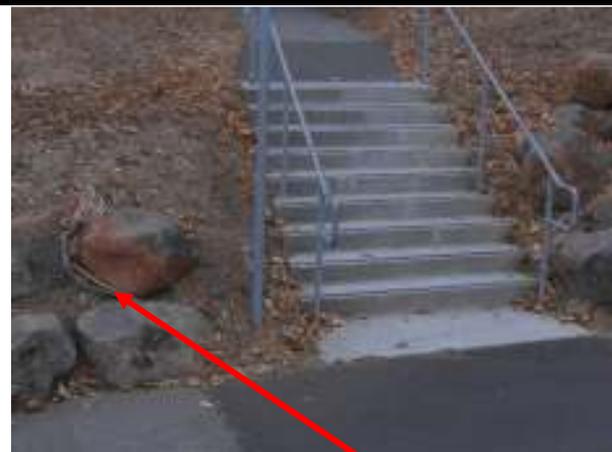
1.5 Remove abandon wires

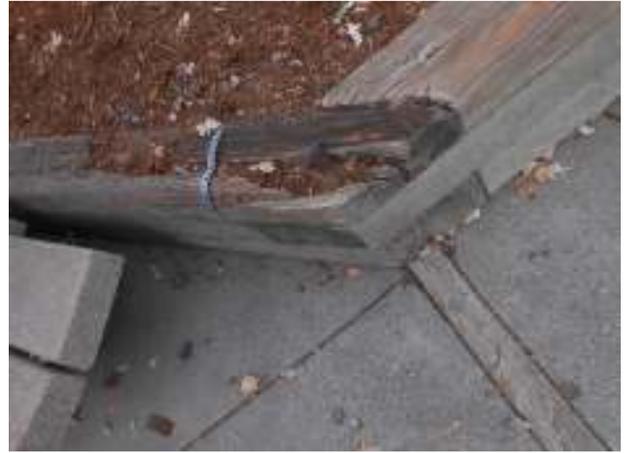
2.2 Replace all damaged retaining wall parts

The retaining walls were deteriorated. If and when further deterioration or movement develops, repair will be necessary immediately to reduce the potential for collapse of the walls

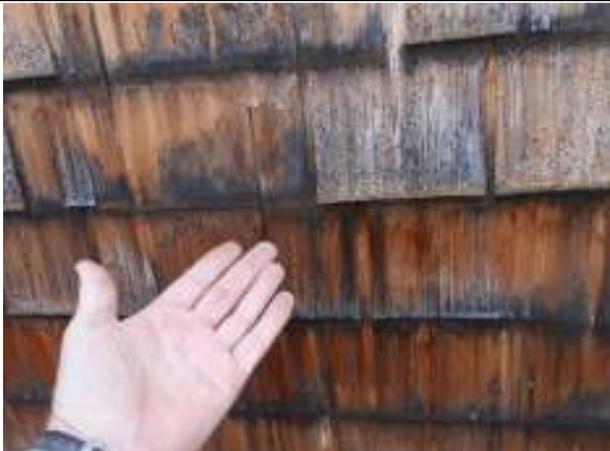
2.3 Replace siding as required, notice missing shingles

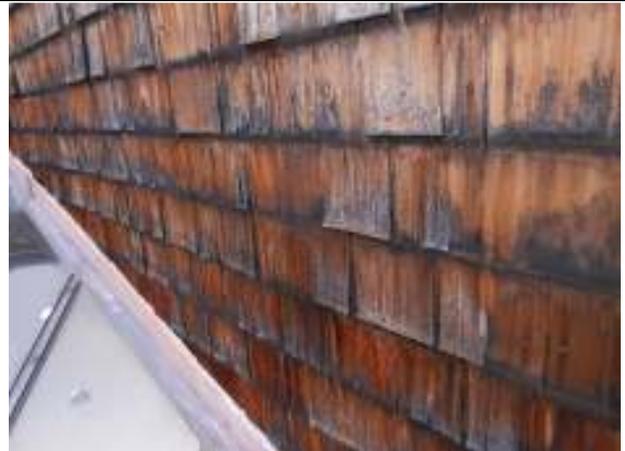
2.4 Replace siding as required, notice missing shingles

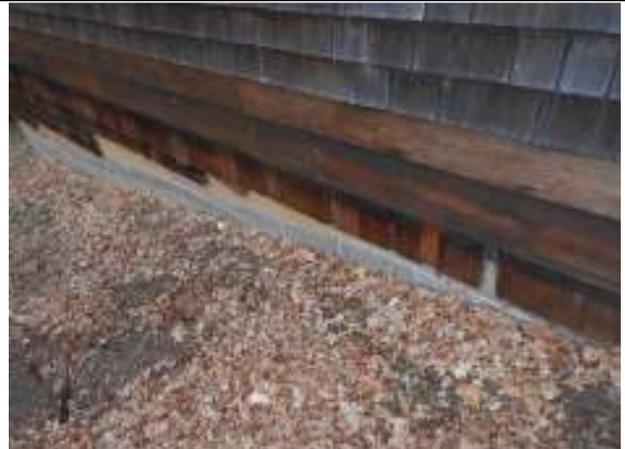
2.6 Replace siding as required

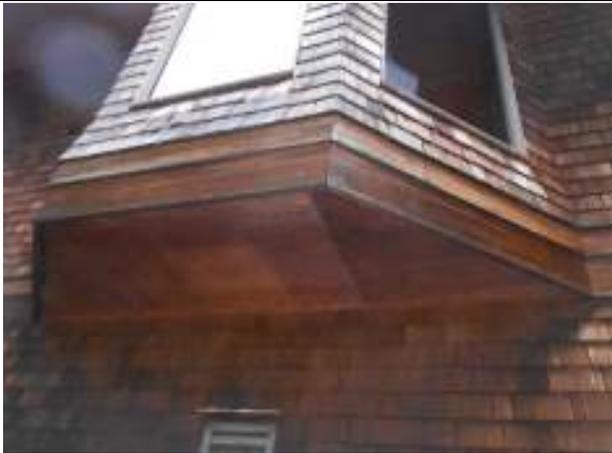
3.1 Replace siding as required

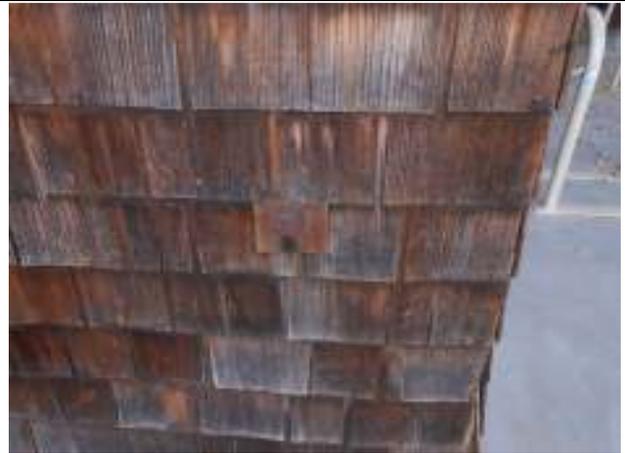
3.2 Replace siding as required

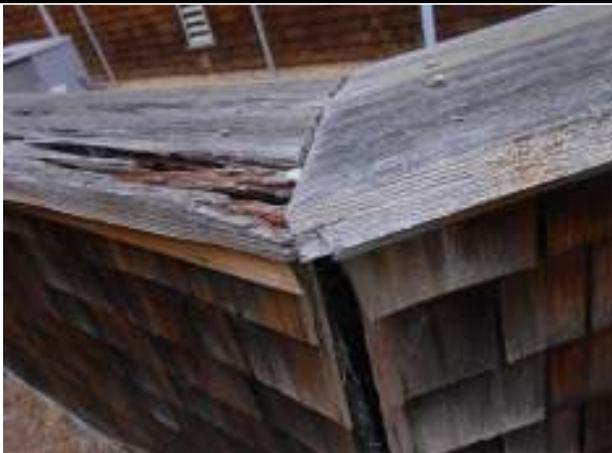
3.3 Replace/repair siding and cap as required

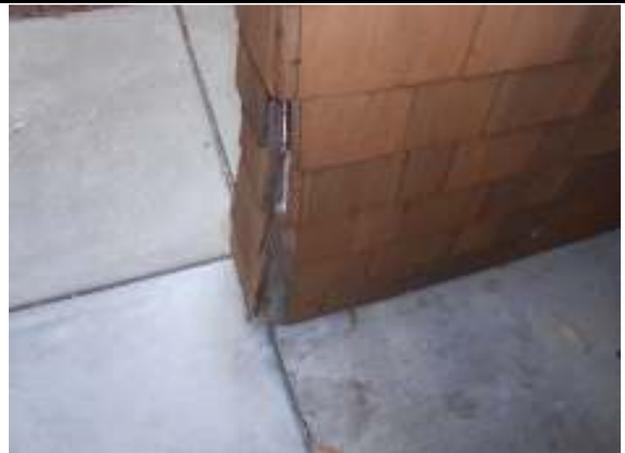
3.4 Replace/repair siding as required

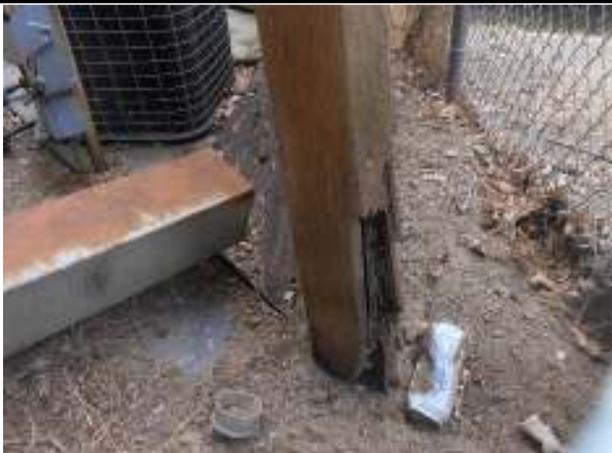
3.5 Replace siding as required, correct grade, 6" clear

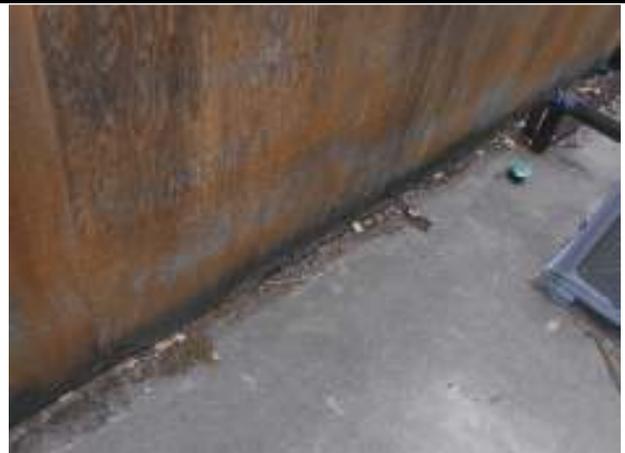
3.6 Replace/repair siding as required

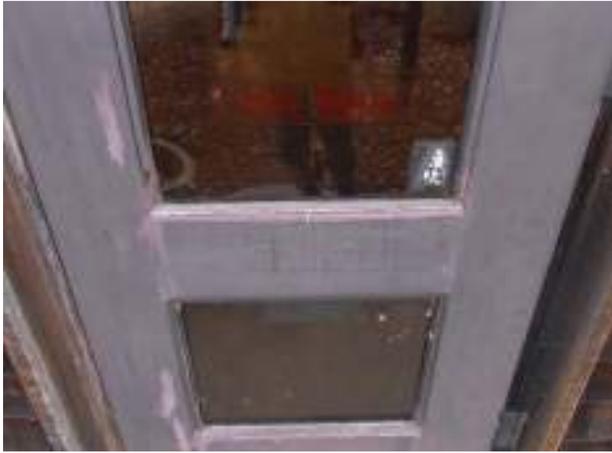
4.1 Replace damaged exit glass door

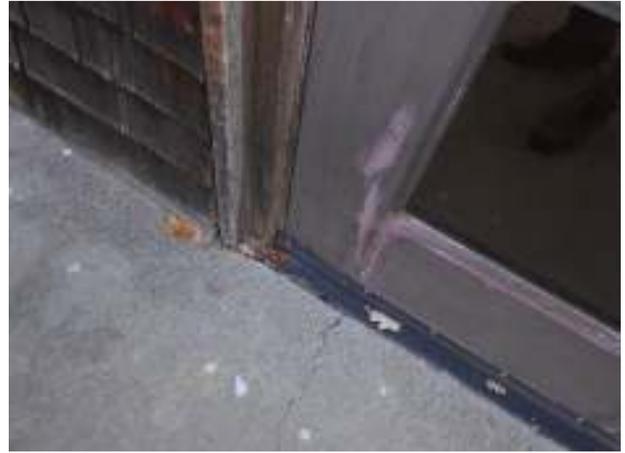
4.2 Replace damaged exit glass door

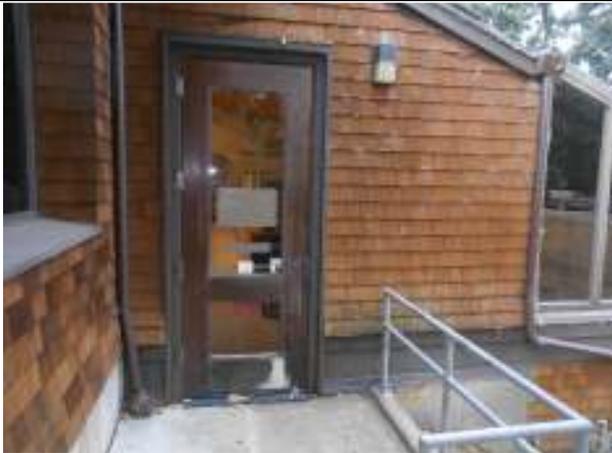
4.3 Replace damaged exit glass doors

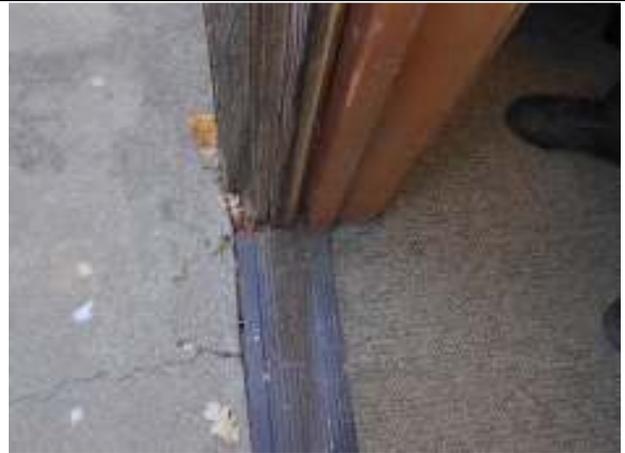
4.4 Repair/replace damaged door jambs

The frame and/or jamb for the Left side exit door was deteriorated. All damaged components should be repaired, if possible, or replaced in a manner that complies with current industry standards.

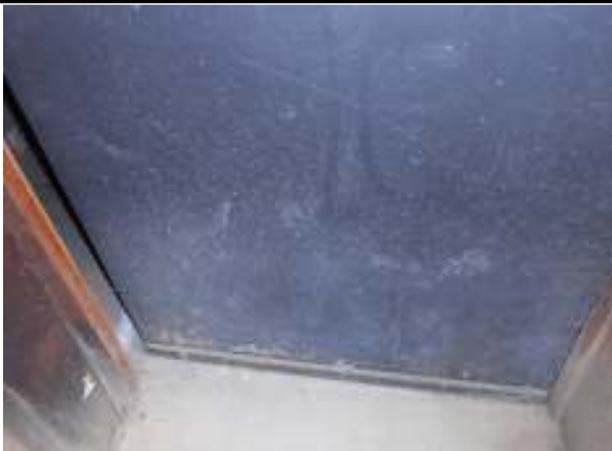
4.5 Replace/repair damaged basement doors

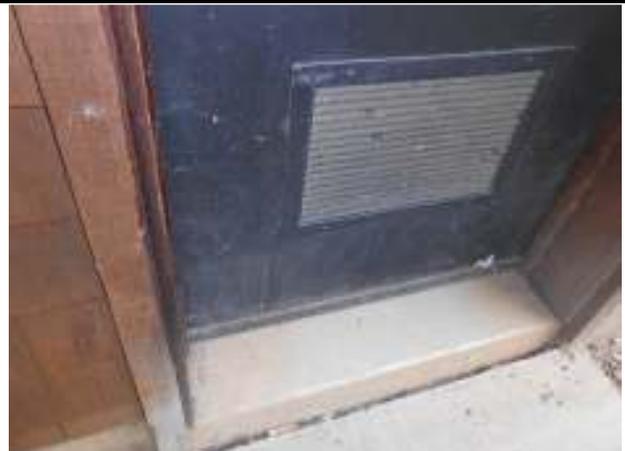
Replace/repair damaged basement doors

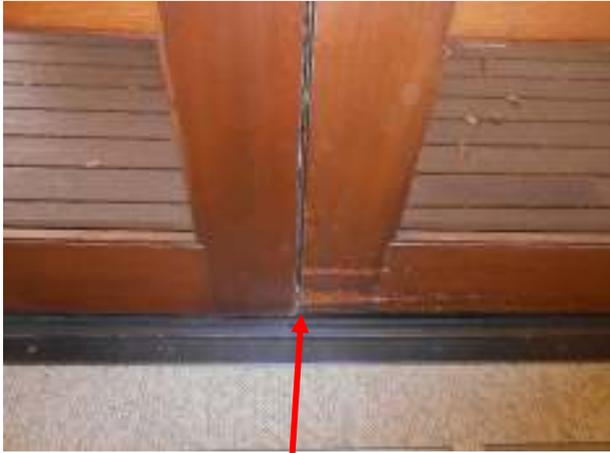
5.1 Correct weather strip at Deck door astragal

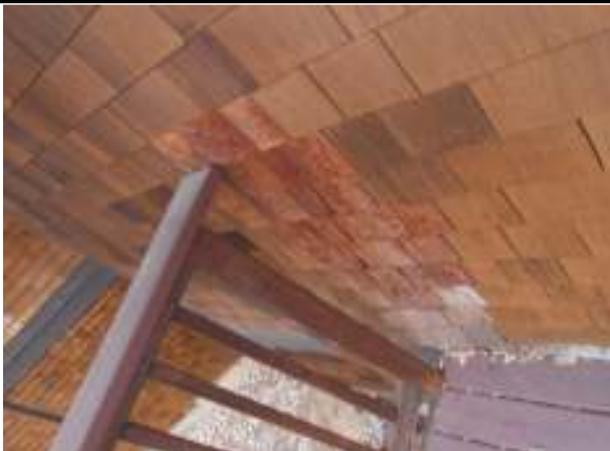
5.5 Noted recent repair to siding at deck rail?

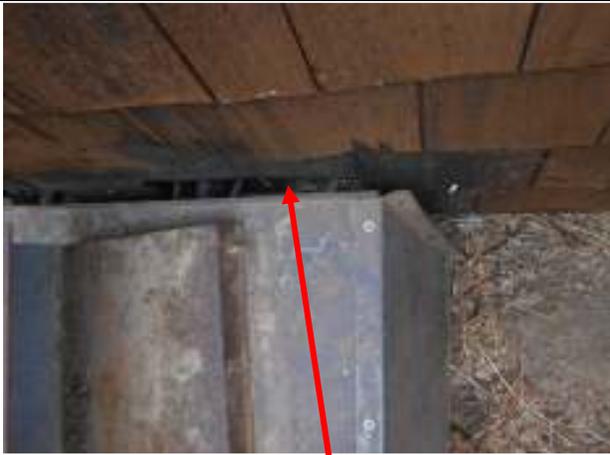
6.1 Close all opening in siding and cover insulation

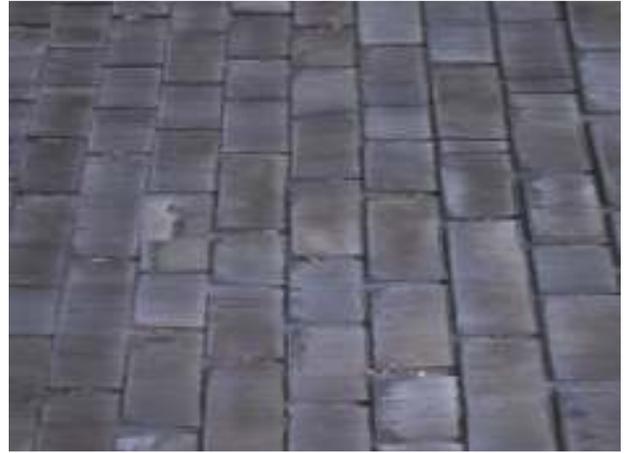
7.2 Replace all damaged roof shingles

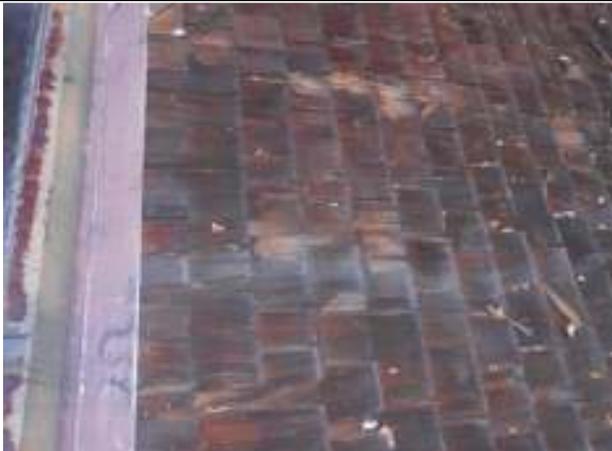
7.3 Replace all damaged roof shingles

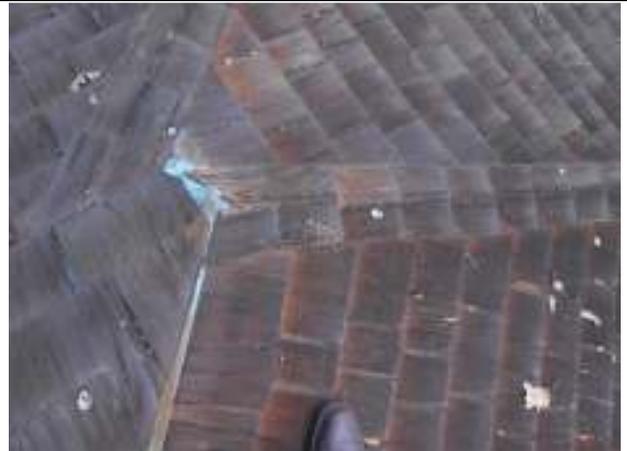
7.4 Replace all damaged roof shingles

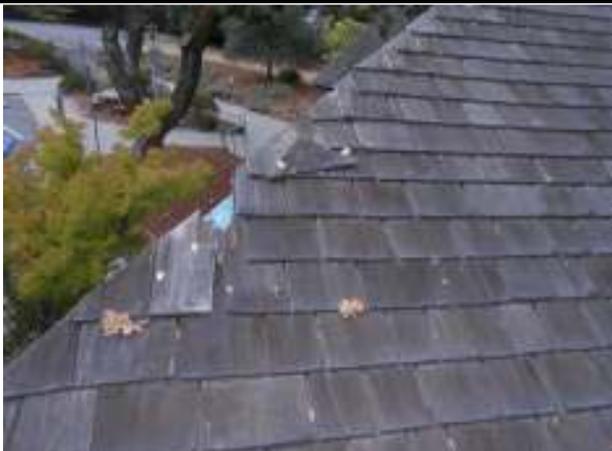
7.5 Replace all damaged roof shingles

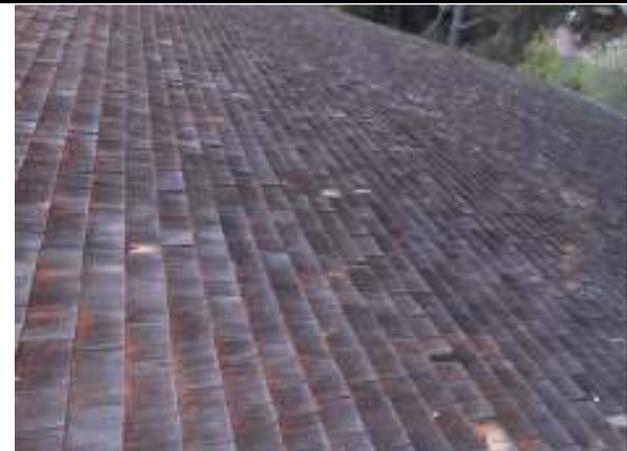
7.6 Replace all damaged roof shingles

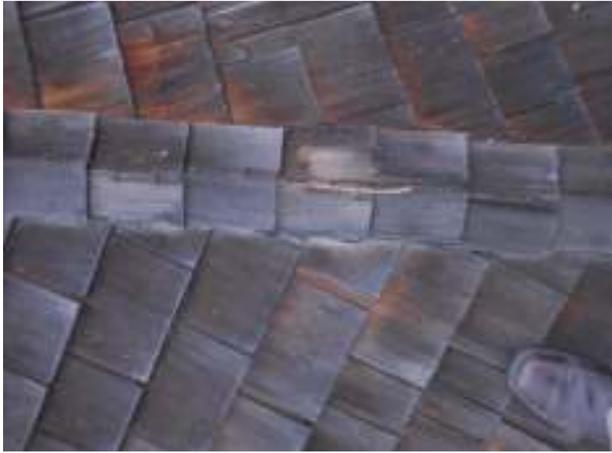
8.1 Replace all damaged roof shingles

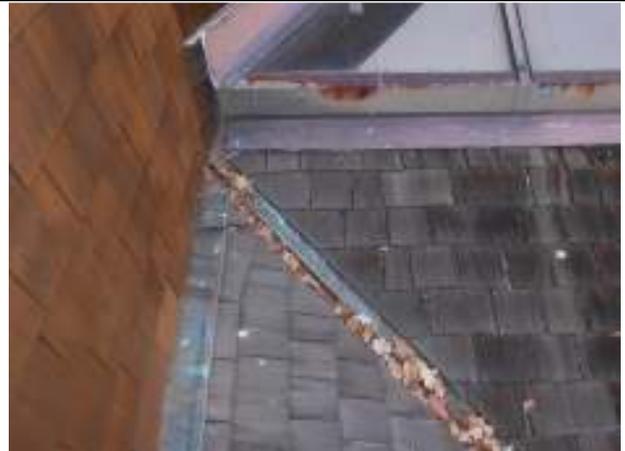
8.6 Replace or prep, repaint all damaged flashing

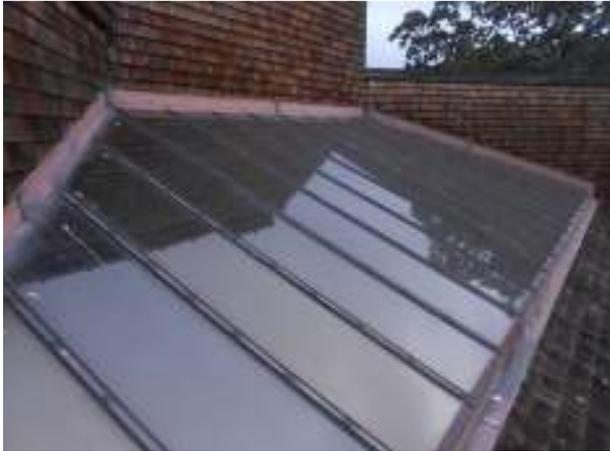
9.1 Correct all leaks in Skylight

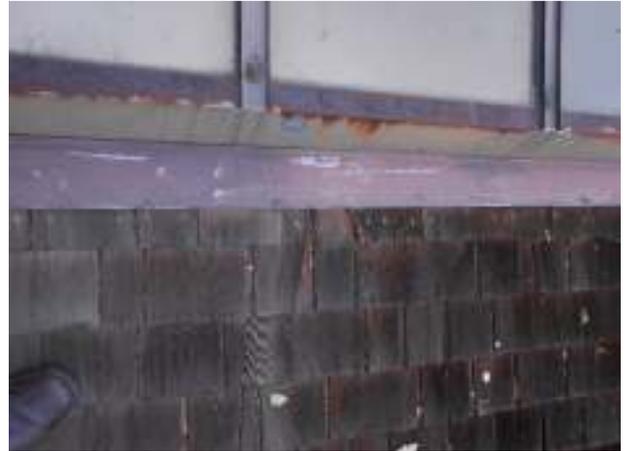
9.2 Replace or prep, repaint all damaged flashing

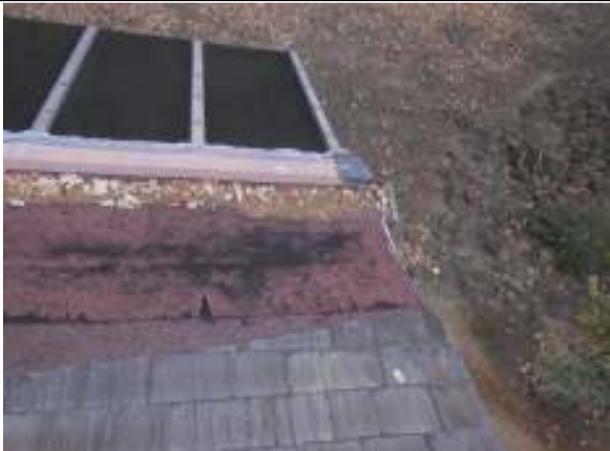
9.3 Replace damaged roll roofing

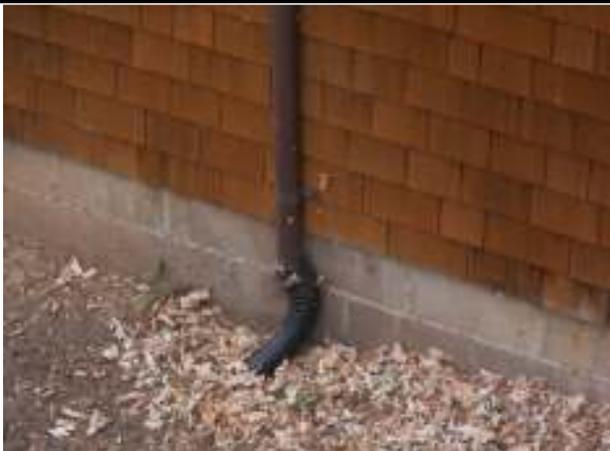
9.5 Replace all corrugated drain pipe with rigid/smooth

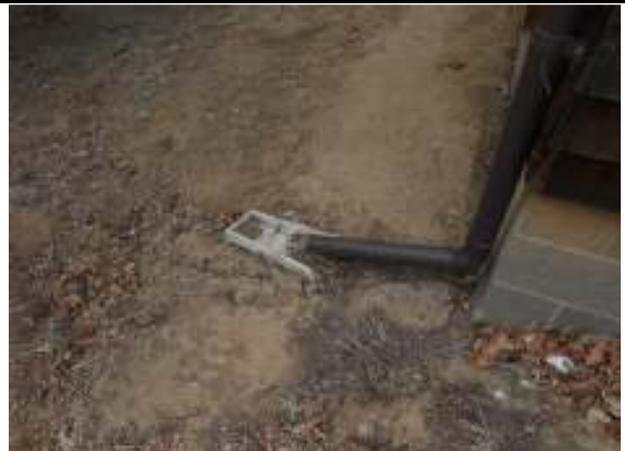
9.6 Correct Splash block installed backwards

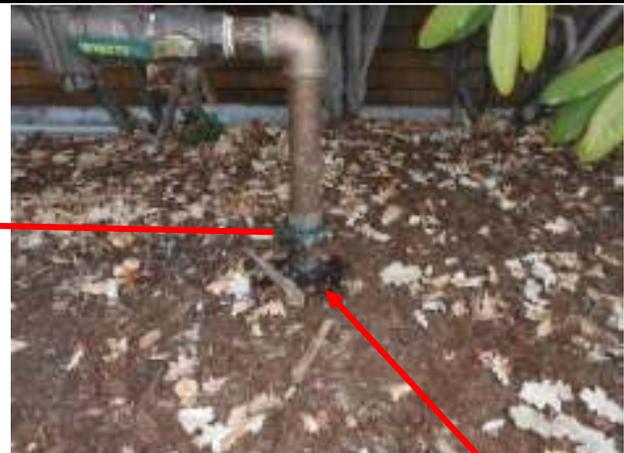
10.4 Correct water check valve pipe leak

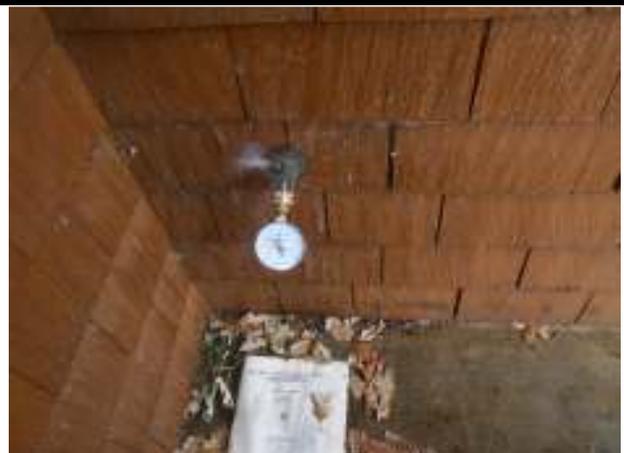
10.6 Correct hose bib valve leak

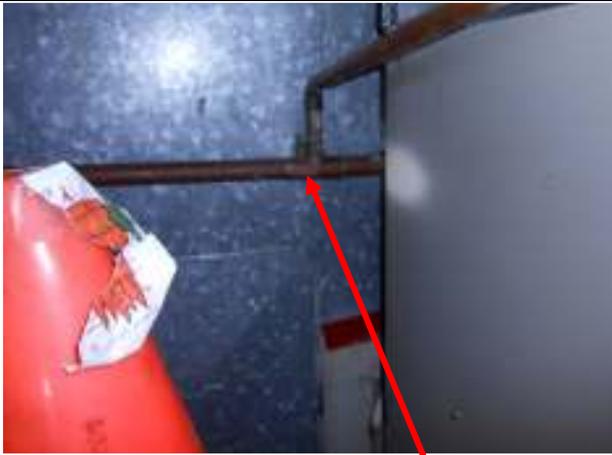
11.1 Correct Condensate line leak at fitting

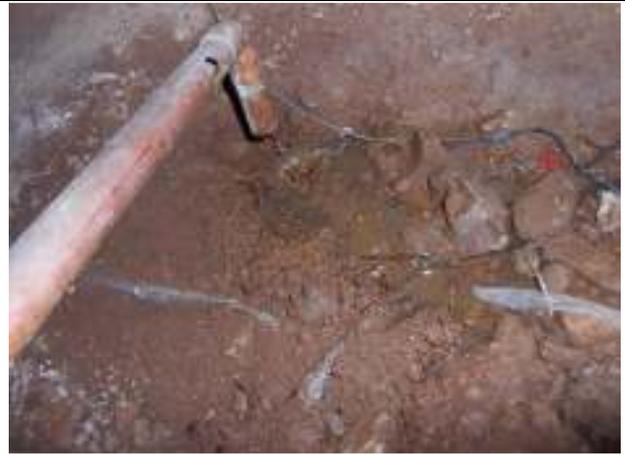
11.2 Relocate condensate discharge to exterior

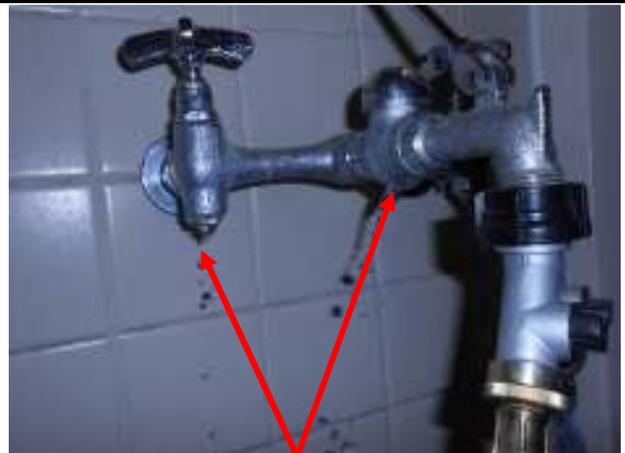
11.4 Correct leaks in Janitor closet faucet

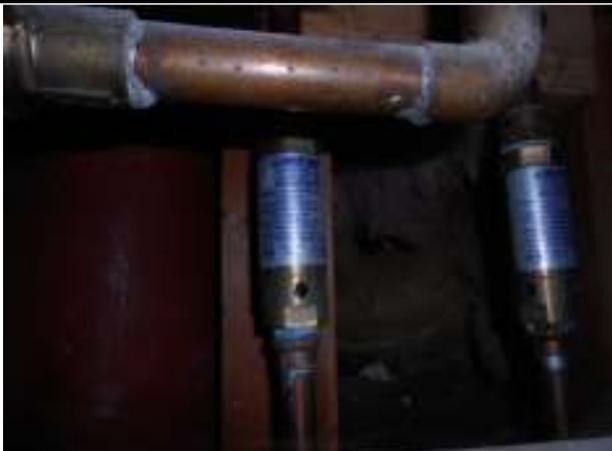
11.5 Drip valves for restrooms floor drain traps

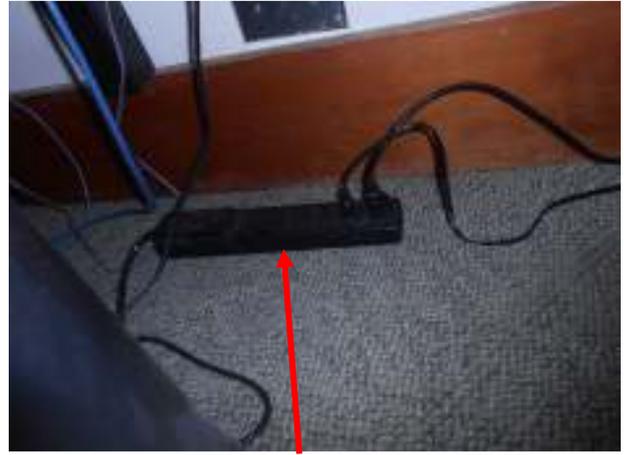
12.2 Provide additional conditioned power outlets

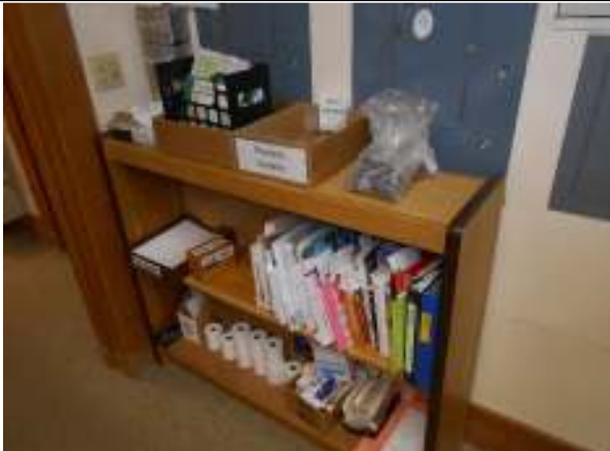
12.3 Provide signage to "Keep area clear 36"

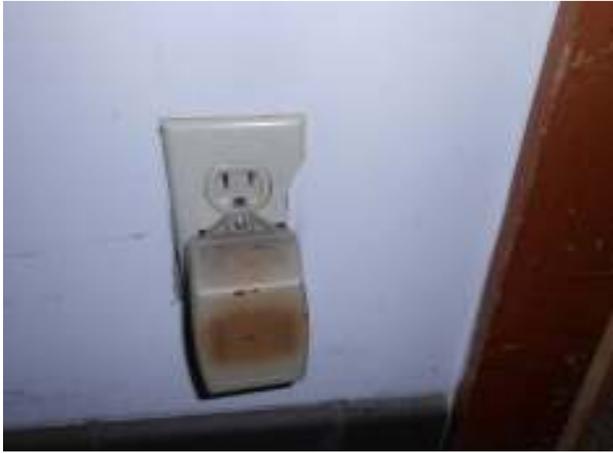
13.1 Remove transformer, replace plate, Janitor closet.

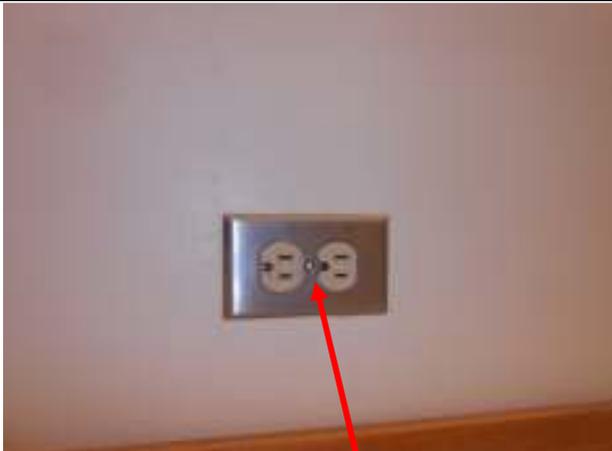
13.3 Replace all broken receptacles

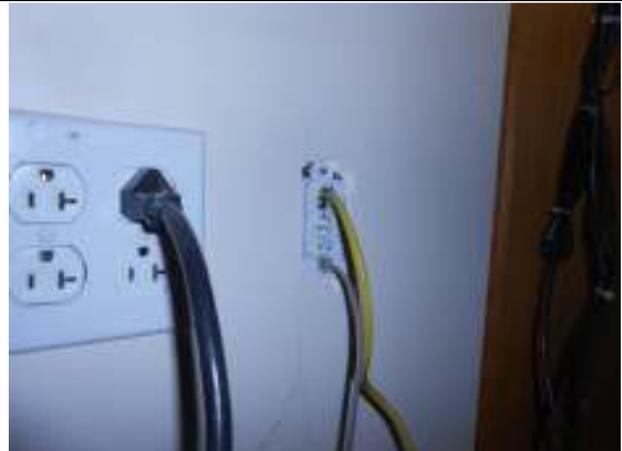
13.4 Add plate covers were missing

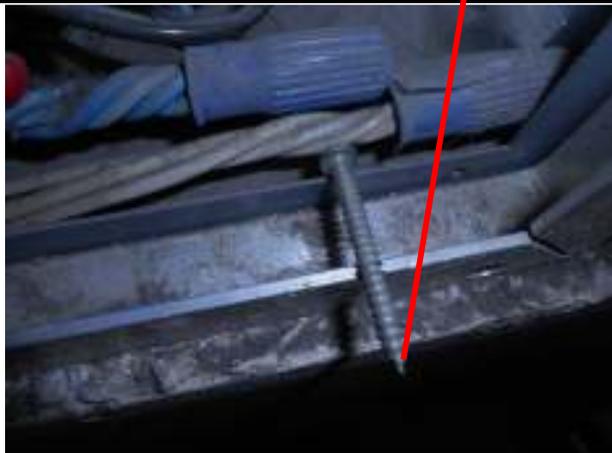
14.3 Replace all pointed screws with blunt tip

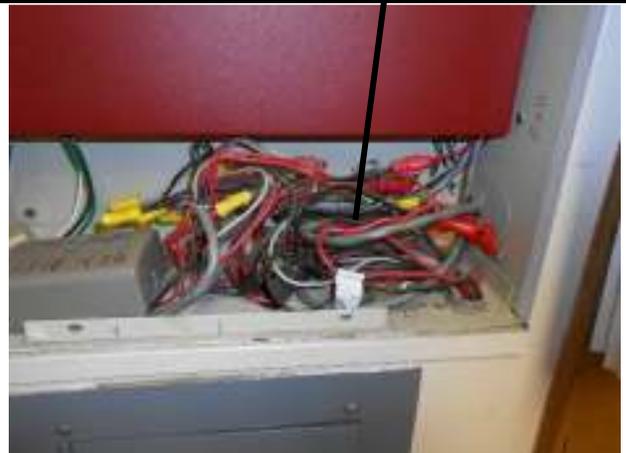
14.4 Add protection to 120v supply

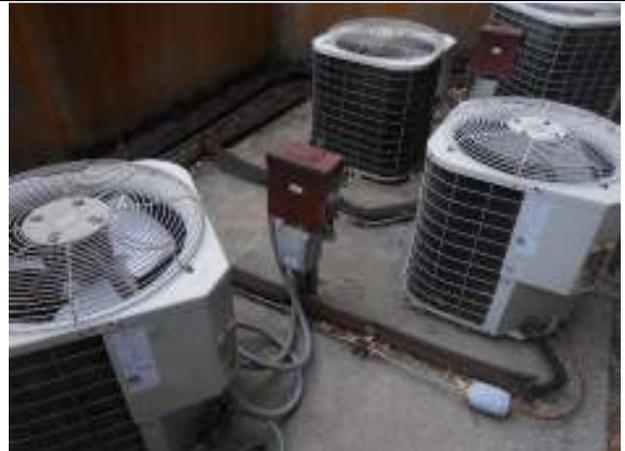
35. The local AC compressor Federal Pacific disconnect enclosure, 5 of the 6, was corroded and deteriorated. This reduces the reliability of the equipment and connections within the disconnect. Any damaged, improperly installed or deteriorated local disconnect equipment should be repaired or replaced by a qualified, licensed electrician who should certify that the work has been completed in a manner that leaves the system safe and dependable.

17.4 Replace 5 each, FP panels at AC compressors

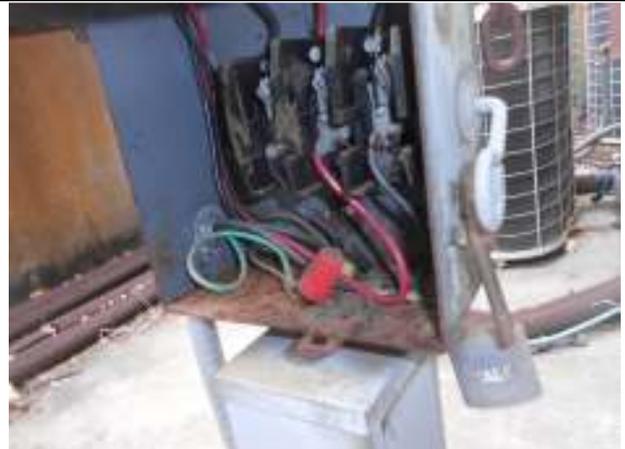
17.6 Replace 5 each, FP panels at AC compressors

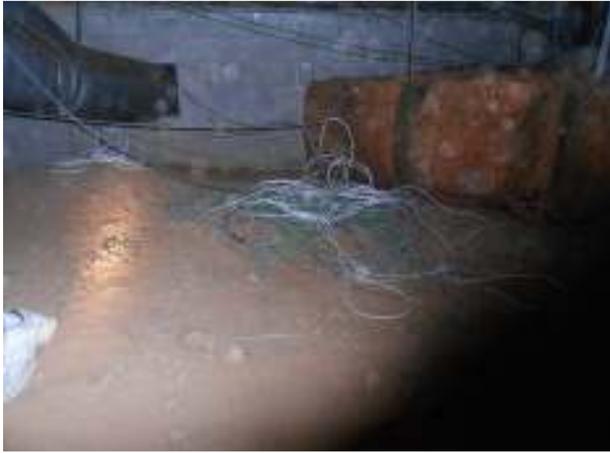
18.1 Remove all debris in crawl space

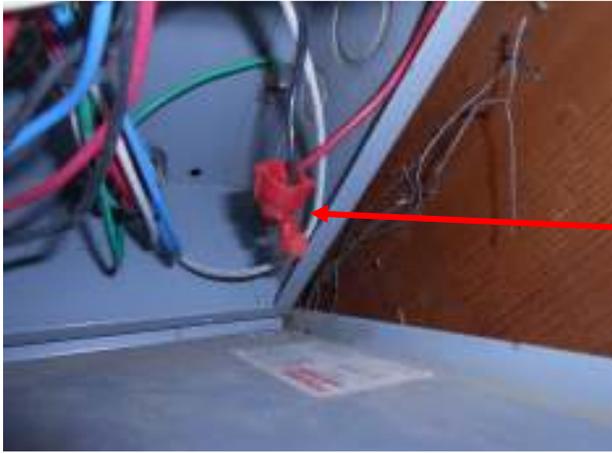
22. Arching wires melted a wire nut, see pics 19.1 and 19.2. The possibility of fire from such a condition is a very real concern. This wire nut was replaced during the inspection. All others in the area should be examined and corrected as soon as possible to prevent the possibility of fire or a shorted circuit.

19.1 Over heated wire nut was corrected and replaced

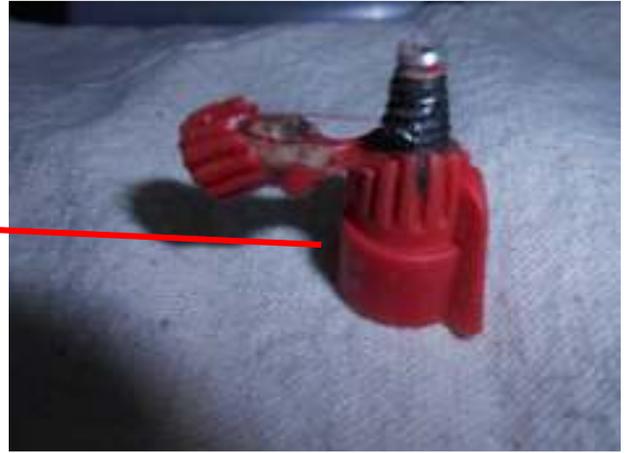
19.2 Substandard install: Overheated wire nut

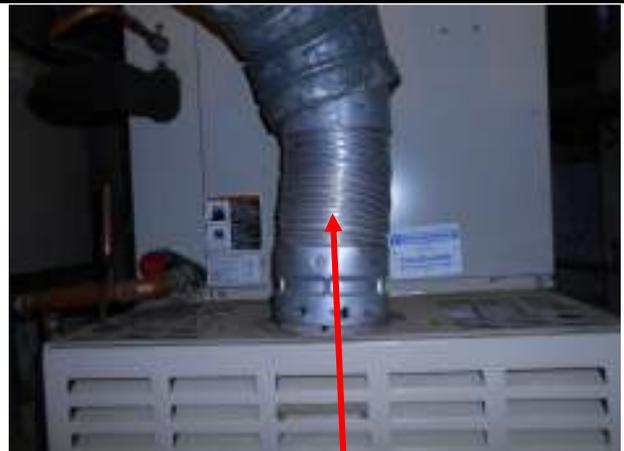
20.6 Substandard: Replace vent pipe with "B" vent

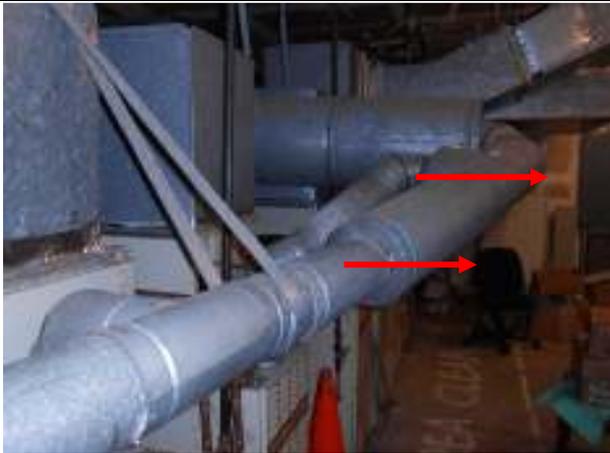
21.1 Substandard vents, add support for correct pitch

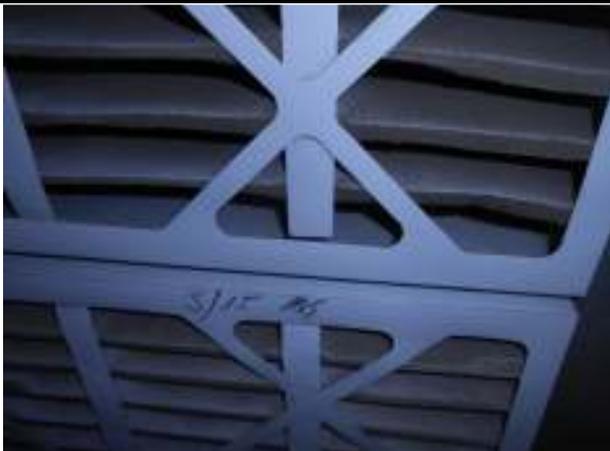
21.5 Replace dirty air filters

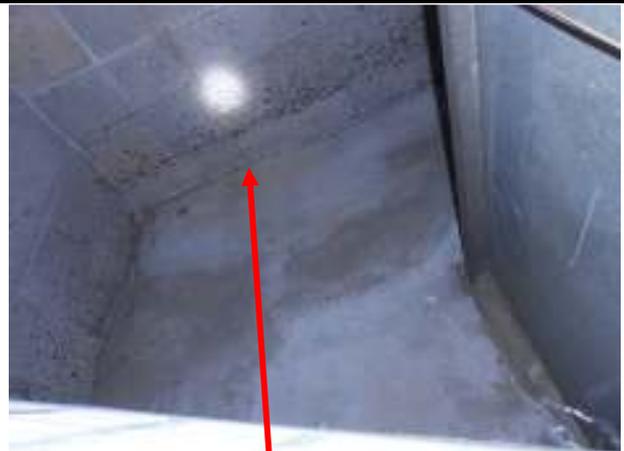
21.6 Correct drainage so water is not in return air duct

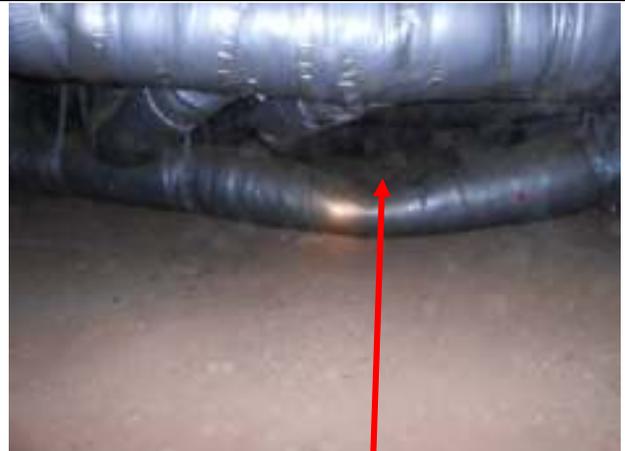
22.4 Replace crushed duct and get all ducts off dirt

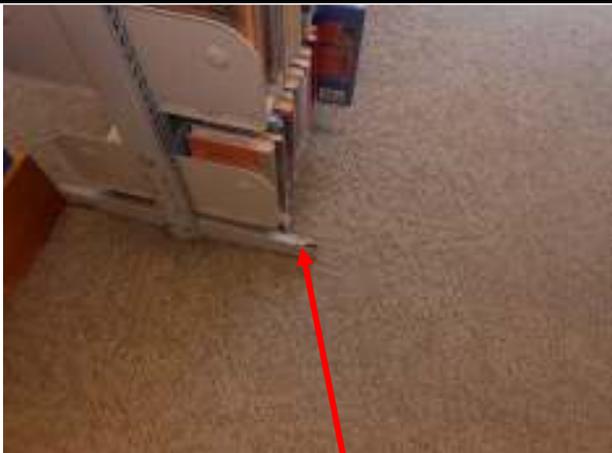
24.5 Correct trip hazard

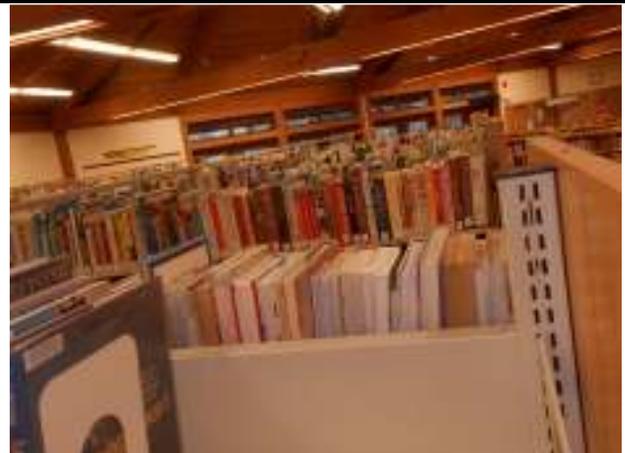
24.6 Add upper seismic braces as required

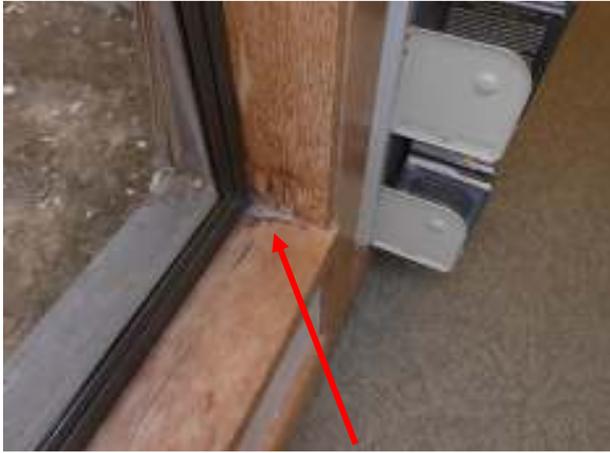
25.1 Correct all water leaks

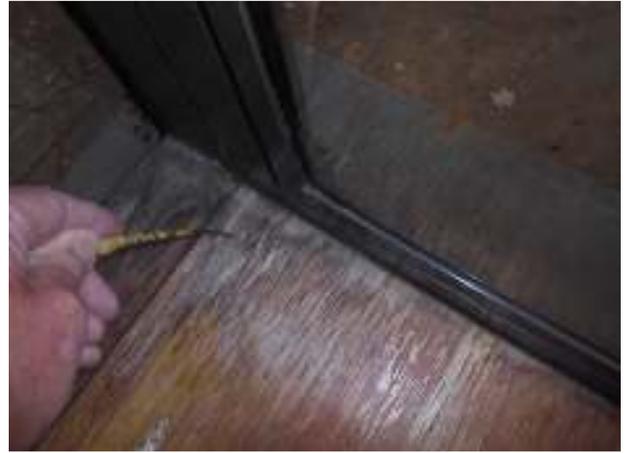
25.2 Correct all water leaks damage

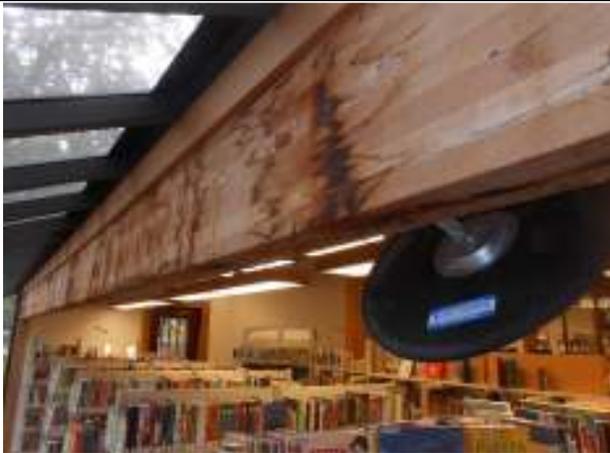
25.3 Correct all water leaks

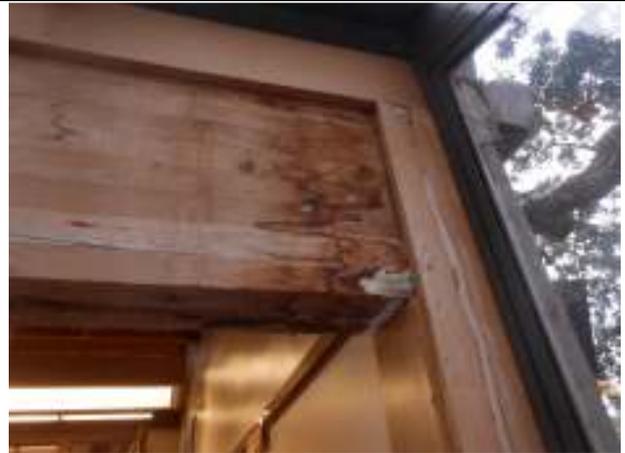
25.4 Correct all water leaks

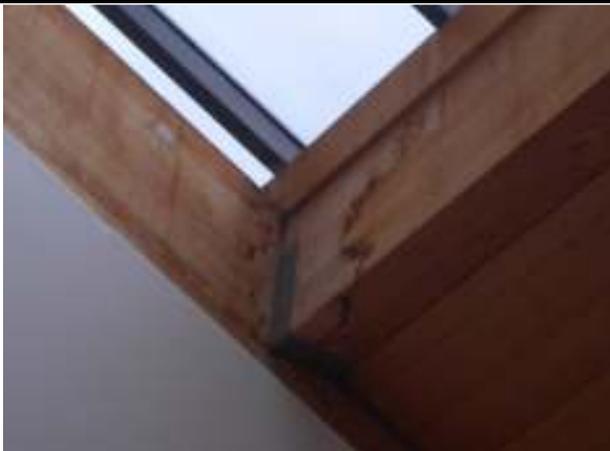
25.5 Correct all water leaks
