**PRELIMINARY TECHNICAL
MEMORANDUM NO. 2**
County of Marin, Department of Public Works
Flood Control Zone No. 3
Crest Marin Creek Pump Station
66-inch Diameter CMP Inlet Culvert Review

DATE: March 22, 2007

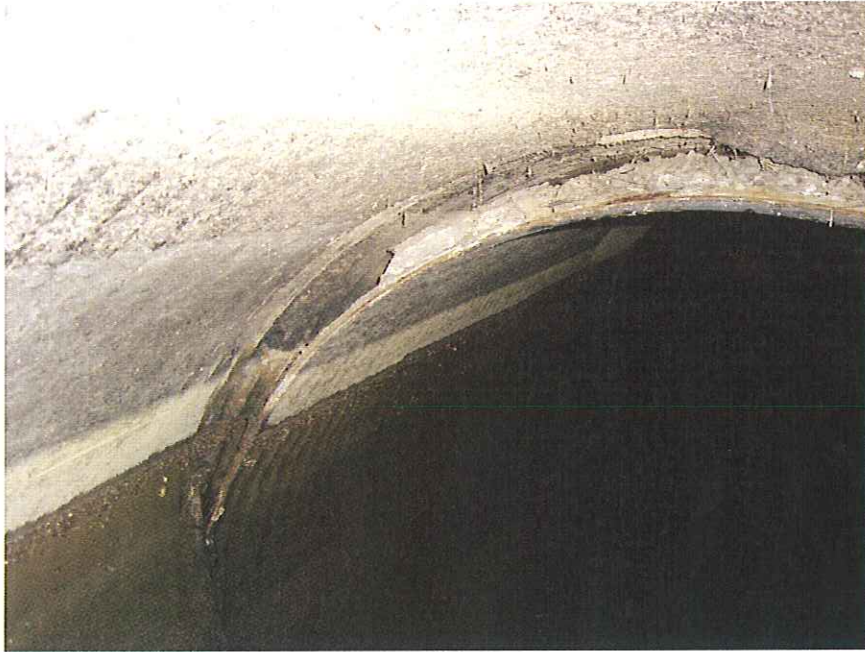
The CMP was measured to be out-of-round by approximately four to six inches with the deformation creating an elliptical shape (see Photo 1 below). The culvert appears to have settled four to five inches at the invert (see Photo 2 below). This may be the result of loss of bearing material due to soil washout at the invert and the haunches of the CMP. Soil applies pressure to the culvert, but also supports the CMP and much of the load. We note that the asphalt or mortar lining does not appear to be visually distressed or disbonded and contributes to the stiffness of the ring. The CMP is separated at the joint splice near the transition section. Reviewing the record drawings provided, there appears to be 3'-6" to 4'-0" of soil cover for the culvert.

Photo 1 – Deflection at Top of Culvert

- The District should continue to monitor the culvert on a regular basis to note any additional settlement at the invert. Additional deformation in the ring could result in a localized crushing of the culvert wall. This would not necessarily result in a collapse of the culvert, but may represent a performance limit of the CMP with regard to a reduction in the safety factor of the steel. A flexible circular ring such as the CMP is in equilibrium when it is subjected to uniform external pressure of the soil. If the settlement of the culvert continues

and the ring deformation increases, remedial measures may be required to maintain the operable function of the culvert.

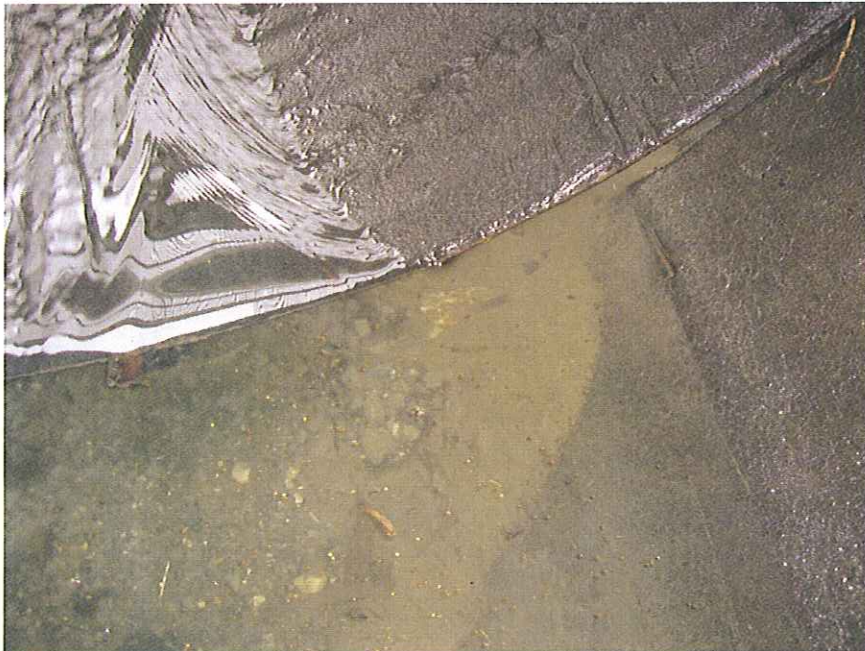
Photo 2 – Settlement at Culvert Invert
