CORNER RECORD

Document Number 28-124-18
City of MILL VALLEY County of MARIN, California

Brief Legal Description PARCEL 1. 5 PM 12

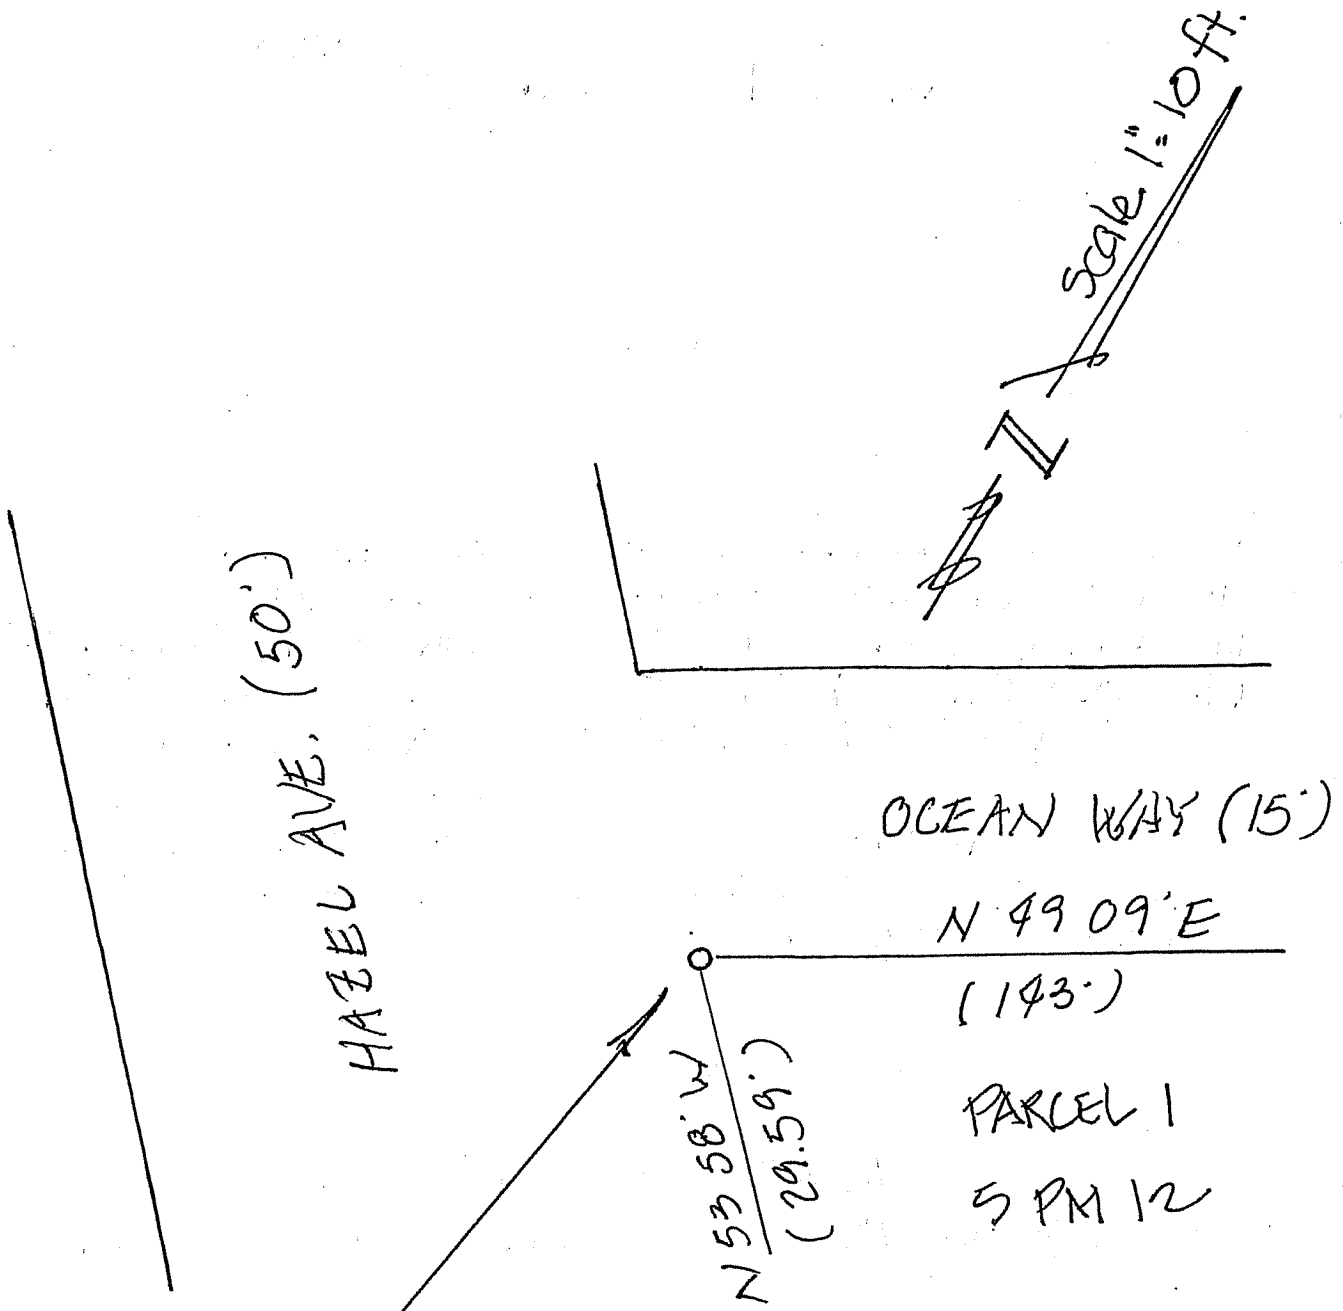
Found 2x2 (ORIGINAL CORNER) with RE TAG 12510
IN A DETERIORATED CONDITION AT THE
NORTHWESTERLY CORNER OF PARCEL 1, 5 PM 12
(INTERSECTION OF THE TWO COURSES 'N 49° 09' E,
143' E N 53° 58' W, 29.59'. see SKETCH ON REVERSE SIDE

This CORNER RECORD
 Found deteriorated 2x2 HUB
 w/ RE 12510 TAG (ORIGINAL
 CORNER TO 5 PM 12)
 set 1/2" rebar with PLS CAP 5379
 TO PERPETUATE LOCATION

set 1/2" REBAR with PLS CAP 5379 "SCRANTON"
AFFIXED TO TOP OF REBAR & DRIVEN FLUSH
WITH SURROUNDING grade
