**MARIN COUNTY STREAM CROSSING INVENTORY AND FISH PASSAGE  
EVALUATION**

**FINAL REPORT**

**Prepared for the County of Marin – Department of Public Works**

**Ross Taylor and Associates**

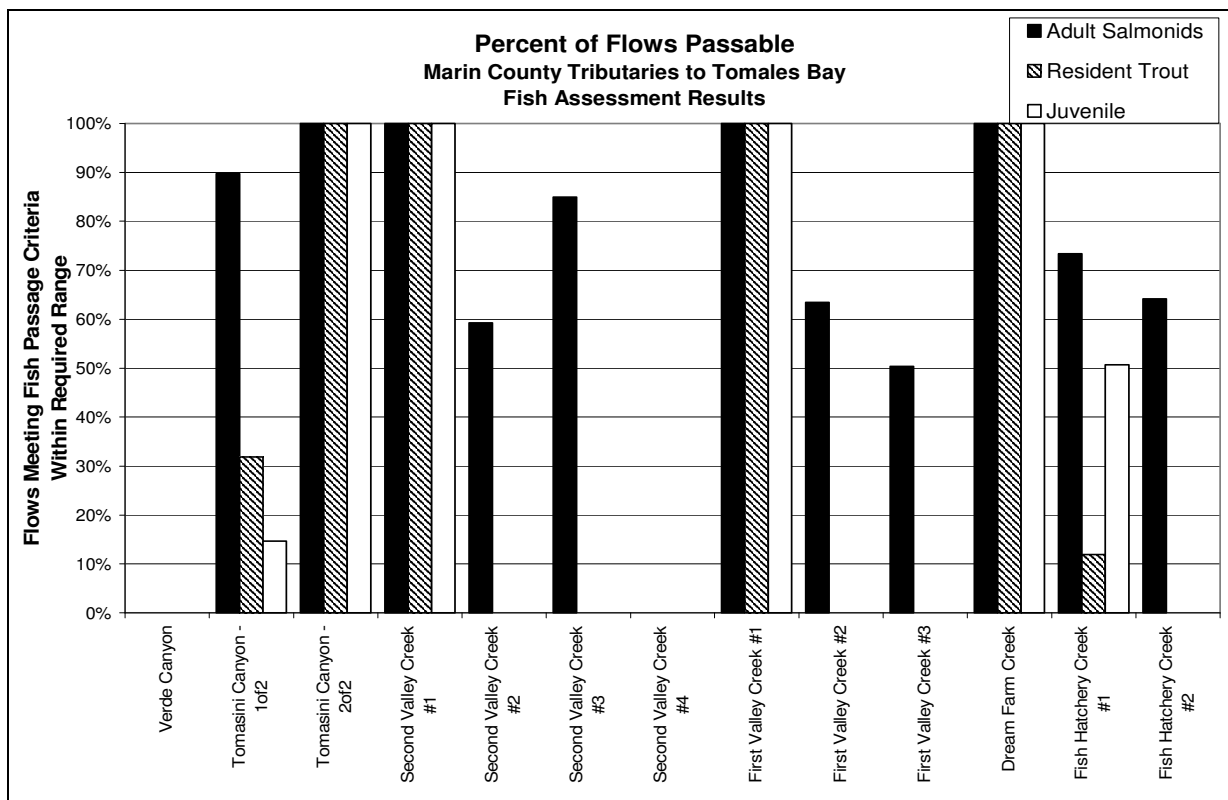
Figure 7. Percent passable as estimated by the Green-Gray-Red evaluation filter and FishXing for 12 Marin County stream crossings within tributaries of the Tomales Bay sub-watershed, by three groups of life stages.

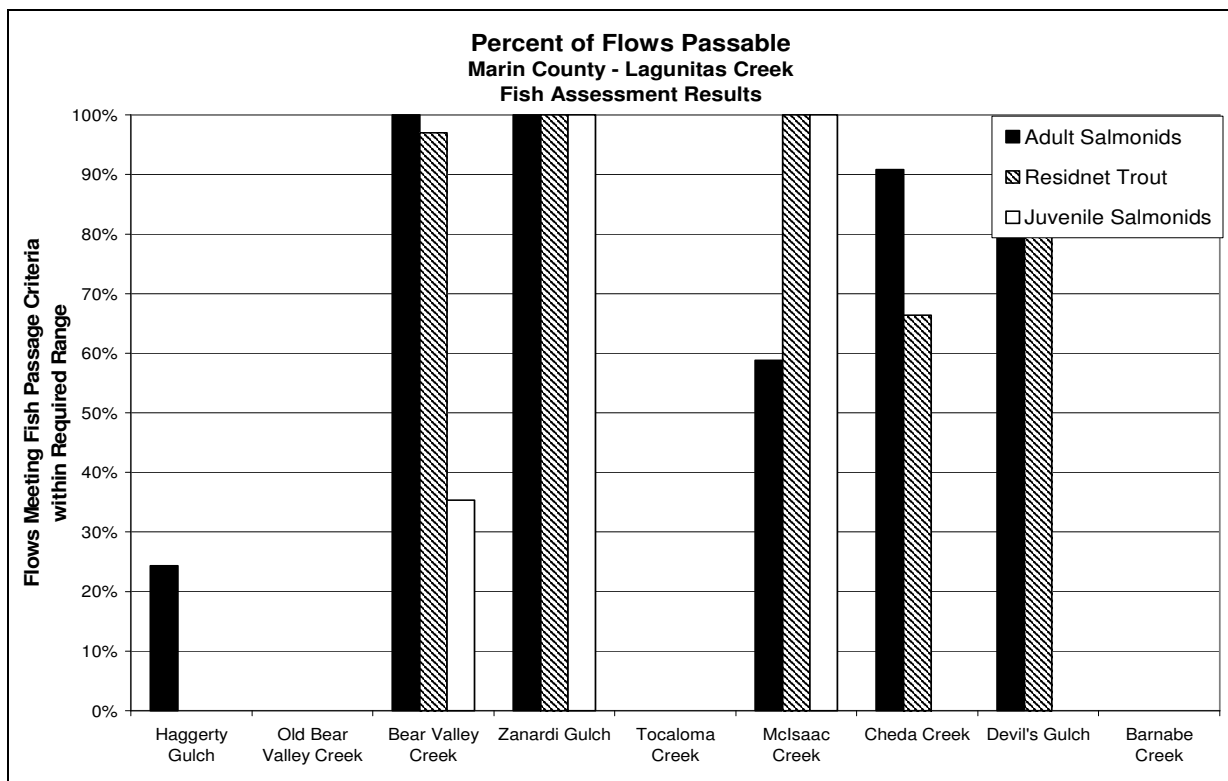
Figure 8. Percent passable as estimated by the Green-Gray-Red evaluation filter and FishXing for nine Marin County stream crossings within tributaries of Lagunitas Creek, by three groups of life stages.

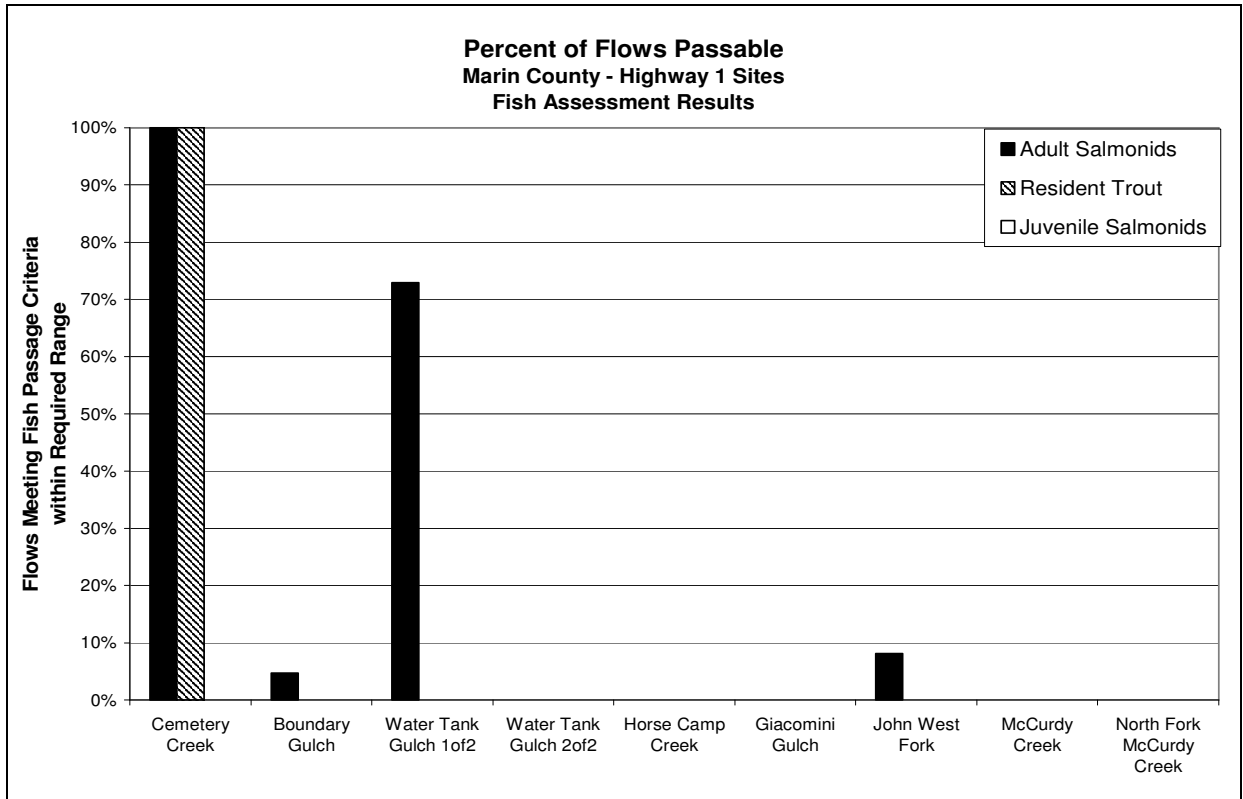
Figure 9. Percent passable as estimated by FishXing for eight Marin County stream crossings located on Highway One on tributaries to Olema Creek and Pine Creek, by three groups of life stages.

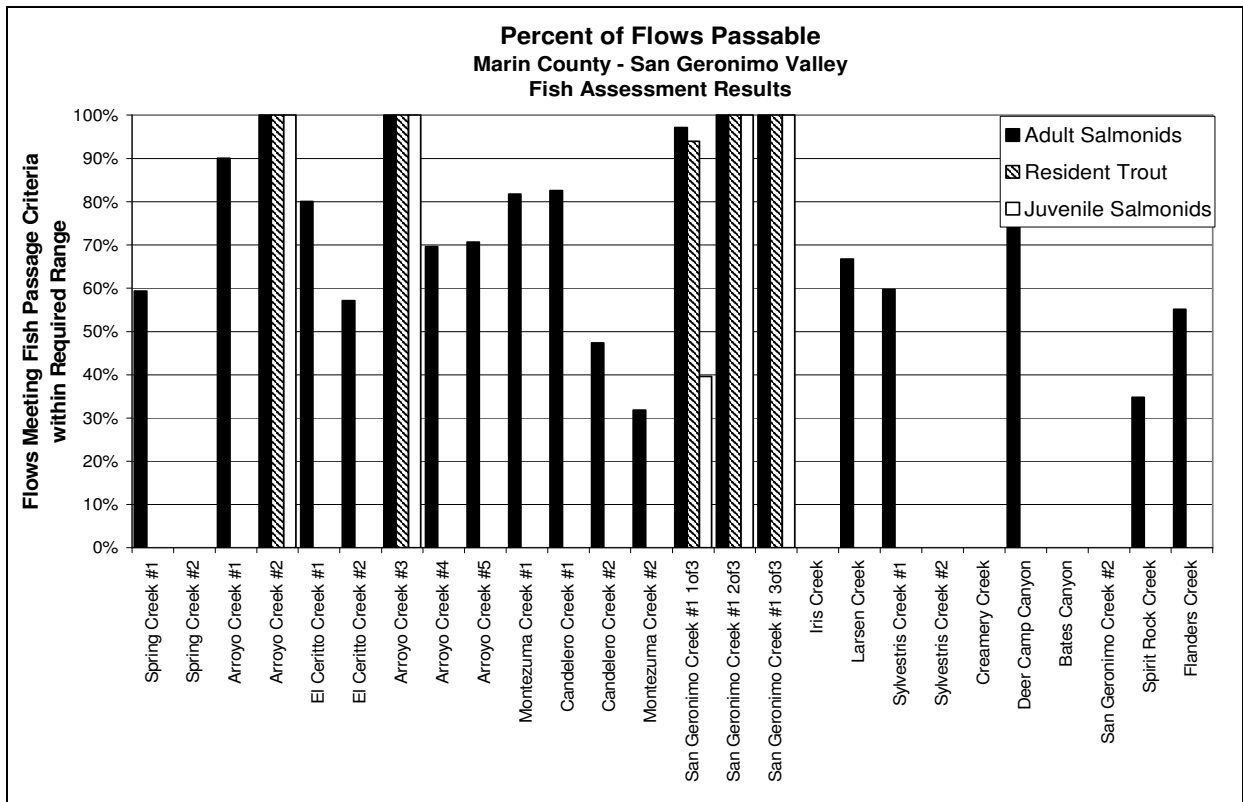
Figure 10. Percent passable as estimated by FishXing for 24 Marin County stream crossings within the San Geronimo sub-basin of the Lagunitas Creek watershed, by three groups of life stages.

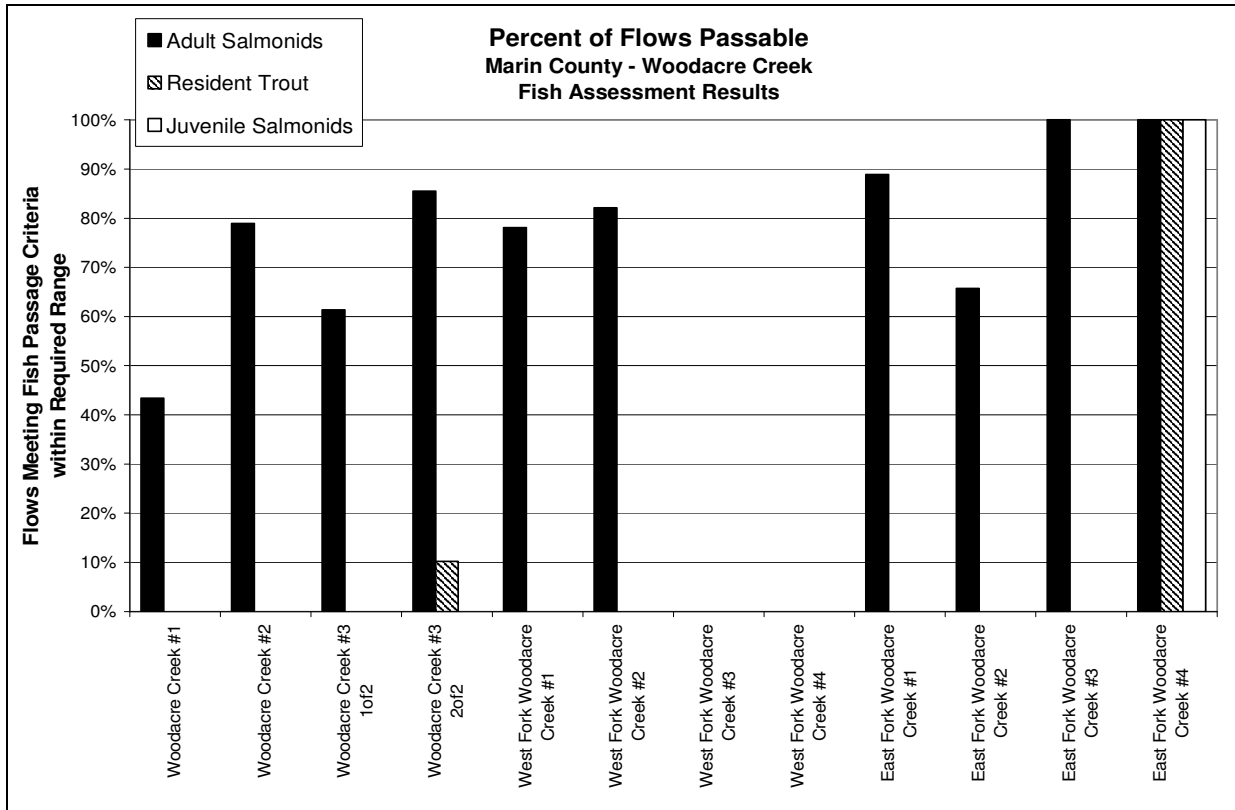
Figure 11. Percent passable as estimated by FishXing for 11 Marin County stream crossings within the Woodacre Creek sub-basin of the Lagunitas Creek watershed, by three groups of life stages.

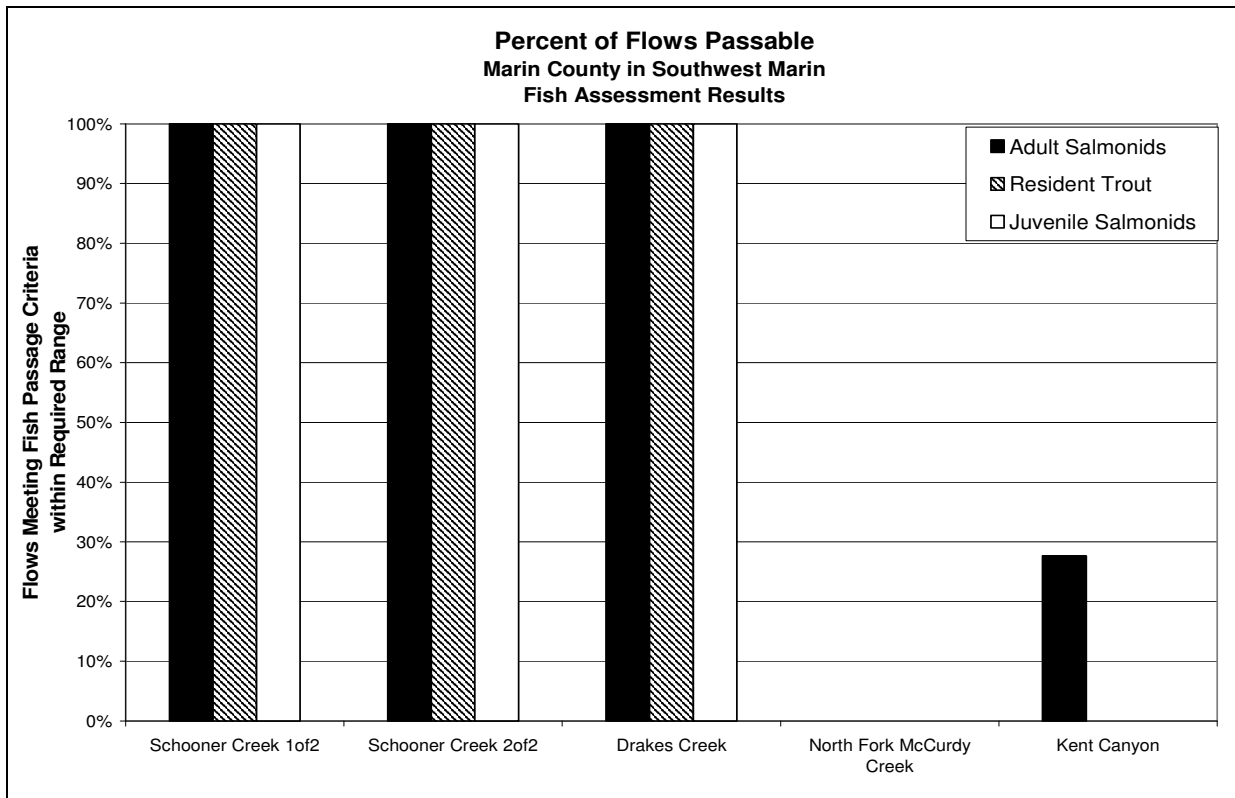
Figure 12. Percent passable as estimated by FishXing for four Marin County stream crossings on tributaries located in southwestern Marin County, by three groups of life stages.

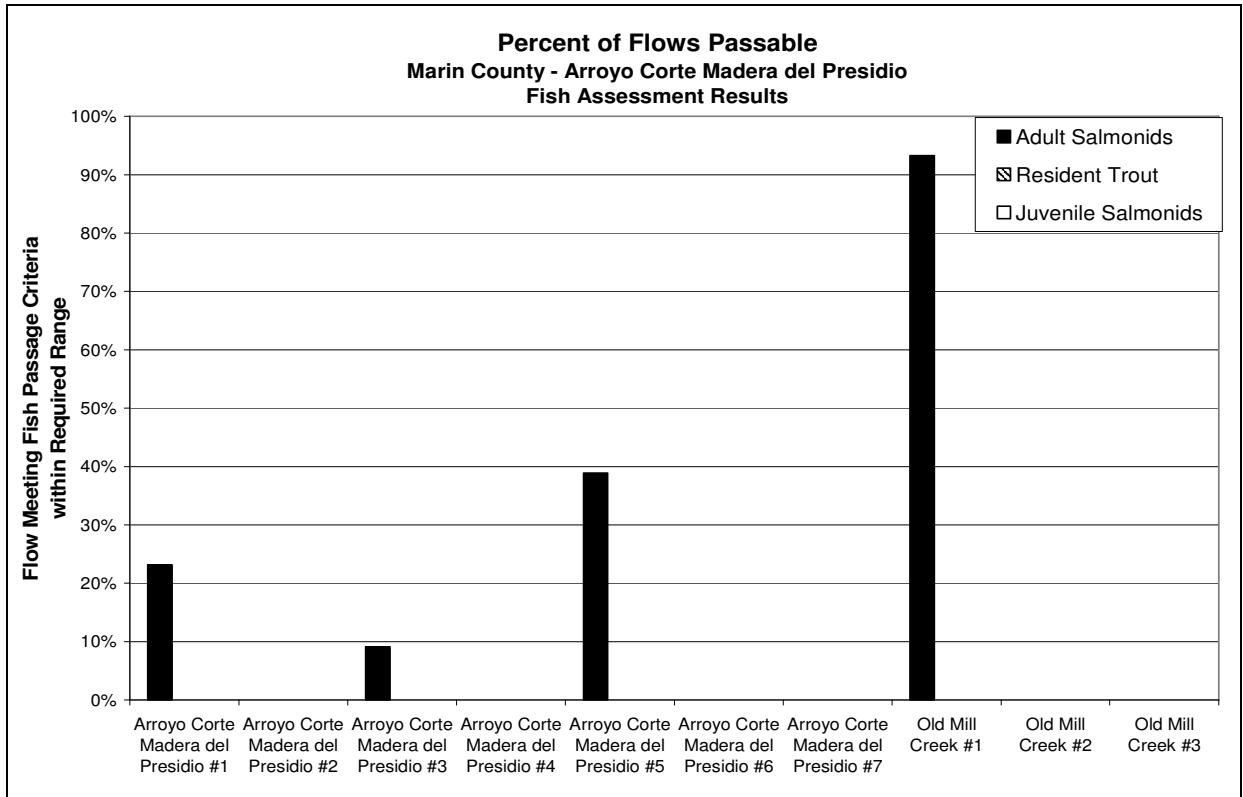
Figure 13. Percent passable as estimated by FishXing for 10 Marin County stream crossings within the Arroyo Corte Madera del Presidio watershed, by three groups of life stages.

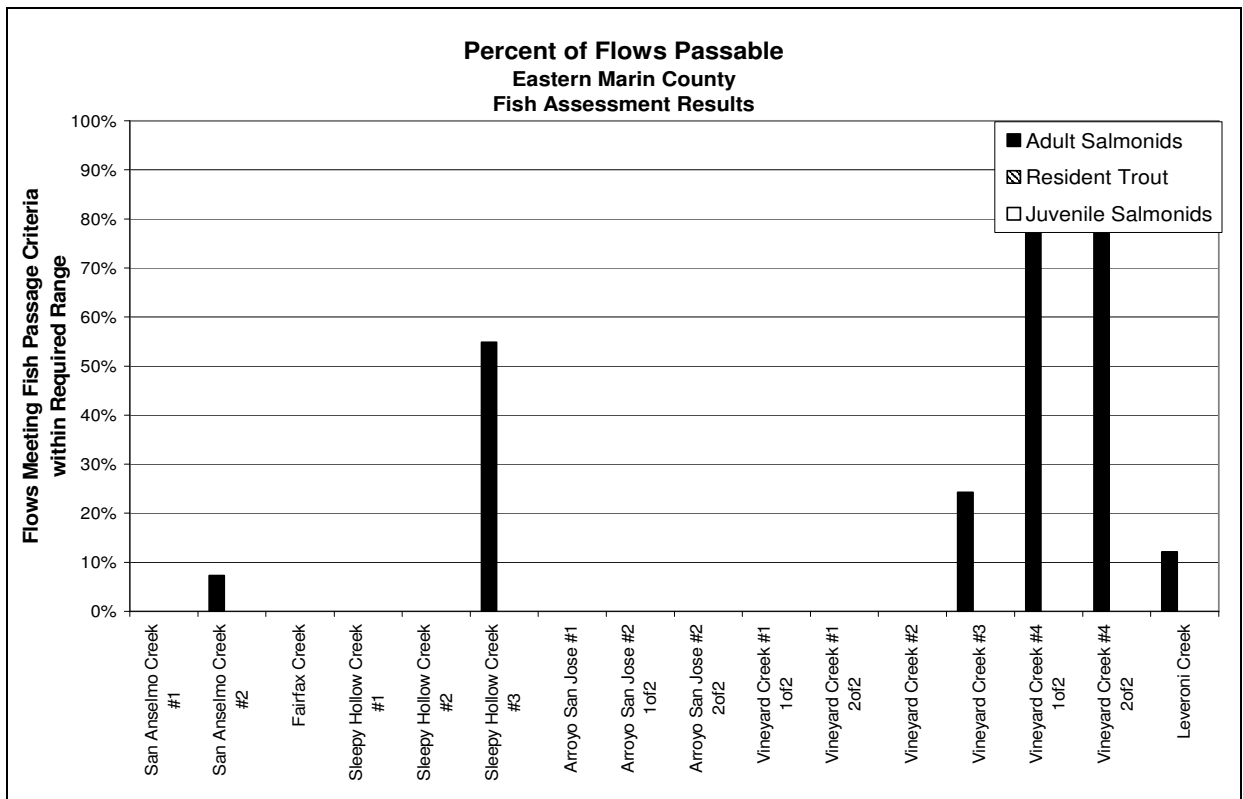
Figure 14. Percent passable as estimated by FishXing for 13 Marin County stream crossings within eastern Marin County watershed, by three groups of life stages.
