Preliminary Arborist Report

**1501 Lucas Valley Road
San Rafael, CA**

November 2023

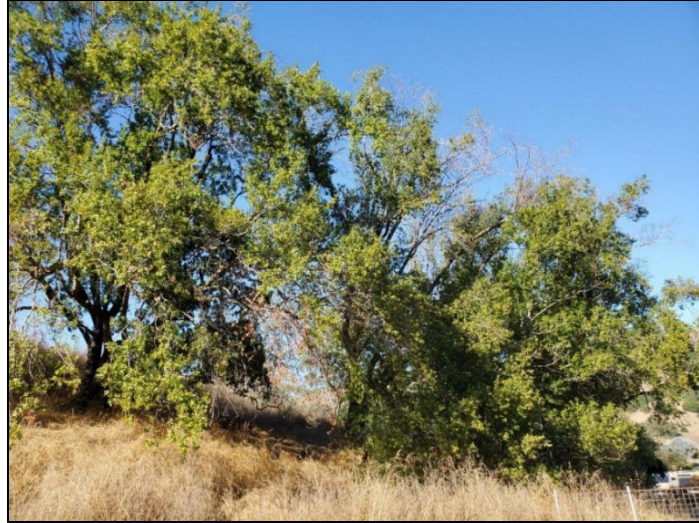
Photo 1 (right). Most California bays were growing together in stands on the hillside.

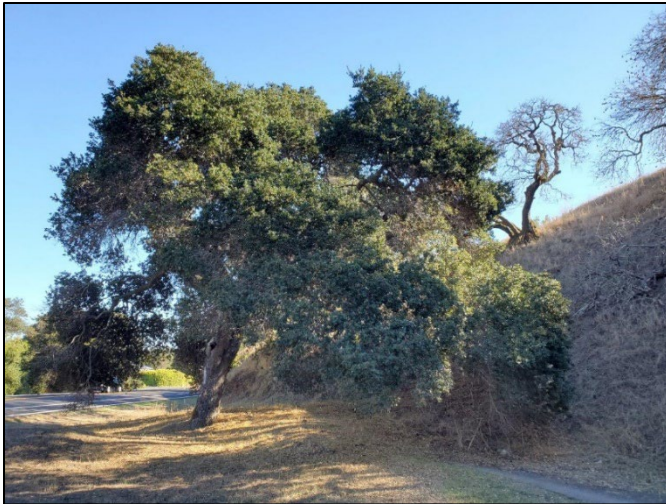
Photo 2 (below). Coast live oak #232 was in good condition and was growing near Lucas Valley Road.

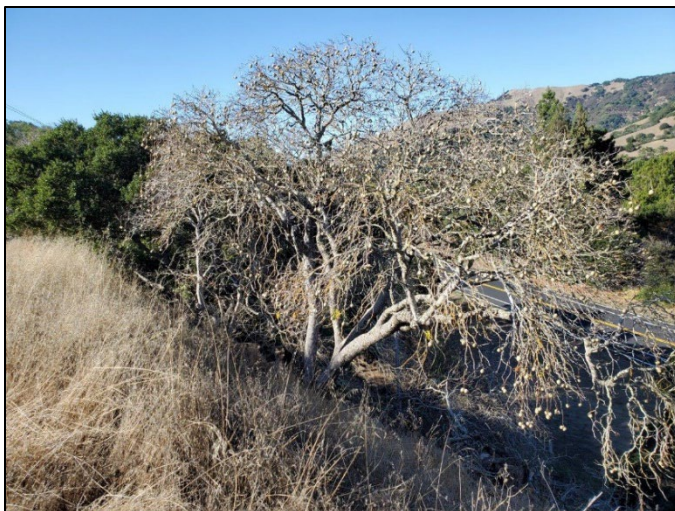
Eighteen (18) of 21 California buckeyes were in poor or very poor condition, with basal decay and multiple attachments at the base. Buckeyes #264, 265 and 266 were in fair condition. Most trees were growing on a steep slope down to Lucas Valley Road on the east edge of the site (Photo 3). Diameters ranged from 7 to 18 inches, with an average of 10 inches.

Photo 3. Most California buckeyes were growing on a slope at the east edge of the site.

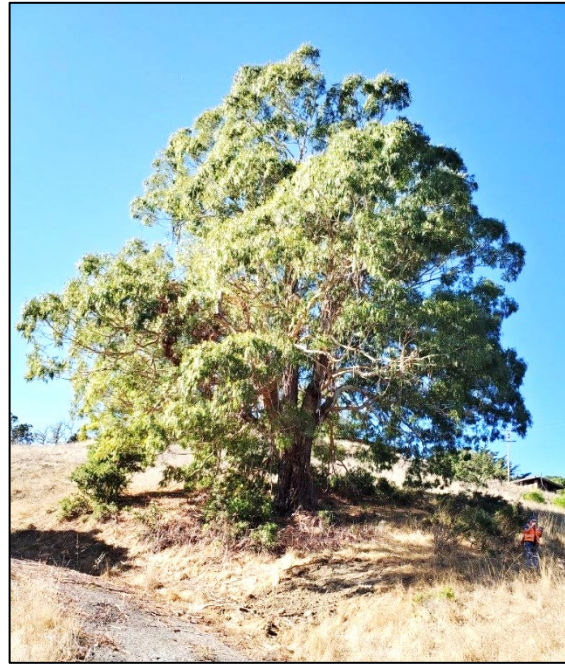
Photo 4. Nichol's willow-leaved peppermint #146 was the largest tree assessed.

1. Revise the grading plan to preserve Nichol's willowleafed peppermint #146. Hold grading at least XX feet from the tree. (I'll let you fill in the recommended distance!)
2. Establish the horizontal and vertical elevation of all trees recommended for preservation and located within 25-feet of proposed demolition and construction. Include trunk locations and tag numbers on all plans.
3. Allow the Consulting Arborist to review all future project submittals including grading, utility, drainage, irrigation, and landscape plans.
4. Plan for tree preservation by designing adequate space around trees to be preserved. This is the **TREE PROTECTION ZONE**. No grading, excavation, construction or storage of materials should occur within that zone. Route underground services including utilities, sub-drains, water or sewer around the **TREE PROTECTION ZONE**.
