## PRELIMINARY GEOLOGICAL STUDY REPORT

MARIN CITY PROPERTY  
DONAHUE STREET  
MARIN CITY, CALIFORNIA

3427.01.04.1

June 22, 2017

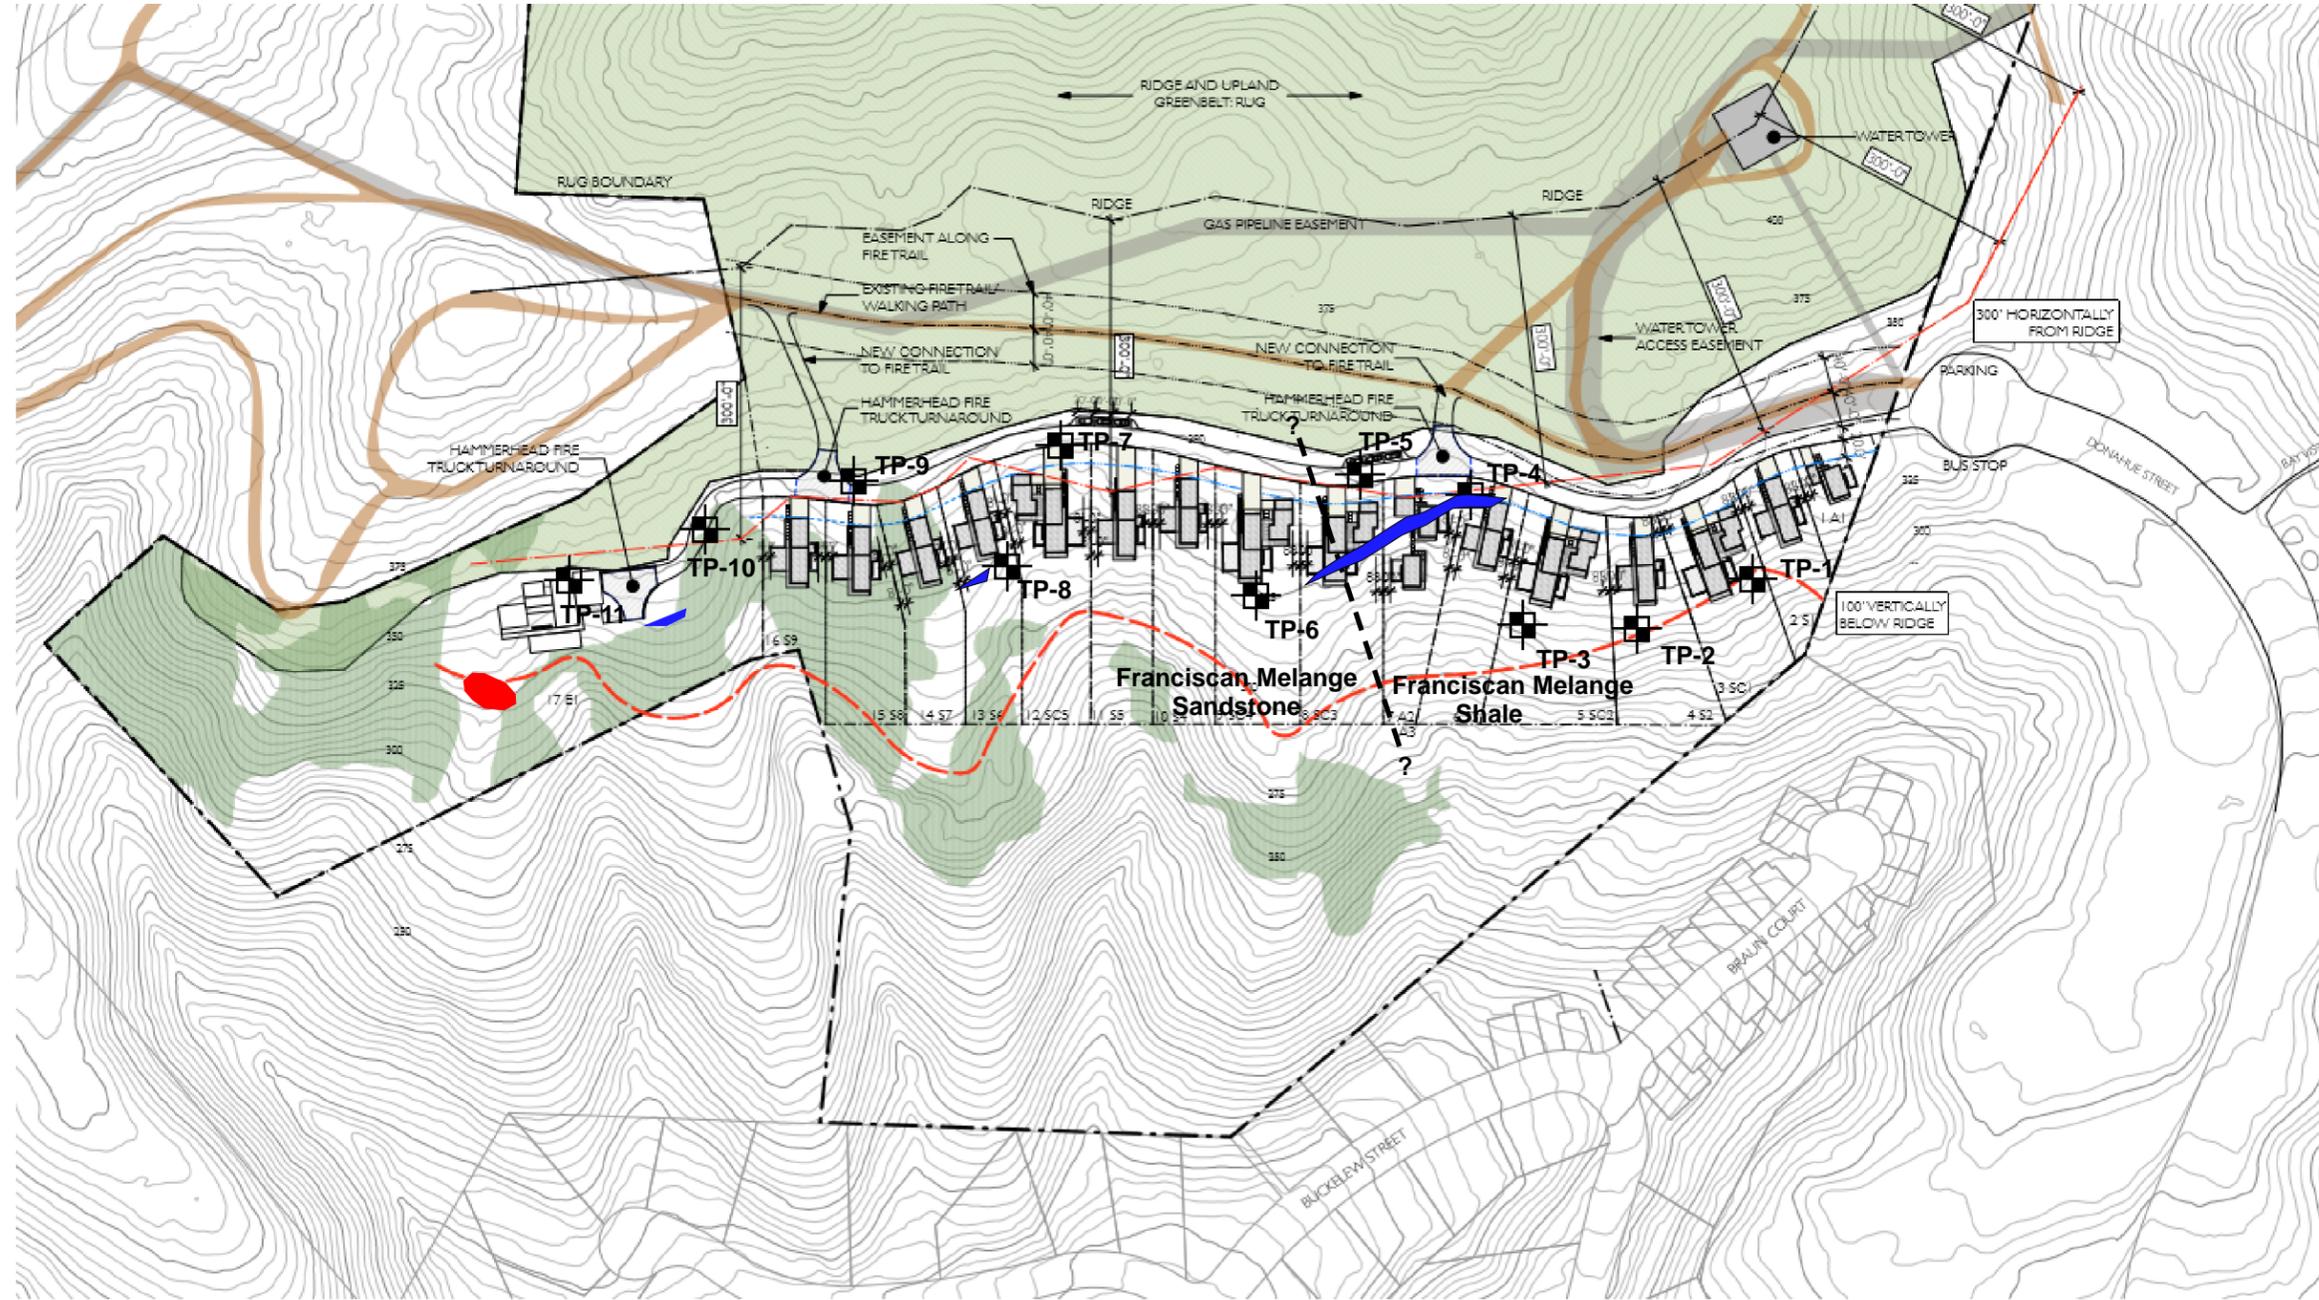
<b>EXPLORATION PLAN</b> Marin City Property Donahue Street Marin City, California	PLATE <b>2</b>
	Job No: 3427.01.04.1    Date: June 2017

The surface soils are locally covered by up to 3 feet of heterogeneous fill. Heterogeneous fill is a material with varying density, strength, compressibility and shrink-swell characteristics that often has an unknown origin and placement history. The approximate extent of the heterogeneous fill is shown on Plate 2. The fill consisted of sandy clays with gravel to cobble size rocks which appeared to be of medium plasticity and low expansion potential.

The proposed building envelopes must be located away from unstable areas and steep slopes in order to reduce the risks associated with slope instability. The location of the building envelopes in relation to such areas is shown on Plate 2. Initially, a structural setback of approximately 50-feet from unstable areas and breaks in slope of 2:1 or steeper should be established. A site-specific study should finalize recommended structural set backs.

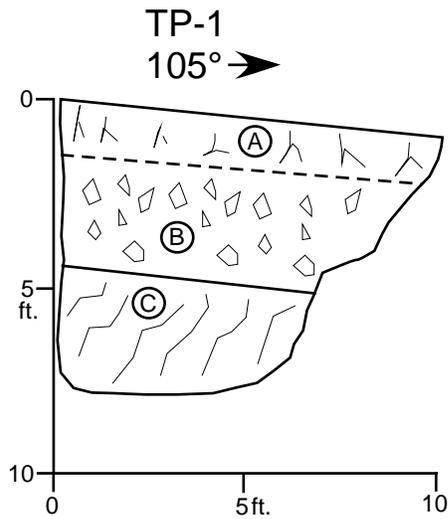
Ⓐ BROWN SANDY CLAY (CL), stiff, dry, porous with roots and gravel.

Ⓑ ORANGE-BROWN CLAYEY GRAVEL (GC), dense, moist, fine to coarse grained with few roots.

Ⓒ GRAY BROWN SHEARED SHALE, soft to firm, friable, highly weathered.

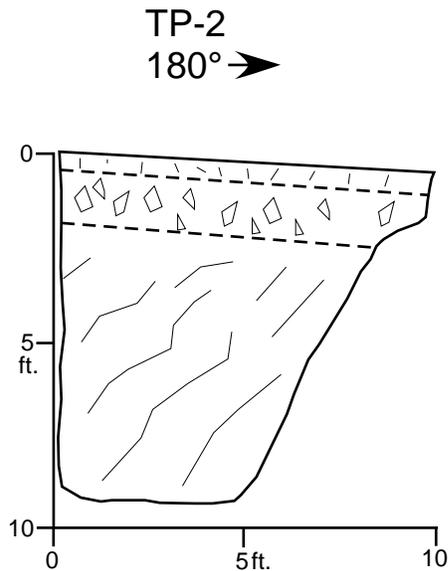
Ⓐ BROWN SANDY CLAY (CL), stiff, dry, porous with roots and gravel.

Ⓑ ORANGE-BROWN CLAYEY GRAVEL (GC), dense, moist, fine to coarse grained with few roots.

Ⓒ GRAY BROWN SHEARED SHALE, soft to firm, friable, highly weathered with clay pockets, wet.

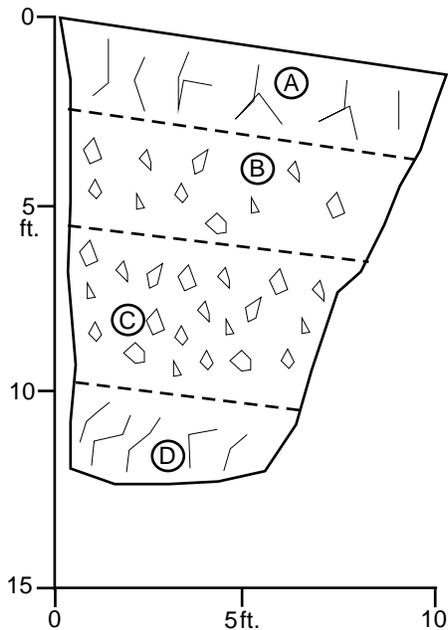
TP-3  
95° →

- Ⓐ DARK BROWN SANDY CLAY (CL), soft, moist, porous with roots and gravel.
- Ⓑ ORANGE-BROWN SANDY CLAY (CL), stiff to very stiff, moist with gravel.
- Ⓒ ORANGE-BROWN SANDY CLAY (CH), very stiff, moist with abundant gravels.
- Ⓓ GRAY BROWN SHEARED SHALE, soft to firm, friable, highly weathered.

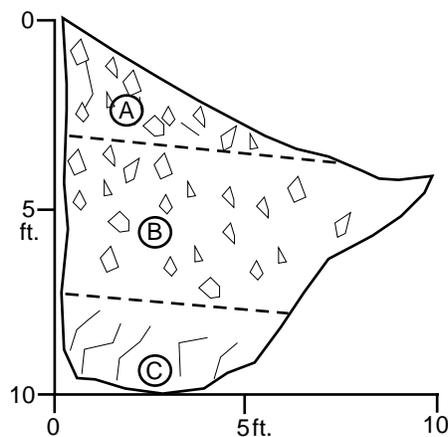
TP-4  
75° →

- Ⓐ DARK BROWN SANDY CLAY (CL), stiff, dry, porous with roots and abundant gravel to cobble size rocks. (FILL)
- Ⓑ ORANGE-BROWN SANDY CLAY (CH), very stiff, moist, with abundant gravels.
- Ⓒ GRAY BROWN SHEARED SHALE, soft to firm, friable, highly weathered with clay pockets, wet.

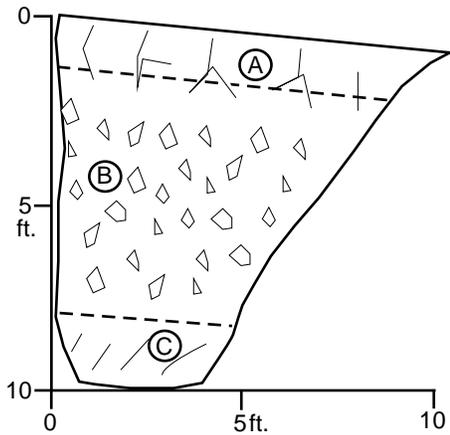
TP-5  
135° →

- Ⓐ BROWN SANDY CLAY (CL), stiff, dry, porous with roots and gravel.
- Ⓑ ORANGE-BROWN CLAYEY GRAVEL (GC), dense, moist, fine to coarse grained with few roots.
- Ⓒ GRAY BROWN SHEARED SHALE, soft to firm, friable, highly weathered, with abundant clay pockets and very close fractures

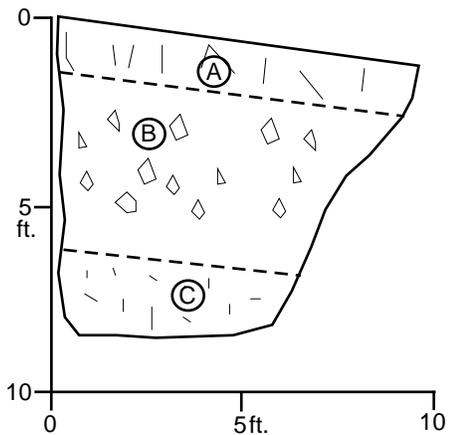
TP-6  
56° →

- Ⓐ BROWN SANDY CLAY (CL), stiff, dry, porous with roots and gravel.
- Ⓑ ORANGE-BROWN SANDY CLAY (CL), stiff, moist, some sandstone gravels.
- Ⓒ ORANGE BROWN SANDSTONE, firm, friable, highly weathered. with close fractures

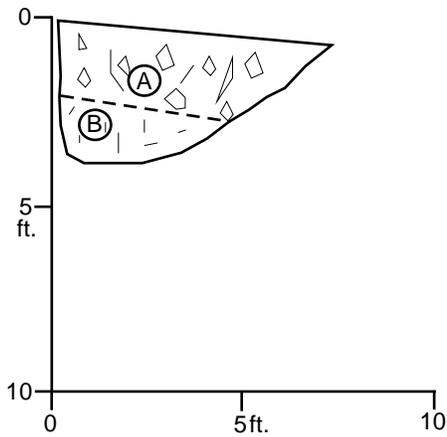
TP-7  
80° →

- Ⓐ BROWN SANDY CLAY (CL), stiff, dry, porous with roots and gravel.
- Ⓑ ORANGE BROWN SANDSTONE, moderately hard, weak, highly weathered, with close fractures

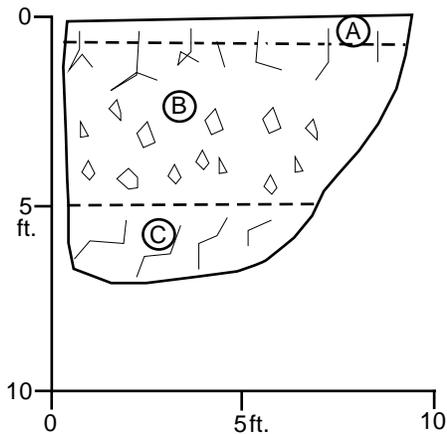
TP-8  
90° →

- Ⓐ BROWN SANDY CLAY (CL), stiff, dry, porous with roots and gravel. (FILL)
- Ⓑ ORANGE-BROWN SANDY CLAY (CL), stiff to very stiff, moist, with sandstone gravels.
- Ⓒ ORANGE BROWN SANDSTONE, moderately hard, weak, highly weathered, with close fractures.

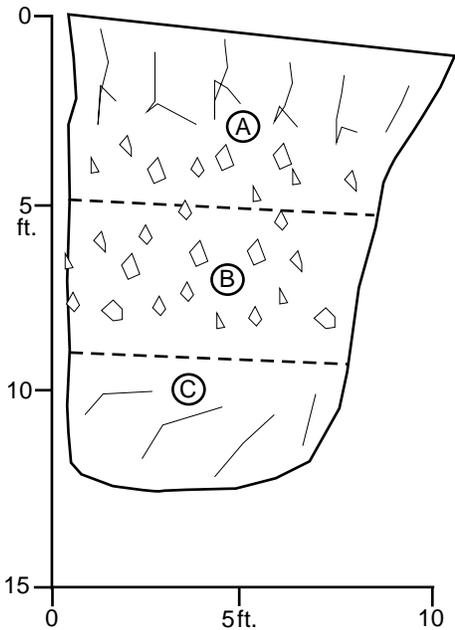
TP-9  
265° →

- Ⓐ BROWN SANDY CLAY (CL), stiff, dry, porous with roots and gravel. (FILL)
- Ⓑ ORANGE-BROWN SANDY CLAY (CH), stiff to very stiff, moist, with sandstone gravels.
- Ⓒ ORANGE BROWN SANDSTONE, moderately hard, weak, highly weathered, with close fractures.

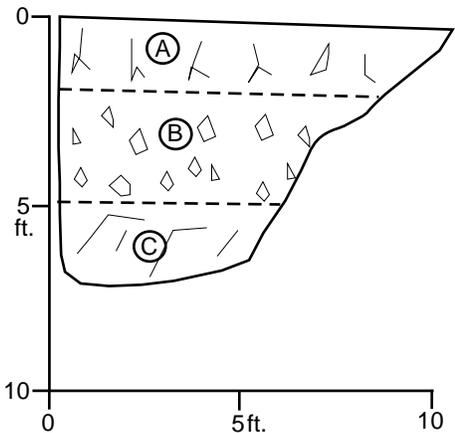
TP-10  
75° →

- Ⓐ BROWN SANDY CLAY (CL), stiff, dry, porous with roots and gravel. (FILL)
- Ⓑ ORANGE-BROWN SANDY CLAY (CL), stiff to very stiff, moist, with sandstone gravels.
- Ⓒ ORANGE BROWN SANDSTONE, friable, weak, highly weathered, with close fractures.

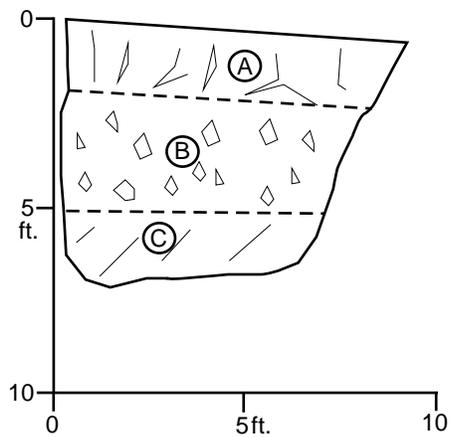
TP-11  
65° →

- Ⓐ BROWN SANDY CLAY (CL), stiff, dry, porous with roots and gravel. (FILL)
- Ⓑ ORANGE-BROWN SANDY CLAY (CL), stiff to very stiff, moist, with sandstone gravels.
- Ⓒ ORANGE BROWN SANDSTONE, friable, weak, highly weathered, with close fractures.
