February 13, 2019

**Subject:** Arborist Report for 187 Sacramento Avenue, San Anselmo

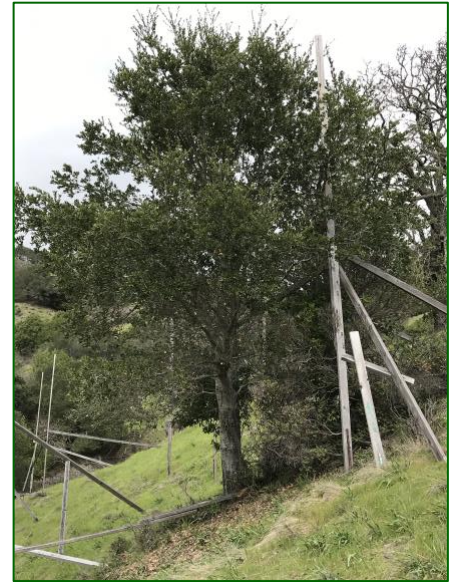
Coast live oak (*Quercus agrifolia*). This healthy oak has a single main trunk that spans 9.8" in diameter at breast height (dbh) and supports a balanced crown of dense, dark green foliage to a height of 16' (photo top right). It shows no signs or symptoms of sudden oak death (*Phytophthora ramorum*) or trunk decay (*Ganoderma applanatum*). The Marin County Native Tree Ordinance lists coast live oaks of this size as "protected".

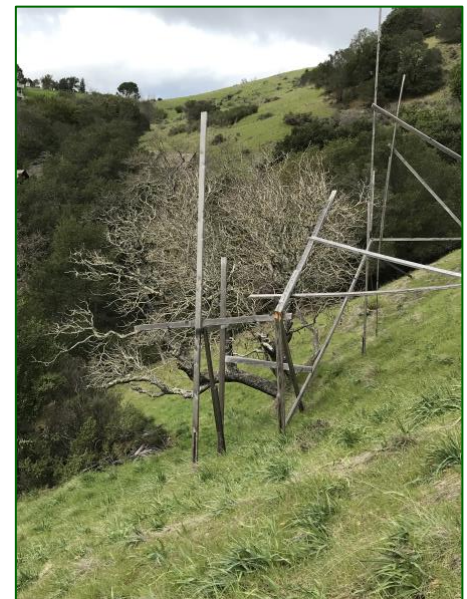
California buckeye (*Aesculus californica*). This healthy buckeye has 5 main trunks that span 4.4", 4.5", 6.1", 6.3", and 11.7" dbh (15.9" dbh combined) that support a crown to a height of 14' above grade (photo bottom right). This drought deciduous tree was dormant at the time of my inspection. I observed no signs of disease or insect infestation. The Marin County Native Tree Ordinance lists California buckeye trees of this size as "protected".
