# CORNER RECORD

Document Number \_\_\_\_\_  
 City of SAN RAFAEL AREA County of MARIN, California  
 Brief Legal Description PARCELS 1 & 2, 1 P.M. 93

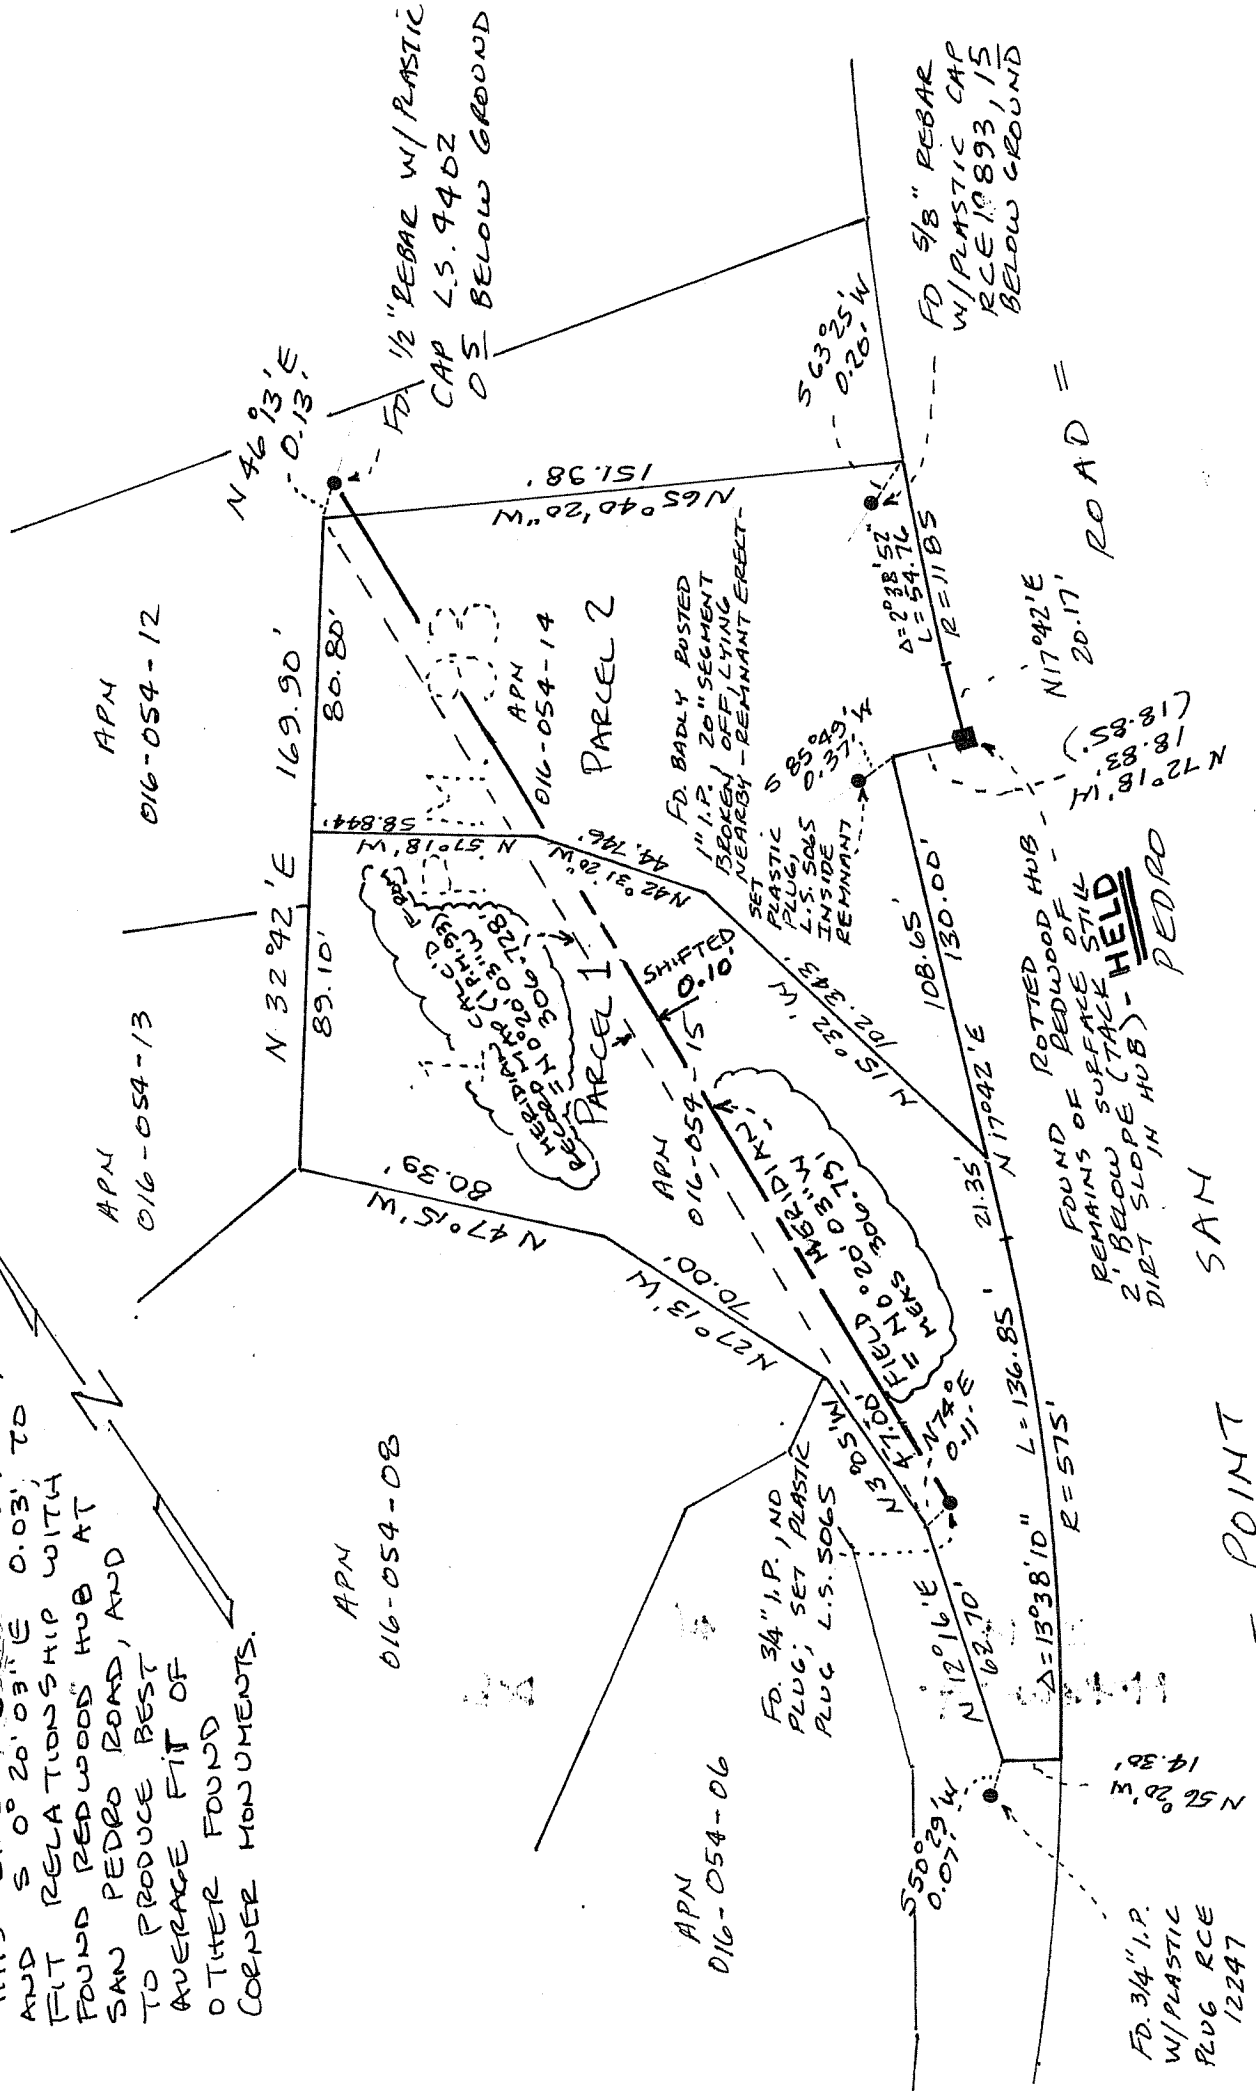
NOTE: TO SET PROPERTY LINES, HELD "FIELD MERIDIAN" PARALLEL TO CALCULATED MERIDIAN (PER 3 O.S. 113 AND 1 P.M. 93), THEN SHIFTED THIS LINE 58.89' 39.57" W, 0.10' AND S 0° 20' 03" E 0.03', TO FIT RELATIONSHIP WITH FOUND REDWOOD HUB AT SAN PEDRO ROAD, AND TO PRODUCE BEST AVERAGE FIT OF OTHER FOUND CORNER MONUMENTS.

FOUND ROTTED HUB - REMAINS OF SURFACE STILE 2' BELOW SURFACE (TACK DIET SLOPE IN HUB) - HELD PEDRO

FD BADLY BUSTED 1" I.P. 20" SEGMENT BROKEN OFF, LYING NEARBY - REMNANT ERECT. SET PLASTIC PLUG L.S. SOLS INSIDE REMNANT

FD 1/2" REBAR W/ PLASTIC CAP L.S. 94 DZ 0.5' BELOW GROUND

FD 5/8" REBAR W/ PLASTIC CAP RCE 10893, 15 BELOW GROUND

FD 34" I.P. AND PLUG; SET PLASTIC PLUG L.S. 5065

FD 34" I.P. W/ PLASTIC PLUG RCE 12247
