Marin Civic Center Roof Cleaning

CONSERVANCY COMMITTEE MEETING
NOVEMBER 8, 2023

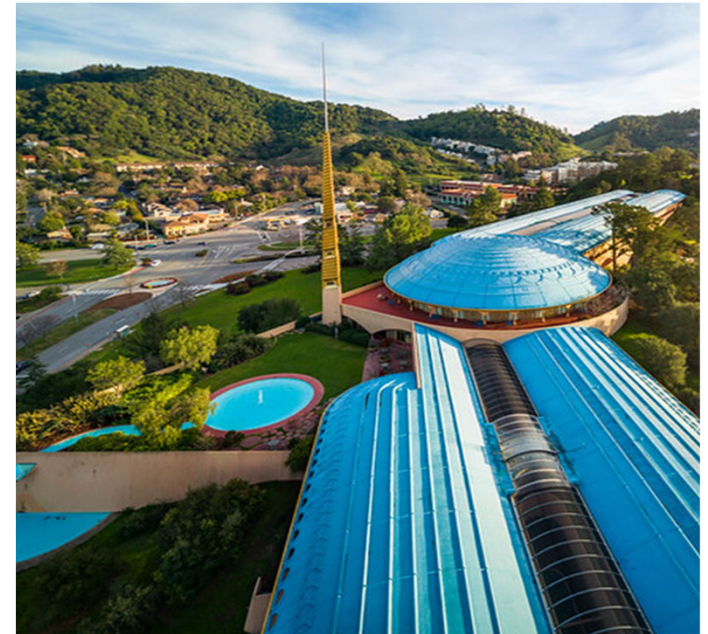
Civic Center Roof History

- Administrative Wing and Library Dome completed in 2018
- Hall of Justice Wing completed in 2020

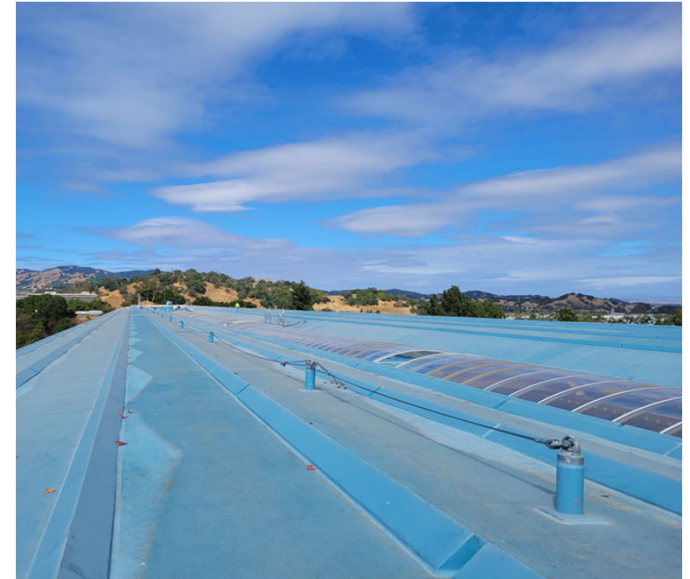
Current Roof Conditions

- Roof has accumulated dirt, dust, ash and other particles, dulling the Marin Blue Color
- Concerns were raised that the roof color may have faded and may not return to the original appearance
- The Marin Blue color is integral to the roofing membrane.
- Cleaning is expected to restore the roof color close to the original Marin Blue

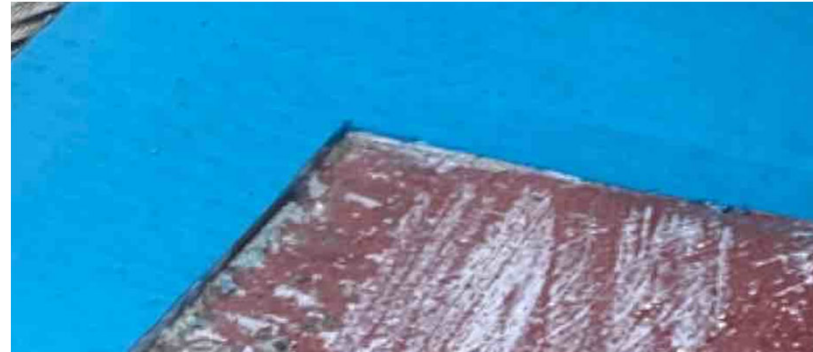
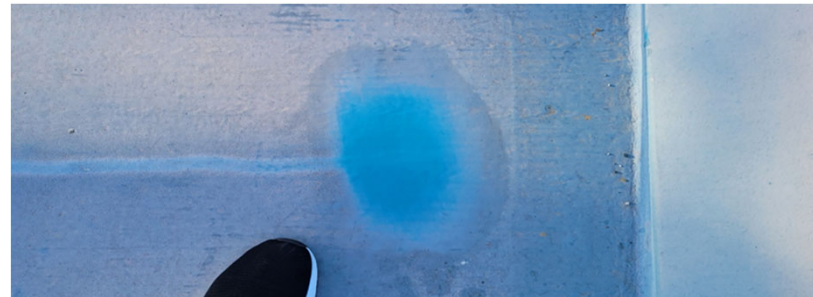
Roofing Membrane Color

- Test patch removal was performed during installation
- Note membrane thickness and Marin Blue color throughout material
- Recent spot test with household cleaner
