**MARIN COUNTY COMMUNITY DEVELOPMENT
BLOCK GRANT (CDBG) PROPOSAL
2014-15**

1. **Project Name:** Fairfax Vest Pocket
2. **Total Amount Requested:** \$ 310,573
3. **Project Sponsor:** Marin Housing Authority
- Non-housing proposals must specify the amount requested from each planning area.

This Physical Needs Assessment (PNA) is prepared at the request of the Marin Housing Authority (MHA). The purpose of the report is to identify and document the building systems as conditions and to make recommendations for improvements.

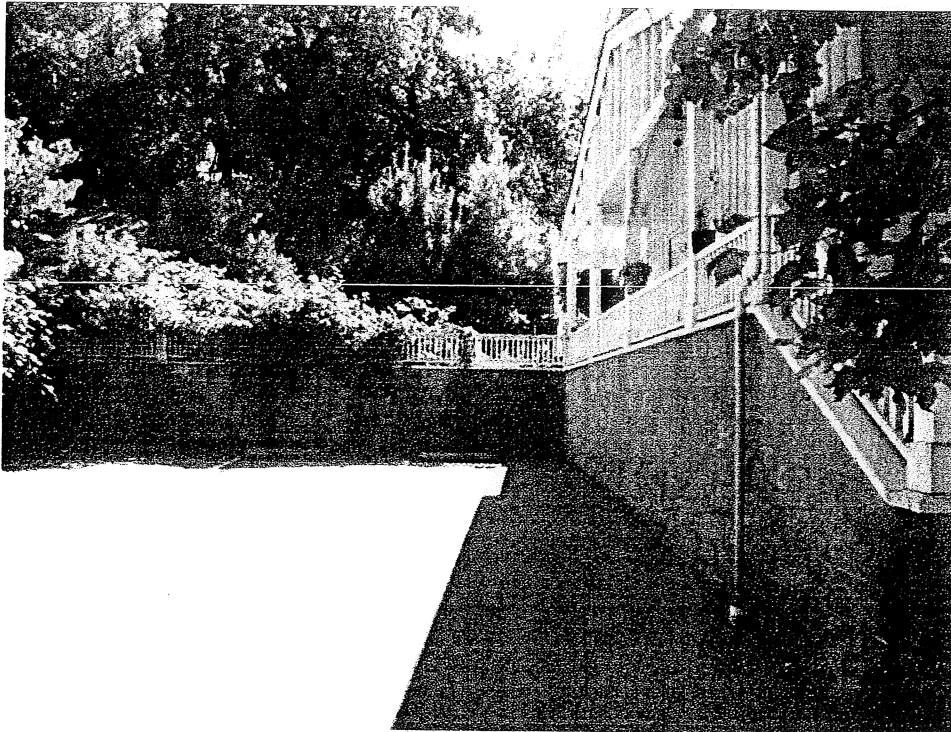
As mentioned, each building has a small parking area containing 3 to 5 parking spaces accessed by driveways. Each lot is paved with asphalt. Each lot contains a designated accessible parking space. Parking space striping is worn at every lot and striping should be redone in the immediate scope of work.

Parking lot at 75 Park Road

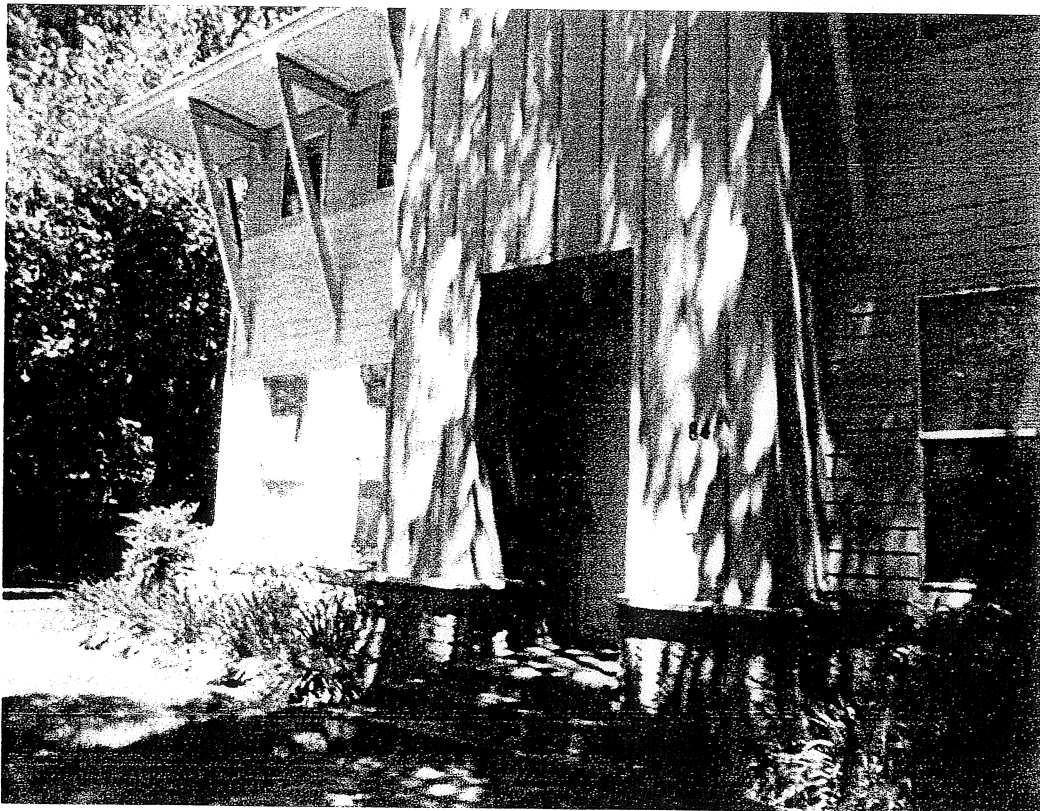
Grass and shrubs at 84 Park Road

A few landscaping upgrades are recommended in the immediate scope of work, including:

- Replace lawns with native grasses and/or drought resistant ground cover.
- All ground cover or earth sloping should be positive – slope away from building footings.
- Remove ivy or other weed ground cover from behind 3 Frustruck. That type of foliage attracts rodents.
- Install rainwater harvesting systems in the below grade areas. Use collected water for irrigation. The harvesting system could include banks of rain collectors along the downspouts for the podium walkways. The harvested water can be used for irrigation.
- Cut back trees that overhang building roofs to prevent leaf debris into roof gutters or install gutter guards. Given the benefits of shade at this location, gutter guards are a much better choice to deal with leaf debris.
- Cure root growth which extends toward or into building bases/foundations.

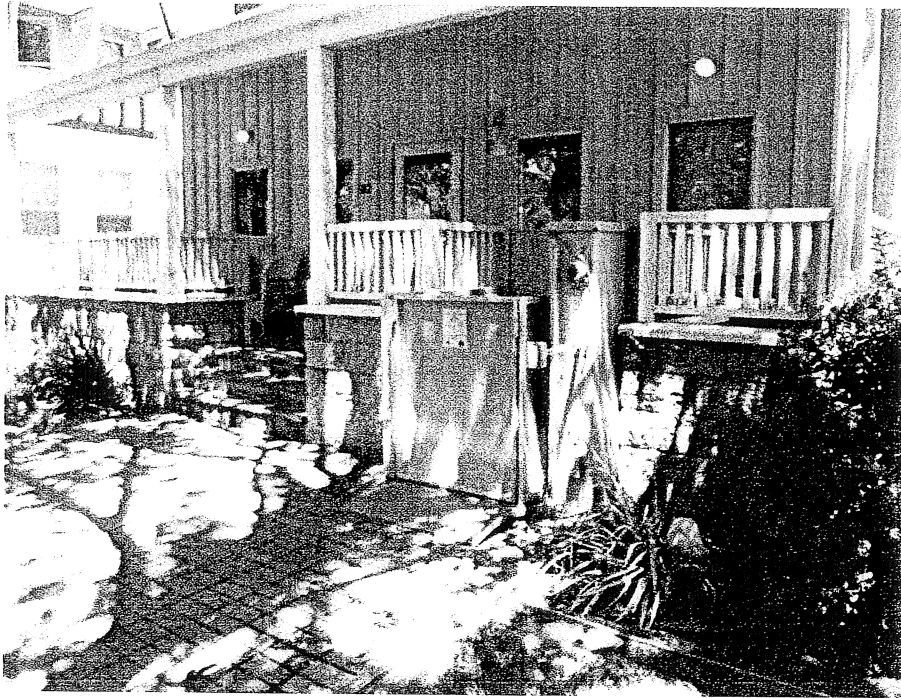
The entry porch at 82 Park is in good condition, but the deck is getting slightly worn.

Entry porch at 82 Park (Community Building)

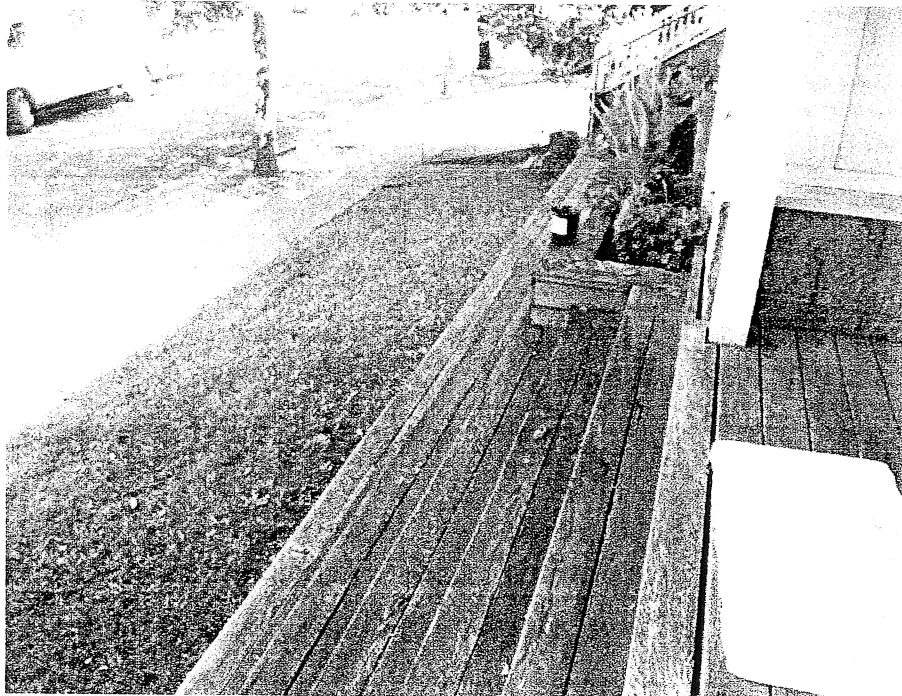
The wood decks that provide access to the fronts and side doors of some of the buildings are showing significant wear and dry rot. 75 Park's entry stairs are the worst of all and include a nosing board that is very loose. Porch railings at 75 Park are dry rotted and should be replaced.

Each building is entered via concrete or wood stairs. The architectural design of the 82 Park, 75 Park and 3 Frustruck buildings included the installation of wood stairs. These stairs, particularly at 75 Park, are in poor condition with loose boards and evidence of dry rot. The wood stairs should be replaced at 75 Park in the immediate scope of work. The use of Trex (though less attractive) may be beneficial and will last longer than wood. Alternatively, the stairs could be replaced with concrete or metal treads.

Entry deck boards at 75 Frustruck. Nosing board is very loose.

A few of the buildings contain porches and exterior walkways at the sides of them. Of these, 75 Park Road has a large wrap around porch that is in fair condition, except that the railings have significant dry rot. The railings should be replaced in the immediate scope of work.

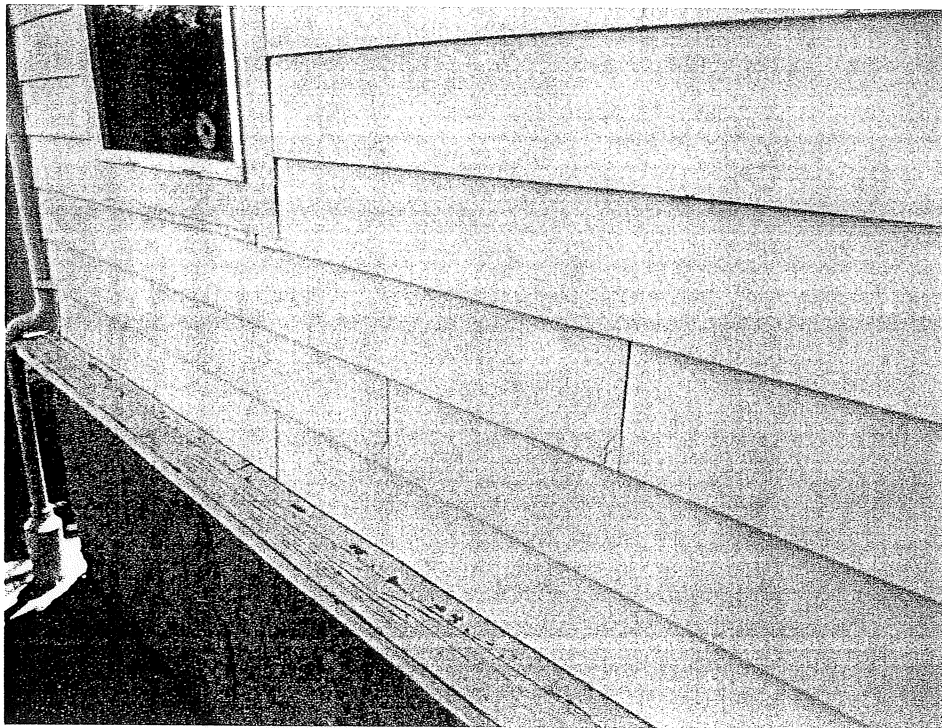
The exterior siding at the buildings is made of board and batten siding, wood panel siding (plywood) and cementitious fiber or wood composition siding. The condition of the siding is fair. All buildings have an immediate need for paint. Many of the buildings also show moderate rust from siding nailing. This is particularly true at the batten nails. When buildings are being prepped for painting, dry rotted materials need to be removed completely as they are found. Rust should be removed completely before painting. All penetrations, in particular nail holes, should be properly caulked and sealed before painting is completed.

Cracked lap siding at 84 Park Road

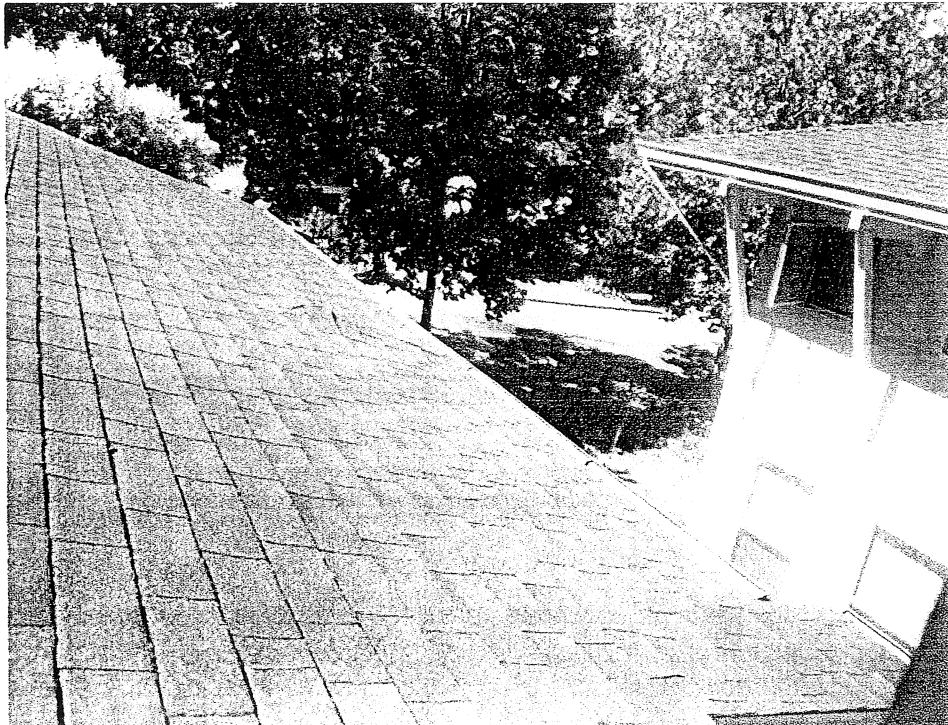
Lump in roof at 5 Frustruck

When roofs are replaced in the future, the gutters and downspouts should also be replaced. All roof penetrations will need to be reflashed/caulked when the roofs are replaced. All downspouts should terminate into concrete splashblocks or into the subsurface drainage, as appropriate for the locations.

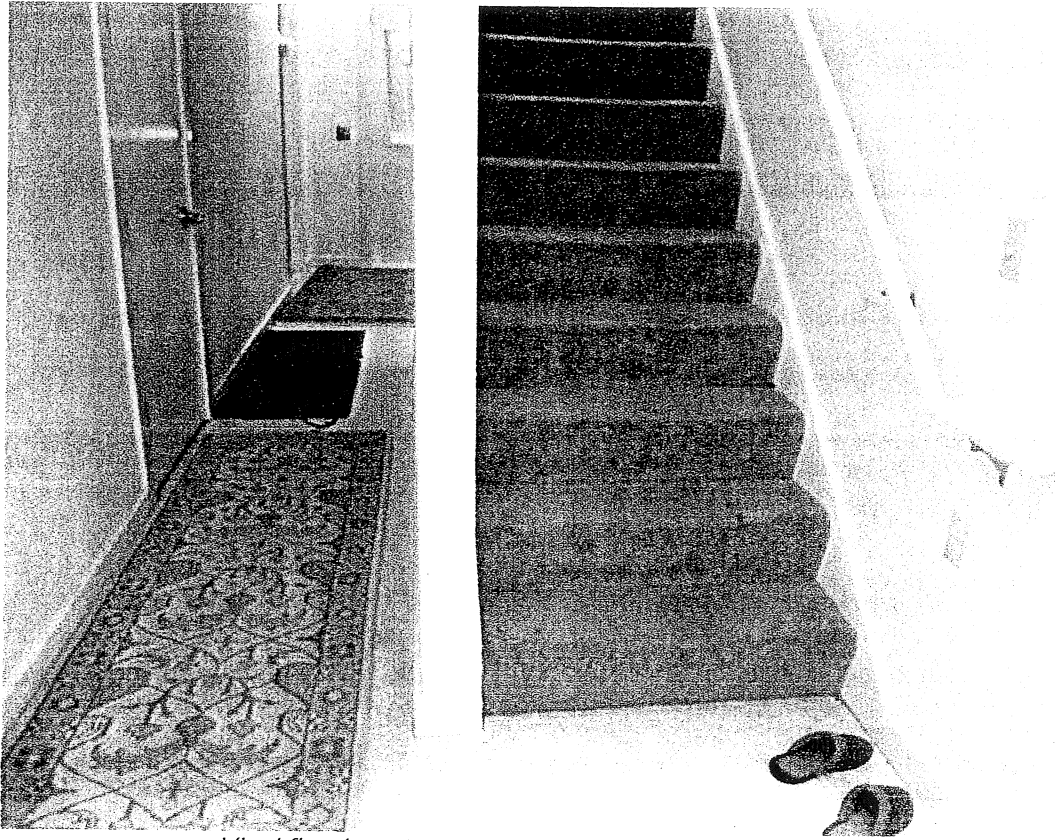
Vinyl flooring at ground floor; carpet at stairs – typical

When sheet vinyl is replaced in the future, it is recommended that a commercial sheet vinyl product should be used when replacing kitchen and bathroom floors, with a minimum 50 mil thickness which will hold up better in the long term. The manufacturer will guarantee replacement vinyl flooring for a minimum of five years. Bathrooms should continue to use sheet vinyl flooring. Vinyl composition tile or sheet vinyl flooring may be utilized at the kitchen areas. The use of bamboo flooring should be considered if funds are available since it is very durable material and it is typically harvested from sustained forests.

Replacement carpet should comply with HUD/FHA materials bulletin "UM44C," and carpet padding should comply with "UM72-80." Furthermore, Replacement carpet should comply with CRI Green Label Plus Carpet Testing Program.

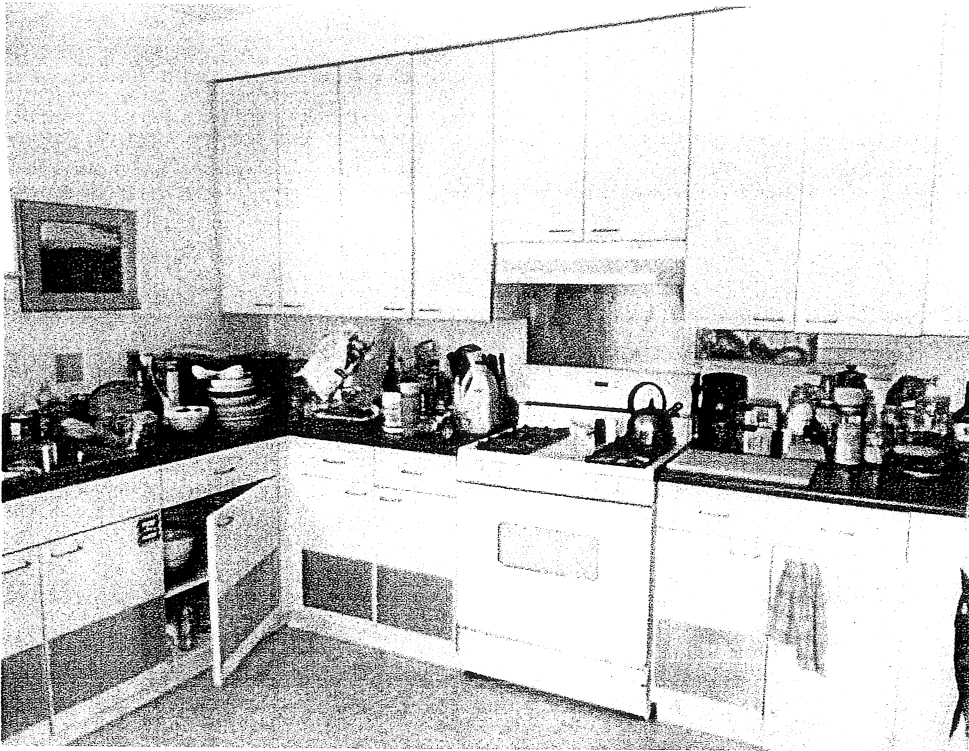
Typical kitchen (84 Park Road shown)

All ranges are 30 inches in size and are manufactured by GE. All range hoods are manufactured by Broan.

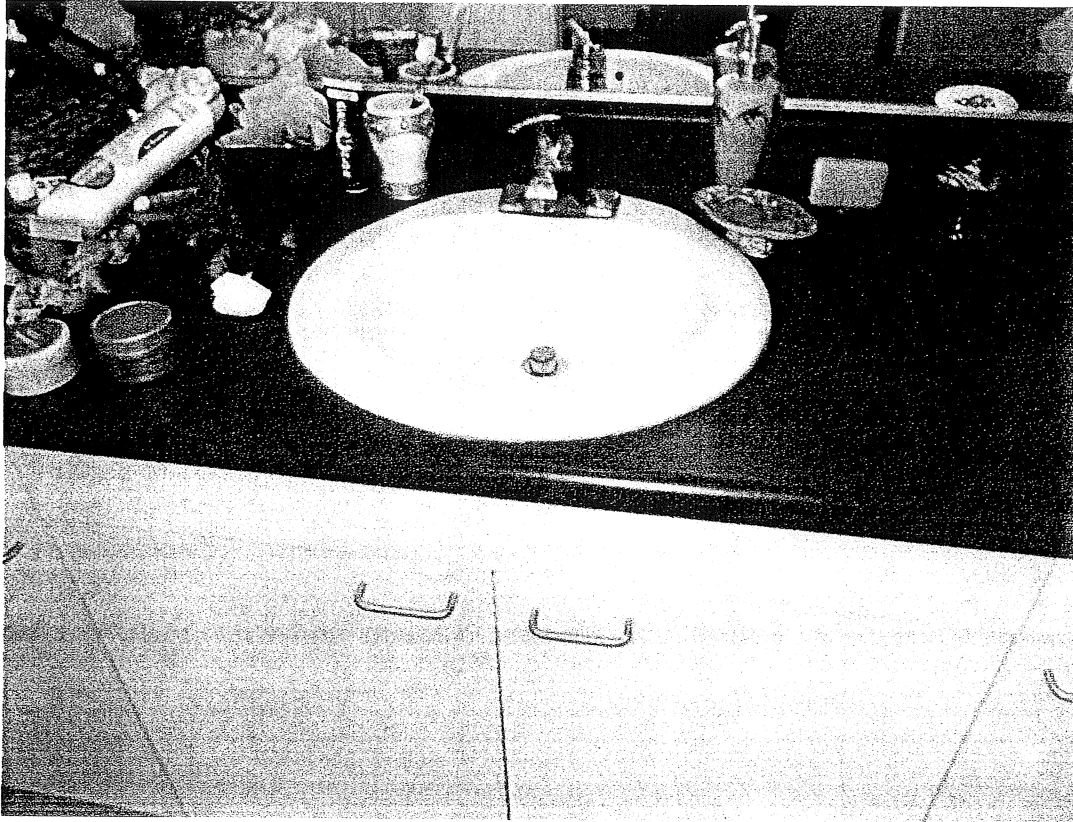
Bathroom cabinet and sink

Future cabinet replacements should comply with minimum cabinet specifications equivalent to WIC (Woodwork Institute of California) Custom Grade Specifications. Cabinets should be paint/stain grade wood, low or high-pressure laminates. Equivalent WIC Economy Grade cabinets are also acceptable.³

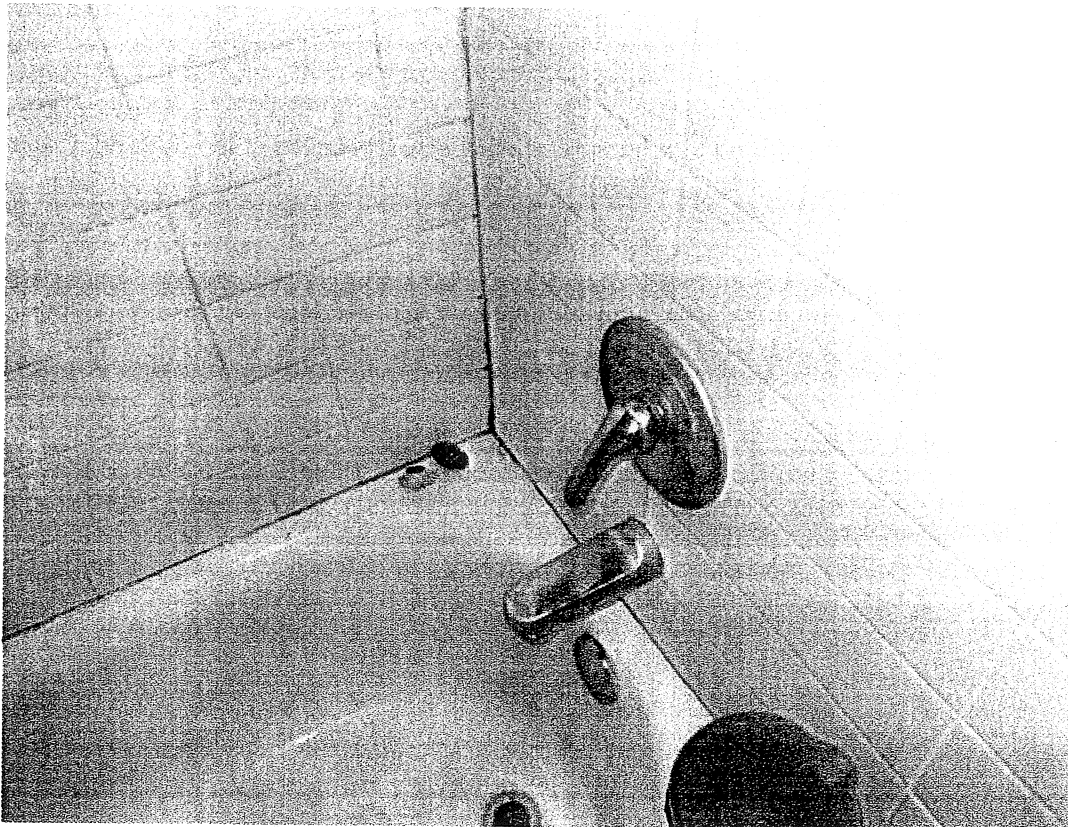
The finishes at the bathrooms with tubs and shower surrounds (the upstairs hallway bathrooms) are typically an enameled steel tub with tile surround. Most were found to be in good condition, however the tub and tile intersections need regular caulking.

Tub surround and tub, mixer and spout. Typical.

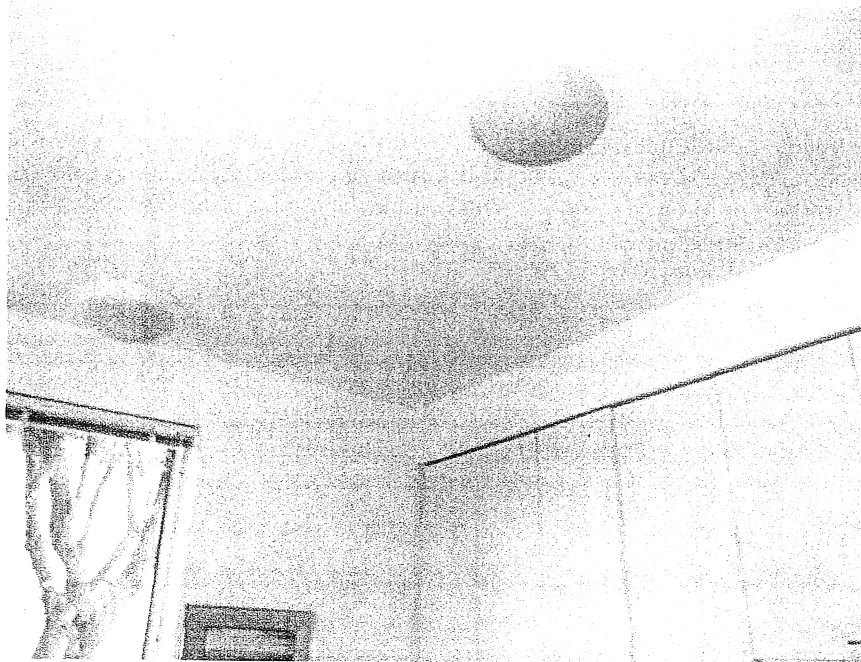
Typical ceiling fixtures at kitchen

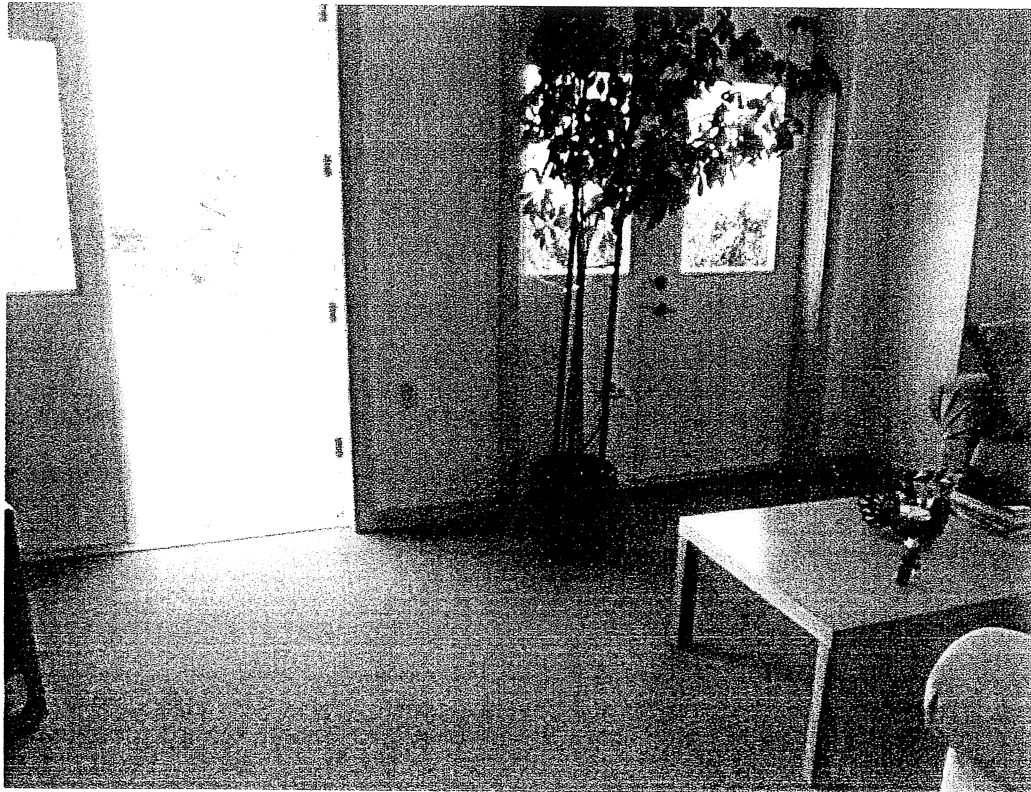
Community Room leading out to patio

The condition of the finishes at the community room is good and no updates are recommended.
