# **BIOLOGICAL ASSESSMENT**

**The Boathouse  
12856 Sir Francis Drake Boulevard**

**Inverness, California**

July 17, 2019

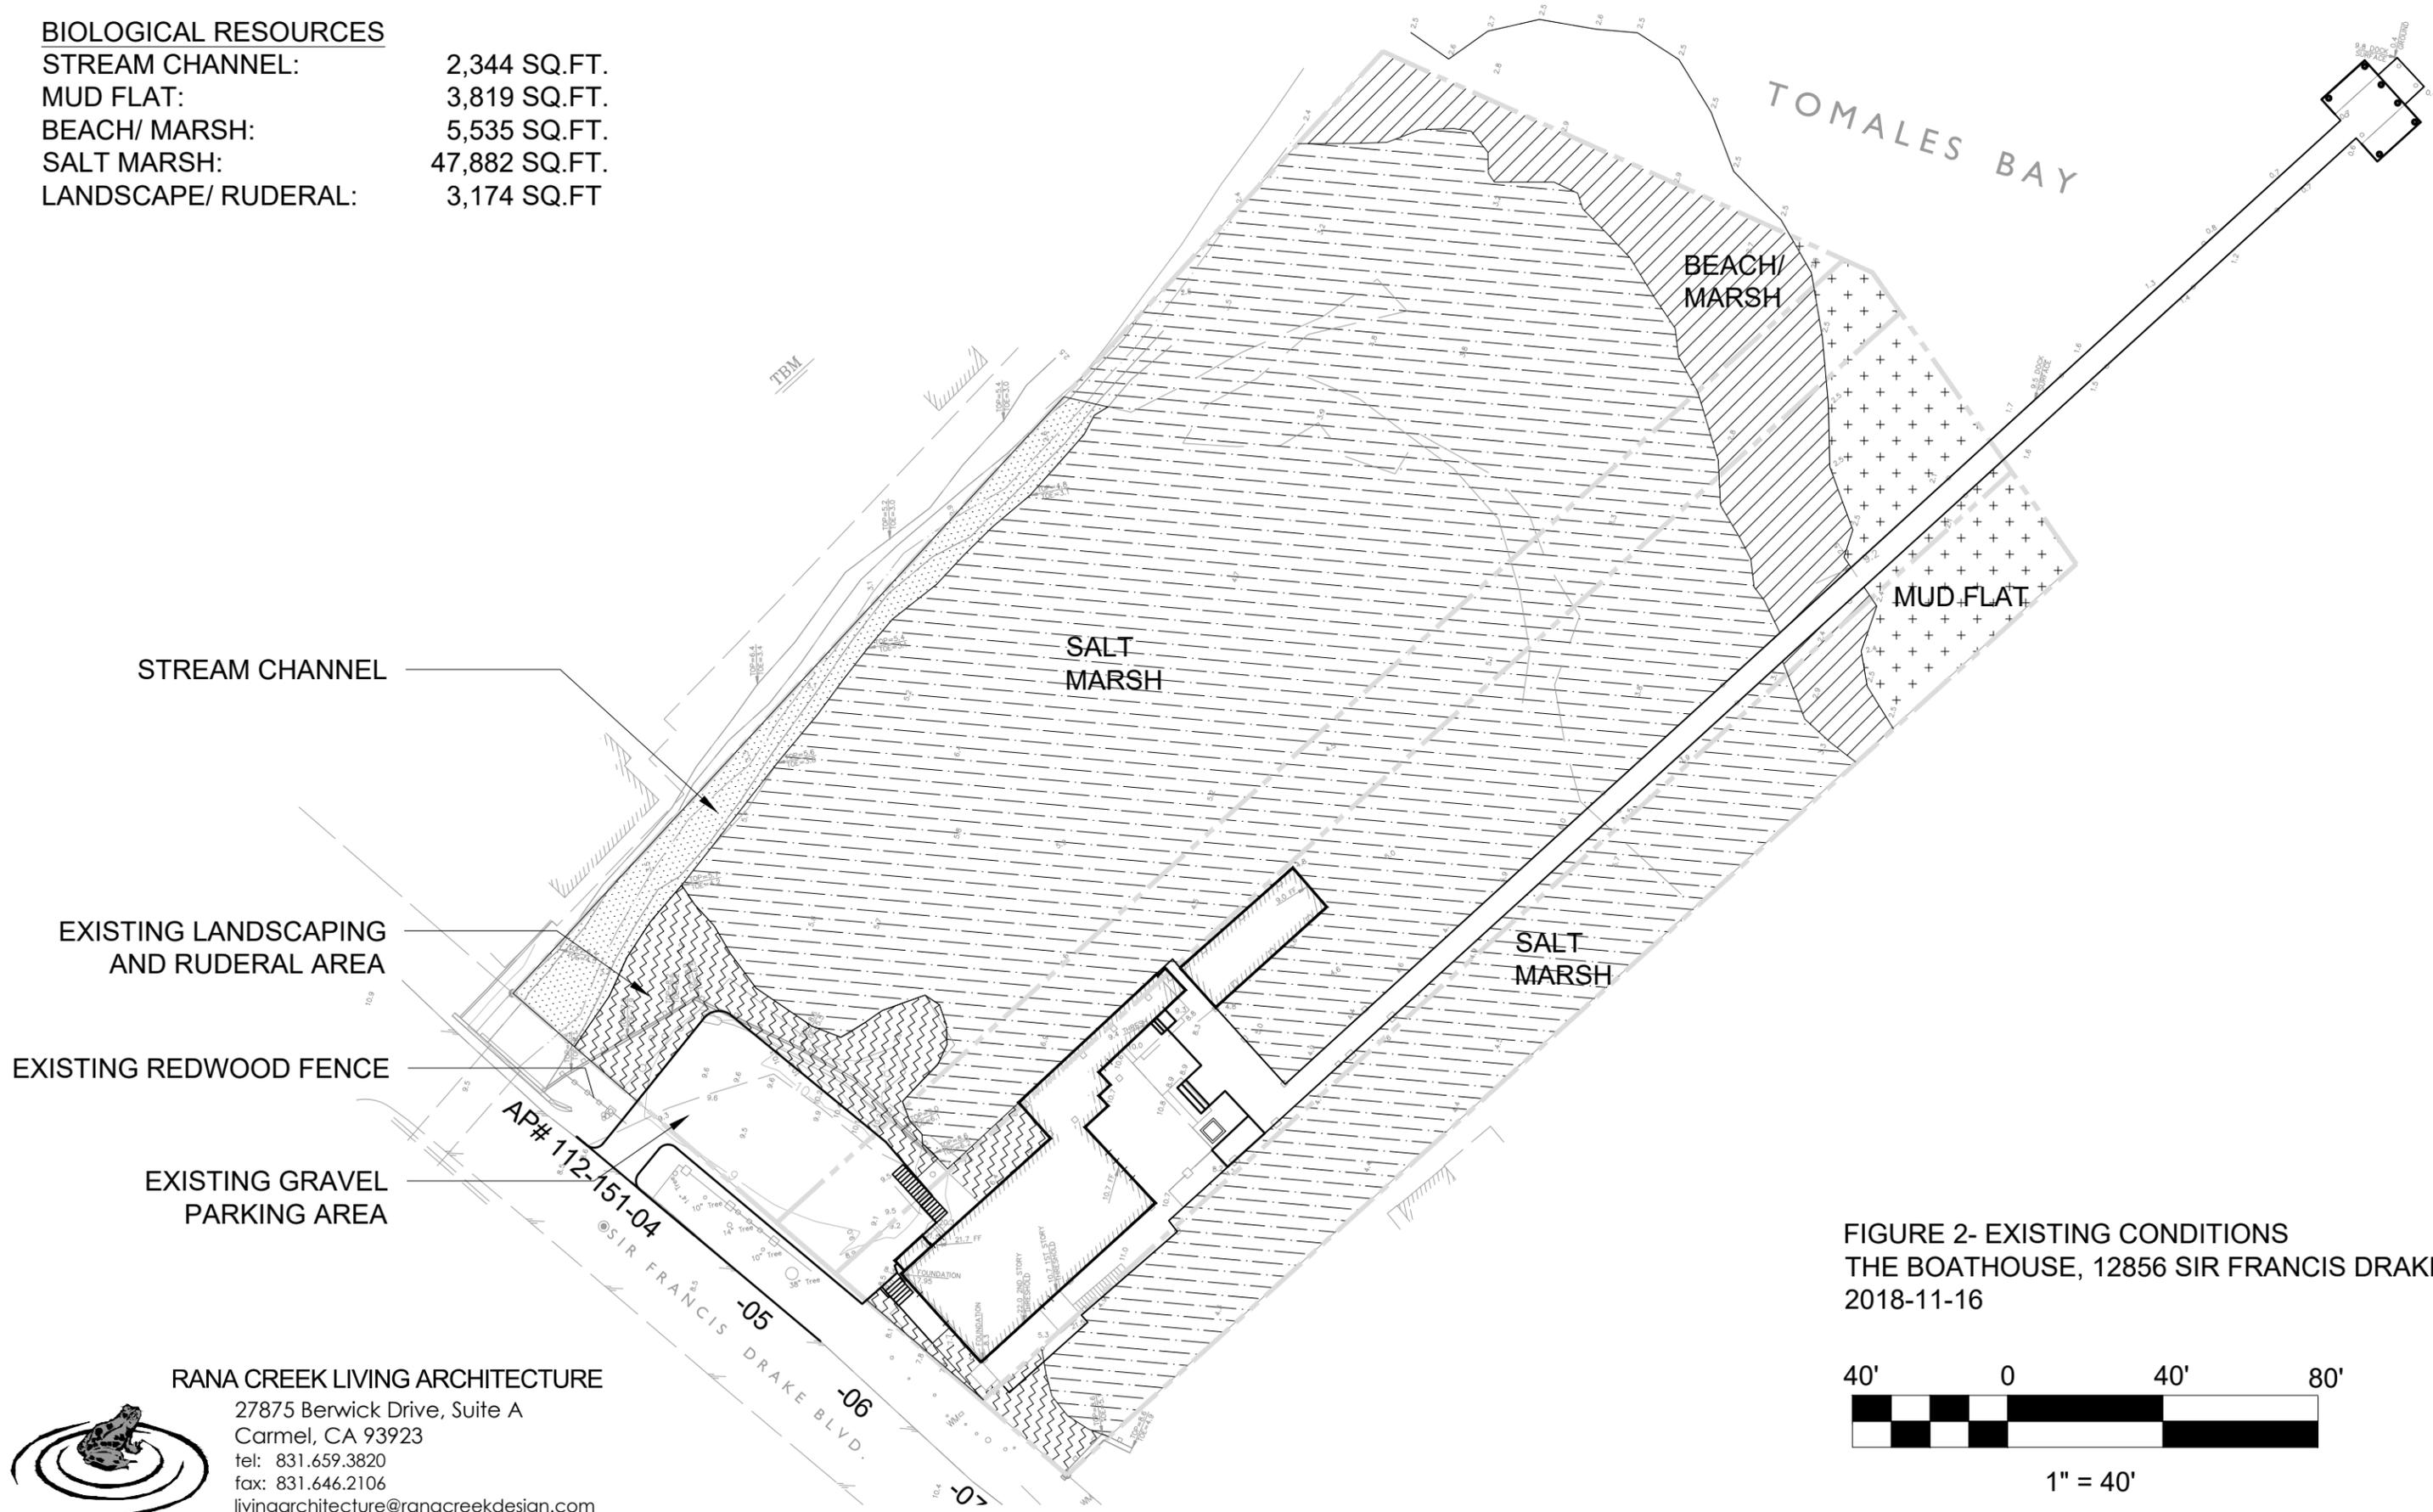
FIGURE 2- EXISTING CONDITIONS  
 THE BOATHOUSE, 12856 SIR FRANCIS DRAKE BLVD.  
 2018-11-16

**BIOLOGICAL RESOURCES**

STREAM CHANNEL:	2,344 SQ.FT.
MUD FLAT:	3,819 SQ.FT.
BEACH/ MARSH:	5,535 SQ.FT.
SALT MARSH:	47,882 SQ.FT.
LANDSCAPE/ RUDERAL:	3,174 SQ.FT.

Nearly all of the property is located within the intertidal zone and regular flooding is influenced by diurnal and seasonal tidal events. As a result, the land contains mostly marsh and mudflat with some open water. The topography is gently undulating and varied as a result of sand and silt deposition as well as subsidence in low-lying areas. The occurrences of salt marsh on the property would be considered wetlands and ESHA by the California Coastal Commission (CCC) and likely would qualify as potentially jurisdictional wetlands regulated by the U.S. Army Corps of Engineers (USACE). Photographs of existing conditions on the property are provided as **Appendix A**.

**Table 4** summarizes the approximate square footage of these four natural communities that lie within the areas temporarily affected by construction activities.

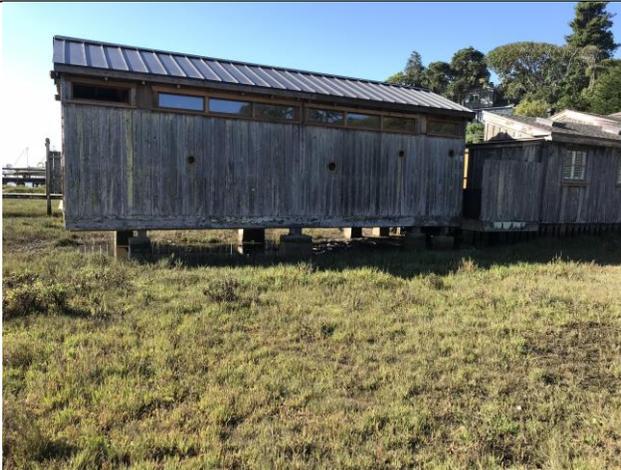
**Photo 1** – North side of Boathouse and salt marsh in the foreground

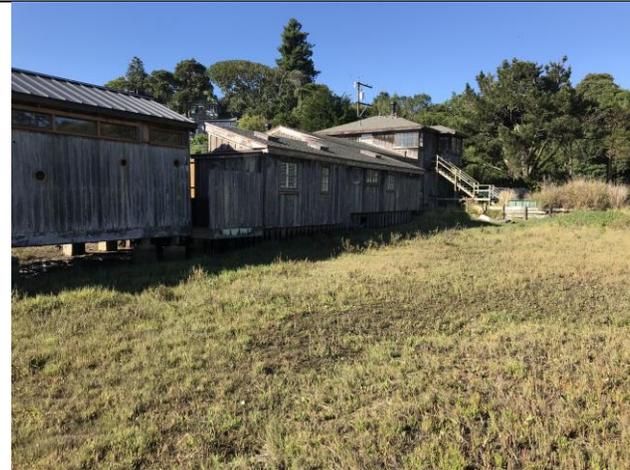
**Photo 2** – Boathouse and salt marsh, looking west towards Sir Francis Drake Blvd.

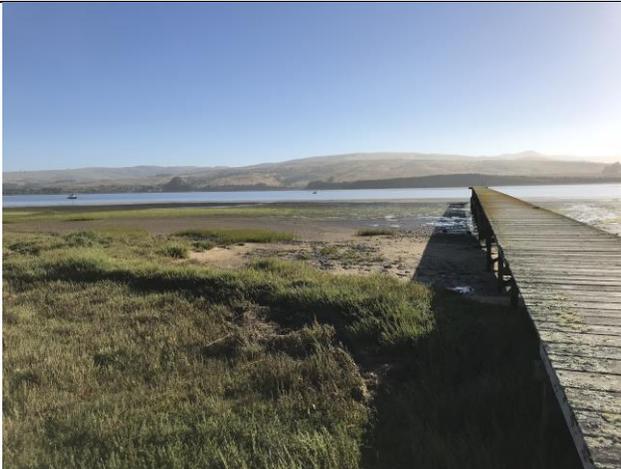
**Photo 3** – Existing dock.

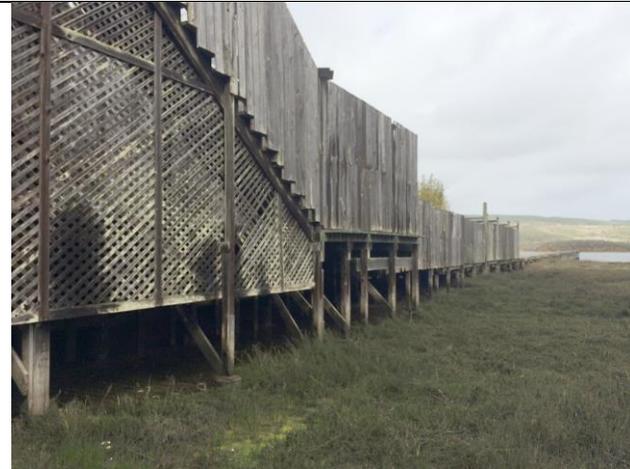
**Photo 4** – South side of Boathouse

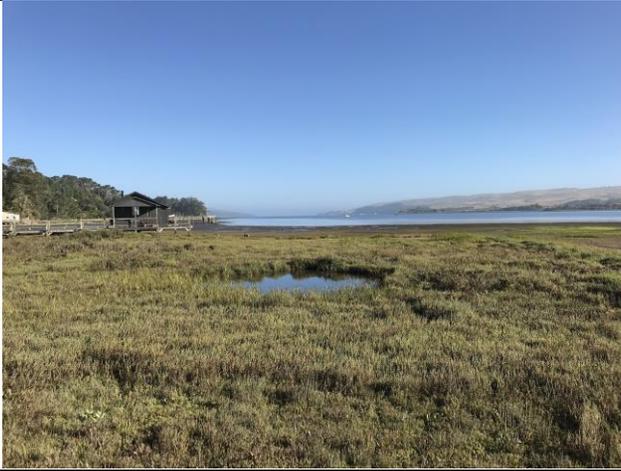
**Photo 5** – Salt marsh and view north up Tomales Bay

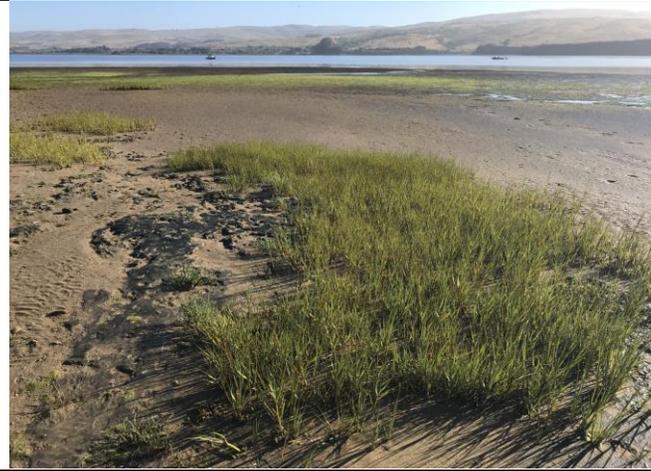
**Photo 6** – Cordgrass growing on edge of sand beach and mudflat.

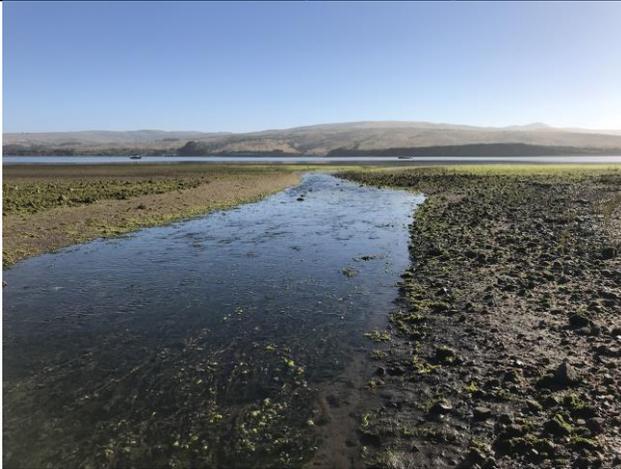
**Photo 7** – Outlet of creek and adjacent mudflats

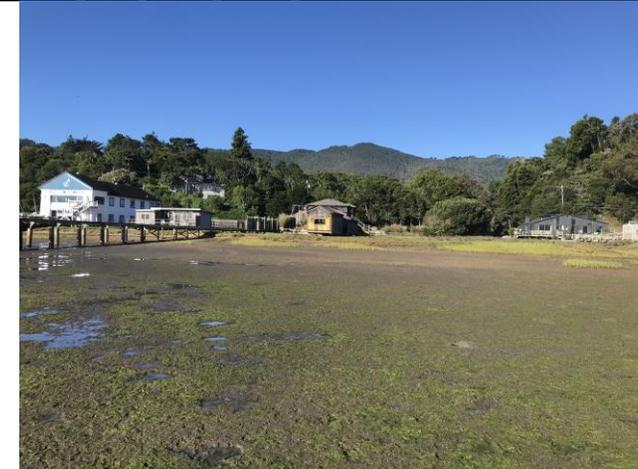
**Photo 8** – View of Boathouse (center) from mud flats. Yacht Club (left) and private residence (right)
