MEMORANDUM

**RE: Planning Commission Hearing of August 23, 2021
Brandon Sullivan et al Appeal of the Sasan Site Plan Review Approval
Agenda Item: 4**

187 Sacramento Avenue, San Anselmo **FIRE CODE NON-COMPLIANCE**

This project fails to meet California Building Standards Code, Title 24, Part 9: California Fire Code & the Marin County Fire Department Minimum Project Requirements

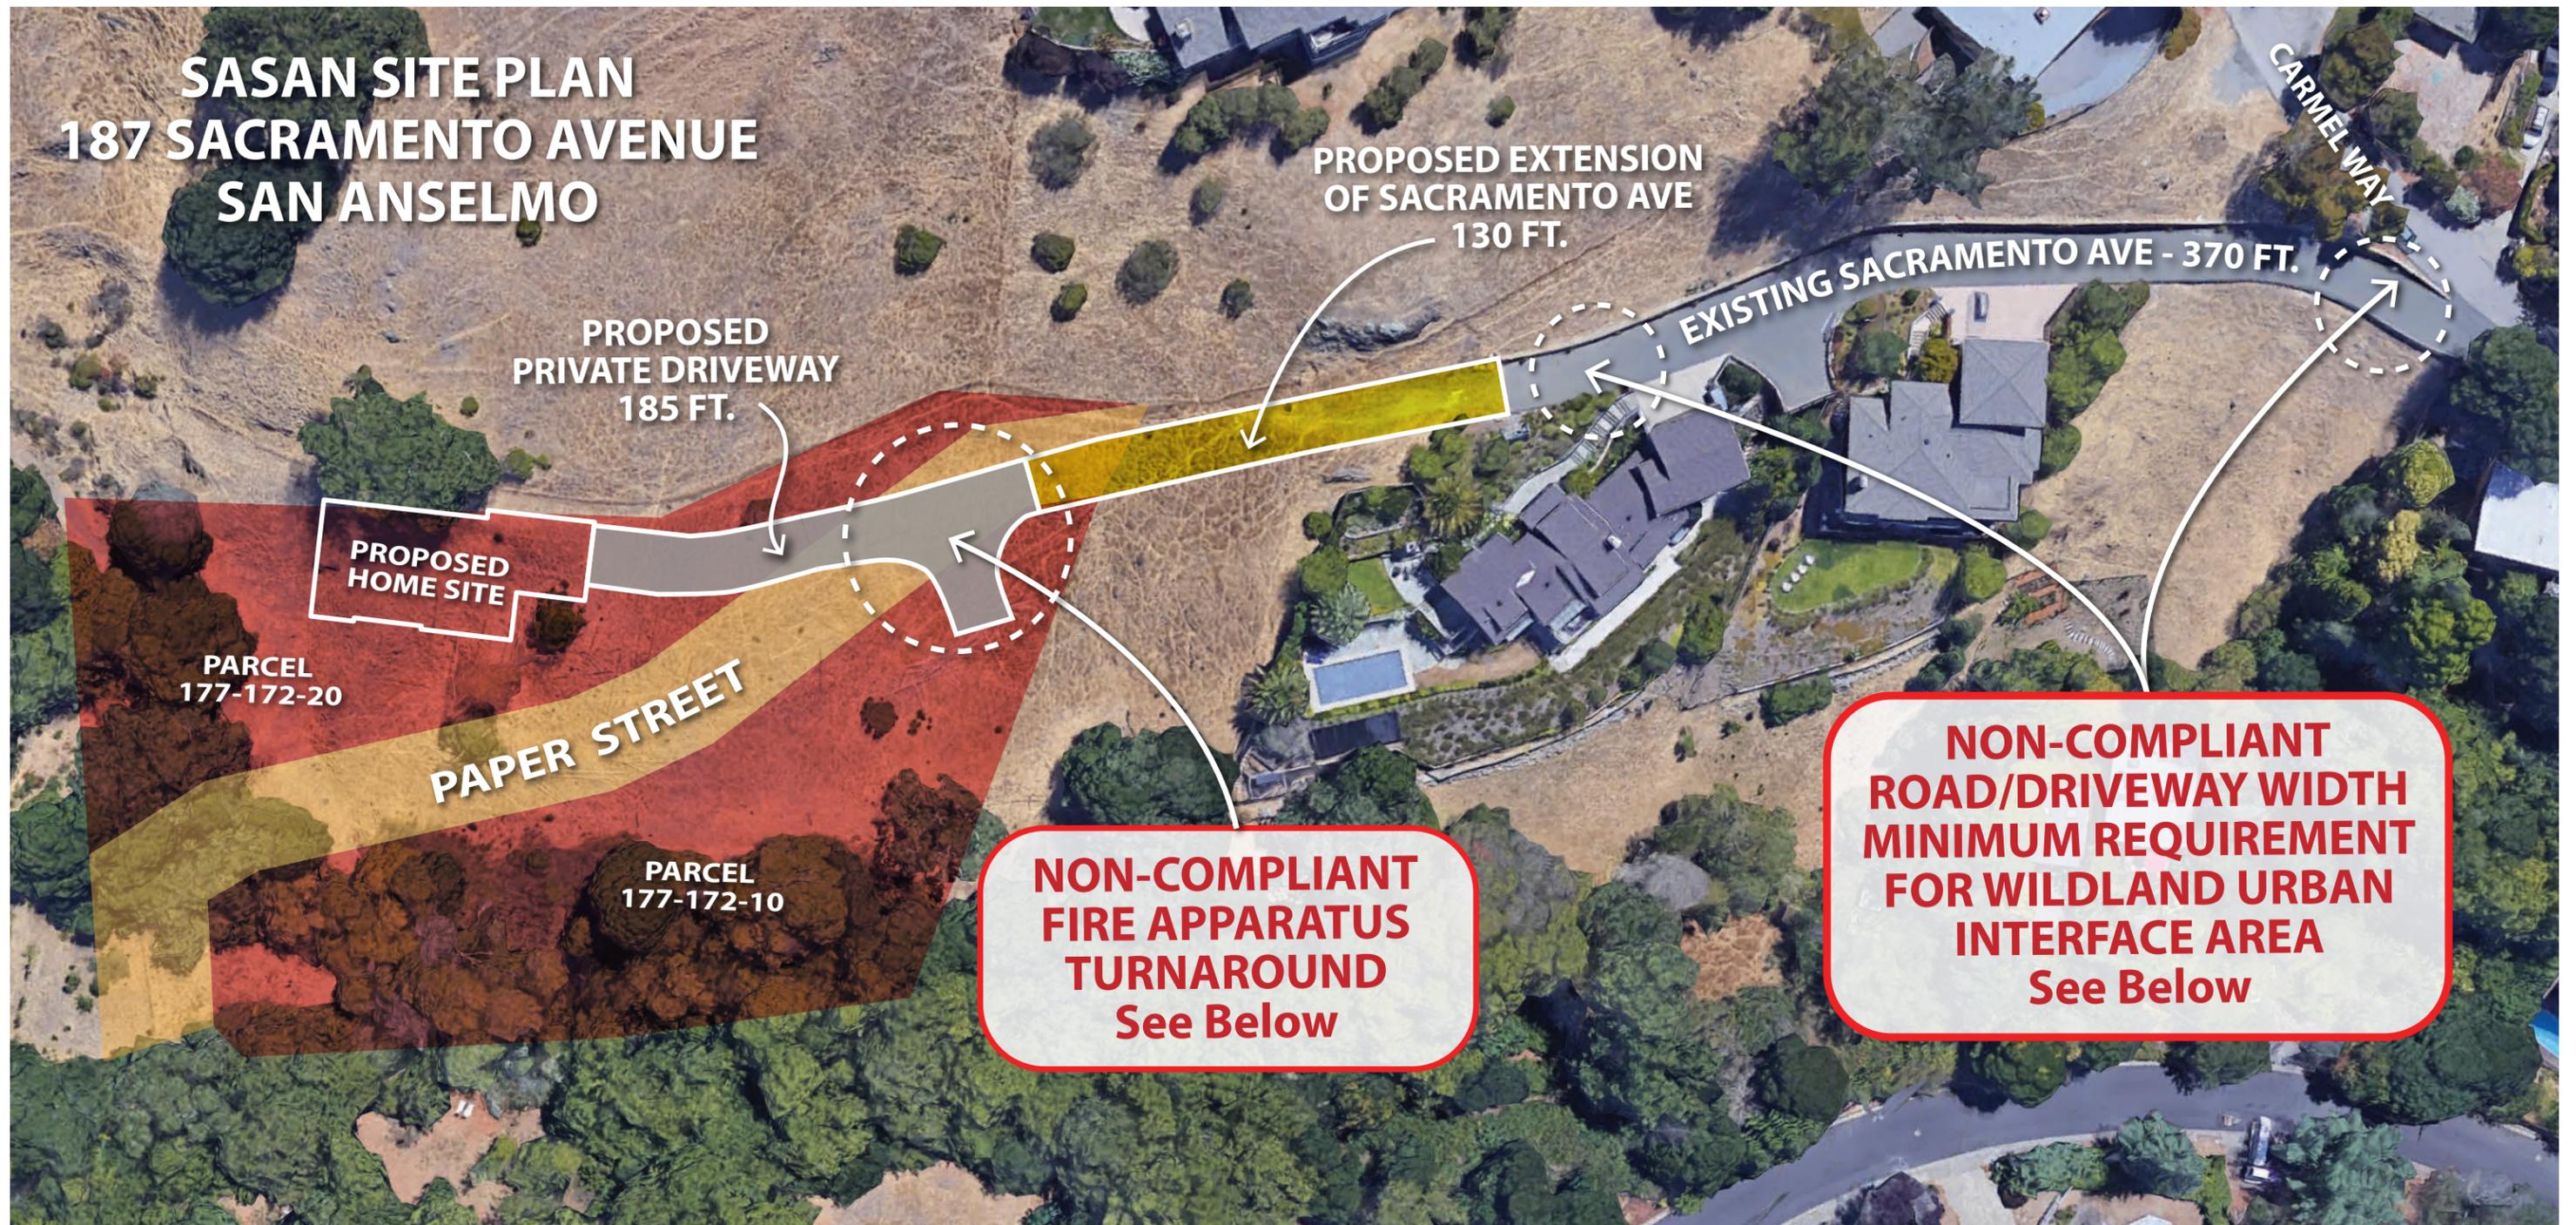
NON COMPLIANT FIRE APPARATUS TURNAROUND

The proposed fire apparatus turnaround does not comply with the minimum requirement as described in the Marin County Fire Departments Wildland Urban Interface Area regulations. The proposed fire apparatus turnaround is 18' x 55', required turnaround is 18' x 60'. **See Page 4 for more information on non-compliance.**

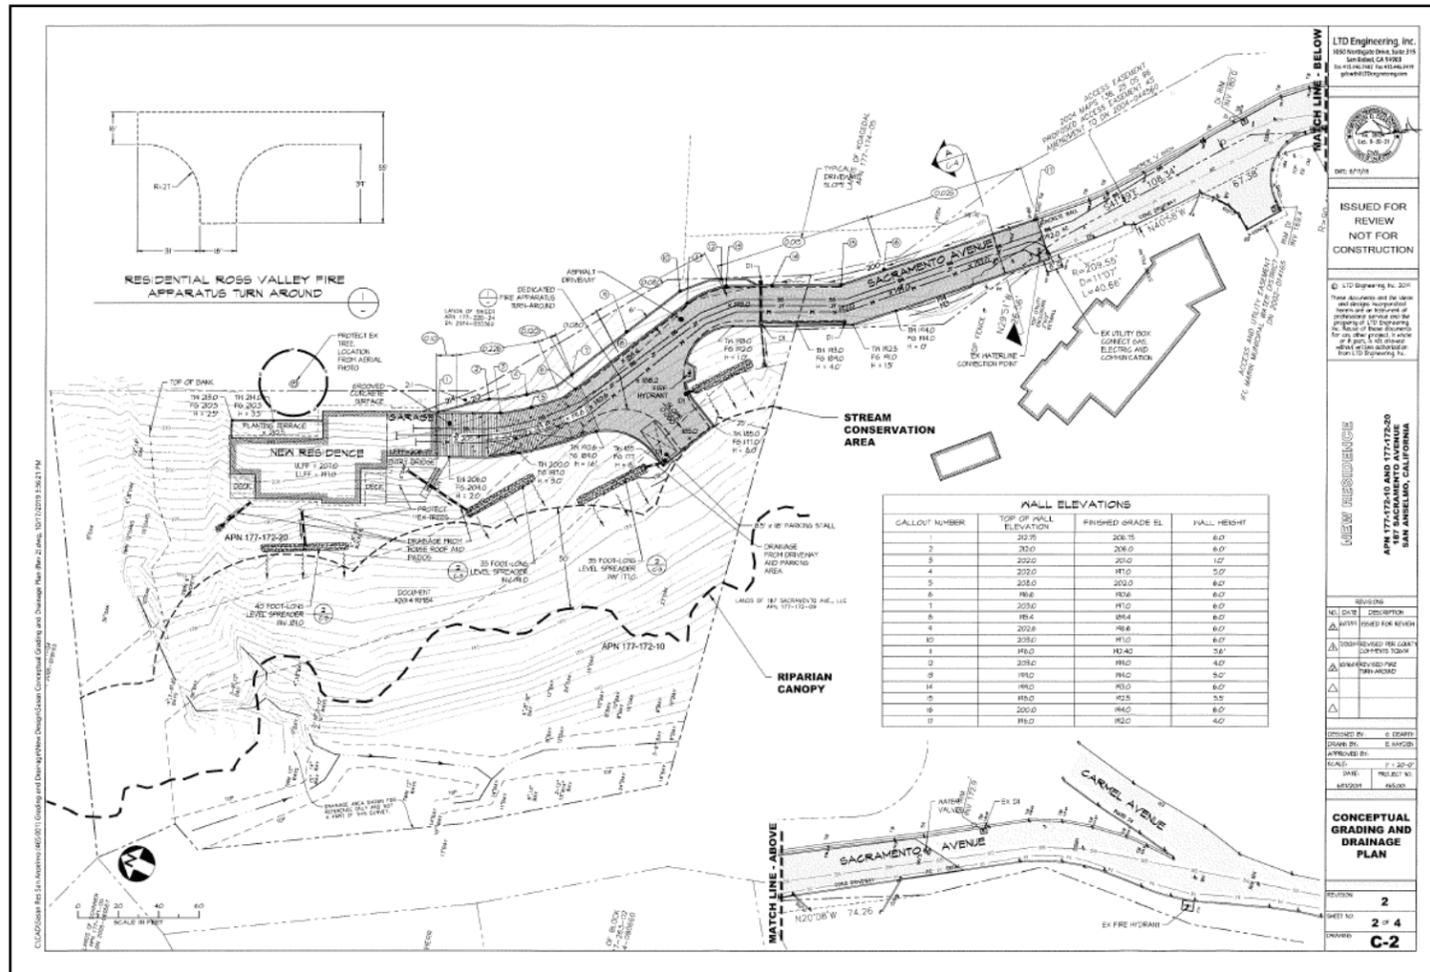
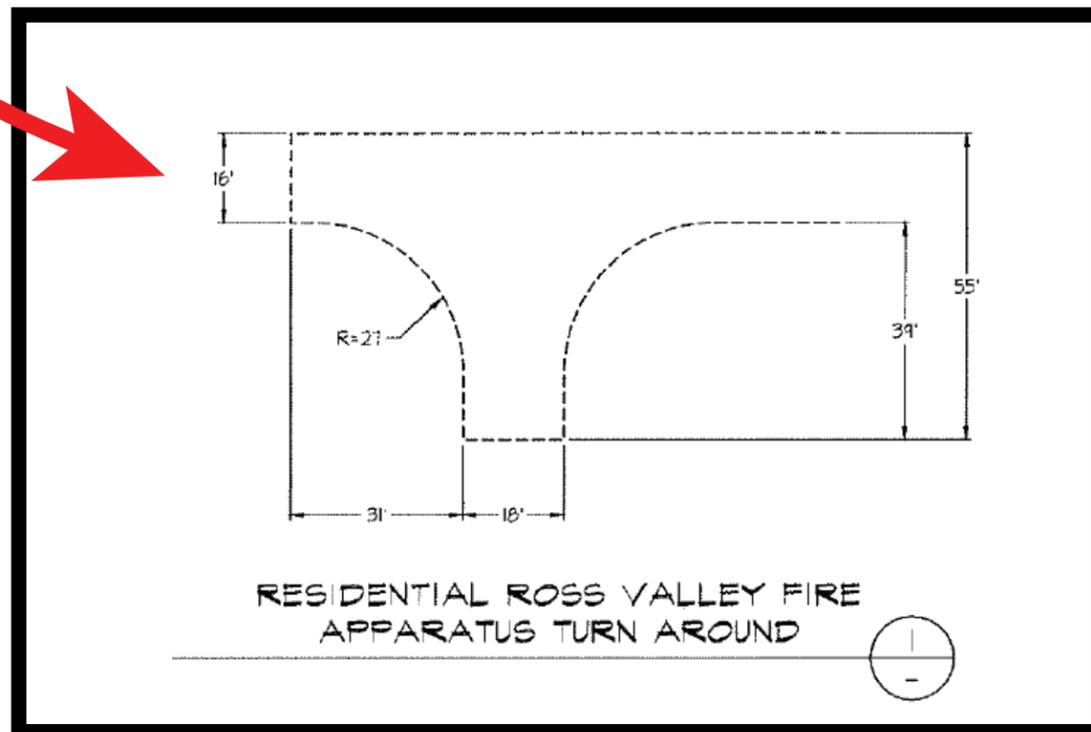
“Turnarounds are required at the END of driveways over 150 feet long in WUI”

(Non-compliant - driveway is 315’ long, turnout is located in the middle of driveway)

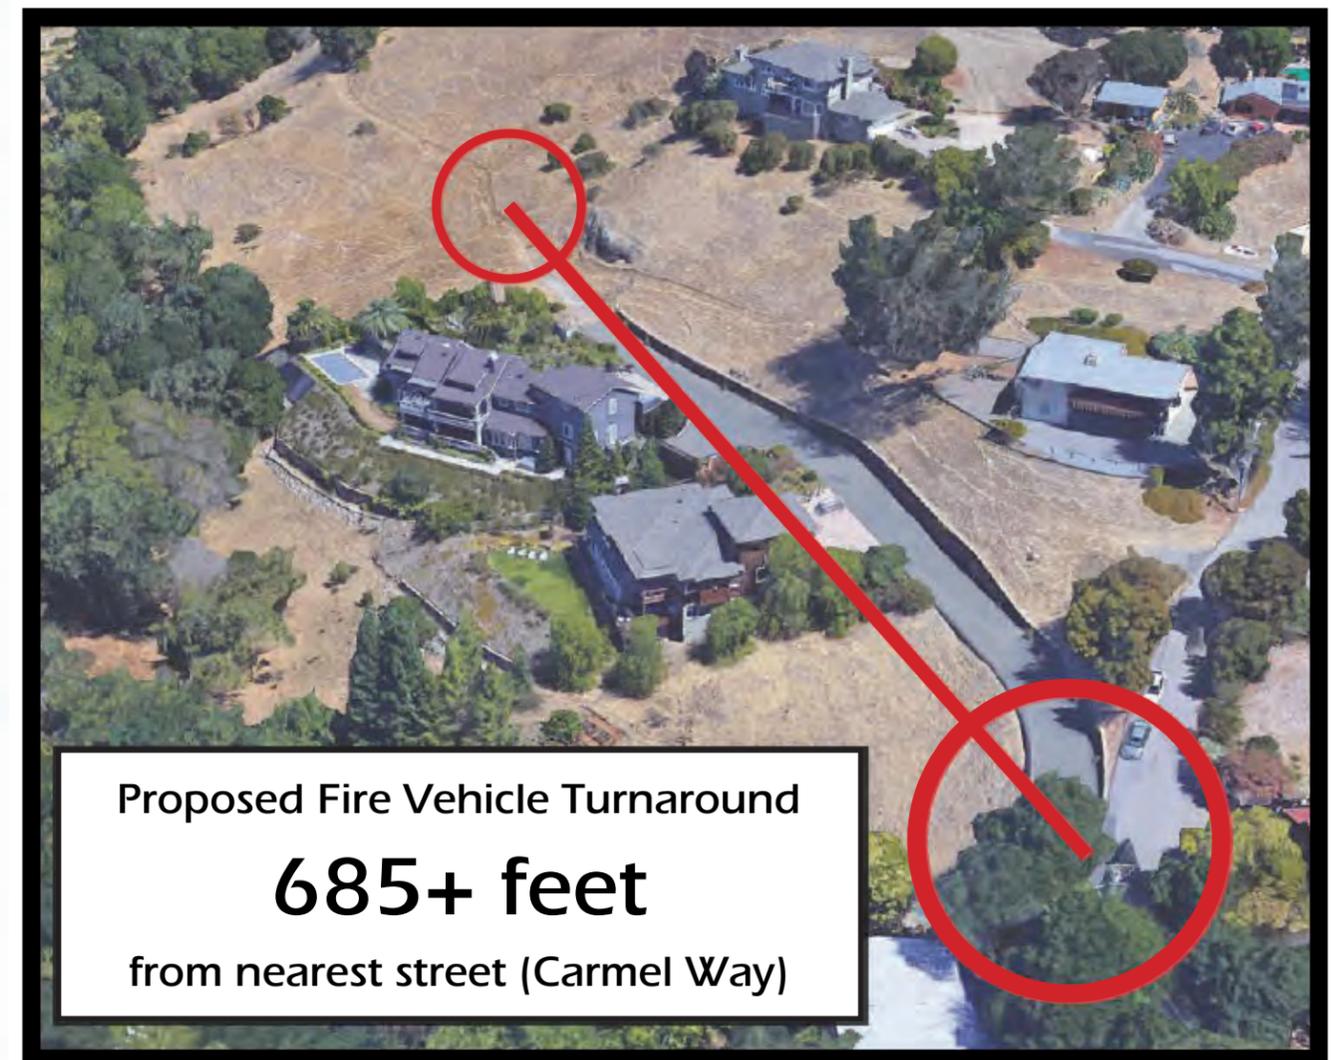
Sacramento Avenue Roadway width
at widest point:

19 feet 5 inches

Marin County Fire Department
CONDITION OF APPROVAL
Roadway width no less than

20 feet minimum

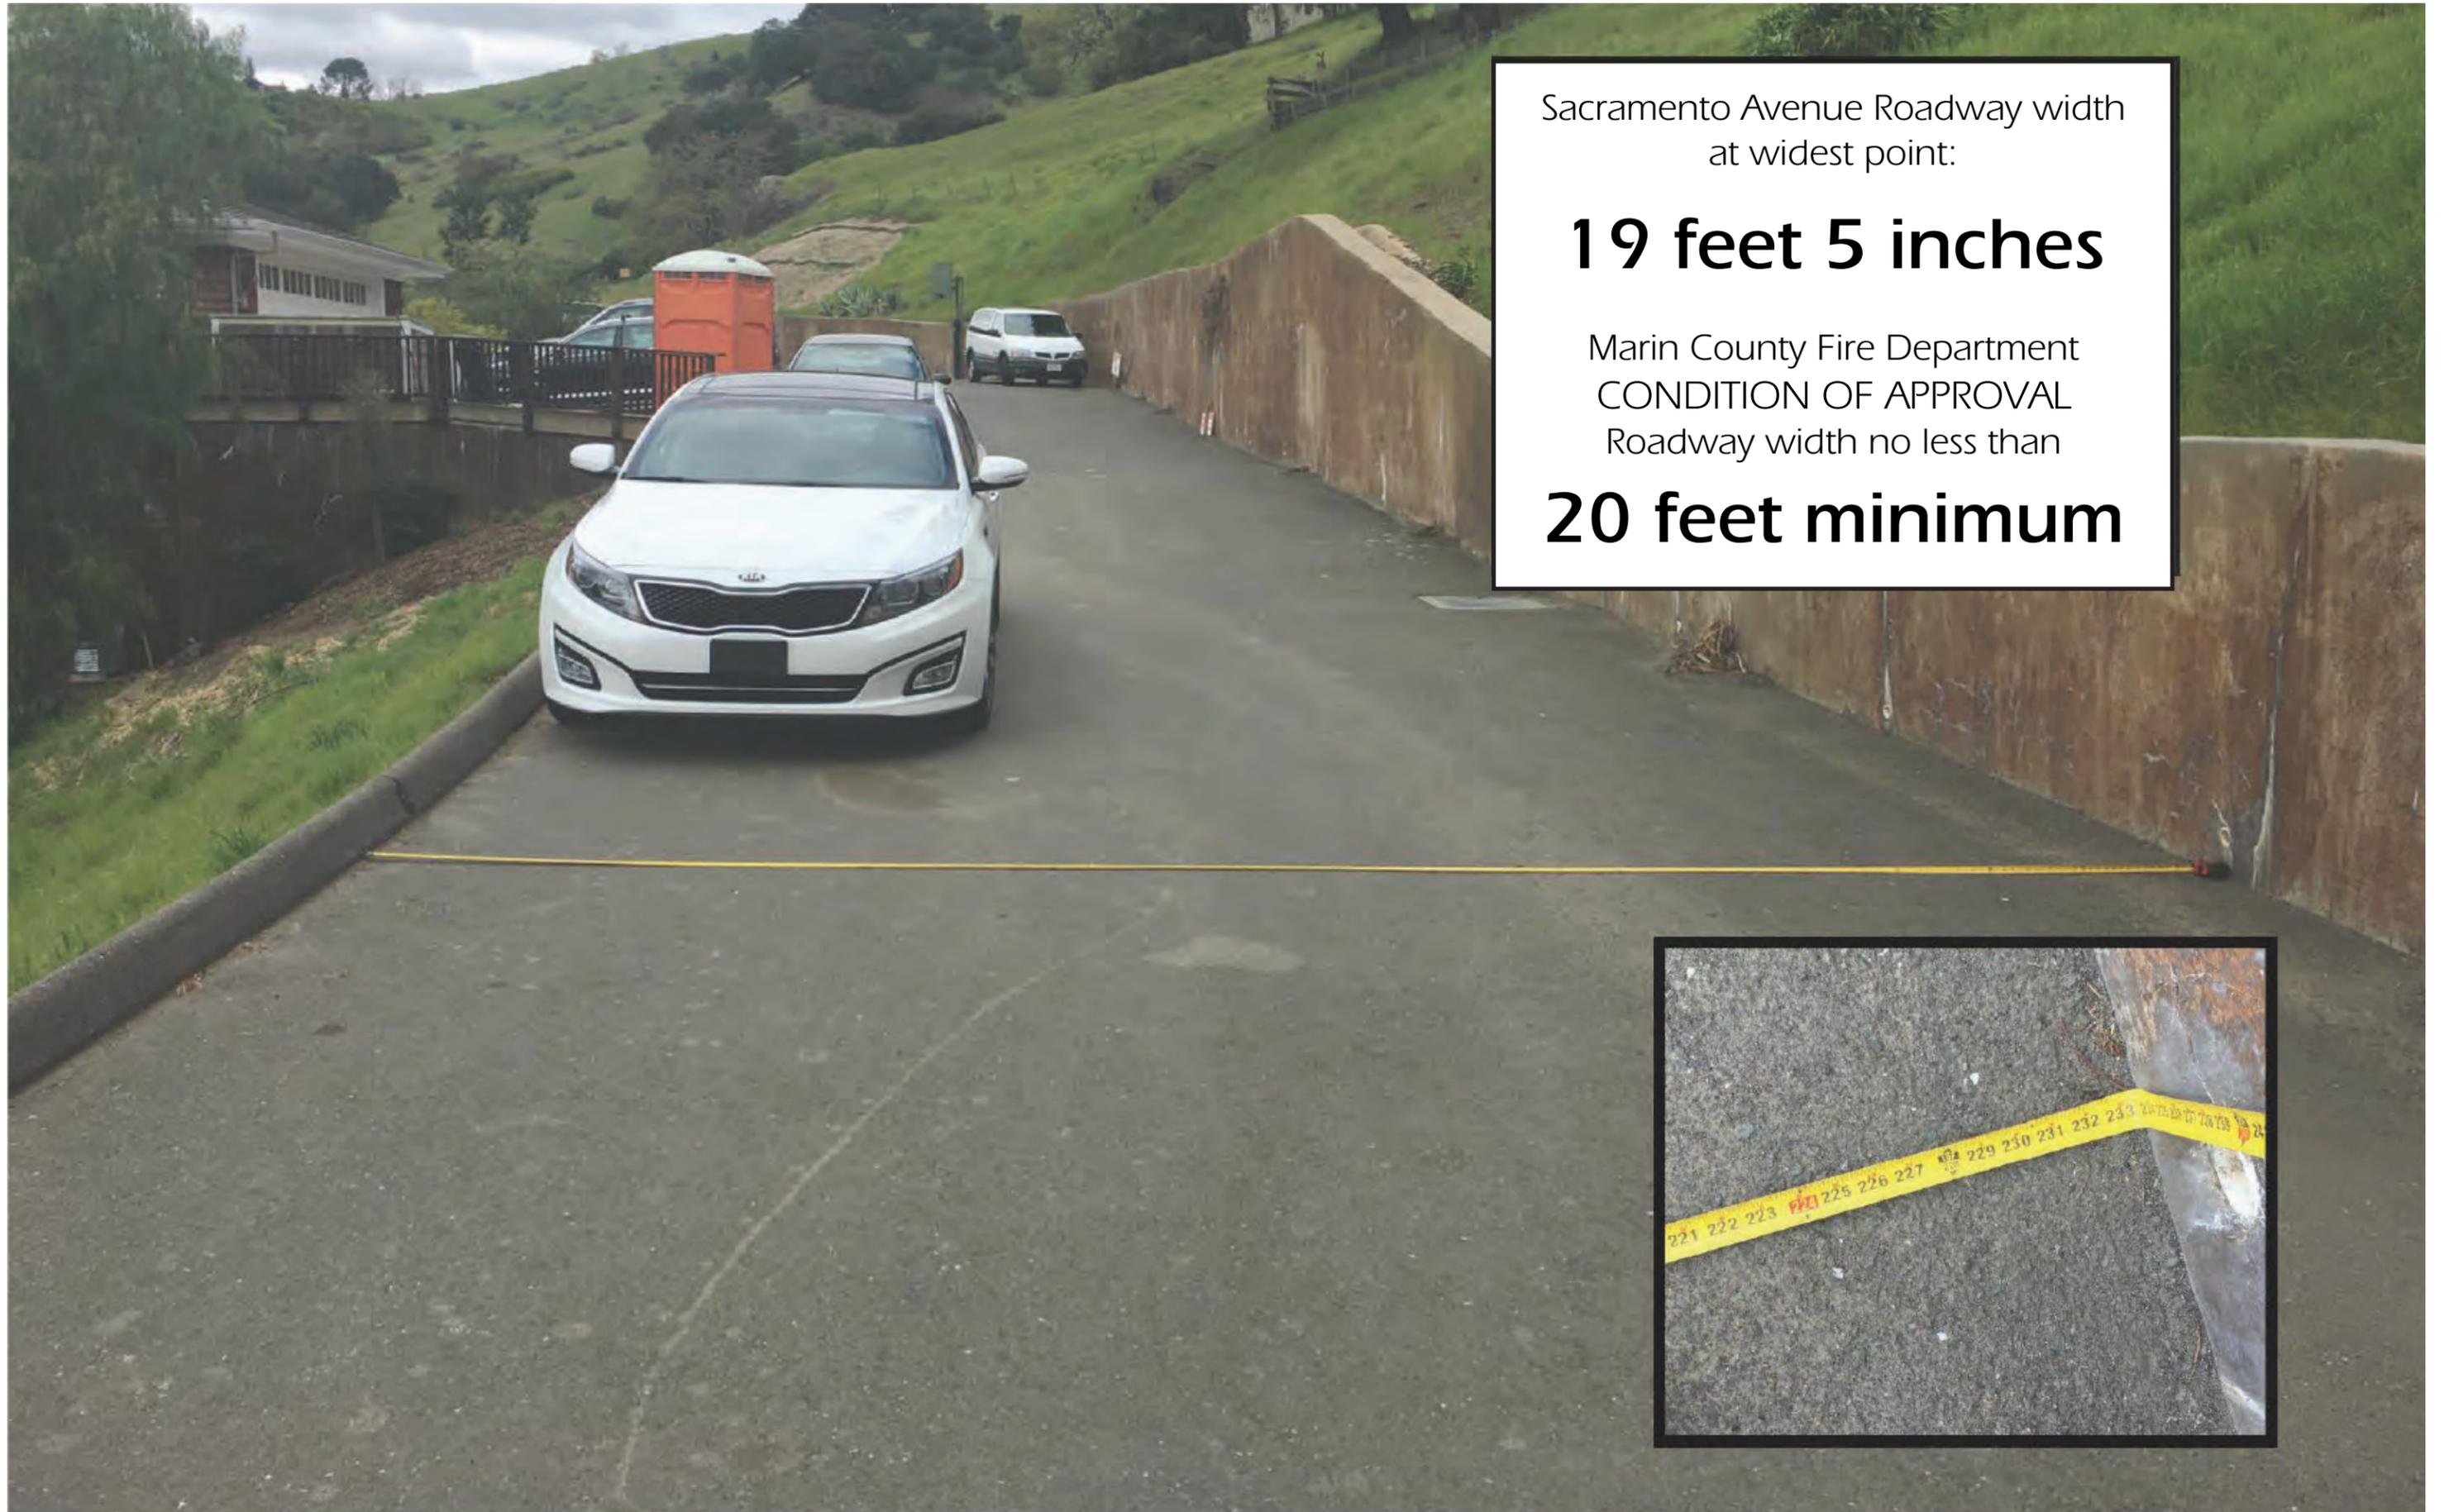
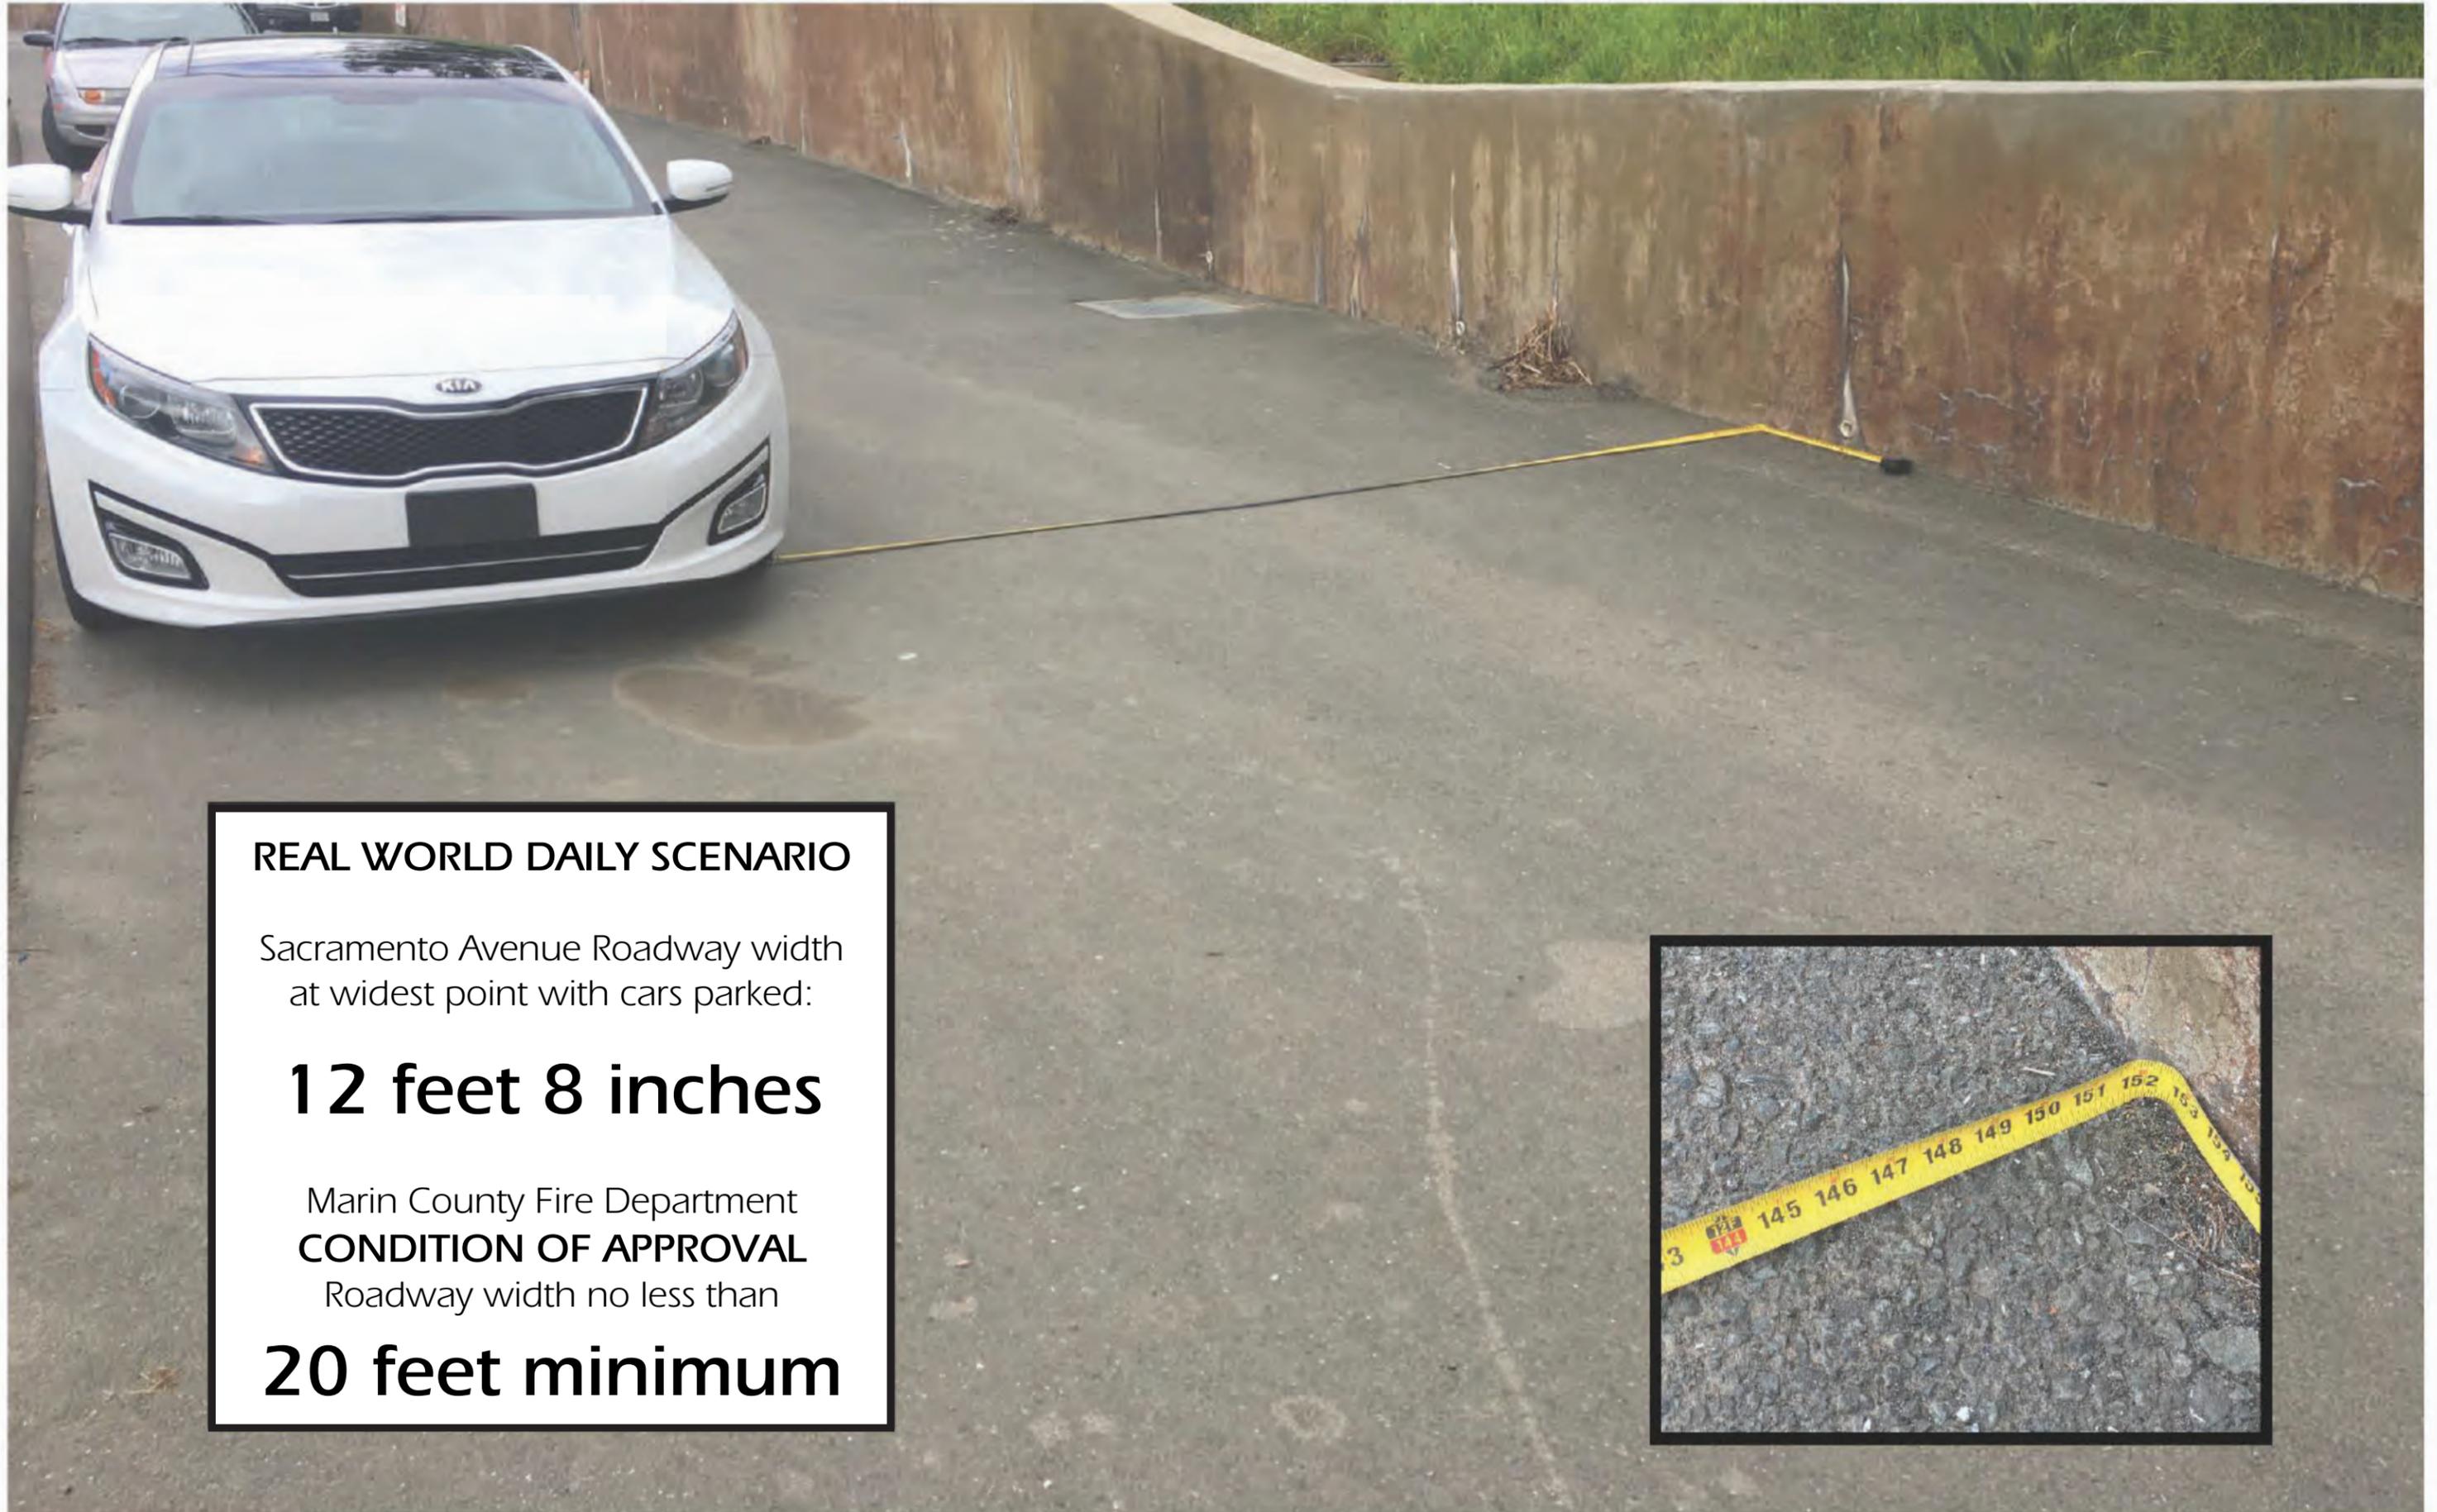
REAL WORLD DAILY SCENARIO

Sacramento Avenue Roadway width
at widest point with cars parked:

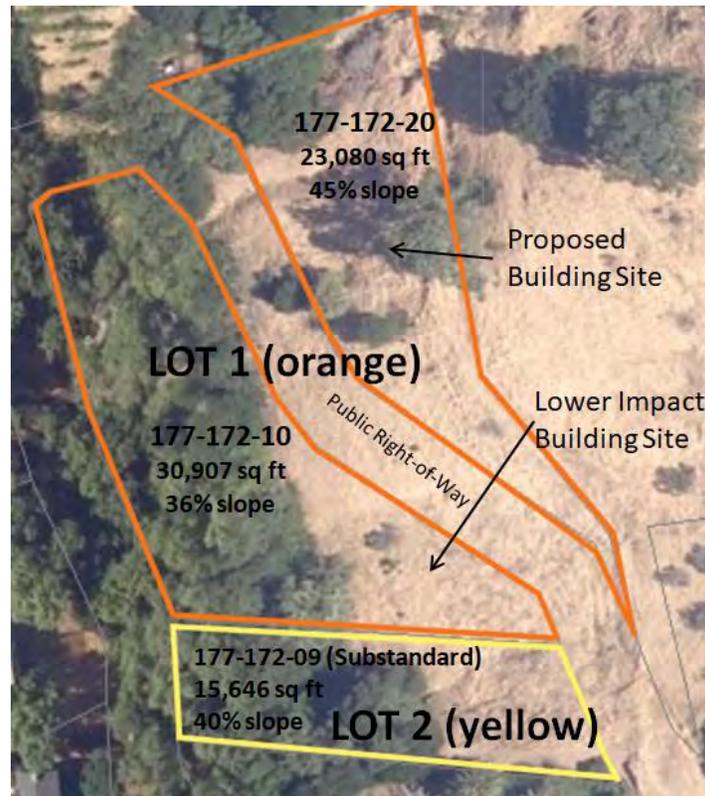
Figure 2. Site layout showing two lots consisting of three parcels.

Figure 2 below shows Lot 1 (orange) is divided into two parcels by the public right-of-way. Even though there are two parcels, only one house can be constructed on this lot in its current configuration. Lot 2 is a substandard lot because it is “at least 50 percent smaller in total area than required for new parcels under the applicable zoning district or slope regulations, in compliance with Section 22.82.050 (Hillside Subdivision Design Standards), whichever is more restrictive” (MCDC Section 22.42.020). Under Hillside Subdivision Design Standards, for lots that have a slope of 40% or greater, the minimum lot area is 43,560 sq. ft. Since this lot is only 15,646 sq. ft. with a slope of 40%, it is more than 50% smaller than the minimum required lot area of 43,560 sq. ft., and therefore is substandard.

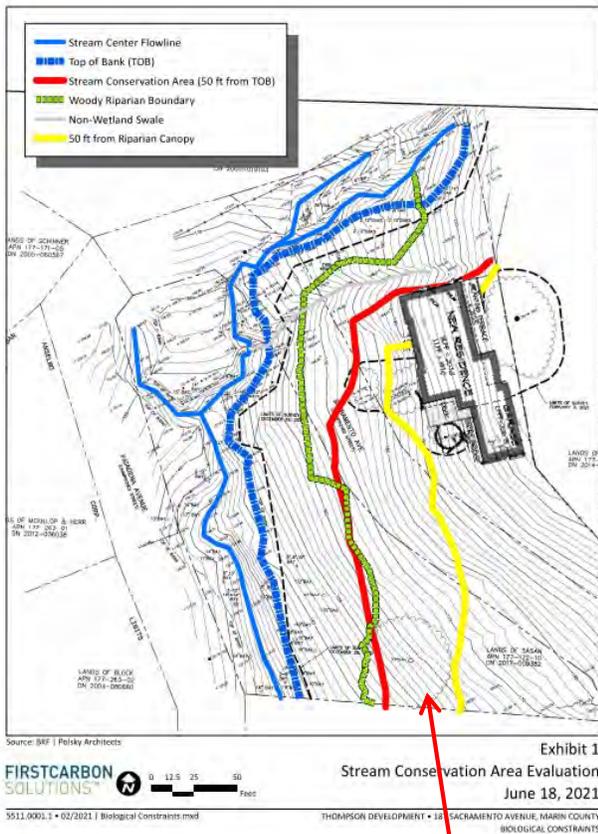
Biological constraints maps show the proposed house is located in the SCA as measured from the riparian canopy.

2021 FCS Site Map. Proposed house is in the SCA as measured from the edge of the riparian canopy (yellow line).

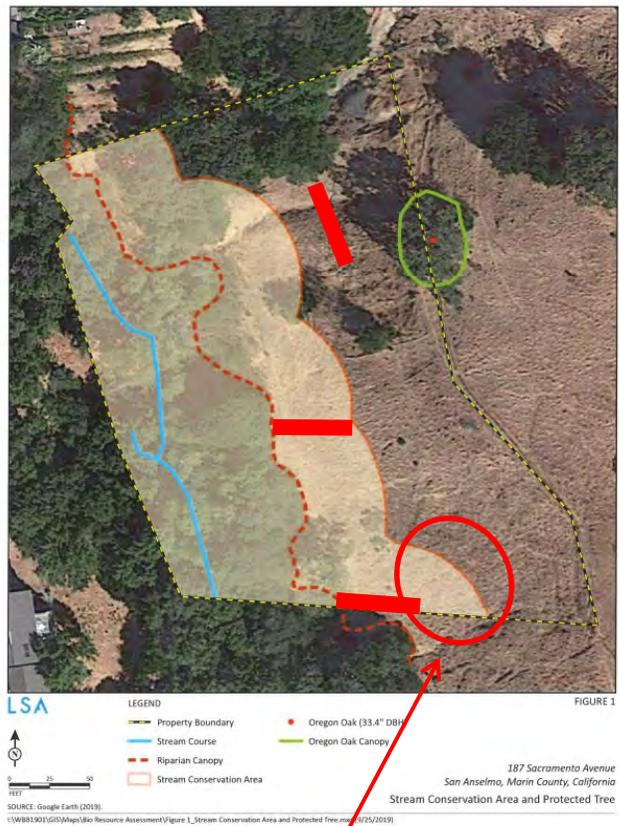
2019 LSA BSA Site Map. Red bars represent 50 feet from the edge of the riparian canopy and clearly show the proposed house is in the SCA even though LSA failed to map the setback from the northern boundary stream. The setback is significantly overextended in the building site favored by neighbors.

Exaggerated SCA setback (50 feet from the riparian canopy) makes the buildable area of this parcel look smaller than it actually is.

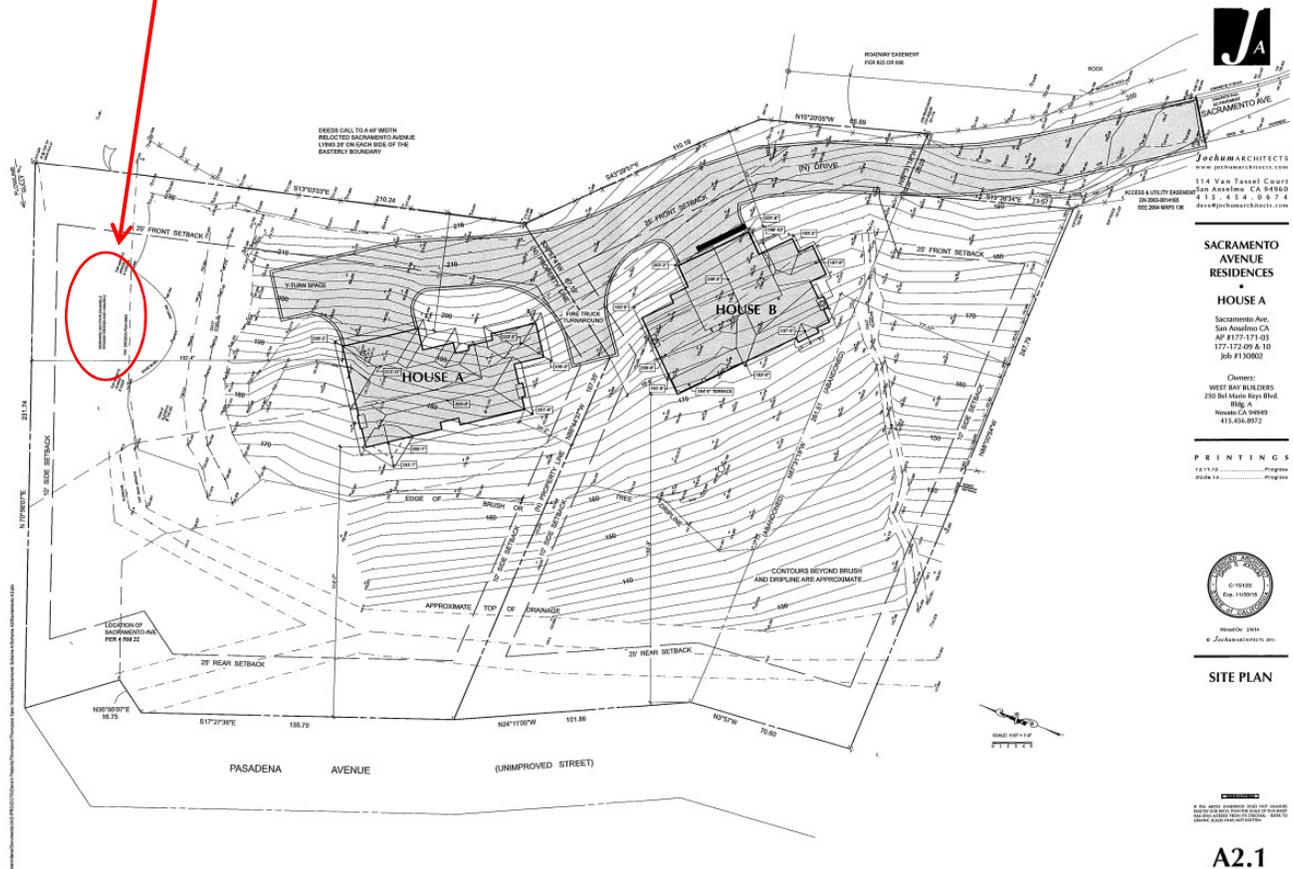
**DRAINAGE HAS FOUR CHANNELS
GROUND ERODED AND UNSTABLE**

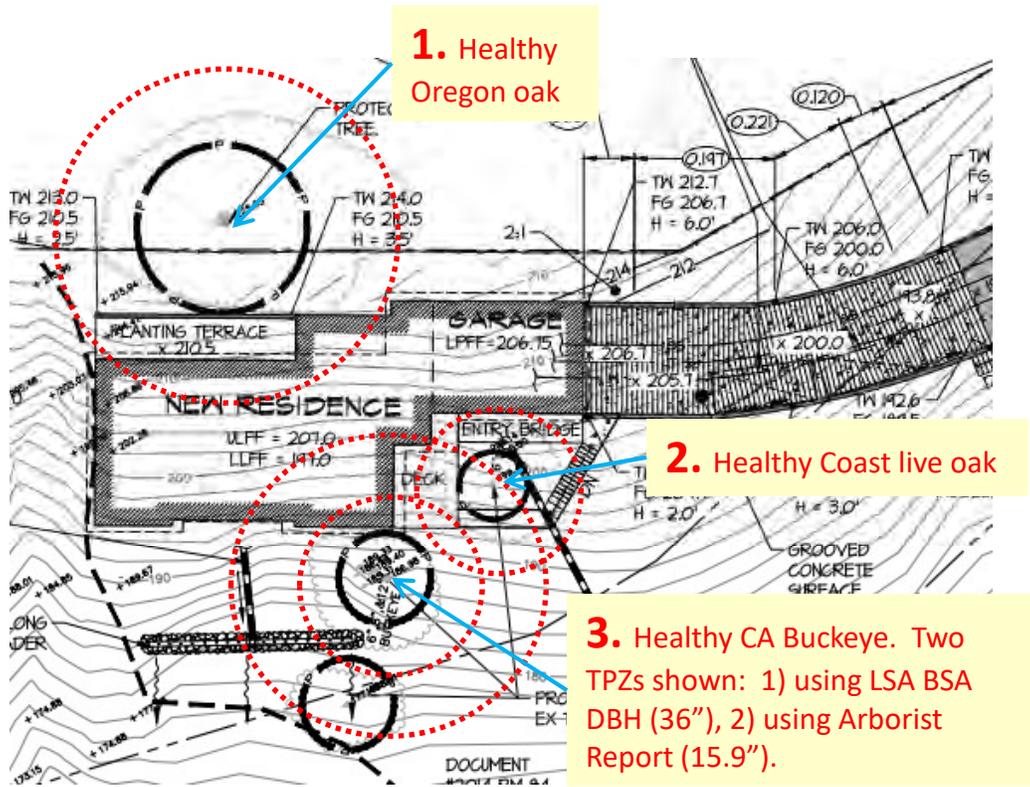
Building footprint encroaches into Tree Protection Zones (TPZs)

If Tree Protection Zones (TPZs) are accurately drawn using DBH as directed in the 2019 BSA (red dotted circles), the building footprint encroaches into TPZs. Encroachment would be even more severe if current tree sizes were used rather than measurements made 3 years ago.

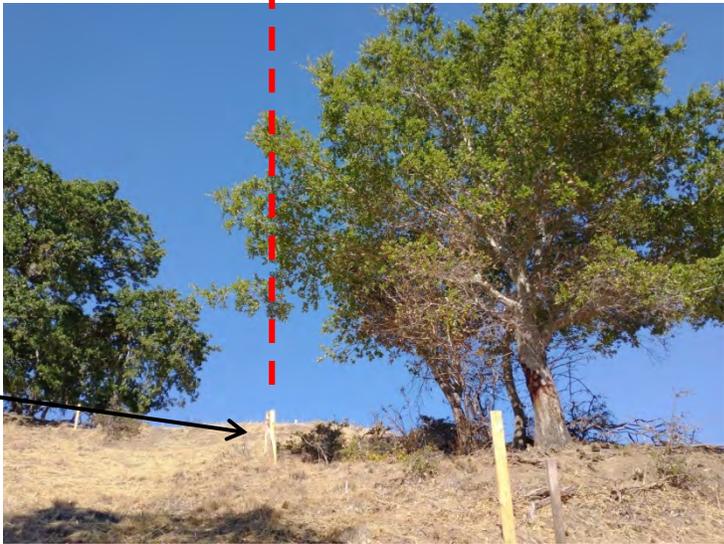
Photos showing Tree Protection Zone (as determined by tree canopy) overlapping the building footprint.

Stakes 31 and 32 marking the southern building edge

Protected oak tree growing near entrance to proposed house

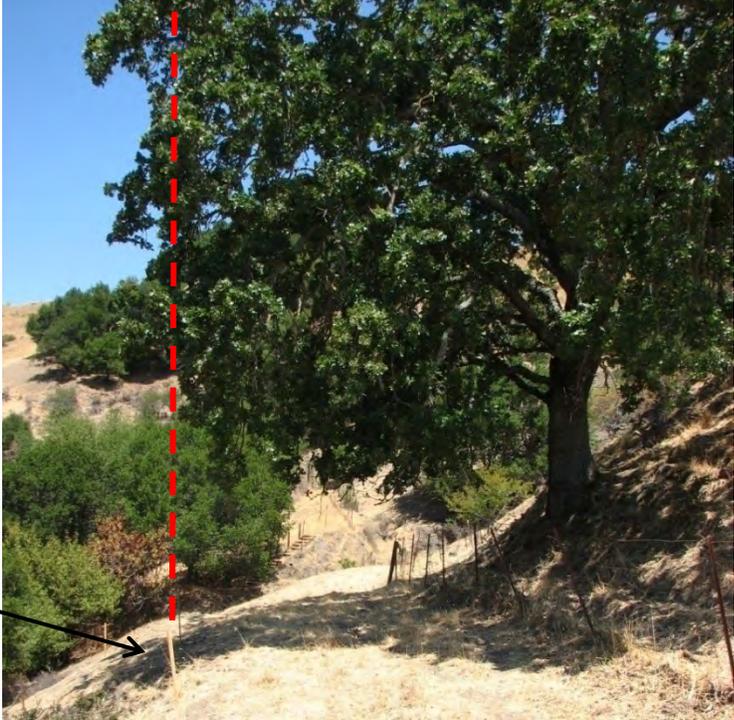
Stake 42 marking the eastern building edge

Heritage oak tree growing along eastern property boundary.

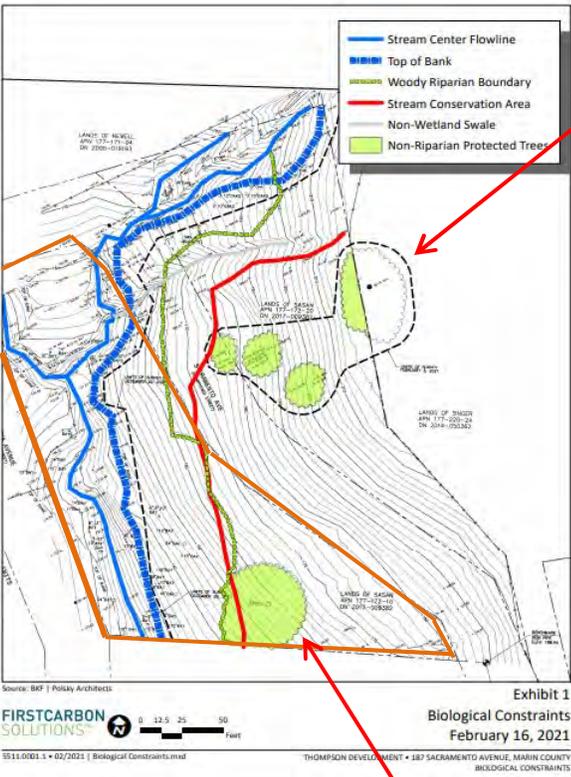
Tree canopy size per MarinMap aerial photograph as compared to FCS Biological Constraints Map

This comparison shows that there is much more space for a house below the public right-of-way than what's represented in the FCS map (left), which overstates the canopy size of the unhealthy oak growing along the southern boundary. It also shows that there is much less space for a house in the proposed location because the applicants have ignored how the canopy is actually growing.

Canopy of healthy Oregon oak growing along eastern boundary. The site map does not accurately show the extent to which the oak canopy overlaps the building site. The canopy shape is not oval as sketched on the site map.

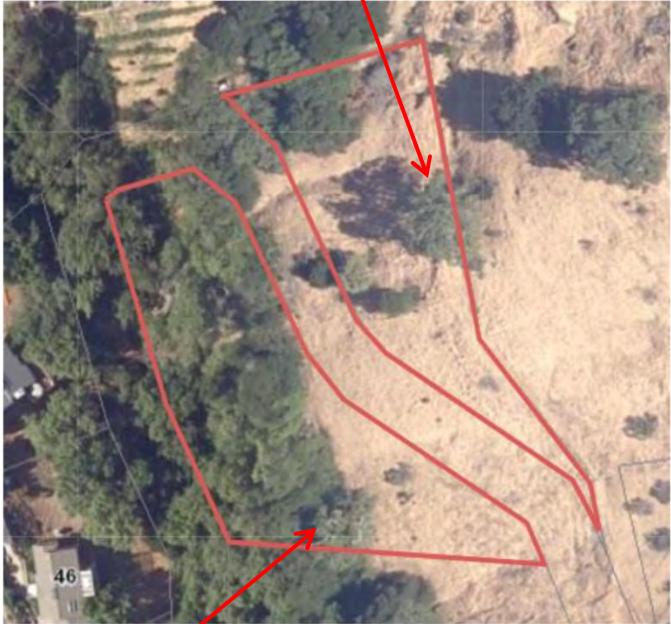
Canopy of unhealthy Oregon oak growing along southern boundary. Note that the canopy is exaggerated in the drawing as compared to the aerial photograph. Also note that the unhealthy oak canopy is drawn about the same size as the healthy oak canopy. Clearly this is not the case.

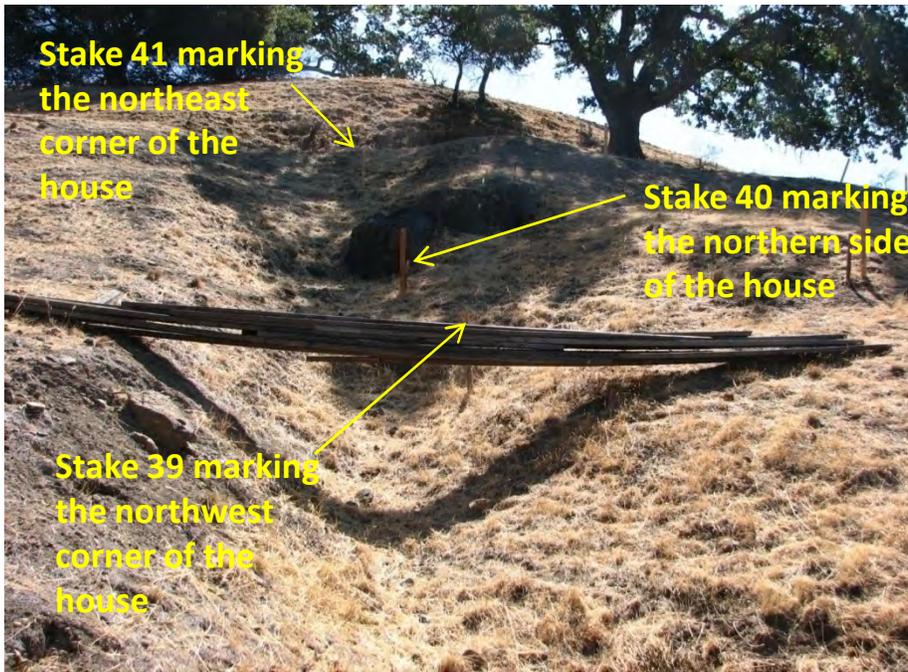
Encroachment of House into the Stream Conservation Area

Stakes #39, 40, 41 were located in the “non-wetland swale” indicated by a gray line on the FCS map until they were recently moved to the south when neighbors pointed out their location was in the SCA. Given the self-admitted “errors” and “confusion” on the part of the applicants, we are not confident the house fits onto this building site.

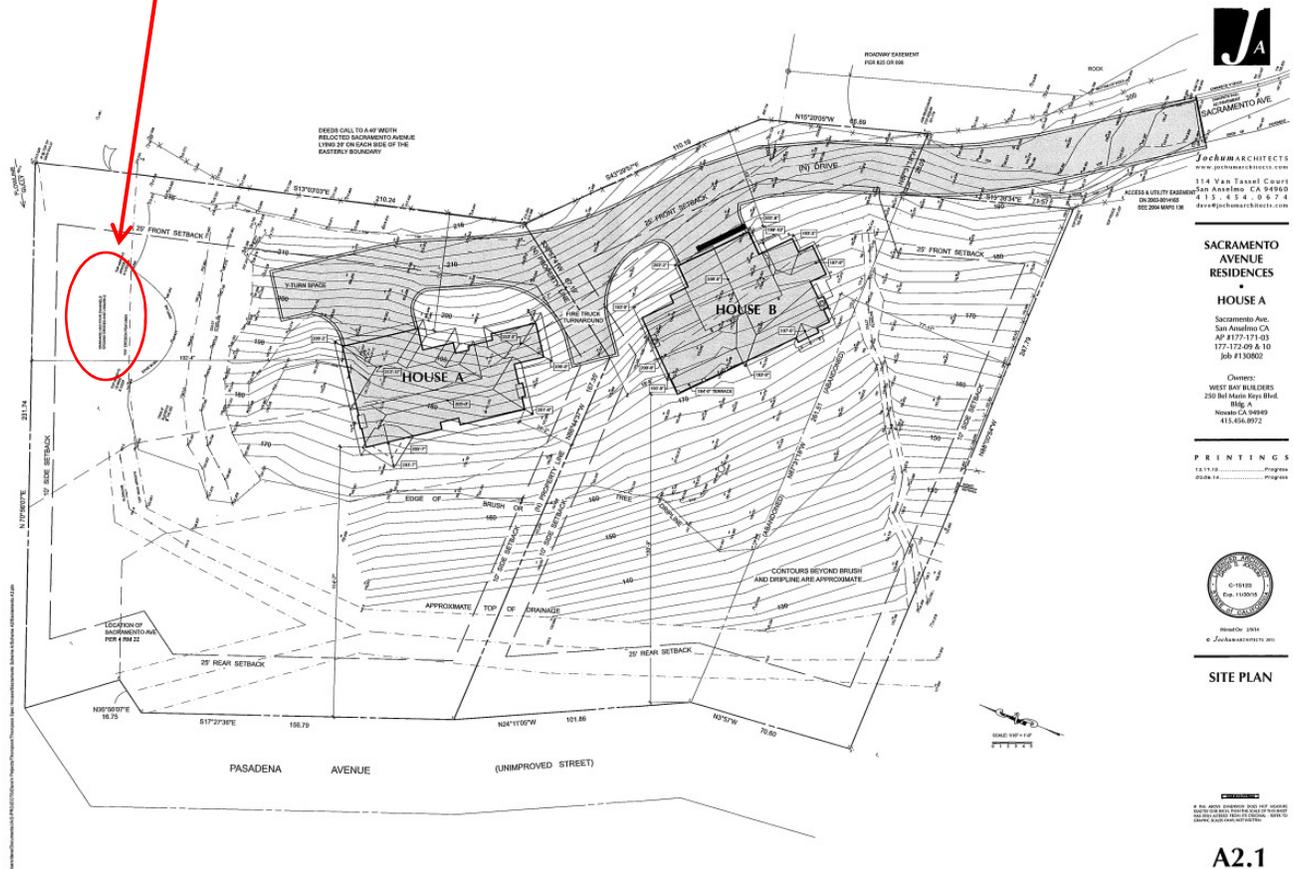
Northern area of the site is eroded and unstable

(DRAINAGE HAS FOUR CHANNELS
GROUND ERODED AND UNSTABLE)
