SIR FRANCIS DRAKE BOULEVARD REHABILITATION PROJECT ENVIRONMENTAL IMPACT REPORT

May 2010

Marin County Department of Public Works
3501 Civic Center Drive
San Rafael, California 94903
Contact: Mr. Dave Bernardi
(415) 499-6530

LSA Associates, Inc.
157 Park Place
Point Richmond, California 94801
(510) 236-6810

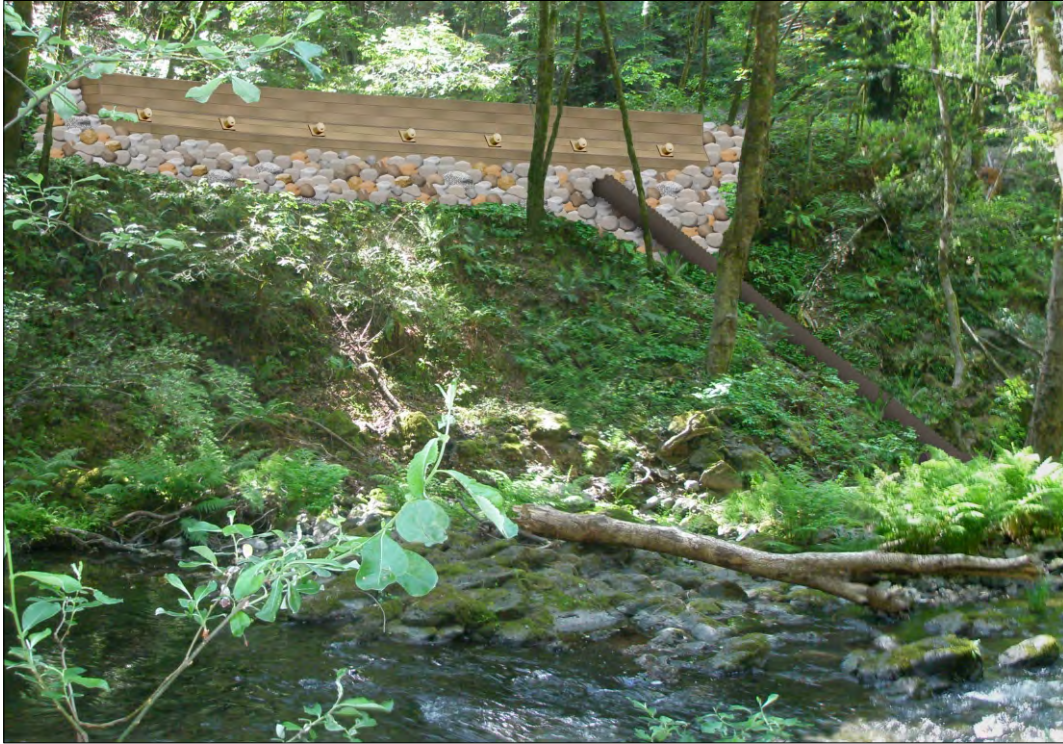
Conceptual visual simulation of proposed slope repair as viewed from Lagunitas Creek

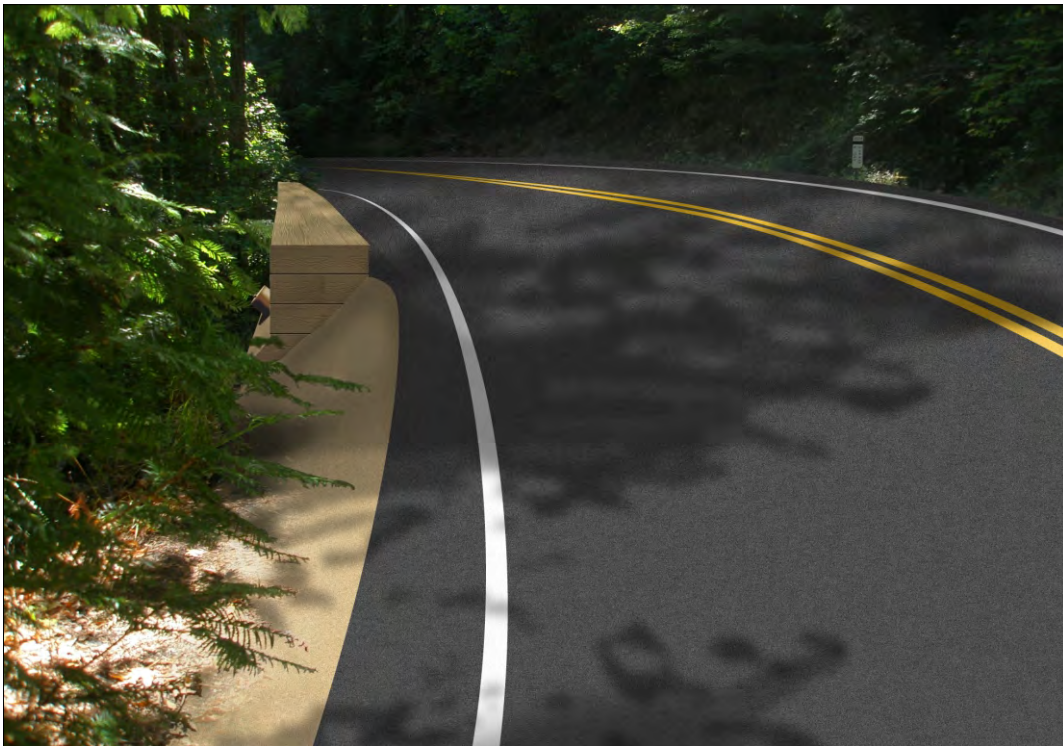
Conceptual visual simulation of retaining wall for slope repair as viewed from Sir Francis Drake Boulevard

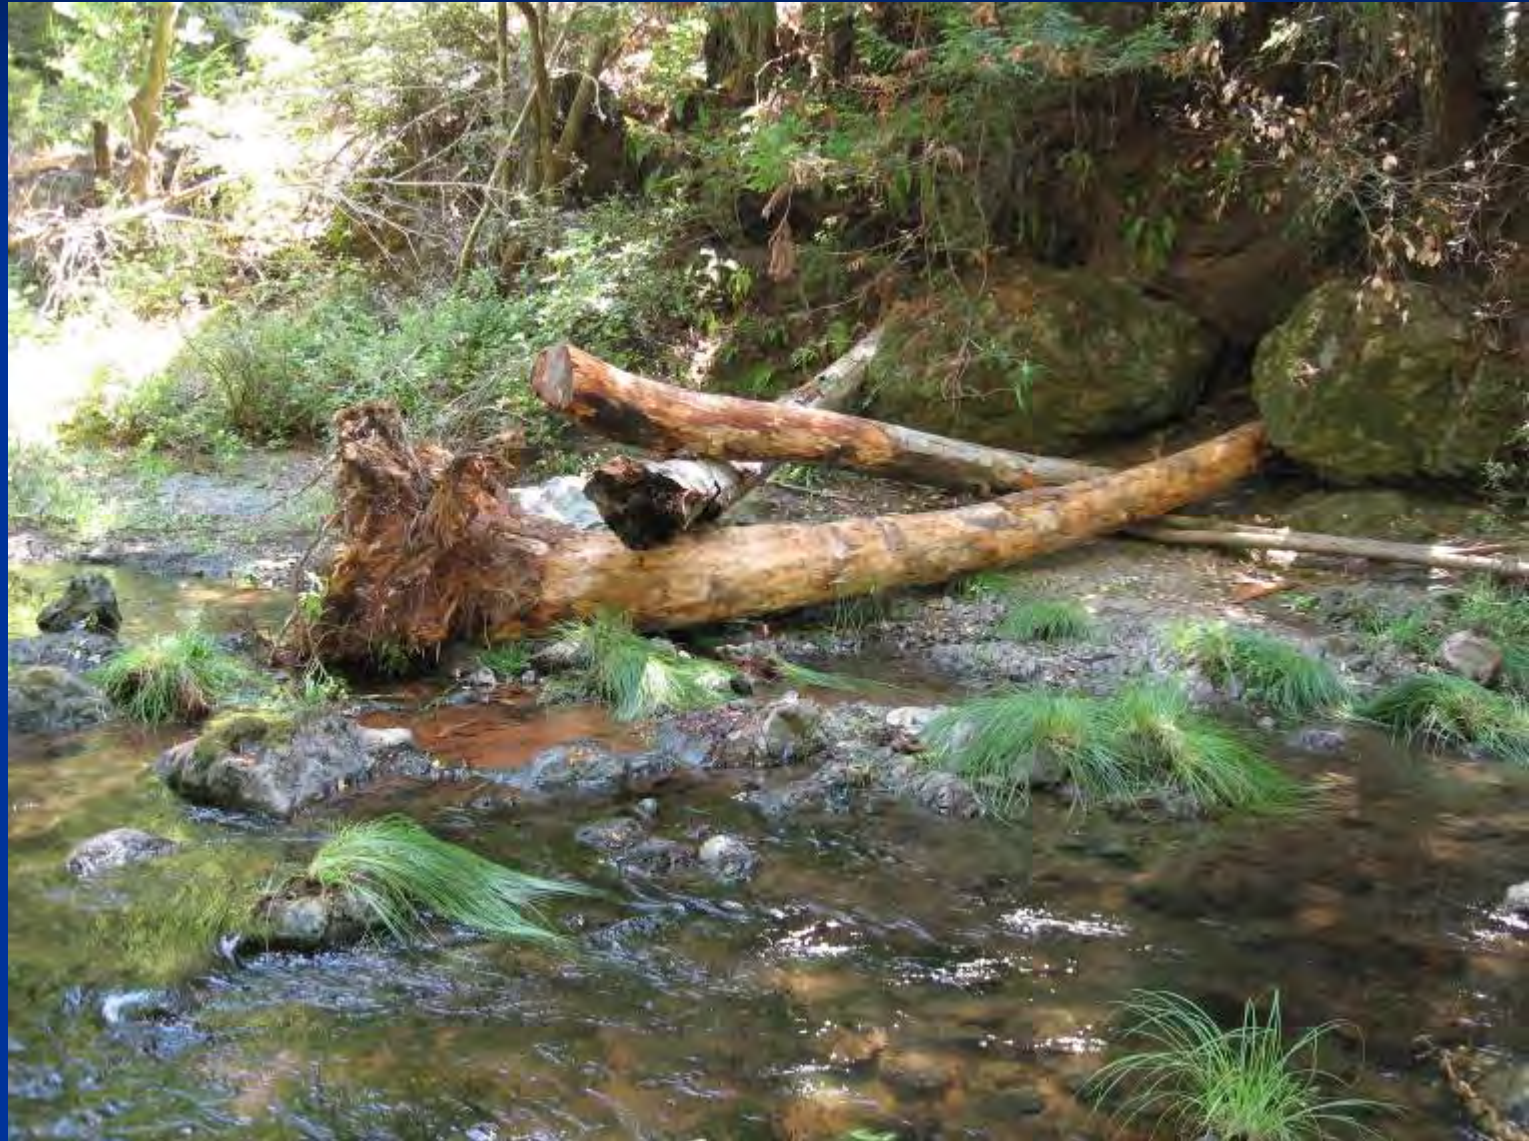
Floodplain Enhancement: Side Channel

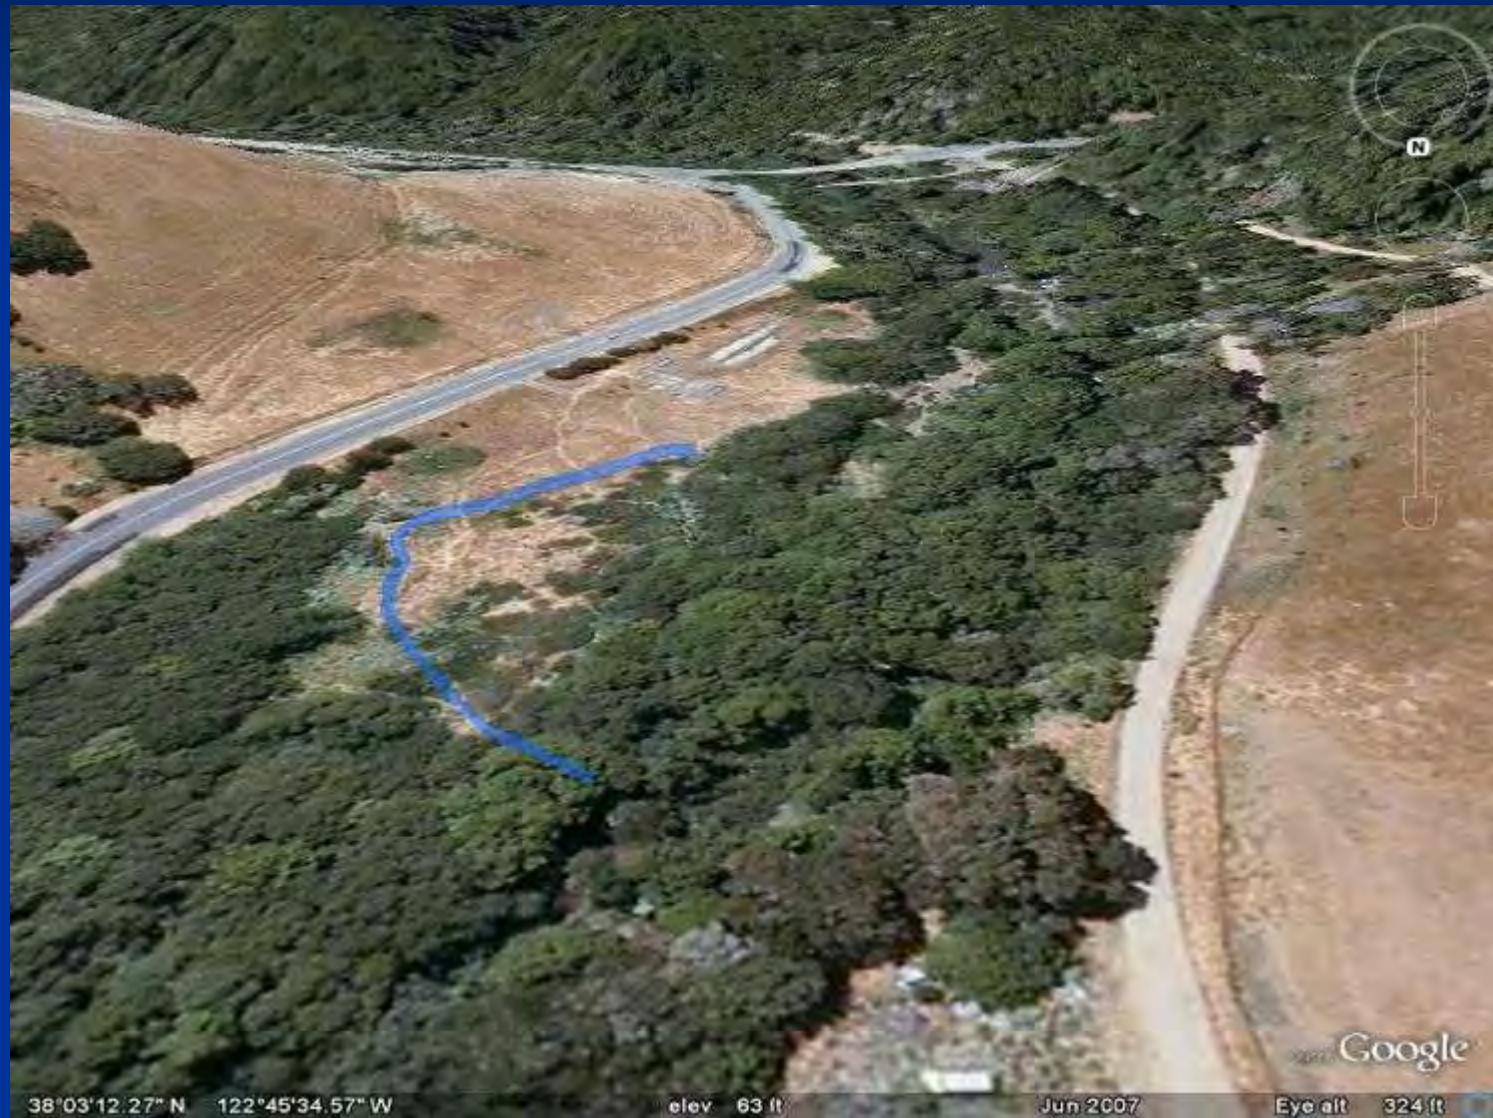
Floodplain Enhancement: Side Channel w/Pool

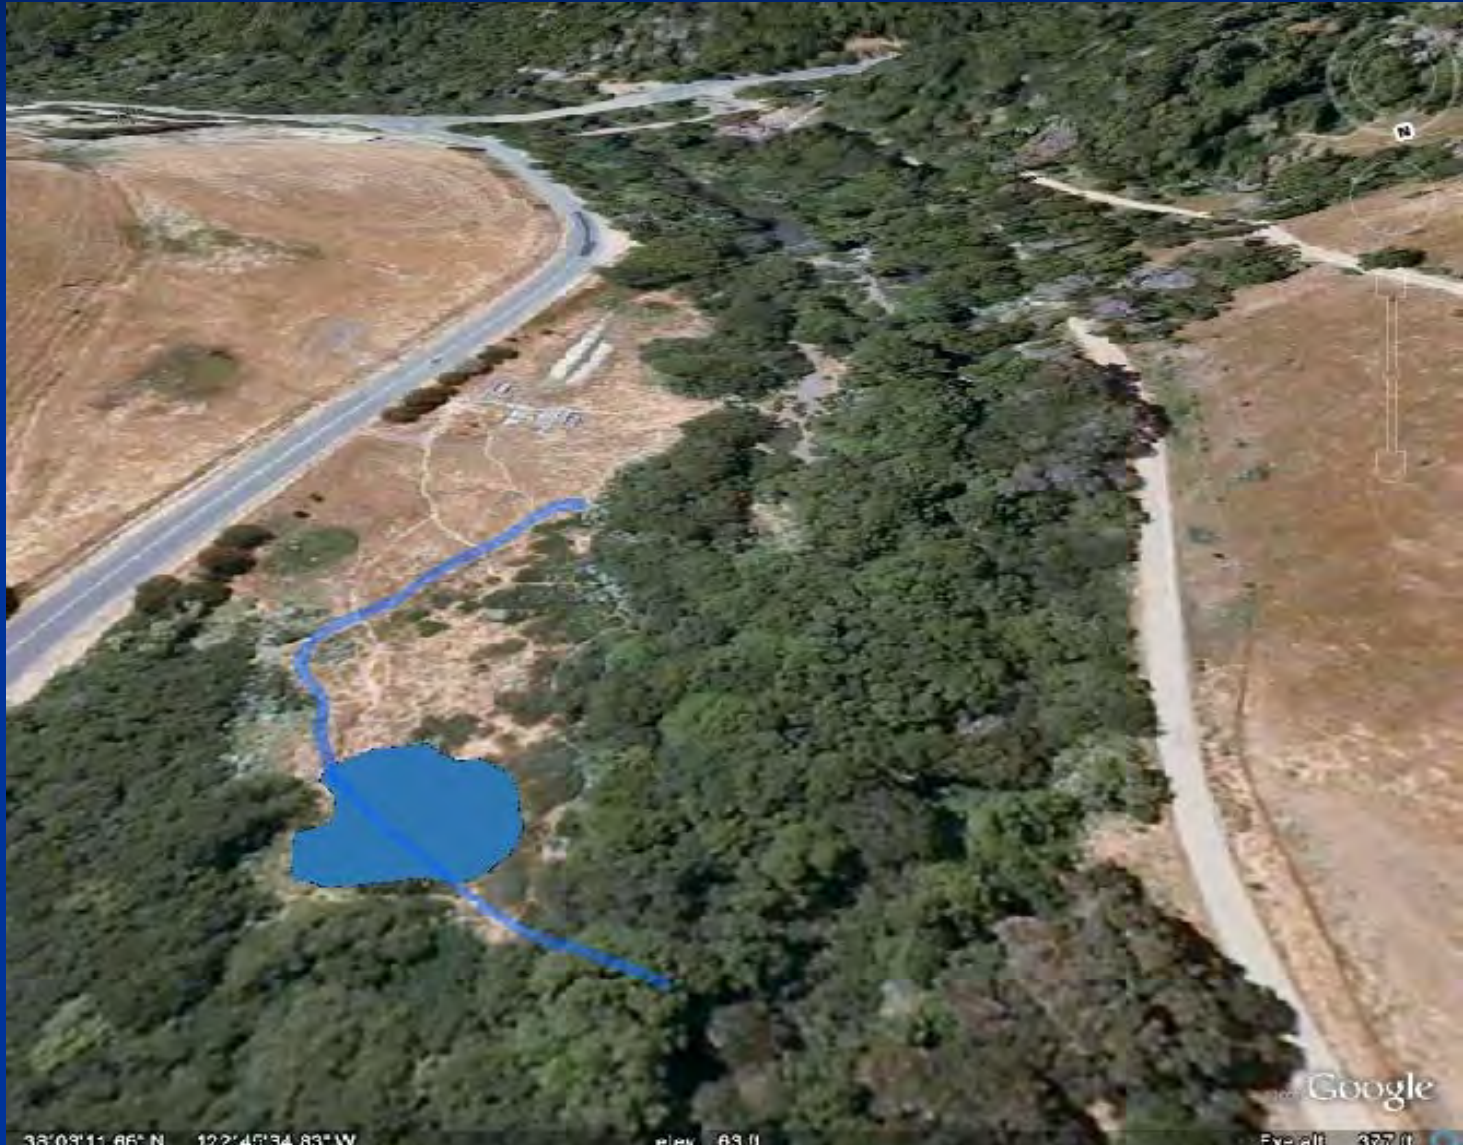
Floodplain Enhancement Log Creek Constrictions
