Stinson Beach Nature-Based Adaptation Feasibility Study Study Memorandum 1

subject Study Memorandum 1: Stinson Beach Existing Conditions
Task 1 Deliverable for Stinson Beach Nature-Based Adaptation Feasibility Study
(ESA Project D17009.00)

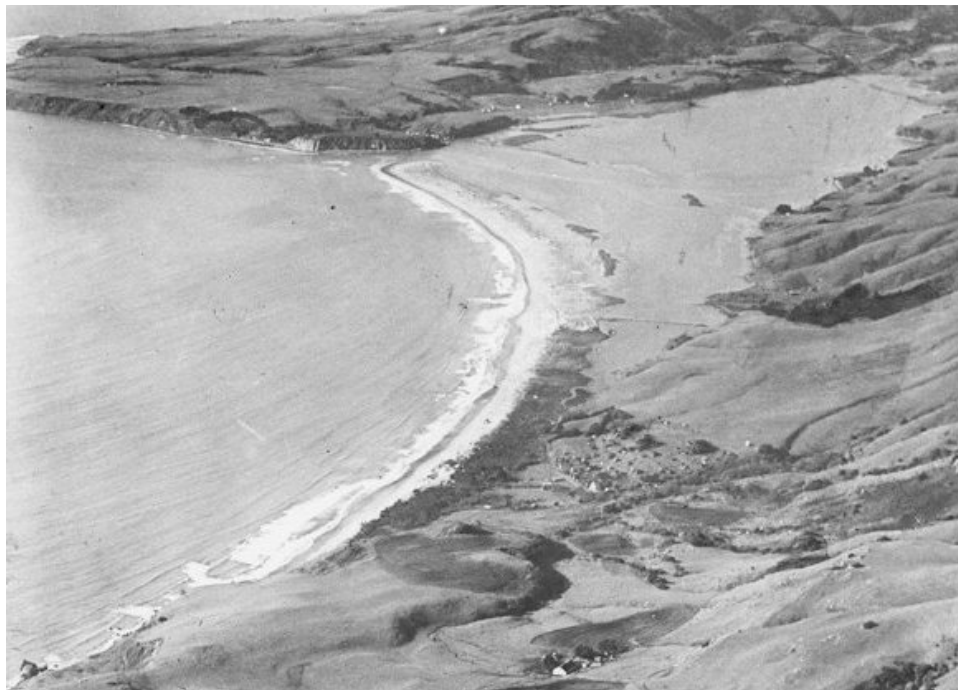
Stinson Beach circa 1910, showing undeveloped sand spit. (Stinson Beach Historical Society)

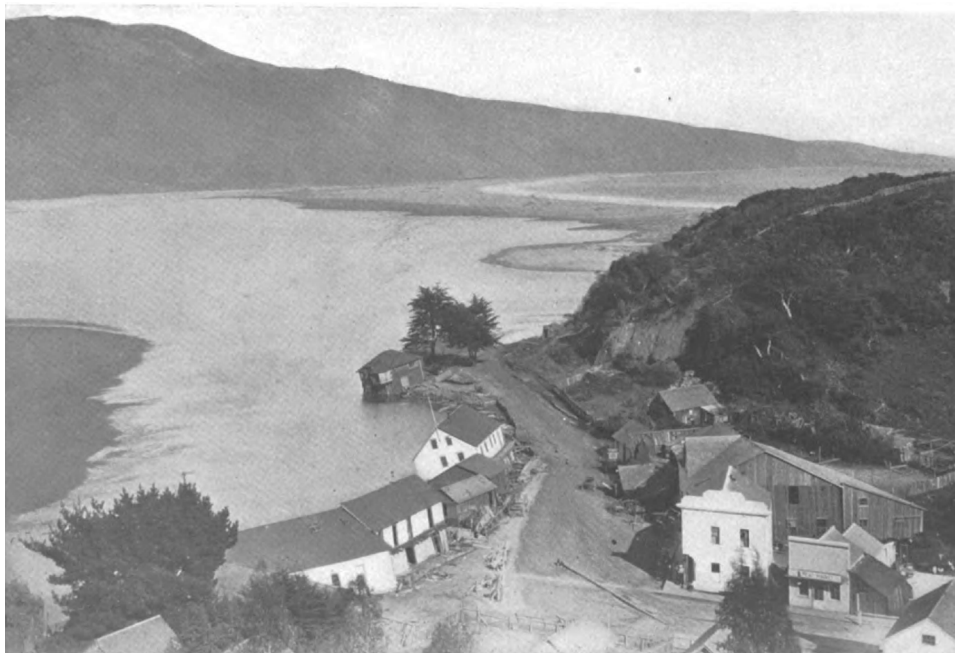
Looking down Bolinas Lagoon and Bay toward the Golden Gate, village of Bolinas in foreground (H.W.F.). Plate 6 B. Andrew C. Lawson, The California Earthquake of April 18, 1906. Report of The State Earthquake Investigation Commission. Carnegie Institution of Washington Publication No. 87, Volume I, Part I.

Stinson Beach was affected by subsidence of the eastern side of the San Andreas Fault in Bolinas Lagoon following the 1906 earthquake: wave overtopping of the spit became frequent and apparently widespread after the earthquake (Lawson 1908:81-82). Plate 6B of the “California Earthquake of April 18 1906” (Lawson 1908) shows a view of Stinson Beach from Wharf Road in Bolinas immediately after the earthquake. Seadrift appears to be a low, wide uniform overtopped terrace, which would be expected if co-seismic subsidence lowered the spit and thus it’s elevation threshold for storm wave overtopping. Geologist G.K. Gilbert (a pioneer in barrier spit geomorphology) recorded his own and local resident observations of Stinson Beach’s change in wave overtopping frequency following the 1906 earthquake:

The east/west fault scarp uplift and subsidence pattern that rejuvenated Stinson Beach by wave overtopping was marked by a visible, measurable transient fault scarp boundary on “Pepper Island” (original name of Kent Island) and its adjacent lagoon flats of Bolinas Lagoon. Gilbert and botanist W.S. Jepson (Lawson 1908) made direct measurements of transient fault scarps on “Pepper Island” sands and muds following the earthquake, estimating an average of 1 ft (up to 1.5 ft) subsidence on the NE side of the fault (Lawson 1908:72). Recent sediment cores (Reidy and Byrne 2006) indicate significant net co-seismic subsidence of the lagoon flats up to 2.7 m during the last two millennia of the late Holocene (after AD 400), unevenly balanced by tidal and fluvial sedimentation during gradual sea level rise.

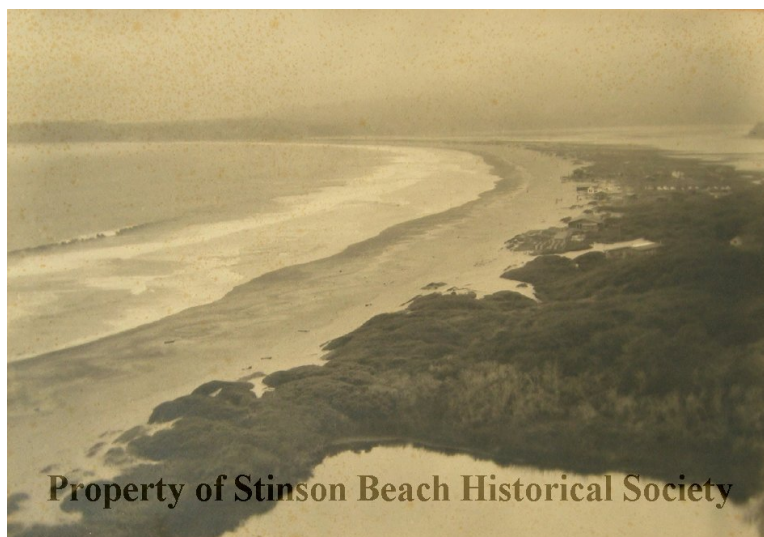
View west from hills above NPS Reach showing historic lagoon in foreground in the location of the existing dirt parking lot. (Stinson Beach Historical Society)

The extreme eastern end of Stinson Beach, where back-barrier wetlands where non-tidal freshwater pond, swamp (riparian woodland), and marsh, were apparently not impacted by wave overtopping following the 1906 earthquake, and persisted in historical photographs of the 20th century (see below) until most of them were drained and filled. Significant repeated storm wave overtopping of seawater there would likely have caused persistent brackish wetland conditions and associated dieback of salt-sensitive freshwater riparian scrub or woodland dominants, such as willow, waxmyrtle, and red alder. Well-developed, steep foredunes and anomalous wetland dune scrub vegetation were evident in the east end of the spit, where the backbarrier wetlands formed a freshwater non-tidal “lagoon” or dune pond, instead of the tidal lagoon salt marsh. This area corresponds with the approximate location of the modern County Park and GGNRA shoreline and backbarrier parking lots (referred to as NPS reach in this study), where wetland scrub foredunes and emergent groundwater exist today (see historic T-Sheet below).

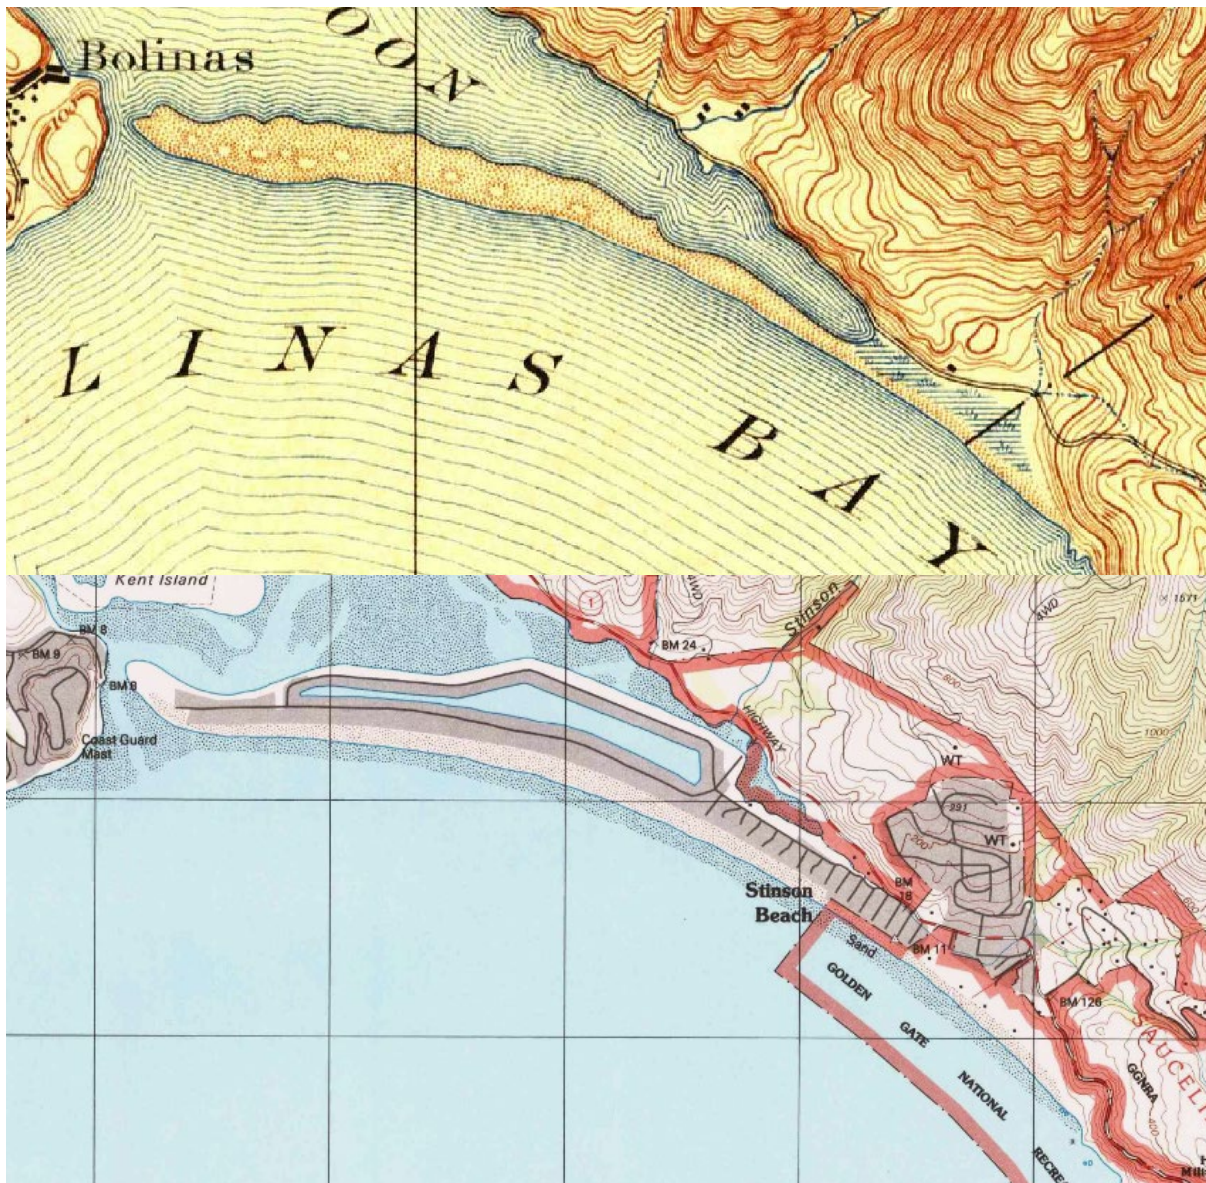
The T-sheet excerpts in Figure 2 below show the extent of fill and development along the sand spit in the 20th century. Development along the western spit backshore were constructed in low foredune areas that experience frequent wave overtopping as well as periodic subsidence as a result of fault activity on the San Andreas fault that passes below the west end of Seadrift. At the eastern end of the spit, development occupies much of what was once a wetland and lagoon complex sustained by freshwater overflows from Easkoot Creek and saltwater from wave overtopping and tides in Bolinas Lagoon.

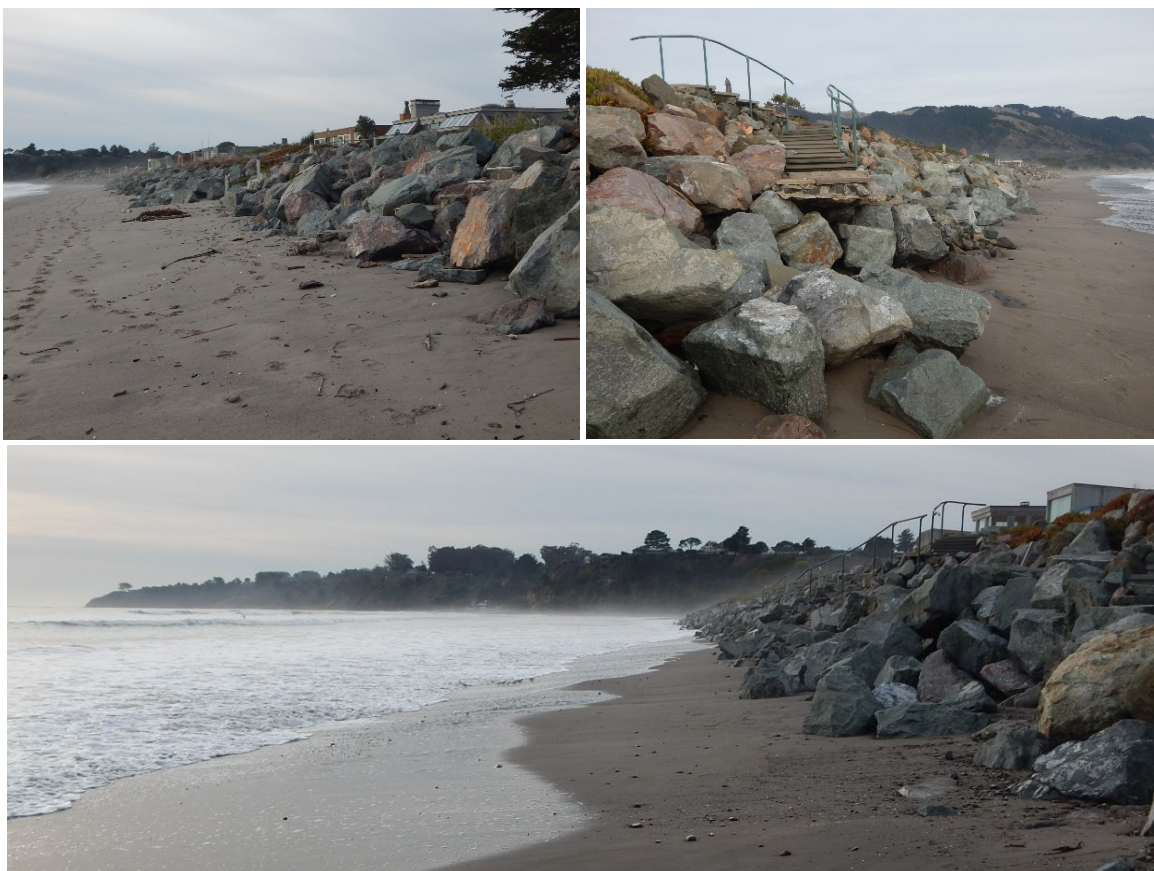
Western rock revetment in Seadrift reach, December 20, 2019. Intertidal beach face is revealed at low tide, the surf zone reaches the revetment at high tide with no backshore. An apparent foreshore trough with visible longshore currents lies close inshore near the beach face. (P. Baye)

Segment 1.1 (Figure 4): Approximately 60 oceanfront lots at the west end of Seadrift are armored by a rock revetment and the beach profile was essentially a low tide terrace (bar and trough inshore) and narrow intertidal beach face up to the toe of the revetment. There was wave reflection off the revetment at mid-tide, and little or no backshore berm profile in the vicinity at the time of the visit. The base of the concrete/rock stairways within the revetment ranged from 0 to 5 feet above the intertidal beach face, indicating significant long-term loss of beach backshore elevation. This segment has essentially no significant remaining foredunes, and no geomorphic space for them either now (December 2019) or in any season in any year shown in recent aerial photographs in Google Earth. This suggests that utilizing foredunes as natural infrastructure in this reach may not be feasible, especially without the space to construct them.

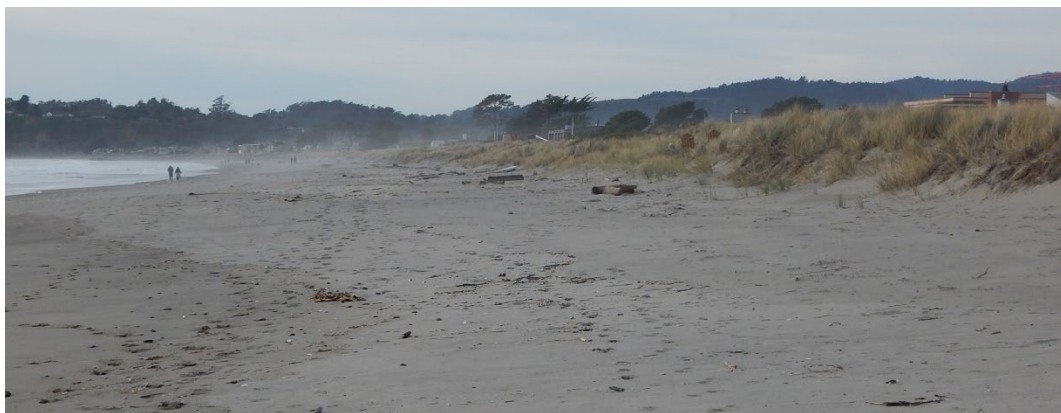
Central Seadrift foredune segment, typical profile with a relatively wide backshore, persistent drift-lines (potential embryo foredunes) and a foredune scarp with extensive recovery of perennial vegetation and slight but significant sand accretion on the seaward slope. December 20, 2019. This profile indicates some backshore persistence over winter for more than 1 year. (P. Baye)

Segment 1.2 (Figure 5): Along the central foredunes of the Seadrift reach (~2,300 feet), the rock revetment is completely buried along approximately 38 oceanfront lots. This segment is characterized by low and apparently relict and stabilized foredunes with persistent decaying leaf litter at the surface, with minimal indicators of recent (1-2 years) wind-driven sand accretion, and many indicators of recent net erosion (scarpred dune faces and exposure of older vegetation at the scarp crest). Homes are landward of the foredunes. This segment has a wider beach than Segment 1.1, which could provide space to construct foredunes as natural infrastructure. However, the

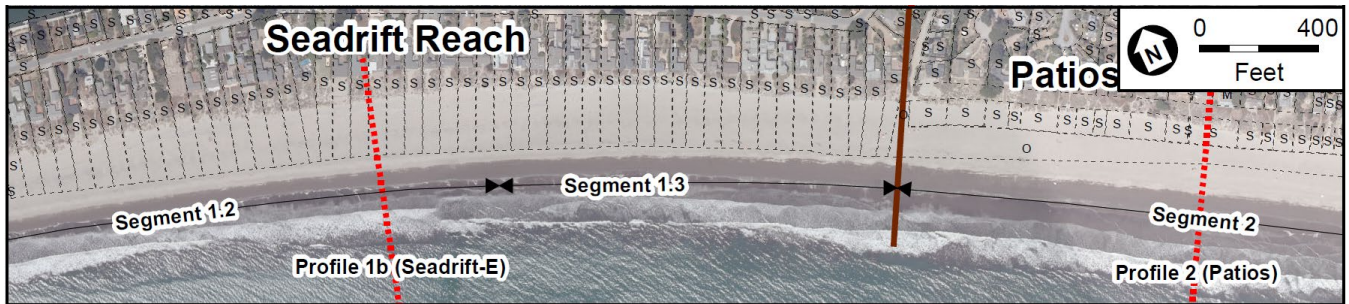
Figure 6
Seadrift Reach - Shore Segment 1.3

Segment 1.3 (Figure 6): Along the eastern end of Seadrift reach, approximately 22 oceanfront lots have relict foredunes with exposed rock revetment. Homes are landward of the revetment and relict foredunes. The foredune vegetation in most of this segment is apparently sand-starved, erosional at the seaward face (scarped dune faces are prevalent), and dominated by marram, iceplant and various ornamental landscaping specimens. The west end

of this segment, however, exhibited the greatest sand accretion (a precursor to foredune formation) and widest backshore areas near its west end. Some of the eastern boulder revetment had been buried by marram-vegetated foredunes accreted to the height of the revetment in past years, burying and obscuring the revetment but has been recently re-exposed by erosion. Relatively young marram foredunes in some locations are perched on the revetment, protected from wave erosion below. However, there is no indication of recent (1 year or older) backshore vegetation seaward of the revetment. This inconsistent pattern suggests alternation between complete erosion of the backshore, and phases of temporary beach recovery and sand accretion, with trapping of sand in the only persistent perennial vegetation perched atop and protected by the revetment. In other words, the only geomorphic space apparently available for persistent foredunes is that which is provided behind the rock revetment given the current range of shoreline positions. In summary, this segment also has a wide beach that could accommodate the construction of foredunes as natural infrastructure. However, the existing rock revetment that spans the Seadrift reach provides some backshore protection and reduces the relative need for additional protective infrastructure at Seadrift in the near term compared to the eastern reaches.

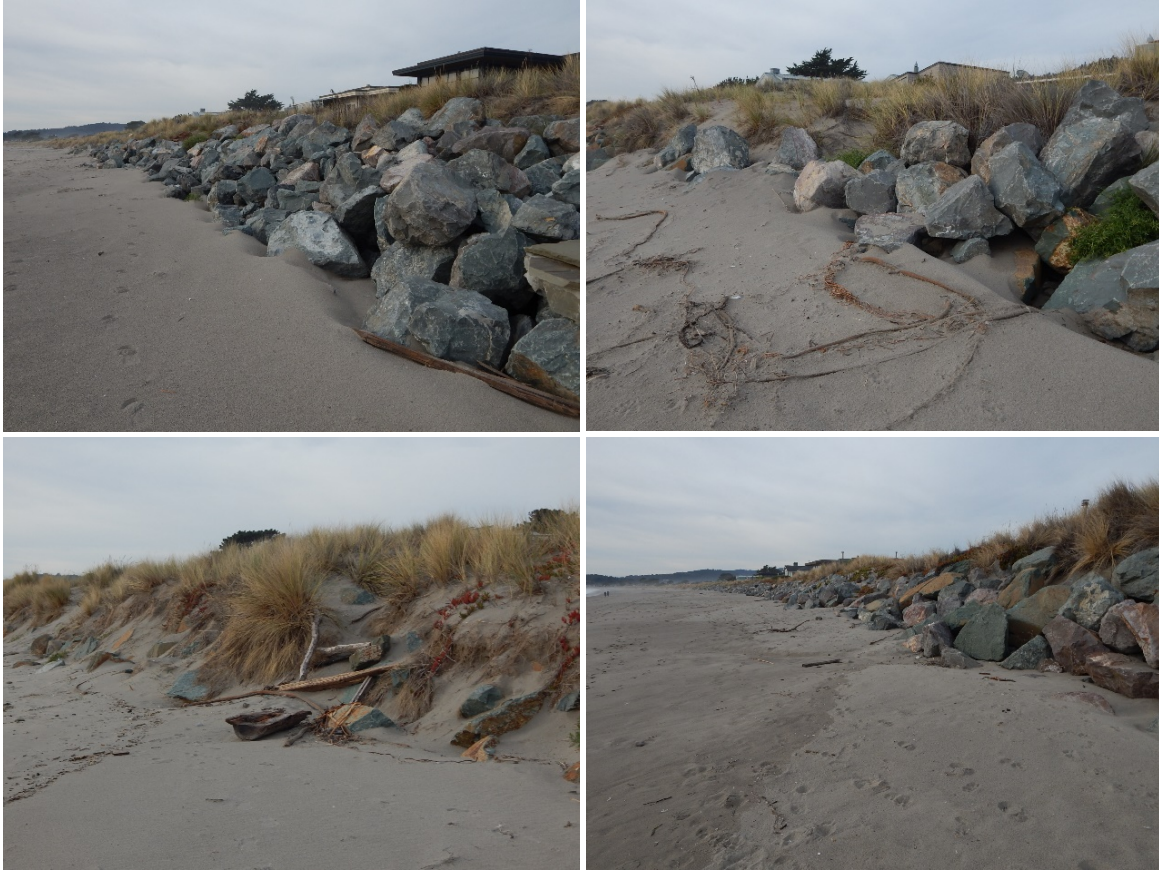
Eastern end of Seadrift rock revetment, December 20, 2019. The boulder revetment here varies between exposed boulders with recent unvegetated wind-deposited sand ramps (SE-oriented) and mixed marram foredunes perched in the revetment, partially eroded or persistent. This profile indicates alternation between severe erosion to the revetment, and episodes of backshore beach and dune accretion. There is currently no significant annual or perennial beach vegetation in the backshore seaward of the revetment. (P. Baye)

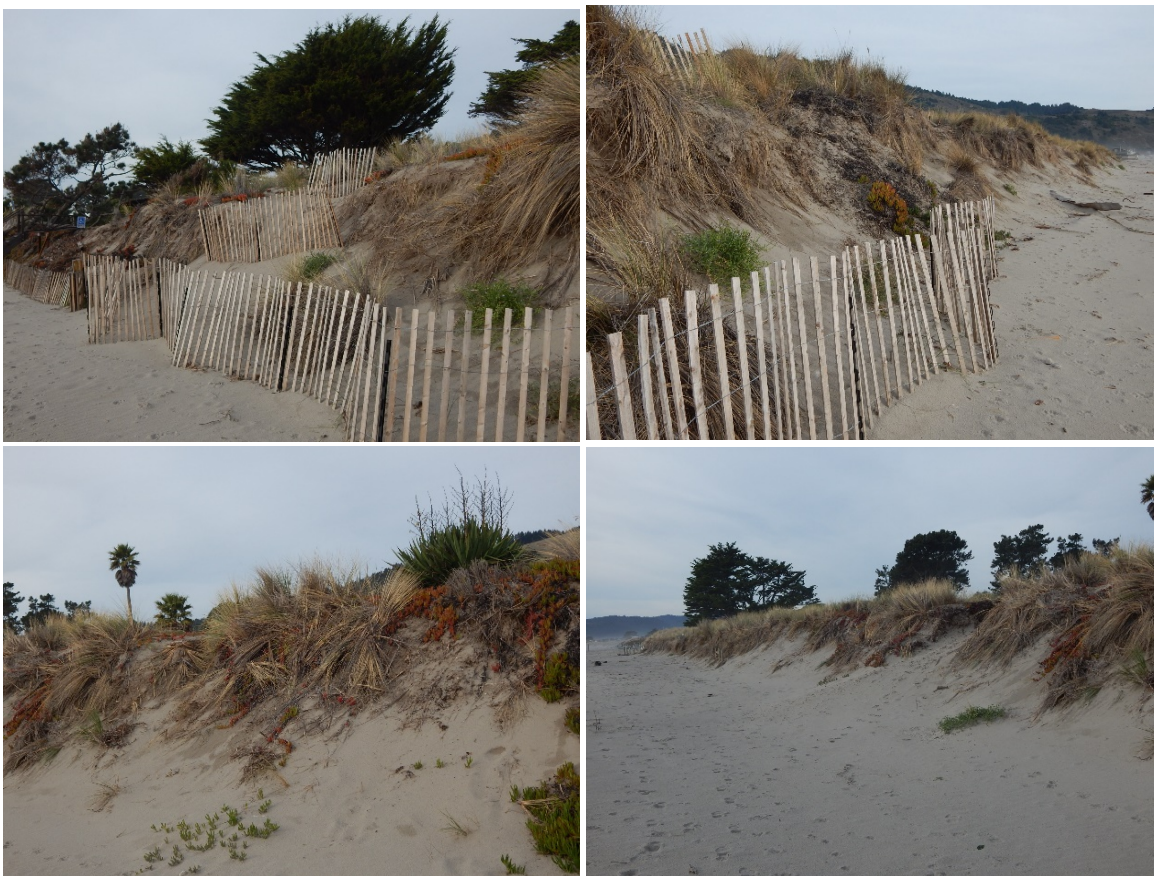
Patios reach, December 20, 2019. All foredunes exhibit “sand-starved” persistent linear scarps, with exposed older graying marram leaf litter at the sand surface. There is no sand burial of attached, matted gray leaf litter, no tapered mounds of wind-blown sand around vegetation patches (sand shadows) in the scarp or above its crest. There is no significant annual or perennial backshore vegetation seaward of the scarp. (P. Baye)

Segment 2 (Figure 7): The Patios reach is comprised of foredunes and a wide beach. West of Calle del Embarcadero (Calle del Occidentale) to Walla Vista are relict foredunes seaward of homes. Relict foredunes here exhibit strong long-term and short-term (recent) erosion indicators, and no indicators of recent significant wind-driven sand accretion.

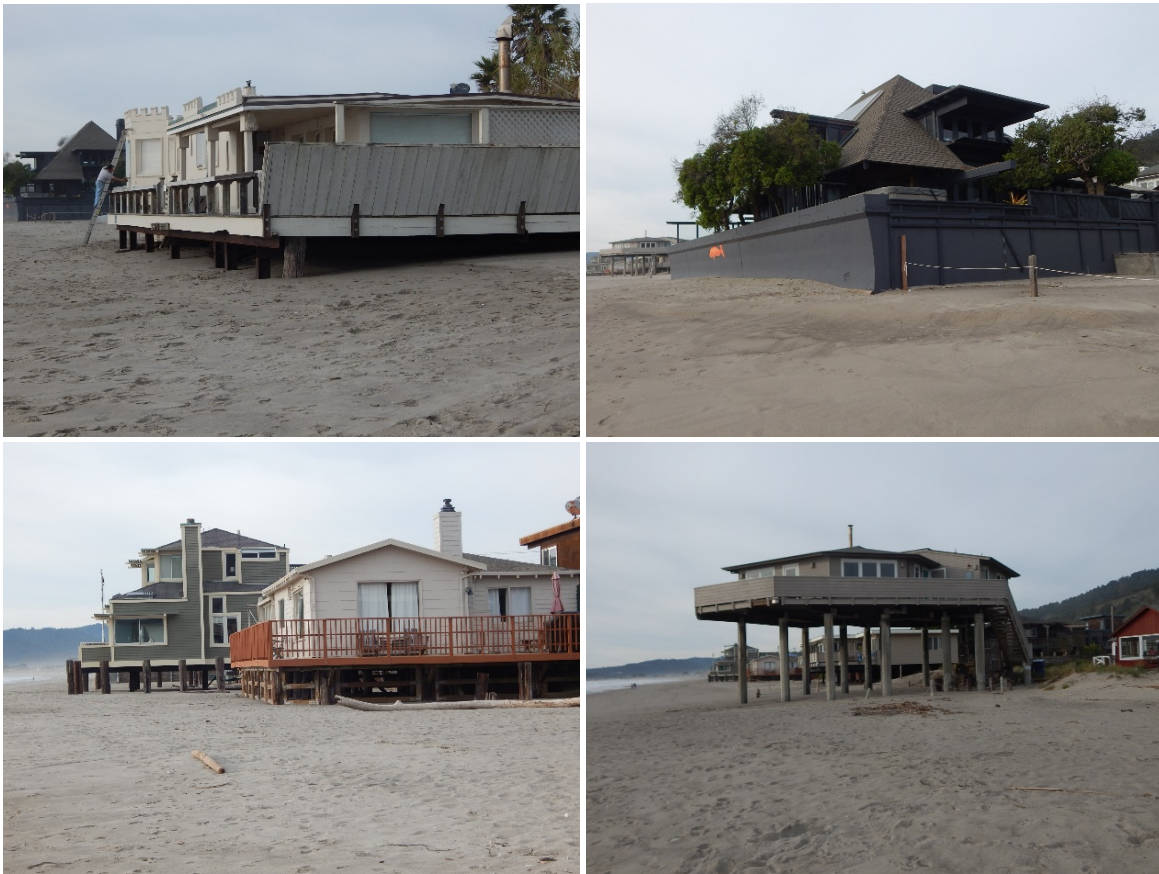
Calles reach, December 20, 2019. Homes are located on the active foreshore and backshore (swash zones of fair-weather and storm beach profiles); eroded foredunes, where they persist, are landward and between the prominent homes. (P. Baye)

Segment 3 (Figure 8): The Calles reach is primarily beach-top residential. The extreme eastern lots along County roads (Calle del Embarcadero to Calle del Pinos) project seaward of the adjacent foredune lines and backshore beach zones, located directly over (pile-supported homes) or on (seawall-protected homes) the beach, with recent swash lines landward of the structures. The setback older homes between them also appear to be positioned seaward of the nearby willow scrub foredunes of the NPS Reach to the east (See *Leymus mollis* account below).

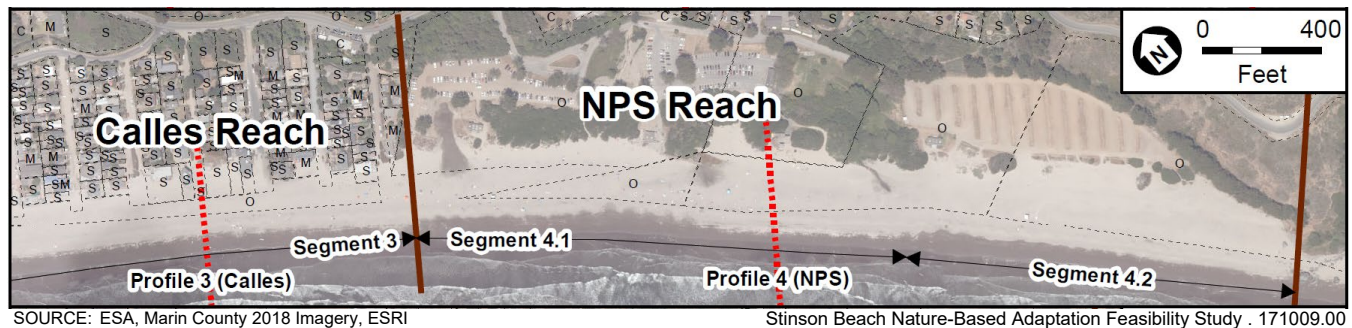
Figure 9
NPS Reach - Shore Segment 4.1

Segment 4.1 (Figure 9): The National Park Service Reach backshore is comprised of freshwater wetland scrub foredunes influenced by seep and distributary channels including Easkoot Creek.

Very distinct and regionally rare wetland scrub foredunes (effectively small precipitation dune ridges; Cooper 1967) occur locally between the Calles and the west end of the National Park Service (GGNRA) overflow parking lot, where high groundwater emerges seasonally at the surface as perennial backshore beach seeps. This is one of the only examples of freshwater wetland-dominated foredunes left on the Central California coast. This segment also contains two seasonal stream distributary mouths connected to Easkoot Creek and Stinson Beach. The eastern small stream mouth breaches the stabilized wetland foredune ridge and drains a disconnected floodplain backwater swamp thicket landward of the wetland-vegetated foredune. The backdune wetland consists of freshwater riparian scrub and marsh dominated by willows (*Salix lasiolepis*, *Salix* spp.), waxmyrtle (*Morella californica*), sedges (*Carex obnupta*, *Scirpus microcarpus*), rushes (*Juncus lescurii*), and many freshwater marsh forb species, including water-parsnip (*Oenanthe sarmentosa*). This wetland foredune is apparently a descendent of the original backdune pond (freshwater lagoon) at the spit's eastern end, either a remnant of the original complex or reassembled from it. The western seasonal stream mouth drains an intermittent overflow distributary channel (bank breach) of Easkoot Creek through an unstabilized public pathway to the beach. The foredune vegetation itself consists of an older salt spray wind-flagged willow-waxmyrtle thicket that traps a dune precipitation ridge, and a younger low marsh-foredune terrace composed of mixed freshwater and brackish marsh vegetation, including coast bulrush (*Schoenoplectus pungens*), saltgrass (*Distichlis spicata*), and Vancouver wildrye (*Leymus xvancouverensis*). The younger marsh-foredunes alternate between accretion and erosion among years. The backshore in the wetland foredune zone is often eroded down to a seasonal stream channel (down to intertidal foreshore) saturated to the surface with freshwater (emergent groundwater). A lens of stream gravel, or wave-reworked stream gravel, sometimes outcrops in the backshore where seep-fed rill erosion and wave erosion expose it. The buried backshore gravels are likely a mechanism of efficient shallow subsurface freshwater discharge from backdune to beach. Little long-term net foredune growth has been observed here since 2011. Storm wave run-up appears to cyclically remove accreted foredune sand where the beach is perennially saturated with shallow groundwater.

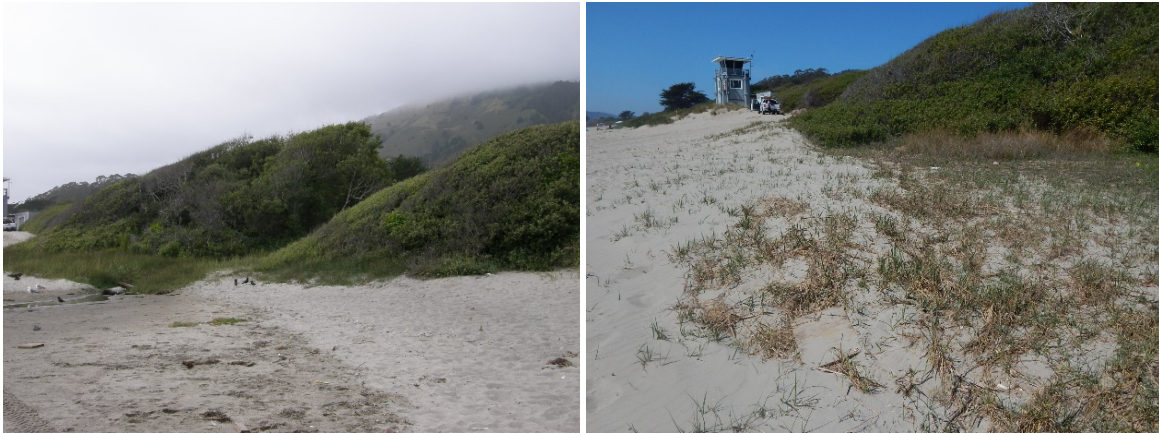
Freshwater marsh vegetation and riparian scrub vegetation dominate foredune area associated with high emergent groundwater (freshwater seeps) between the backdunes and backshore beach. June 17, 2011 (left; willow-waxmyrtle scrub and rush marsh) and April 2, 2013 (right; Vancouver wildrye). (P. Baye)

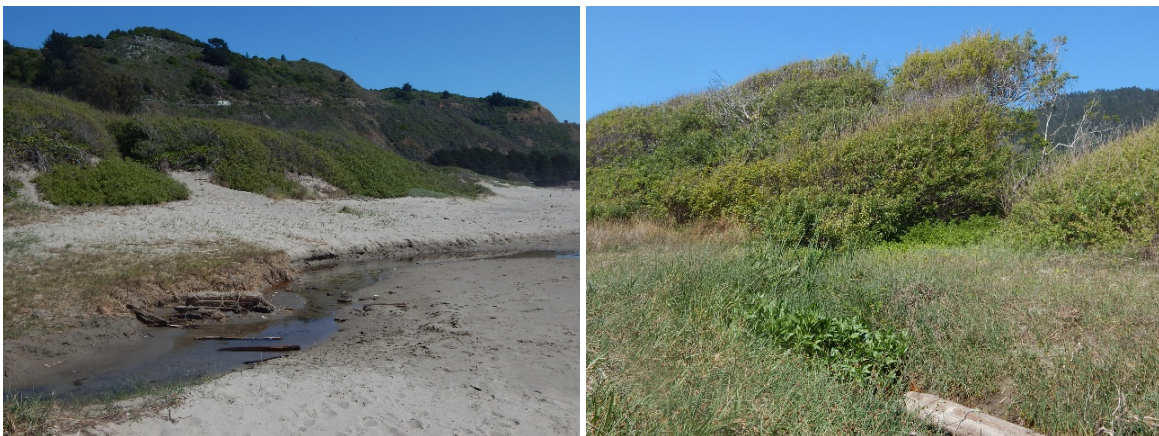
*A perennial to seasonal freshwater channel draining the backdune wetlands supports dominant freshwater marsh vegetation in the foredunes, including broadleaf cattail (*Typha latifolia*), coast bulrush (*Schoenoplectus pungens*) and salt rush (*Juncus lescurii*), excluding typical terrestrial foredune vegetation. This is one of the only examples of freshwater wetland-dominated foredunes left on the Central California coast. April 3, 2015. (P. Baye)*

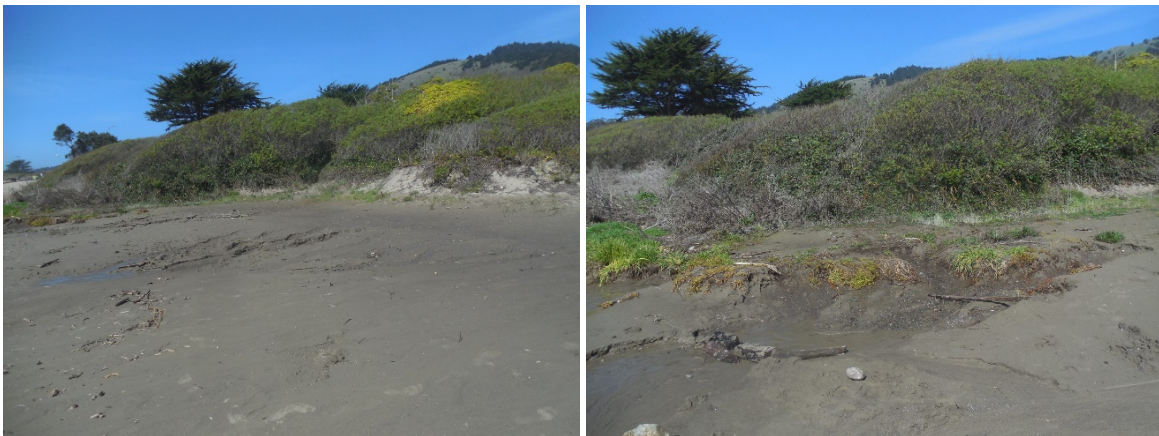
Freshwater seeps and emergent groundwater can dominate the entire backshore profile in wet years with high groundwater, saturating the beach from the toe of the willow-waxmyrtle wetland foredune to the intertidal zone. Seep/spring erosion rills and wave erosion (intensified wave backwash in saturated sand) locally expose outcrops of buried stream gravels. March 6, 2014. (P. Baye)

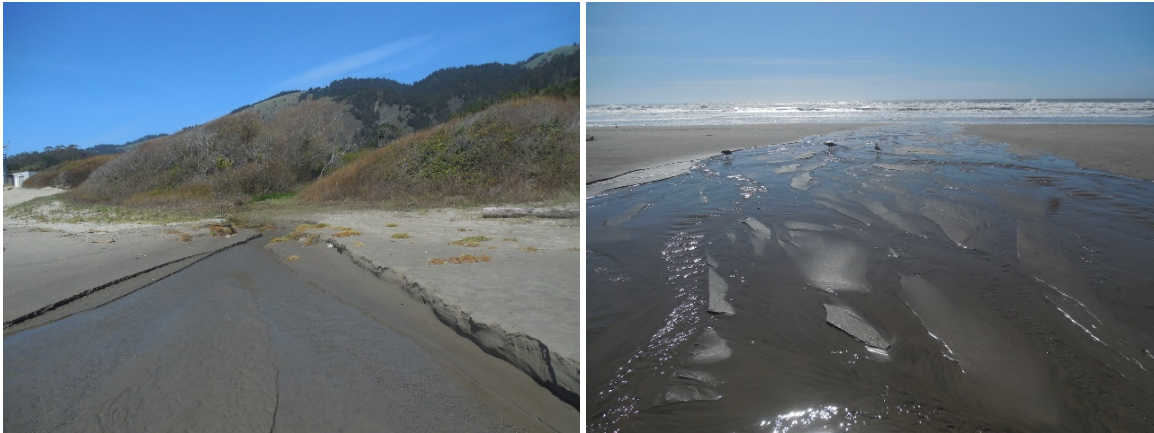
Seasonal freshwater stream discharge from the willow-waxmyrtle wetland foredunes saturates the backshore and foreshore beach below the stabilized stream mouth breach in the foredunes. March 6, 2014. (P. Baye)

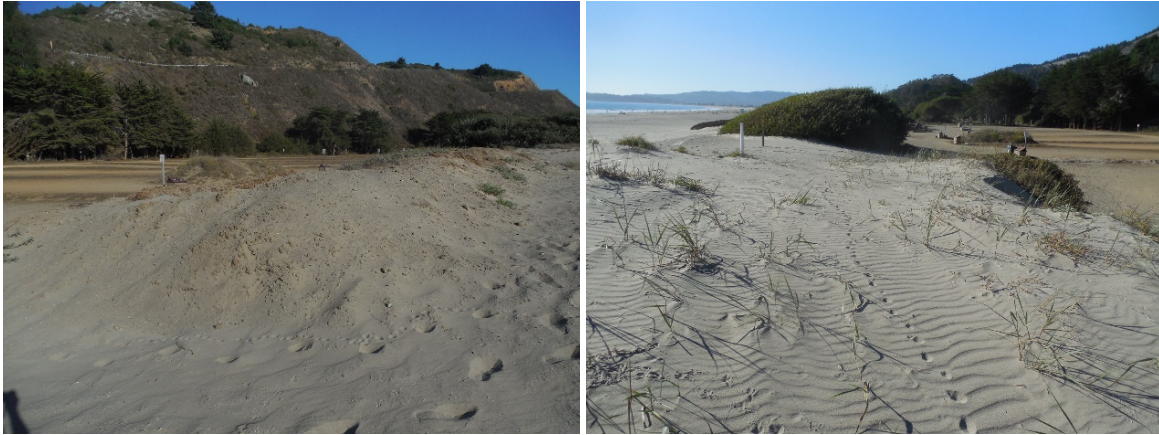
Graded berms of mixed blown sand and parking lot “dirt” fill (gravel, soil, angular pebbles) are placed at the seaward edge of the overflow parking lot, develop sand-trapping vegetation, and become mantled with accreted dune sand. Sept 20, 2013. (P. Baye)

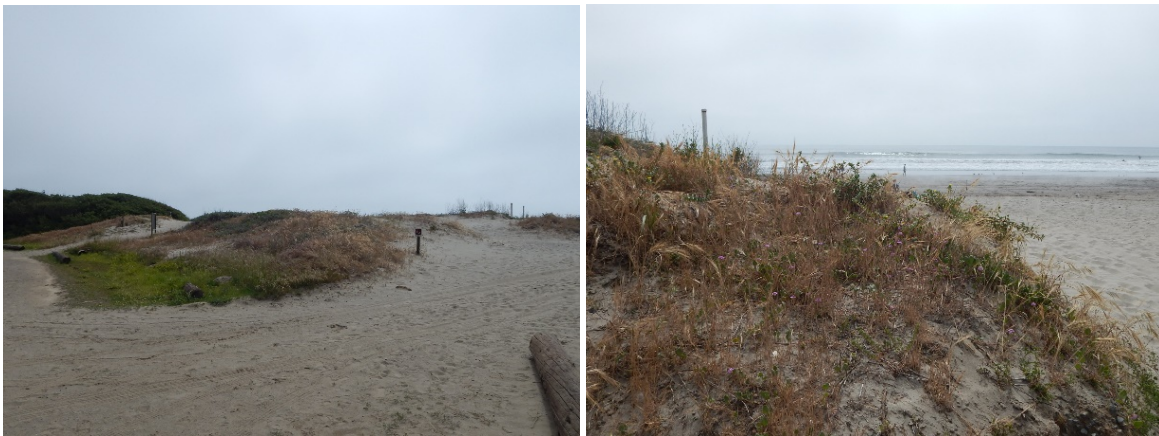
The landward slopes of the eastern berm-nucleated foredunes often have thin or no accretion of dune sand, and expose mixed sand/soil spoils at the surface, which support annual weed-dominated vegetation, mixed with native foredune plants. April 17, 2015. (P. Baye)

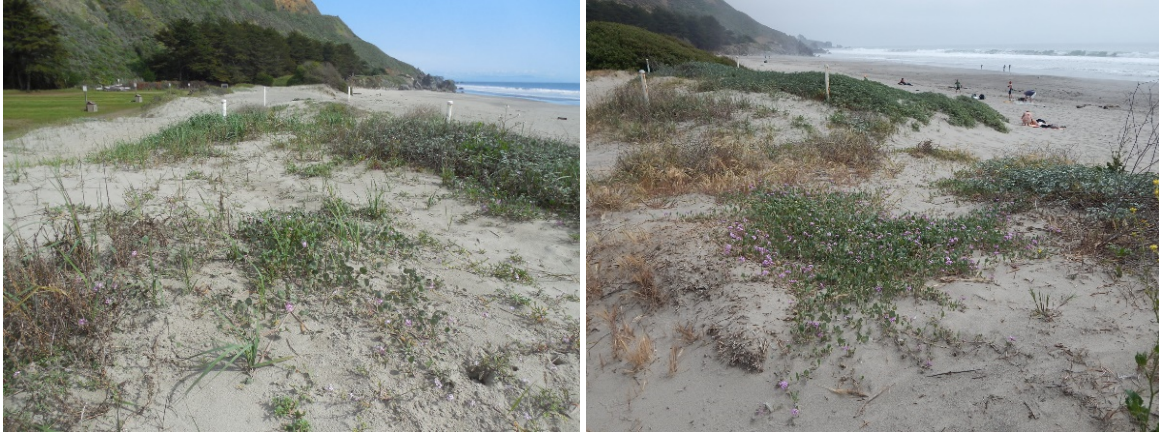
The accreted dune sand on berm-nucleated foredune crests inhibits dominance of annual weedy grasses, and selects for prevalence of native foredune vegetation. The eastern-most Stinson Beach shoreline is oriented with greater exposure to dominant westerly winds compared with central and western shorelines of the spit, and has a wide backshore with finer (medium) sand. These interactions promote vigorous growth of native foredune vegetation. April 5, 2013 (left) and April 17, 2015 (right). (P. Baye)

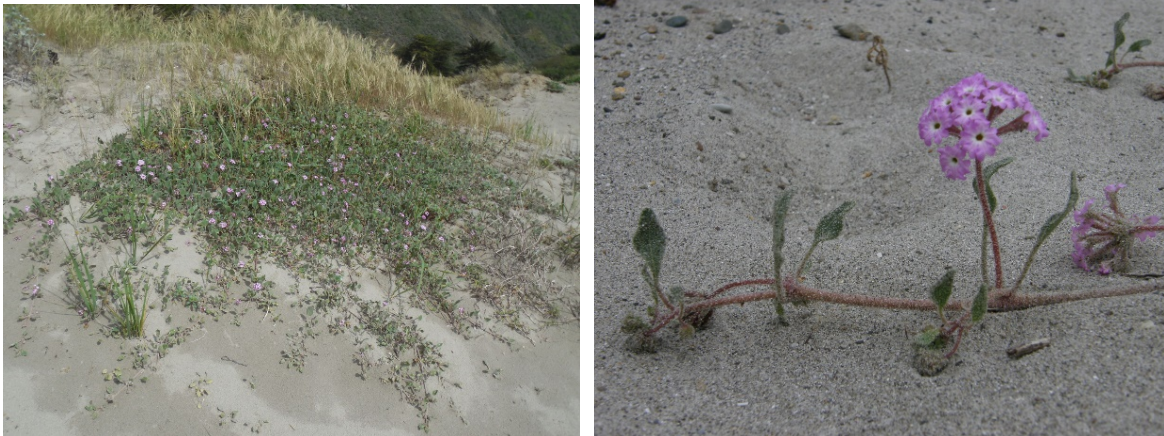
*Perennial colonies of pink sand-verbena (*Abronia umbellata*) occur extensively in the berm-nucleated foredunes bordering the overflow parking lot. June 17, 2011. (P. Baye)*

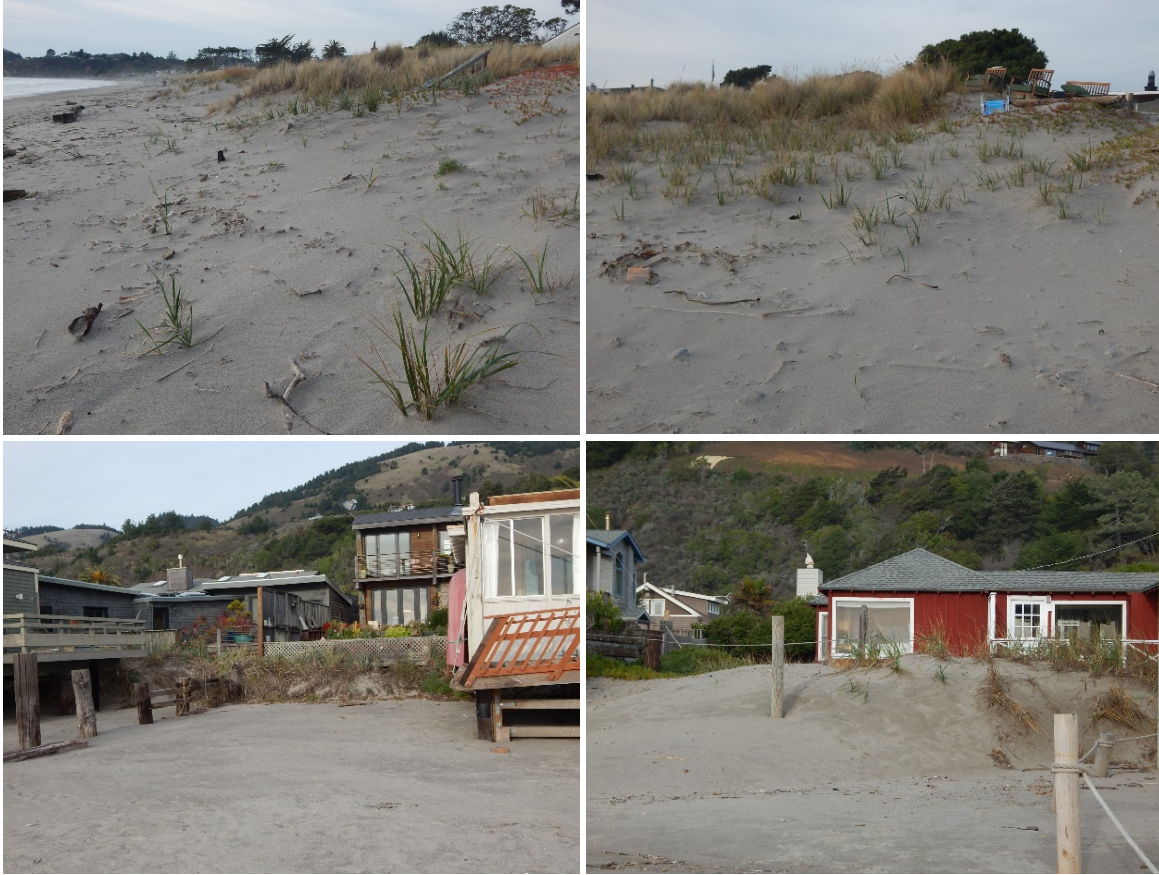
Beach wildrye was apparently planted on sand embankments placed in front of set-back residences within the Calles reach. The sand embankments and wildrye are mostly eroding by undercutting from wave action. (P. Baye)

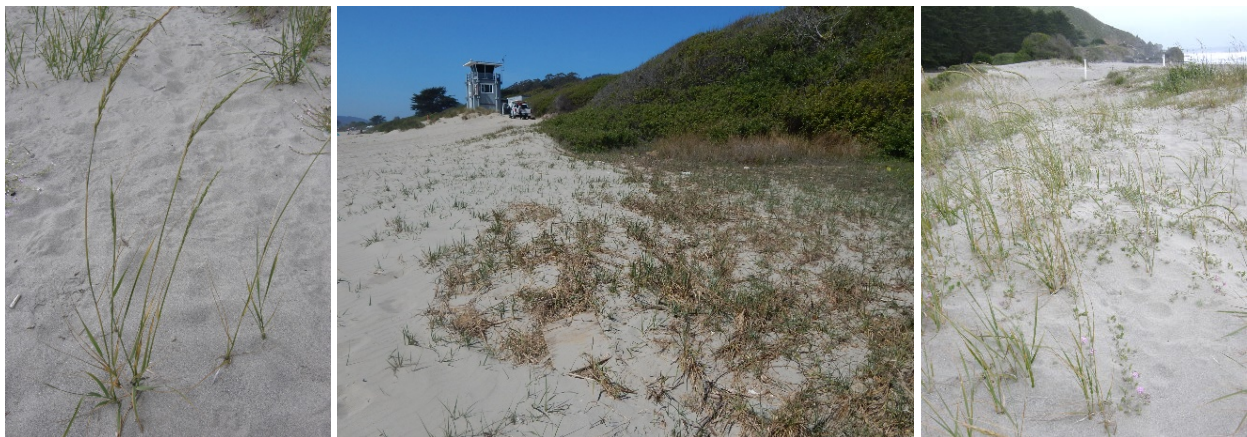
Vancouver wildrye grows in both “marshy” foredunes (freshwater seep-influenced foredunes near high groundwater and wetland scrub) and well-drained accreting foredunes along the GGNRA overflow parking shore, where it often associated with pink sand-verbena (2011-2015). (P. Baye)

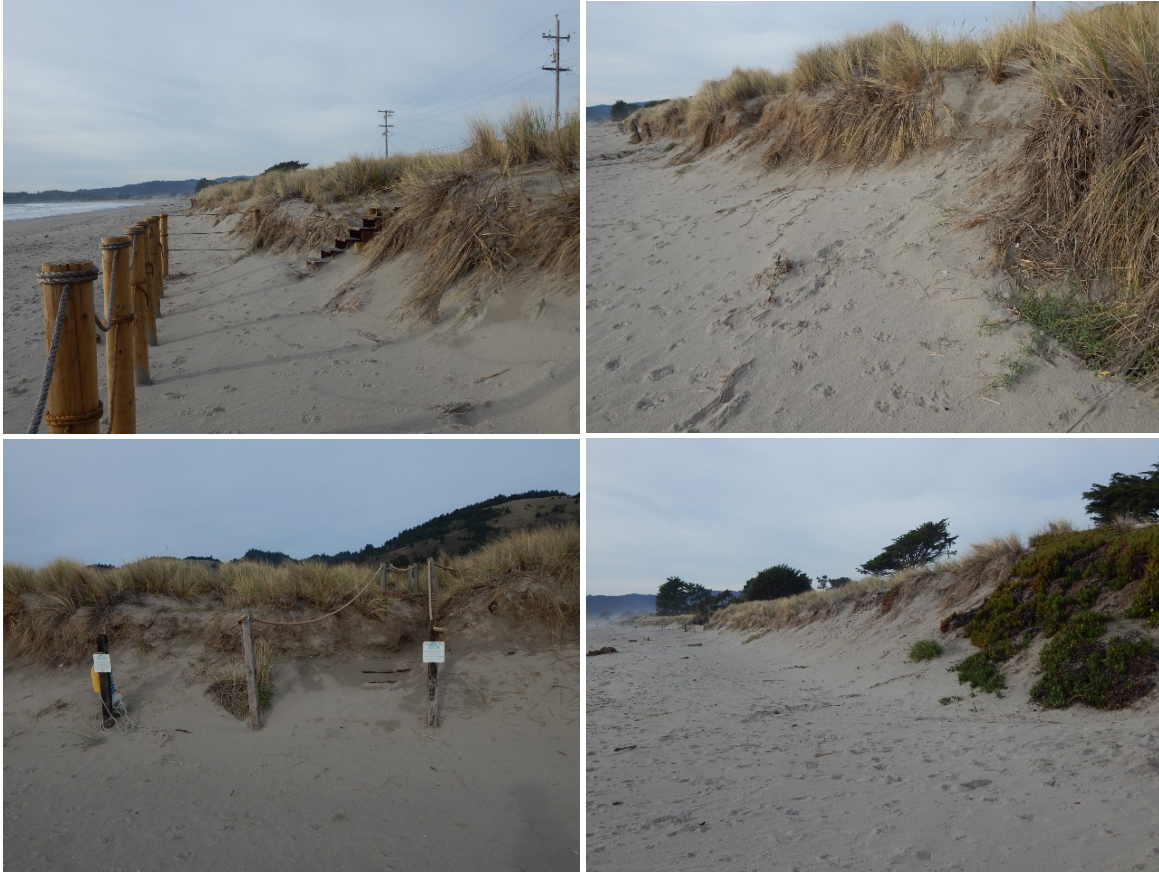
Foredunes at Patios Reach, marram-dominated foredune scarps exhibit minimal post-storm recovery of vegetation and wind-driven ramp sand accretion; exposed roots, leaf litter unburied by sand dominate the surface of the slope, and there is almost no vegetative regeneration seaward of the scarp toe. December 20, 2019. (P. Baye)

With the exception of the foredunes in the central Seadrift reach, all marram stands at foredune crests and even within scarps exhibited abundant accumulation of gray leaf litter at the dune surface. This indicates surface stability or slight surface erosion of foredunes and scarps for at least the past year. Minimal sand-buried litter was observed in the seaward zones of the central foredune reach. This key observation is consistent with local short-term geomorphic indicators of very low-level wind-driven sand accretion: little or no development of sand shadows in the lee of plants or other wind-obstacles (driftwood, debris, etc.) in the backshore.

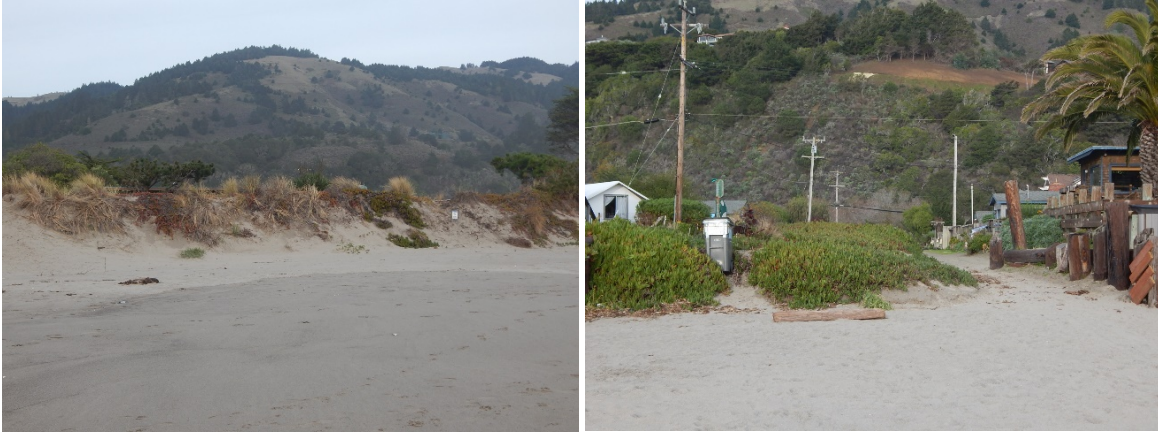
Iceplant occurs in scattered patches along eroding foredune scarps, interspersed with marram, or in single-species stands. Patios foredunes, December 20, 2019. (P. Baye)

Iceplant (*Carpobrotus chilensis* and hybrids with *C. edulis*). Mats of iceplant are established in patches on some eroded foredunes and segments of boulder revetments. Iceplant has a low, flat leaf canopy and slow shoot emergence rates following sand burial; it builds low, broad mounded foredunes at slow rates, because the canopy saturates with sand at low levels of deposition. No iceplant mats were observed with accreted sand, and all iceplant mats exhibited retained old gray leaf litter (unburied) in the canopy. Iceplant apparently has no significant recent role in trapping wind-blown sand along residential shorefront lots at Stinson Beach. Iceplant vigor was usually low (reddish leaves, sparse growth) where it was rooted in interstitial soil or sand fill among boulders in revetments.

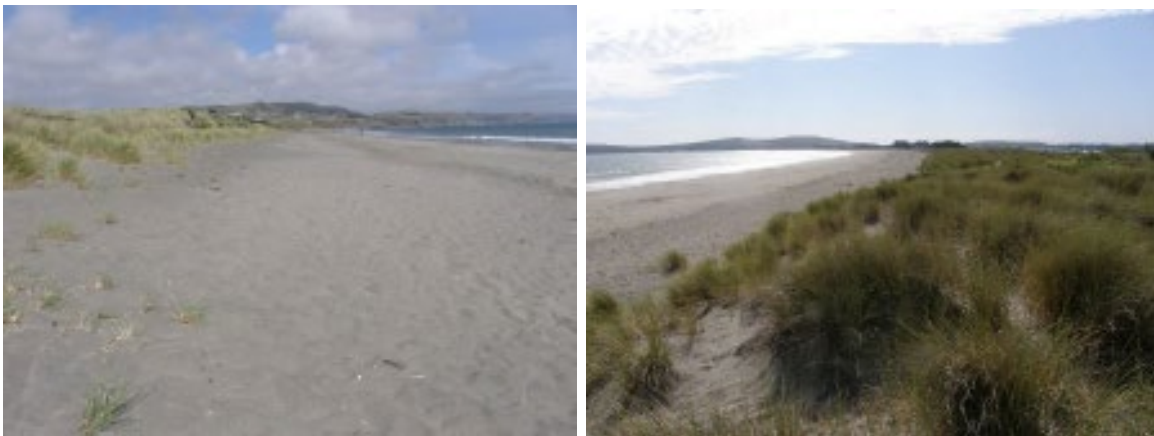
Wide backshore beach (Berm top) at Doran Beach, view to E, provides a long sand deflation fetch for SW winds. Marram dominates the Doran Beach foredune ridge, which ranges between about 1-2 m high (locally lower or higher). The steep seaward slope is a reformed foredune scarp (post-storm profile recovery by vegetation regrowth and sand trapping). (P. Baye July 2009)

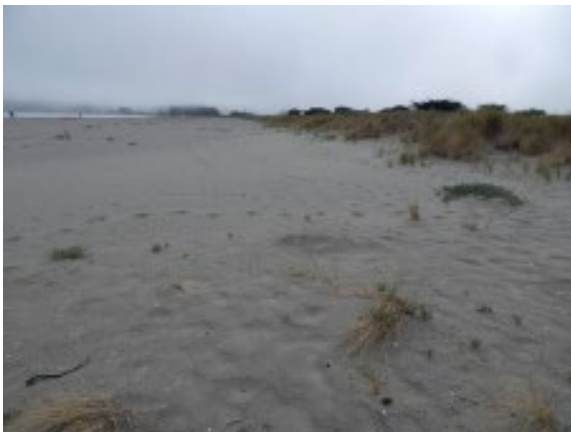
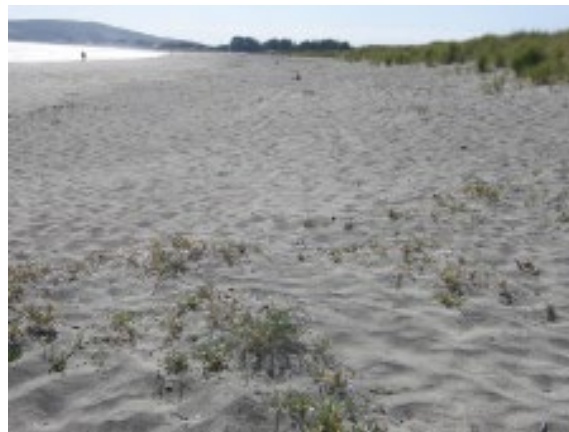
Drift-line and embryo foredune development occurs episodically, and to limited extent, between major storm events at central Doran Beach. The slow vertical accretion of embryo foredunes despite the wide backshore deflation sand source, and exposure to SW winds, is instructive for estimating rates of natural foredune building at Stinson Beach. (P. Baye July 2015 left, July 2009 right)
