Stinson Beach Nature-Based Adaptation Feasibility Study Study Memorandum 1

subject Study Memorandum 1: Stinson Beach Existing Conditions
Task 1 Deliverable for Stinson Beach Nature-Based Adaptation Feasibility Study
(ESA Project D17009.00)

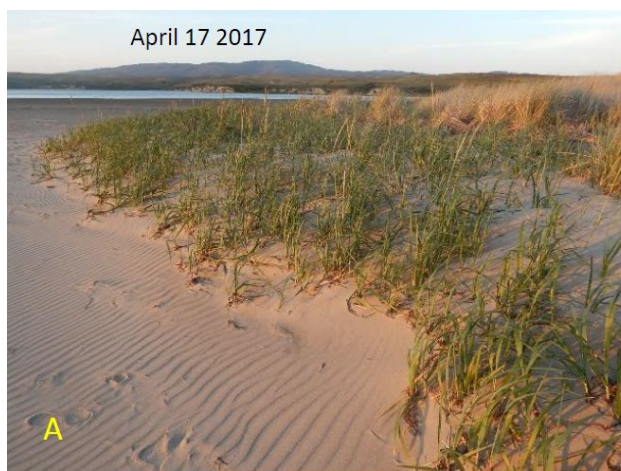
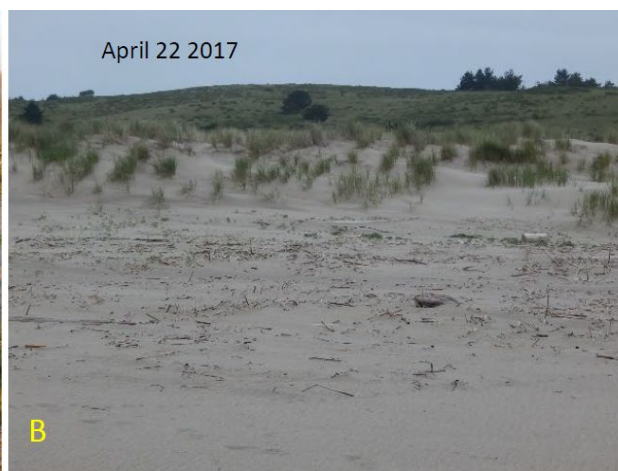
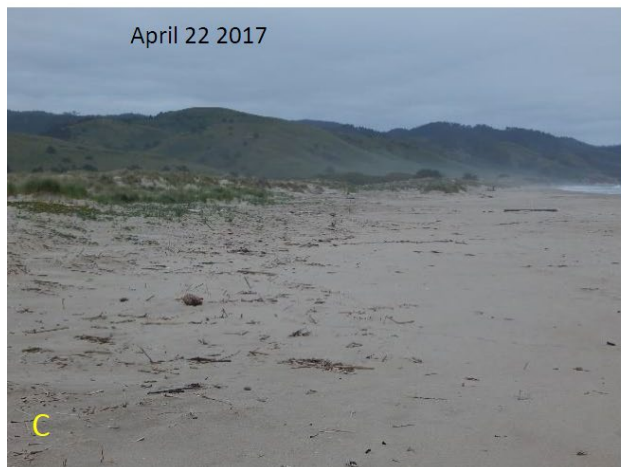
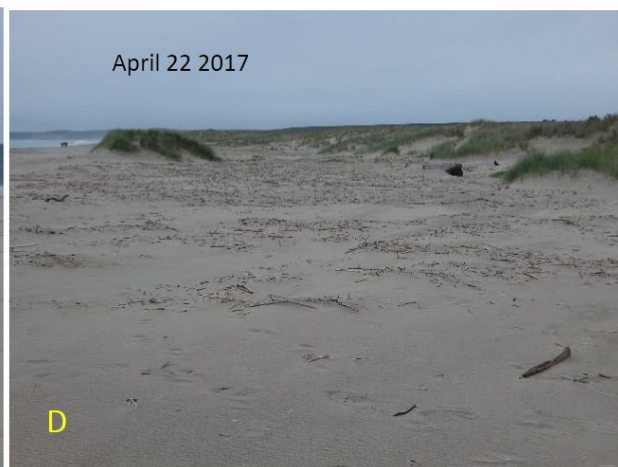
Limantour Beach foredunes include small areas of native beach wildrye foredune vegetation (A) which form gentle slopes and spread widely. Most of the foredunes at the proximal end of the spit (most similar to Stinson Beach) are narrow, continuous foredune ridges 2-4 m high dominated by marram, with wide, irregular zones of embryo foredunes in varying stages of development in post-storm recovery of the beach/foredune profile, during gradual net shoreline retreat. (P. Baye)

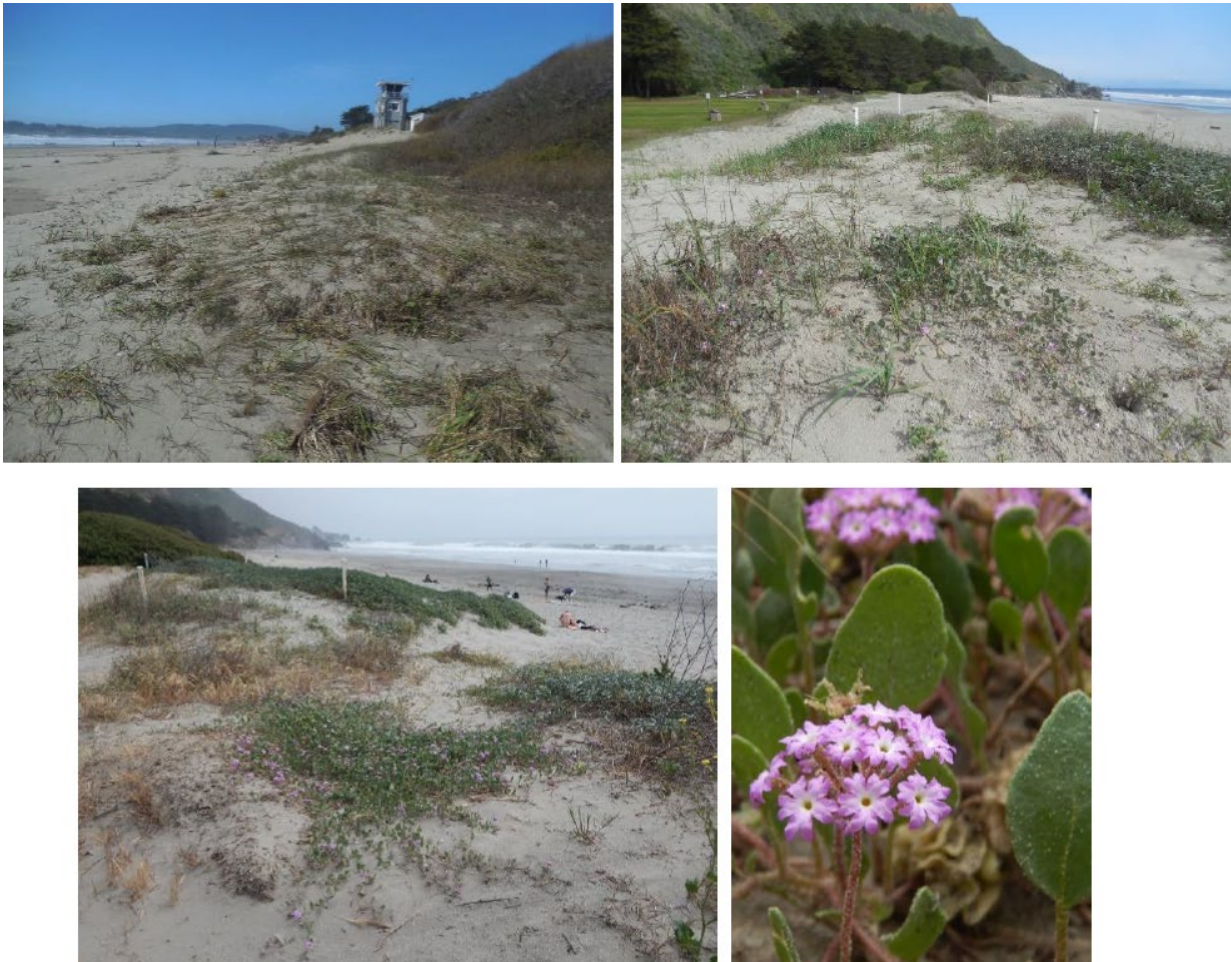
*GGNRA Stinson Beach foredunes vegetation extends from the edge of the willow swamp foredunes (Vancouver wildrye) east to the cliffs, where assemblages also include pink sand-verbena, yellow sand-verbena, beach-bur.
(P. Baye)*

The eastern end of Stinson Beach (GGNRA overflow parking lot, normally closed) is the closest (on site) reference site for Stinson foredune design. It formed by a mix of artificial and natural sand deposition, and plant colonization. GGNRA maintenance crews years ago scraped wind-blown sand from the parking lot and pushed it in windrows along the seaward edge. These piles of mixed dirt and sand formed nuclei of embryo foredunes. The foredunes include mostly native vegetation. Foredune height has grown in the range of 2-3 m (above adjacent backshore beach) over about 15 years.

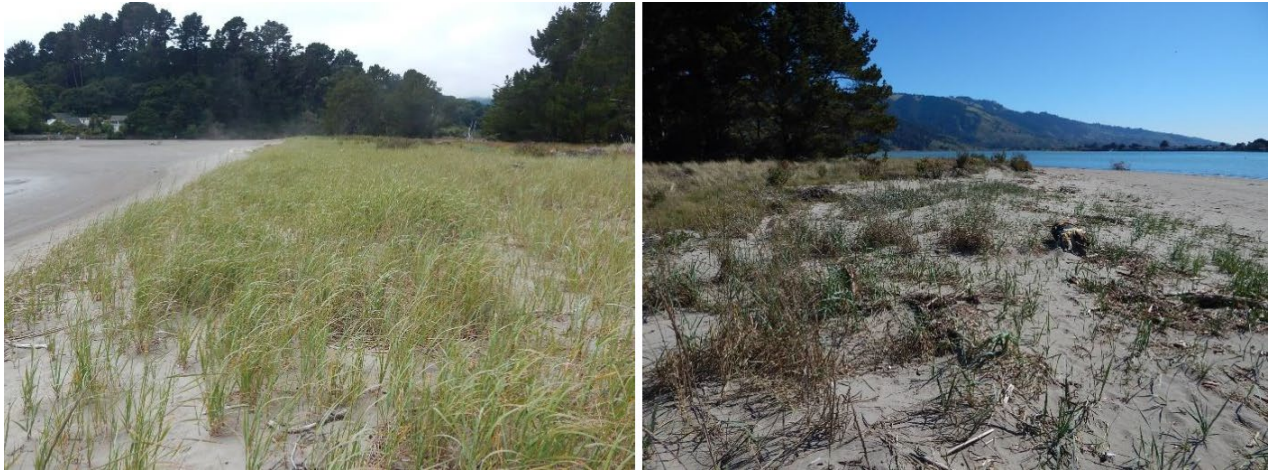
West Kent Island (Bolinás Lagoon) foredune terrace rapidly developed Vancouver wildrye foredunes, during a beach growth phase between 2012-2017. (P. Baye).

The west end of Kent Island is a dynamic sheltered beach in the tidal inlet (aggraded supratidal flood tidal delta). It cycles through erosion and accretion phases driven by the adjacent shallow tidal channel and sandy flood tidal shoals. During growth phases, it develops a wide, low foredune terrace dominated by Vancouver wildrye, which also occurs at both Limantour and east Stinson (GGNRA) beaches. This is a natural hybrid of native dune and seasonal wetland wildrye species. It is associated with other species shared at Doran, Stinson, and Limantour, including north coast sand verbena, and saltgrass. This site is in effect a low-energy extension of the sand spit foredune vegetation of Stinson Beach.

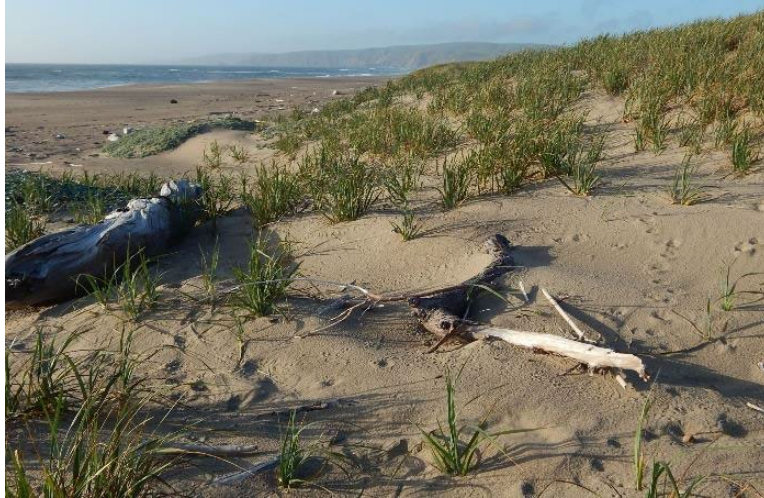
Beach wildrye foredunes at north Abbott's Lagoon, Point Reyes, develop gentle seaward slopes. Driftwood is incorporated in the fabric of these foredunes. (P. Baye, April 2017).

GGNRA has removed marram and released native dune vegetation from its inhibitory influence for over 10 years. Though the west-facing beach is exposed to strong, dominant onshore NW winds, the relatively coarse beach sand has a higher threshold for onshore wind transport and thus limits dune accretion potential. Excellent examples of local native foredune vegetation stands, including single-species dominants and mixed assemblages, occur here. Major stands of silvery beach-pea occur here as single-species and mixed stands with beach wildrye, providing both a model and potential propagule source for these valuable dune-building species with complementary growth-forms.

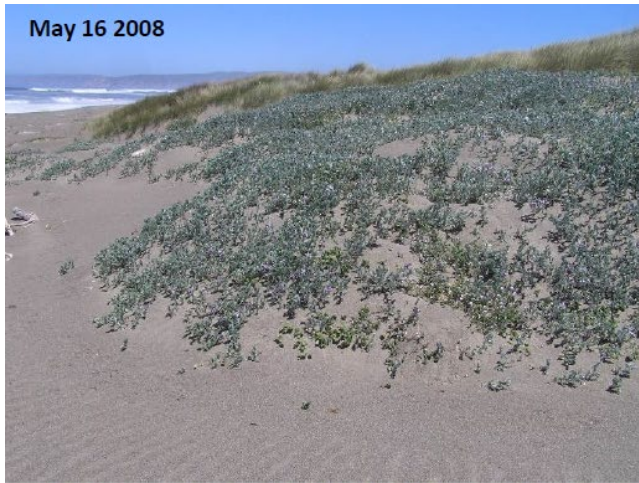
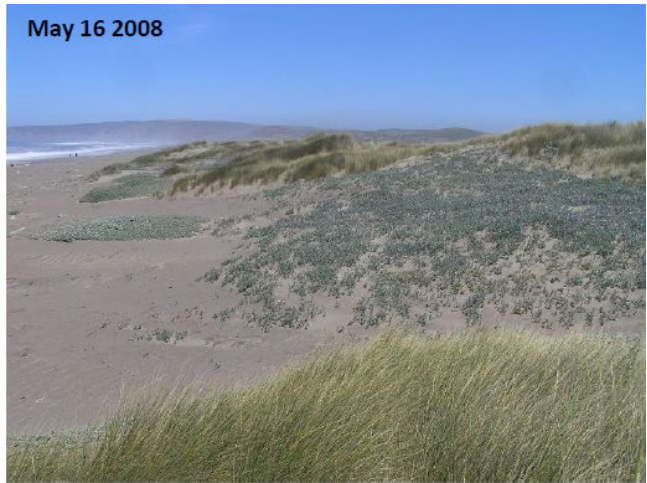
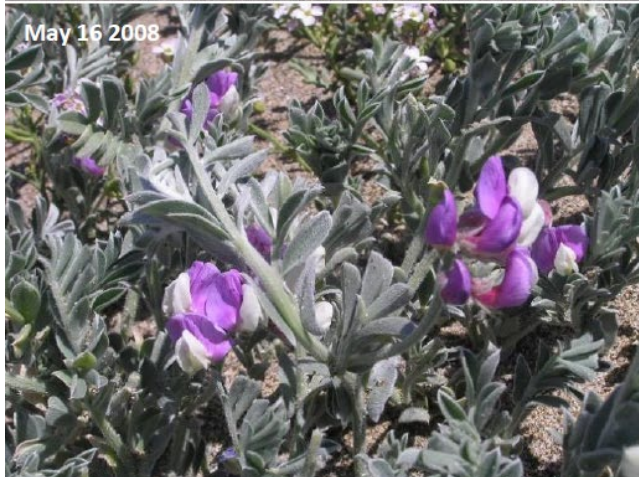
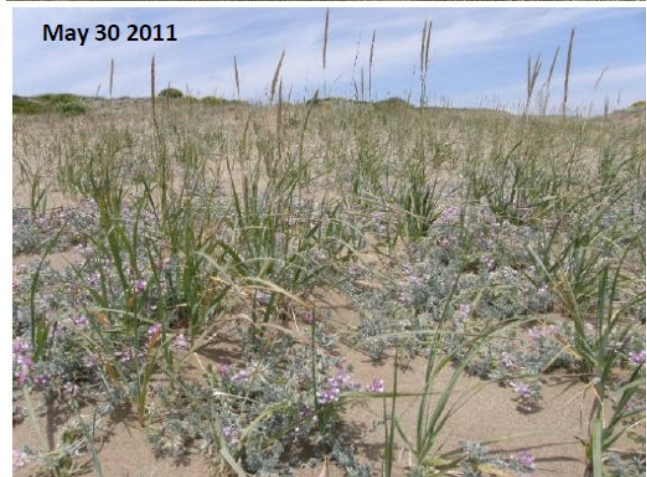
The ornamental native silvery beach-pea occurs in single-species creeping (clonal) stands and forms gently sloping foredunes at Abbott's Lagoon. It also forms mixed stands with beach wildrye here, providing a potential model for Stinson Beach. (P. Baye)

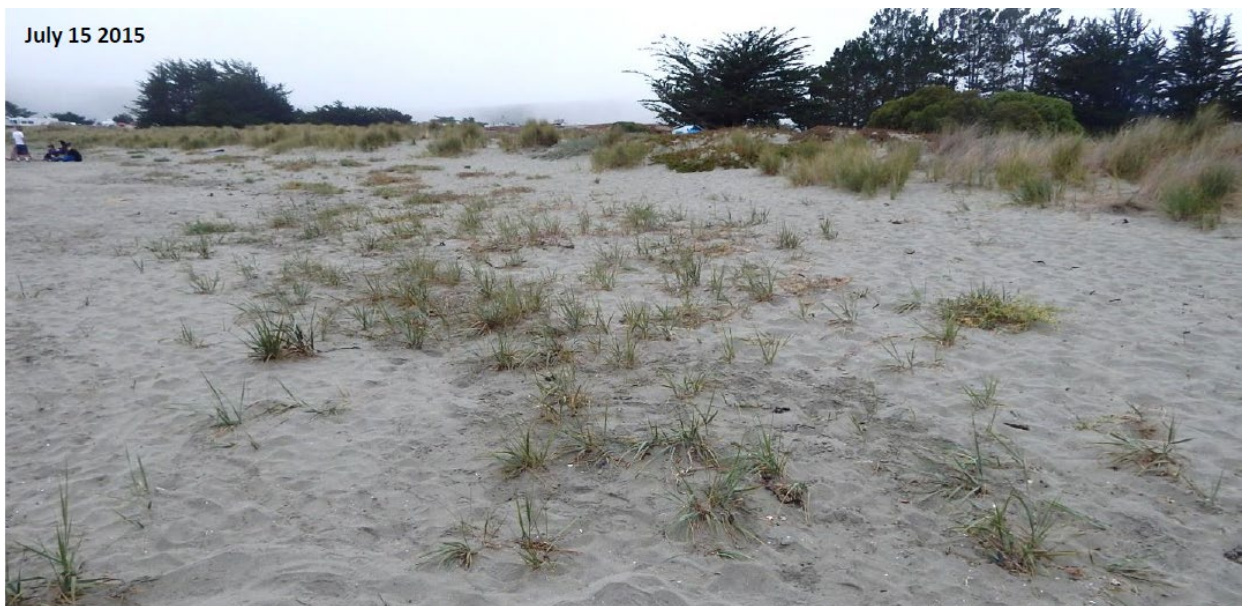
Embryo foredune vegetation at central Doran Beach, dominated by native beach wildrye and non-native sea-rocket. Sand accretion rates are very slow here between storm erosion intervals; little vertical dune building occurs during beach growth phases. Note low foredune ridge dominated by the efficient sand-trapping marram vegetation landward of the embryo foredunes. (P. Baye)

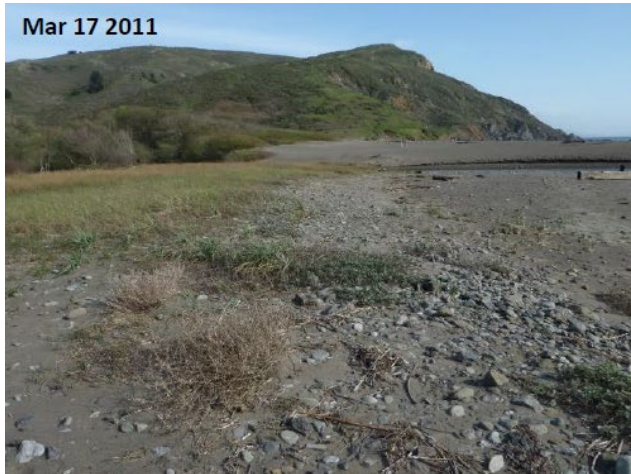
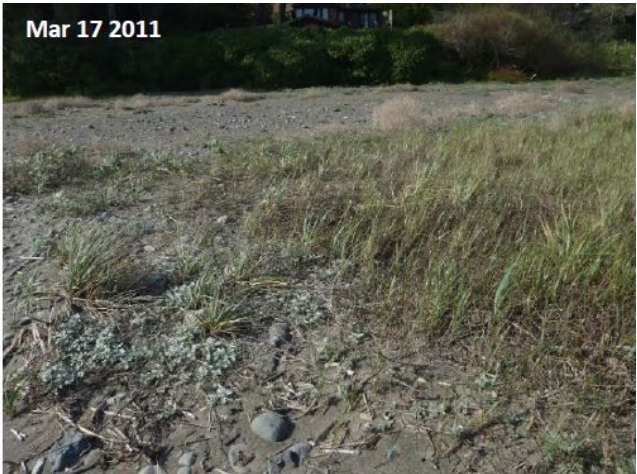
The north end of Muir Beach is a reference site for low foredunes over a cobble beach terrace (washover) dominated by beach wildrye, Vancouver wildrye, and beach-bur vegetation. (P. Baye)

Muir Beach (GGNRA) is a pocket (headland-bound) barrier beach in a river valley south of Bolinas Lagoon. The north end of the beach has a cobble-gravel terrace formed from washovers that rework stream gravel and cobble deposits over which the beach retreats. A thin, low foredune terrace dominated by beach wildrye, Vancouver wildrye, and beach-bur forms over the coarse washover fan and stream delta.

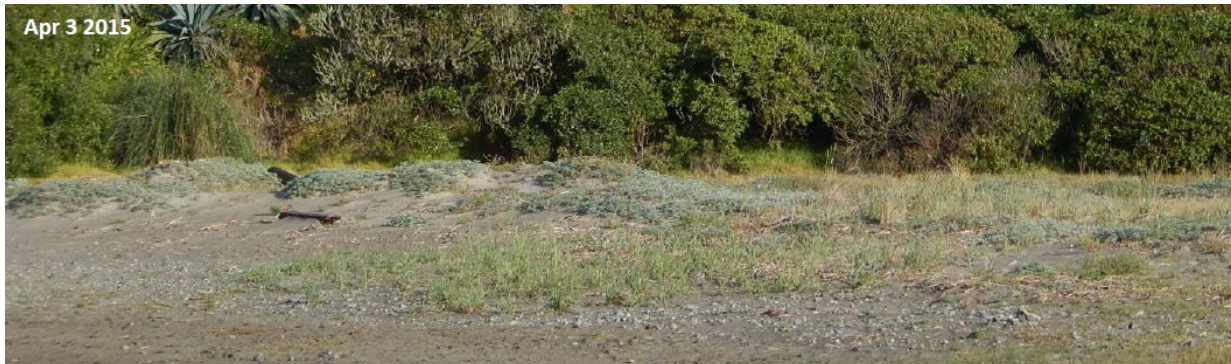
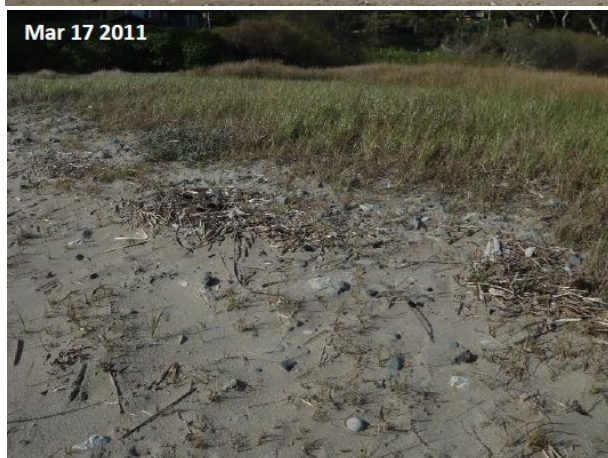
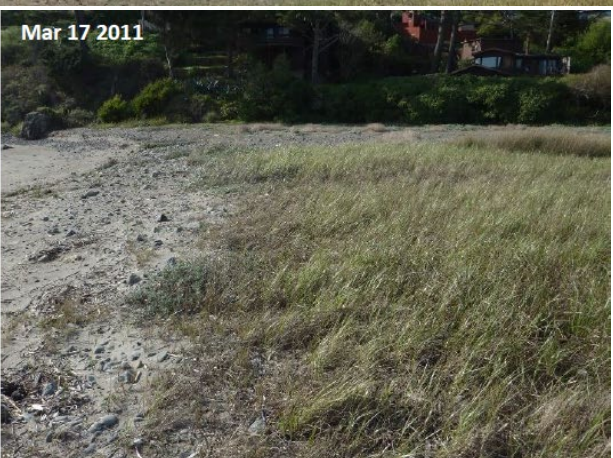
Muir Beach (north end) foredune terrace vegetation is similar to that of Kent Island's west end, but on a cobble washover terrace. (P. Baye)

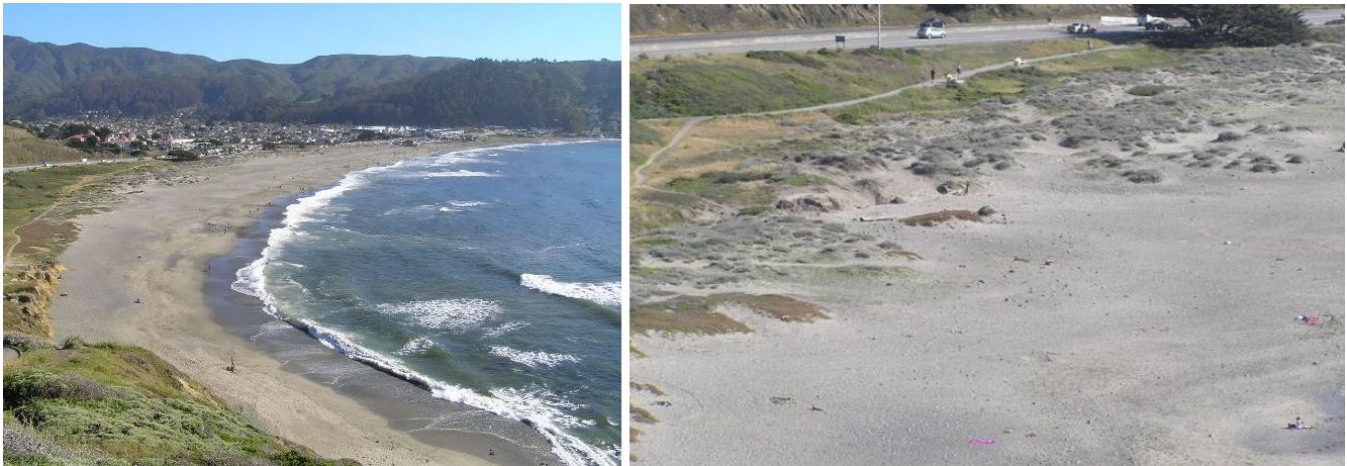
Linda Mar, Pacifica State Beach, has a wide, coarse berm and a low foredune zone. (P. Baye 2009)

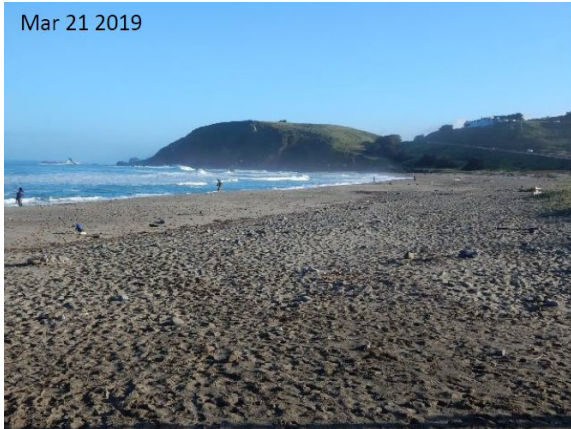
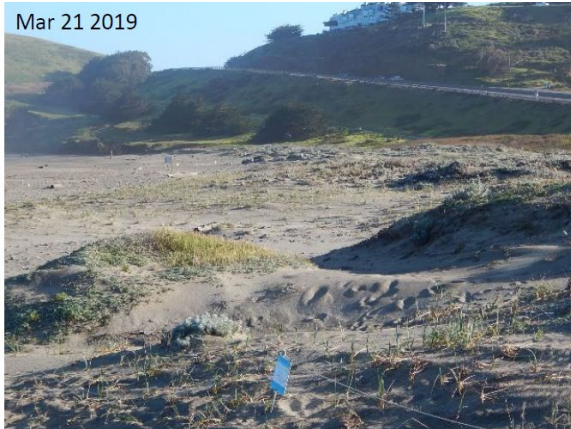
Wide backshore sand deflation fetch at Pacifica State Beach provides wind-driven sand accretion source for low, hummocky foredune zones north of the beach wildrye foredune ridge. (P. Baye)

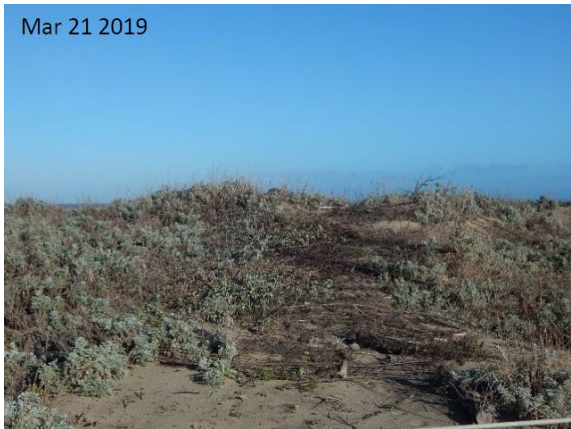
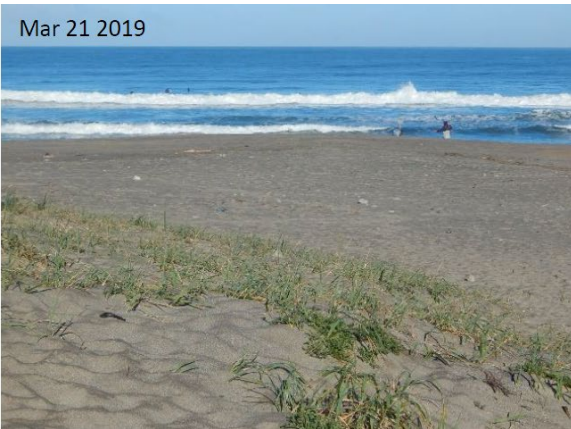
Brush mats close foot trails that may initiate dune blowouts on the lee (landward) slope of the foredunes at Pacifica State Beach. Seaward slopes of foredunes are “self-healing” under low rates of trampling, where creeping beach wildrye recolonizes gaps before blowouts develop. Symbolic fencing deters excessive trampling. (P. Baye)

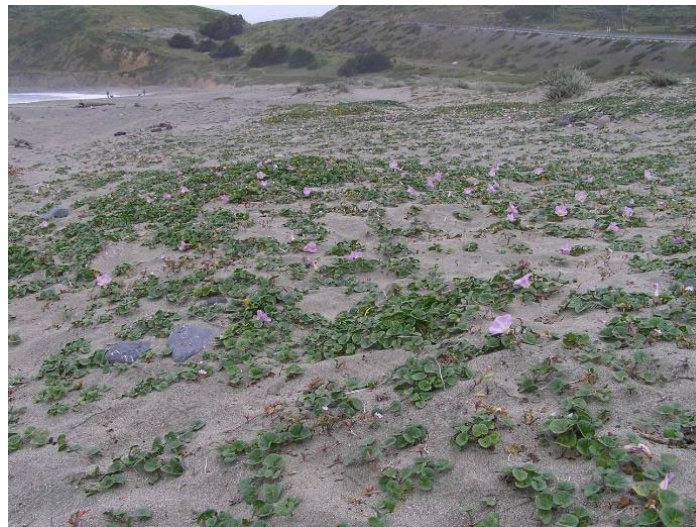
Beach morning-glory has a prostrate growth habit that provides diversity but little dune accretion. (P. Baye)

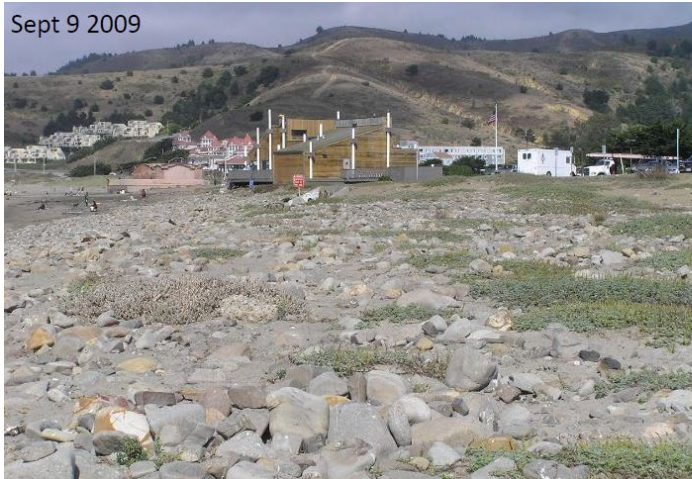
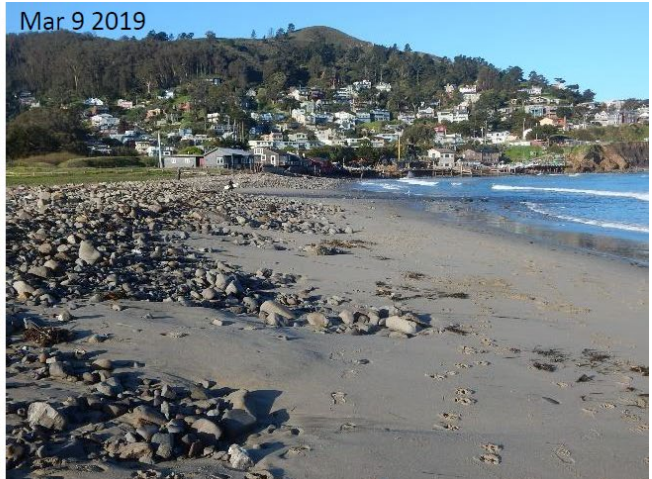
The restored cobble-boulder beach (washover) terrace at the south end of Pacifica State Beach has a thin dune veneer supporting beach-bur and whiteleaf beach saltbush. (P. Baye)

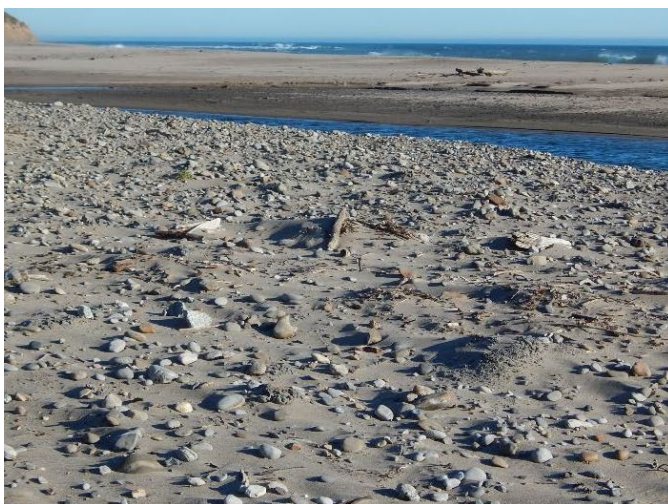
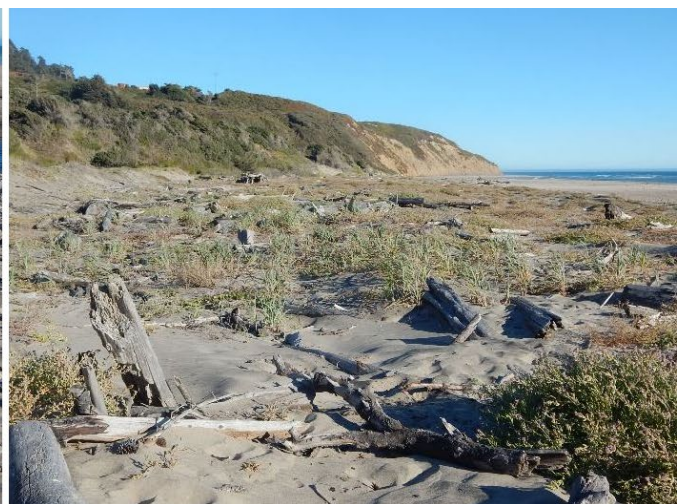
Waddell Creek sandy barrier beach and cobble-gravel, foredunes. (P. Baye)

Waddell Creek Beach, Santa Cruz, is a state park sandy barrier beach at the mouth of a river valley, formed over a cobble-gravel stream delta foundation, like Muir Beach. Part of the cobble beach terrace is exposed south of the creek mouth, where Marram removal has released native embryo foredune vegetation formed around nuclei of driftwood. The foredune vegetation assemblage includes most of the elements found at Doran, Stinson, and Limantour Beach, including beach wildrye, pink and yellow sand-verbena, whiteleaf beach saltbush, and beach-bur. The vegetation undergoes little trampling pressure. The beach has medium sand and a wide low tide terrace exposed to deflation from strong, dry northwest winds. Foredune accretion rates at the south end of the beach are likely to be higher than Stinson Beach, for a given vegetation stand type.

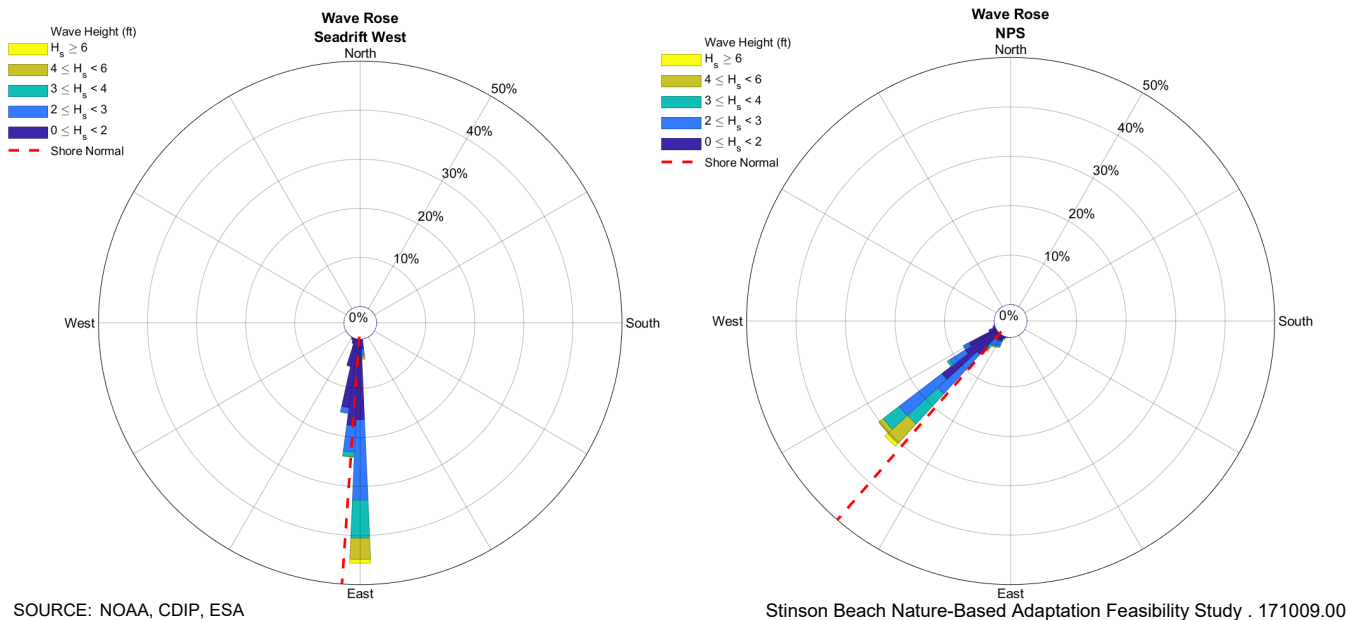
Figure 18
 Nearshore Wave Roses for SWAN output points at West Seadrift and NPS Profile Locations with Normal Angle at Shoreline
