Construction / Safety Monitoring
Gross Field Pavement Project
Marin County Airport
Novato, CA

November 8, 2017 Wednesday
Monitoring / Air Sampling for
Construction

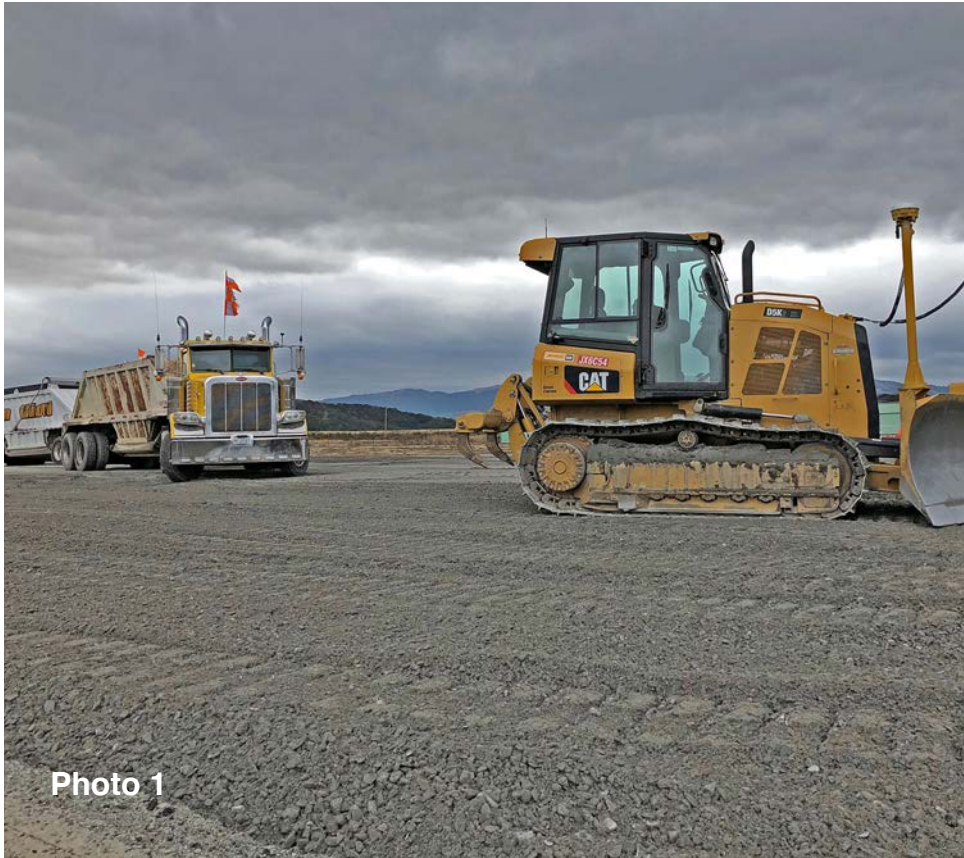
Photo 1 shows the leveling and compaction of the imported road base at the South end of the runway. No visible dust is observed during the loading. 95% to 97% of the serpentine and recycled asphalt have been covered with imported base rock by the end of the day.

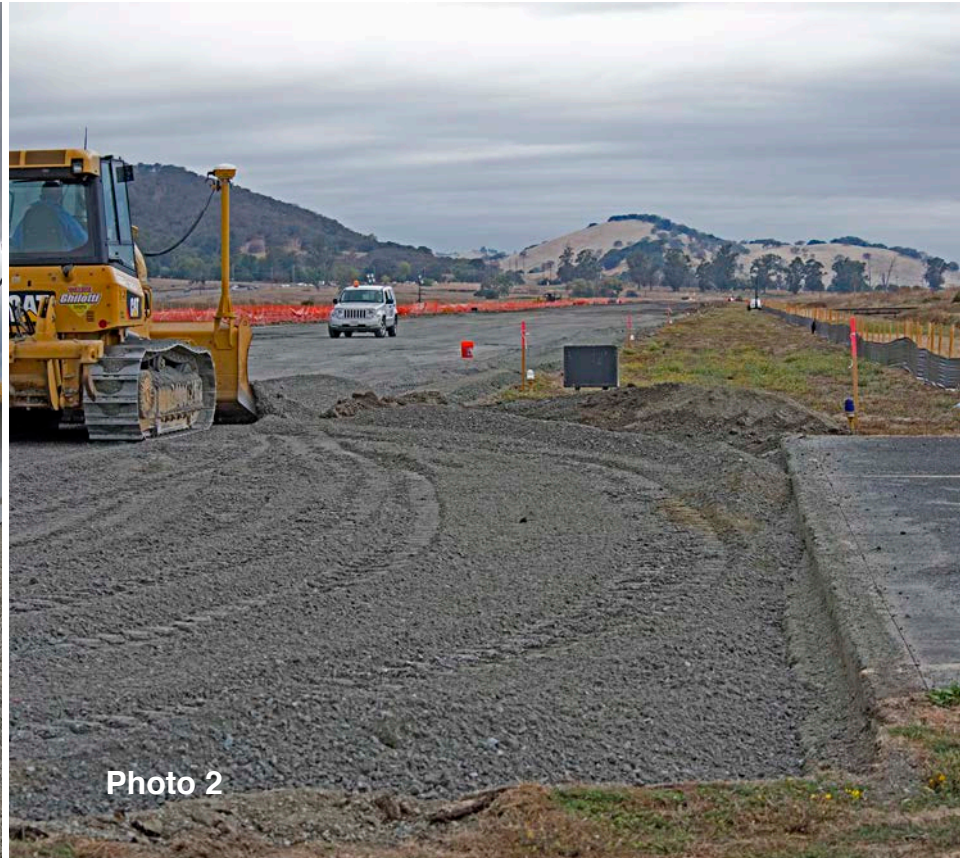
Photo 2 shows the East turnoff and shoulder areas. The gray aggregate is the imported non asbestos road base. No air samples were collected today, due to weather / safety issues. The winds today were from the South / Southeast, averaging 6 to 12 knots.
