**Construction / Safety Monitoring**  
**Gross Field Pavement Project**  
Marin County Airport  
Novato, CA

**November 10, 2017** Friday  
Monitoring / Air Sampling for  
Construction

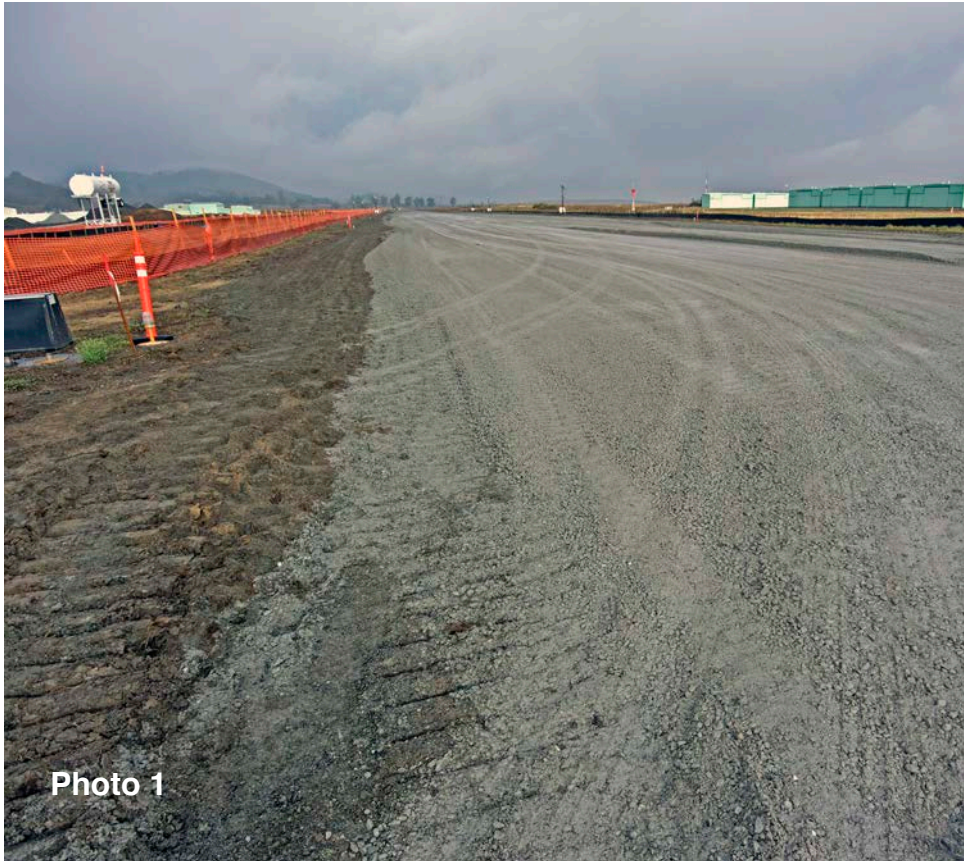
**Photo 1**

Photo 1 shows the view along the Western edge of the runway looking to the North. No visible dust is observed during the loading. The rain at the job site this morning has resulted in very effective dust control

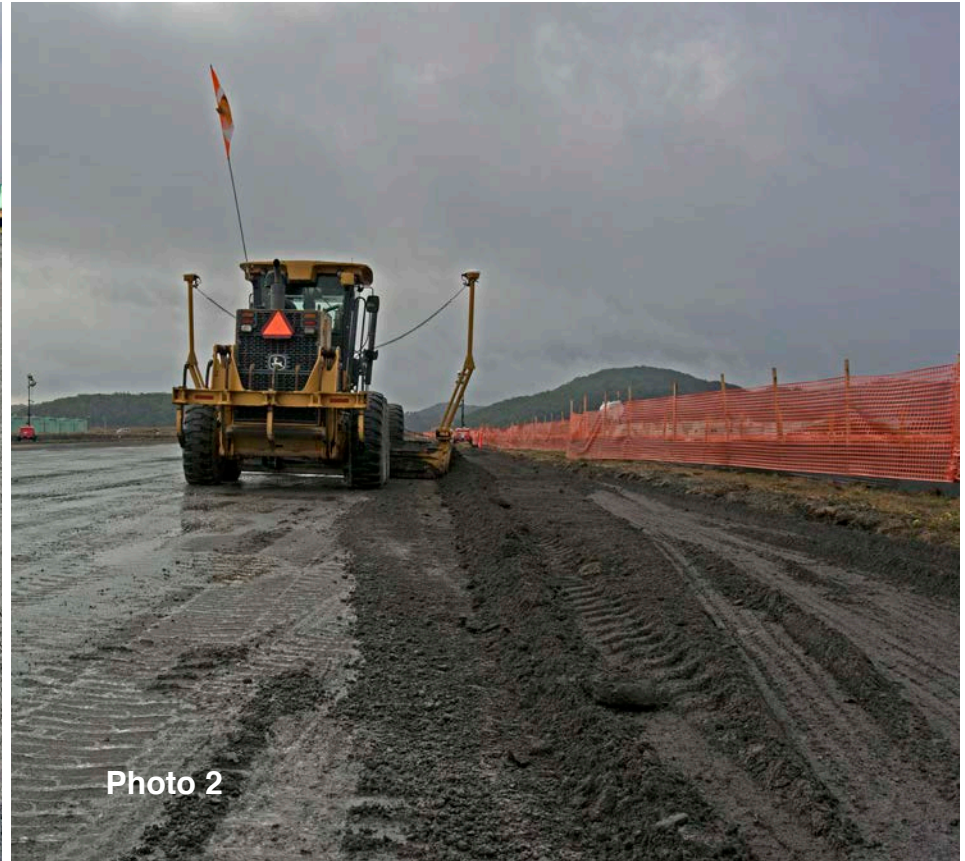
**Photo 2**

Photo 2 shows the road grader along the Western side of the runway. The gray aggregate is the imported non asbestos road base. No air samples were collected today, due to weather / safety issues. The winds today were from the South / Southwest, averaging 6 to 12 knots.
