The final or top layer of road base transport / placement continues with a substantial number of double belly dumps arriving at the site. Despite the rain in the forecast, the work is moving forward. The amount of rain was not that much that the rock could not be placed. The trucks arrive at the North end of the runway 31 and deposit their load. The road grader and compactor are working the rock into the final 5 inch thick layer. The stockpile was checked and found that water penetrated down 3 ". The rains will take the place of stockpile watering on days with this amount of rain. The abatement contractor was no longer working at the site.

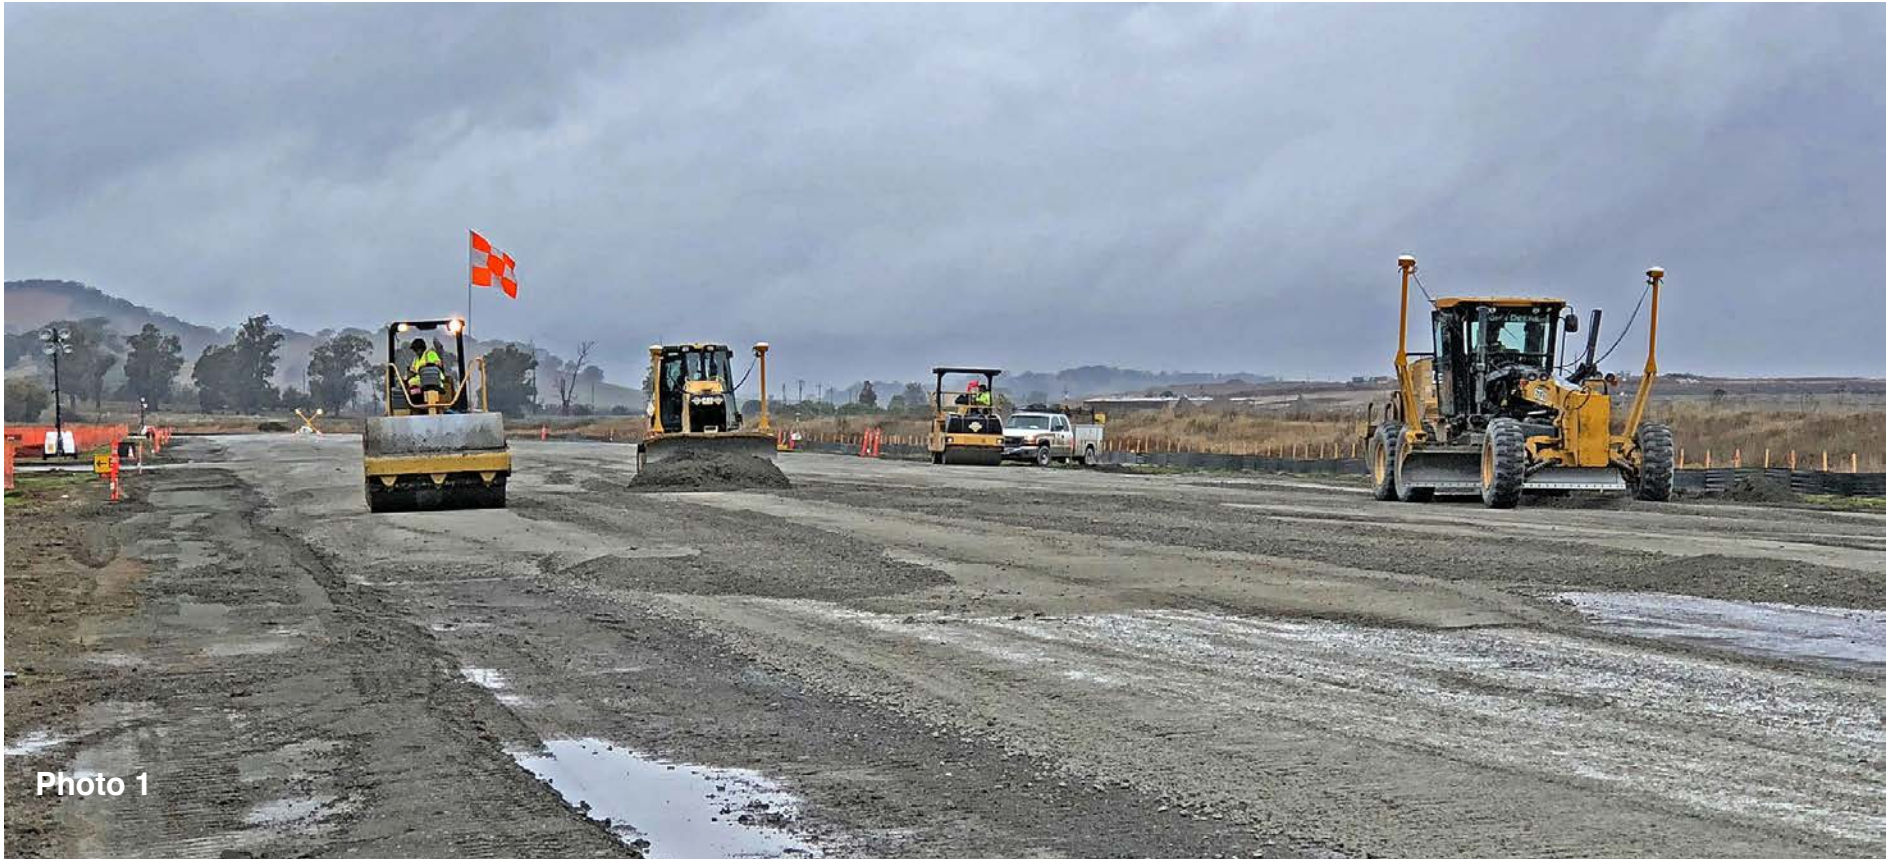
Photo 1 shows the view of the runway looking to the North. The graders and compactors are seen spreading the base rock. The gray aggregate is the recently imported non asbestos road base.
