SIR FRANCIS DRAKE BOULEVARD REHABILITATION PROJECT

SIR FRANCIS DRAKE BOULEVARD REHABILITATION

3.0 PROJECT DESCRIPTION

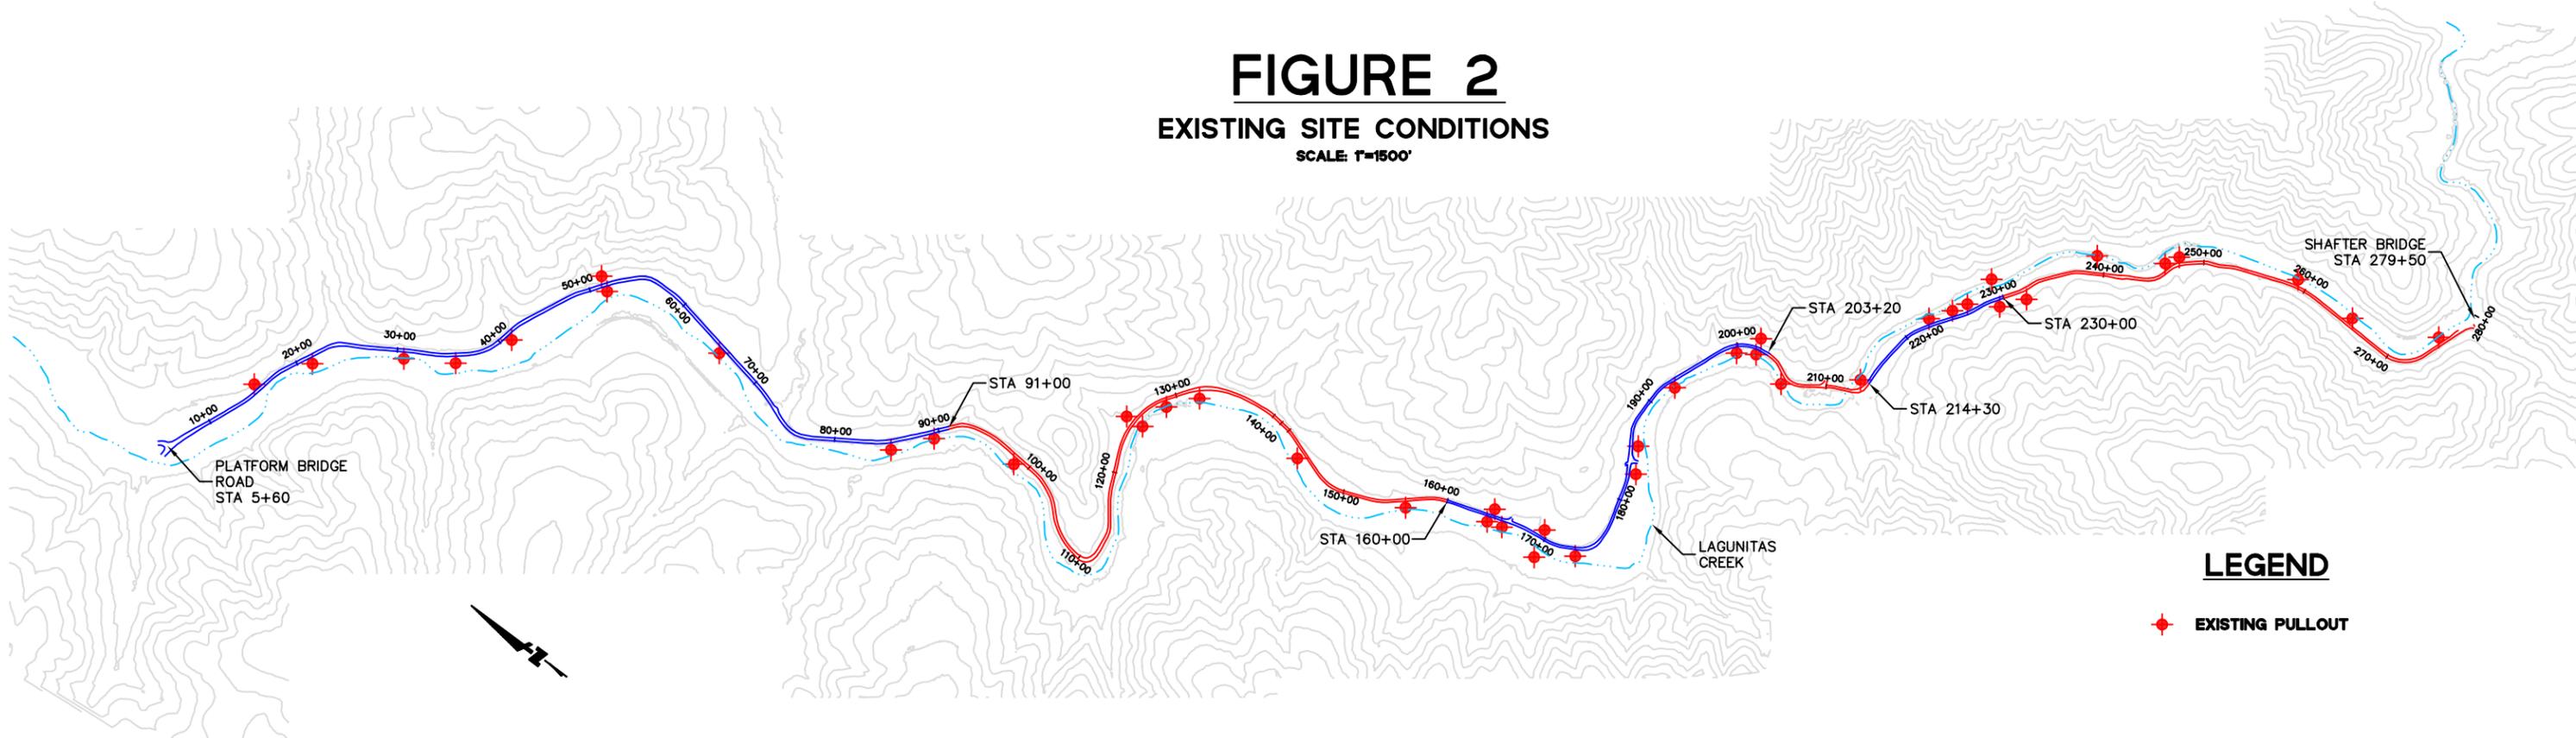
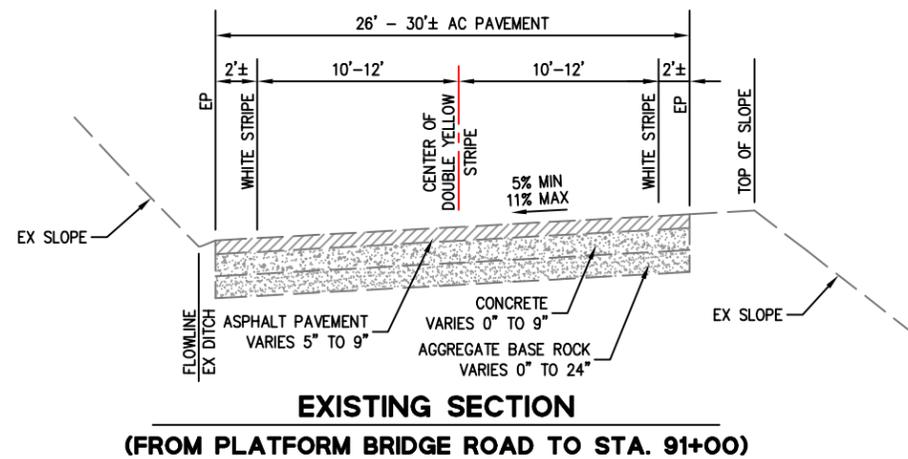
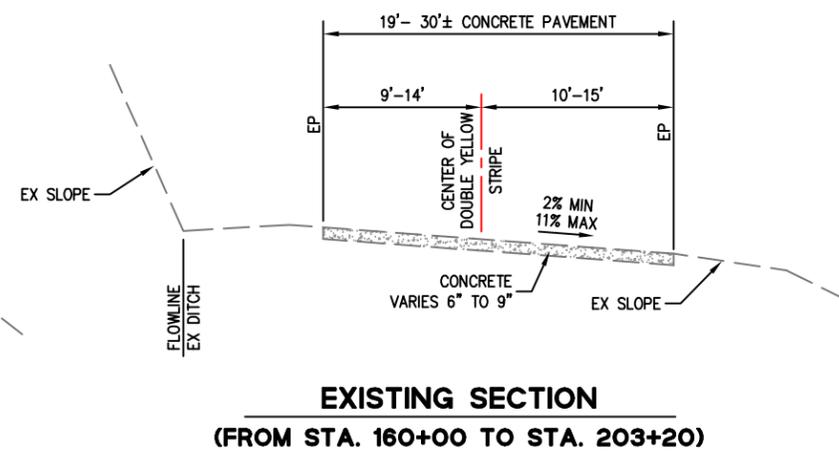
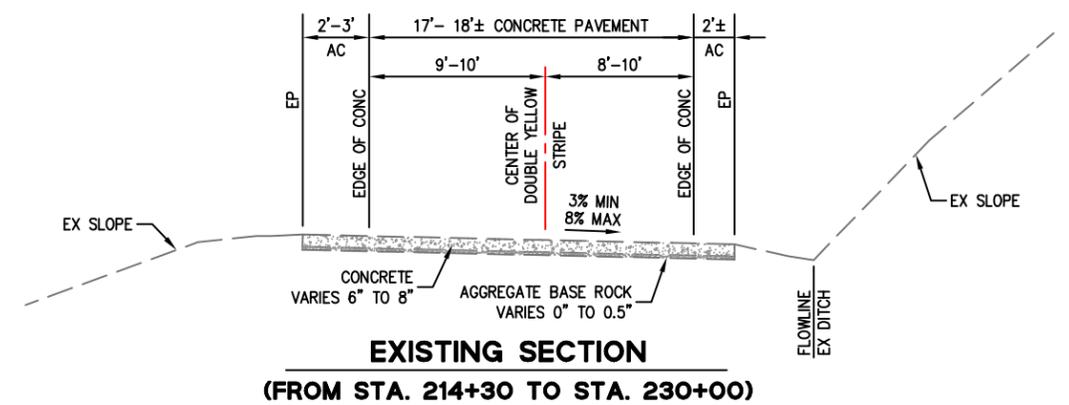
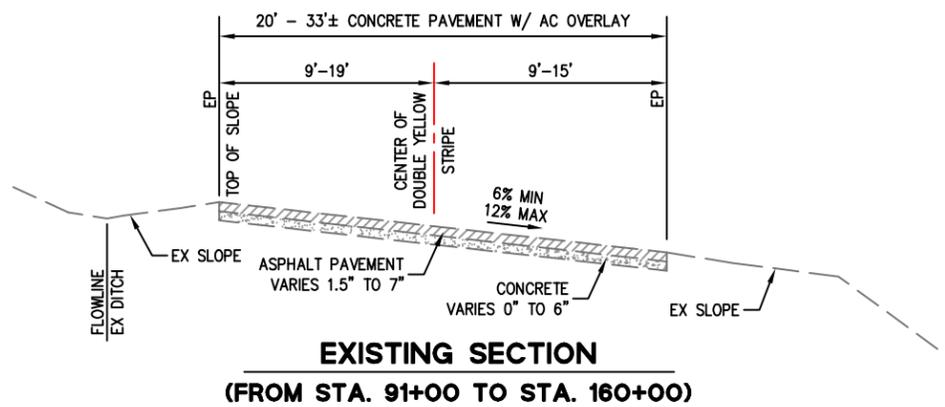
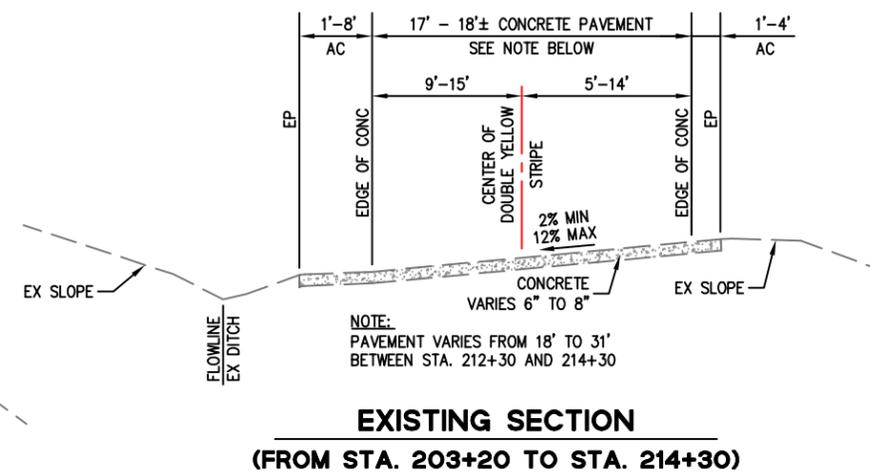
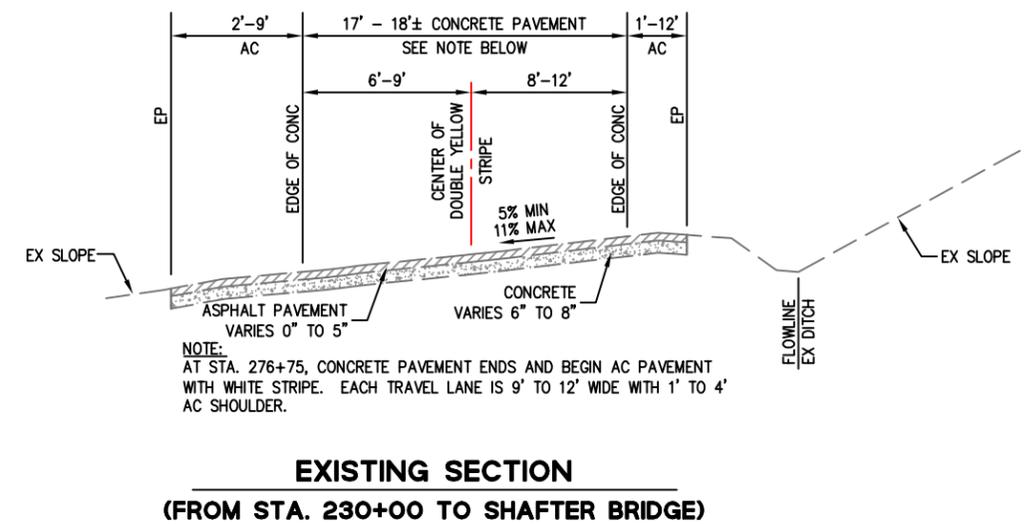
FIGURE 2

EXISTING SITE CONDITIONS

For reference to specific features, a station line as shown in **Figure 2** is provided along the roadway. Each station indicates an interval of 100 feet and commences at Station 5+60 (Platform Bridge Road) and ends at Station 279+50 (Shafter Bridge).

While the roadway's width is highly variable, it is narrowest at Shafter Bridge and widest at Platform Bridge Road. At Shafter Bridge, the roadway is generally 22 to 30 feet wide with lane width of 11 feet but as small as 9 feet. At Platform Bridge Road, the roadway is 32 feet with a lane width of 12 feet. **Figure 2** illustrates various widths contained in the Project Area.

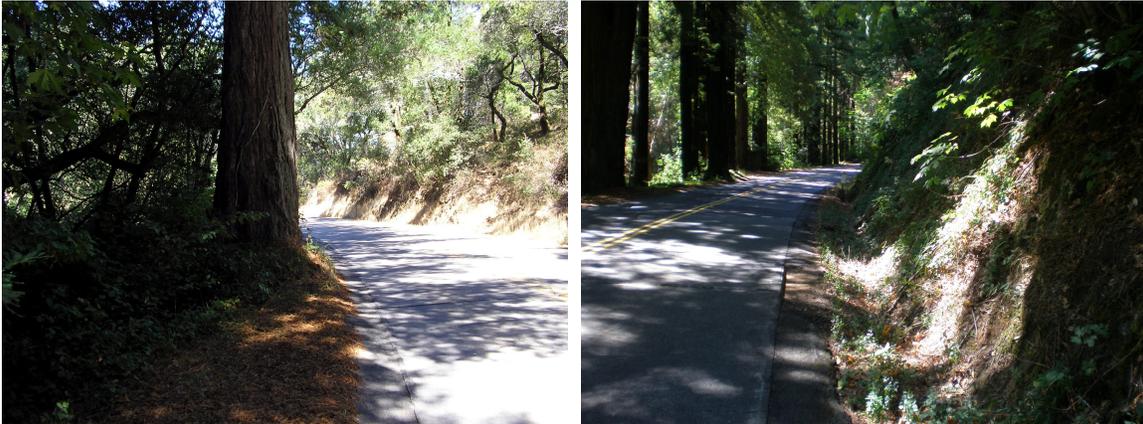
Figure 3: Site Constraints

The horizontal alignment of SFDB is curvilinear and generally parallel to Lagunitas Creek. In response to the numerous tight radius curves along the roadway, the posted speed limit varies from 15 MPH to 40 MPH. The vertical alignment does not vary significantly with grades ranging from 0.1% to 3.5%. The lowest and highest elevations along the centerline of the roadway in the Project Area are 82 and 209 feet respectively based on the National Geodetic Vertical Datum of 1988. In section, the existing roadway is super elevated and bordered by sloped banks in excess of 45 degrees. The roadway is significantly constrained by trees, vegetation, and topographic features which are often only a few feet from the existing edge of pavement as illustrated in **Figure 3**.

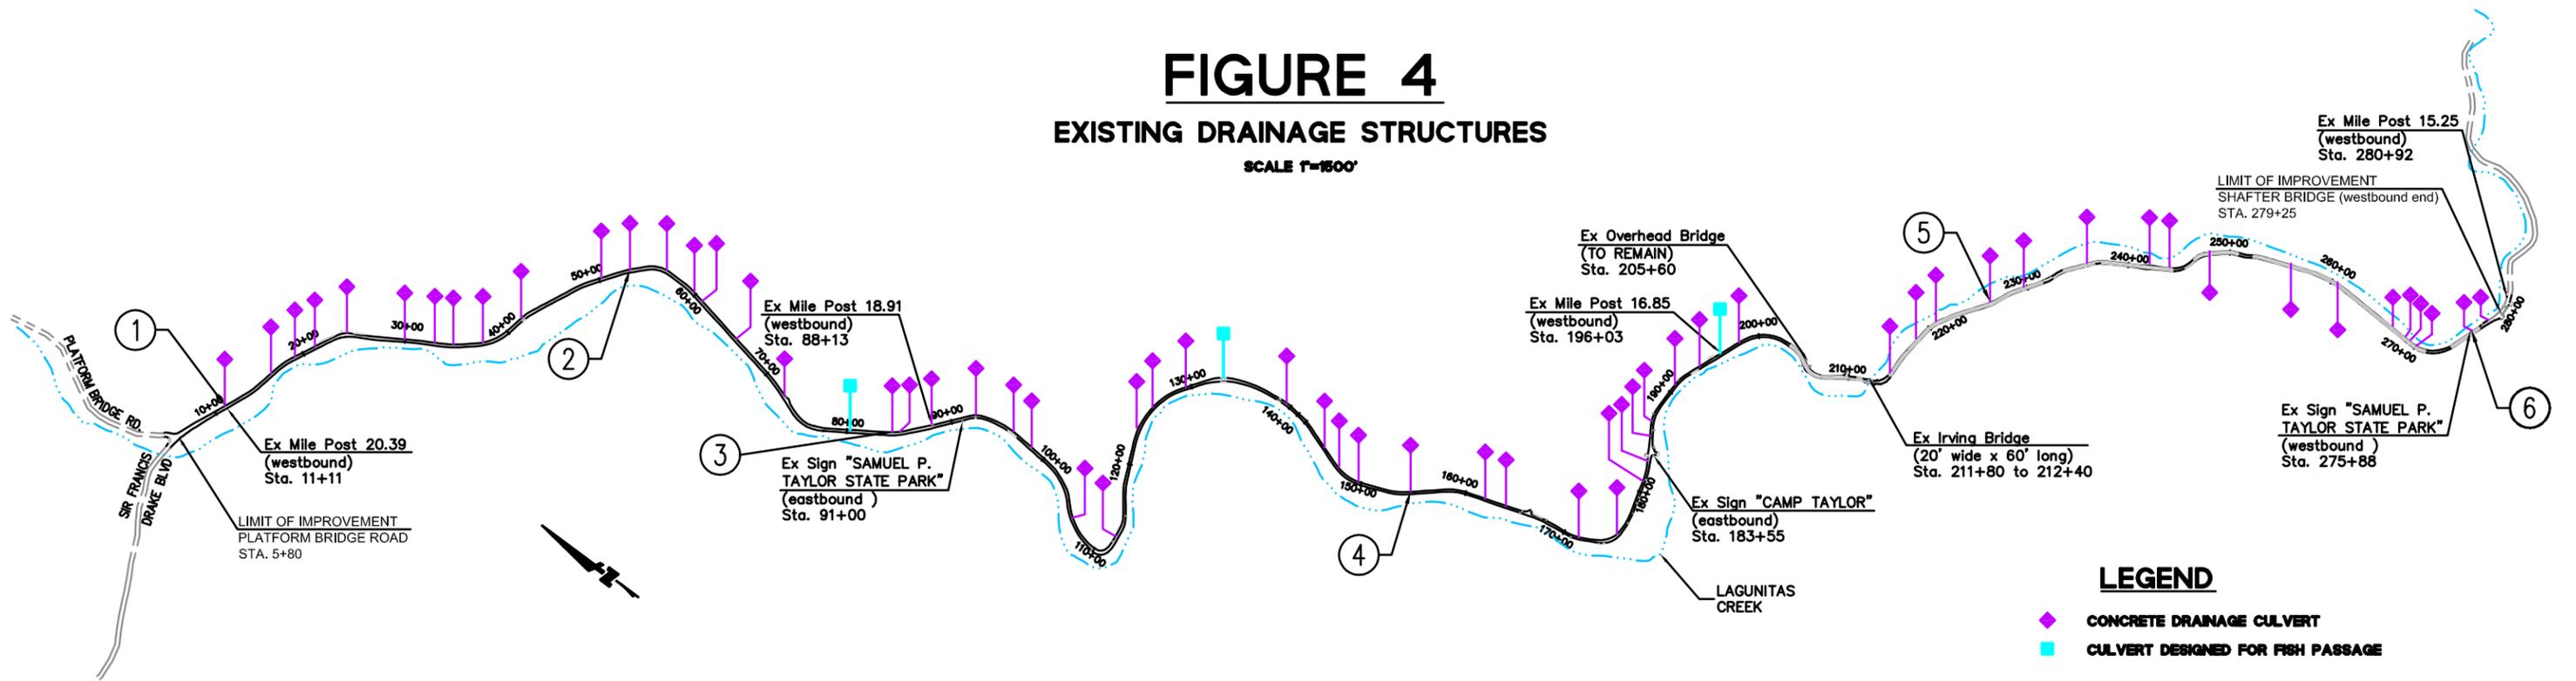
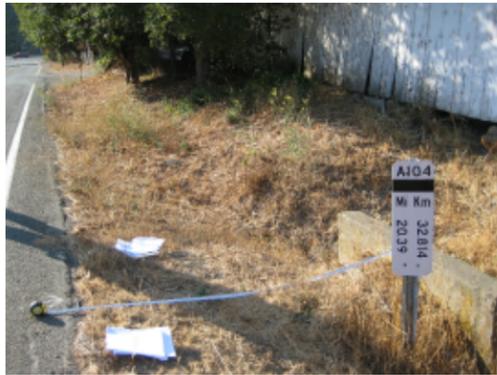
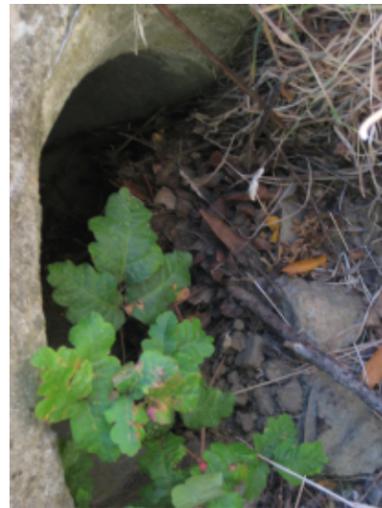
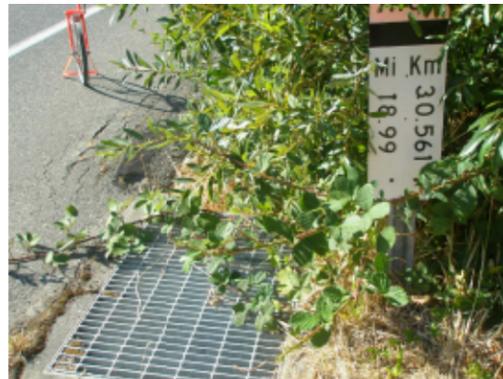
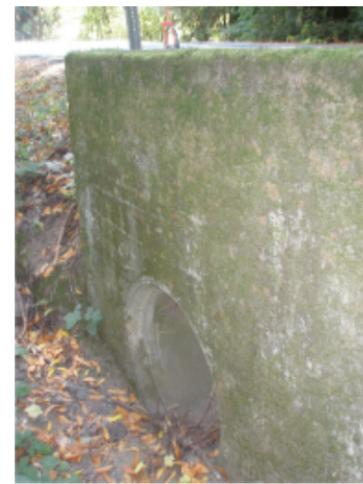
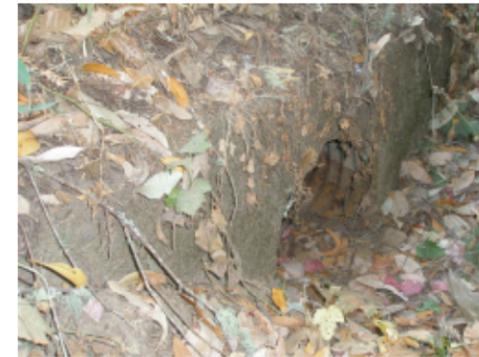
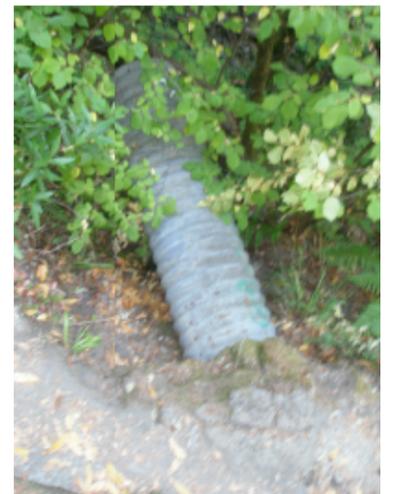
FIGURE 4

EXISTING DRAINAGE STRUCTURES

edge of pavement to Lagunitas Creek. When the roadway slopes towards the hillside, the water is trapped between the edge of pavement and the toe of slope. The water ponds to the elevation required to convey flow to an existing culvert which eventually discharges under the roadway to Lagunitas Creek. As the profile SFDB is generally flat and ditches are not well defined, storm water inundates a portion of the lane during significant storm events. There are 62 corrugated metal or plastic pipe culverts and two large concrete box culverts that cross SFDB. Locations of these features are shown in **Figure 4**. According to Public Works maintenance staff and site observations, many of the metal culverts have corroded and require replacement.

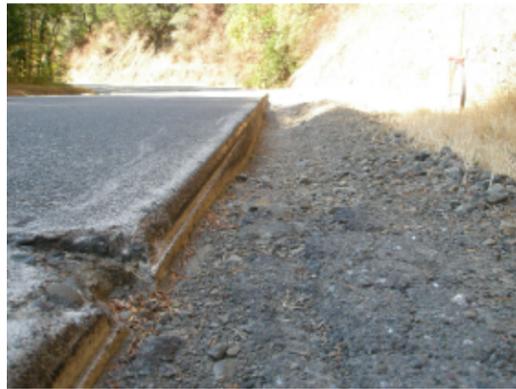
① **DISLOCATED SLAB**

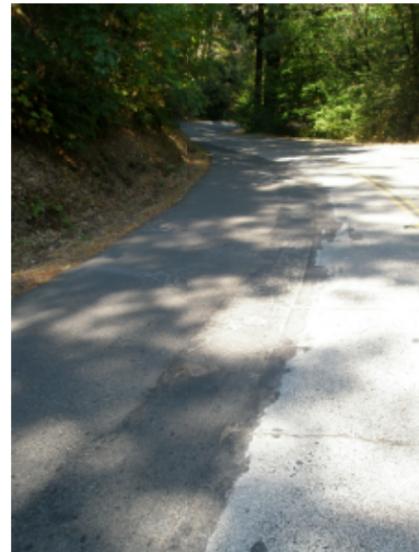
② **SHOULDER ALLIGATOR CRACKING**

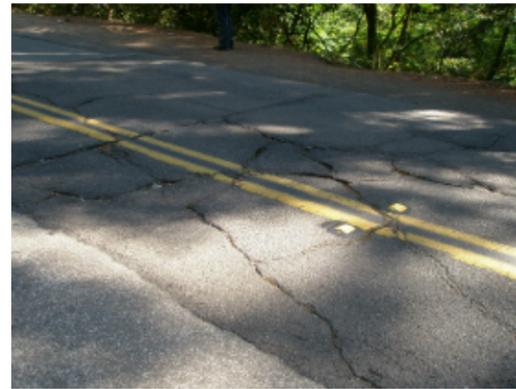
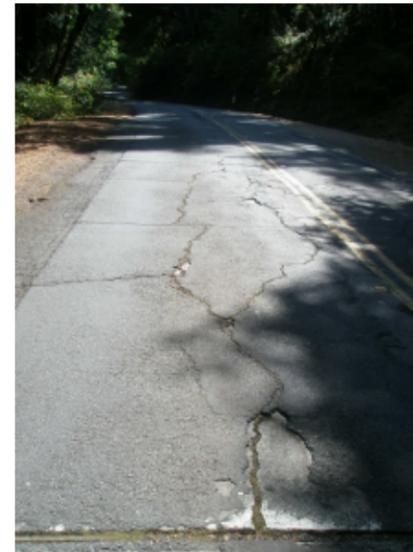
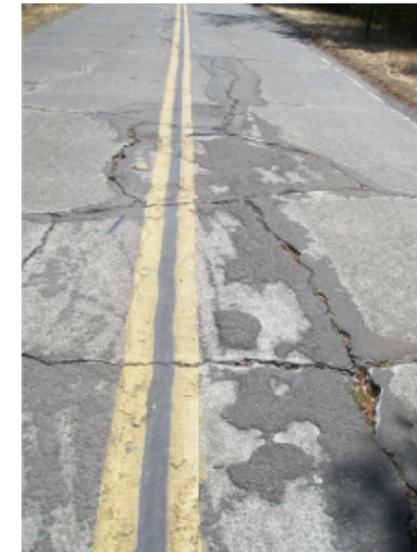
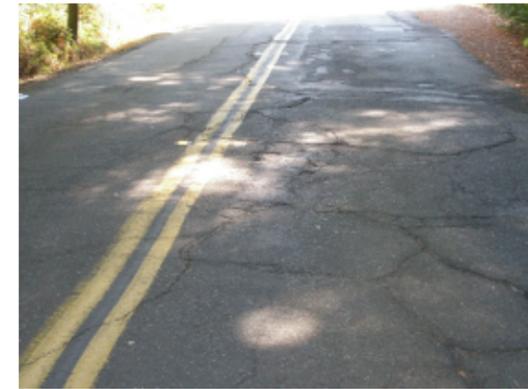
③ **SHATTERED CONCRETE SLAB**

④ **SHATTERED CONCRETE SLAB**

⑤ **SHATTERED CONCRETE SLAB**

⑥ **SHATTERED CONCRETE SLAB**

Segment 1 is primarily composed of concrete pavement with shattered slabs of medium to high severity. The pavement is considered to have failed and has exceeded its design life.

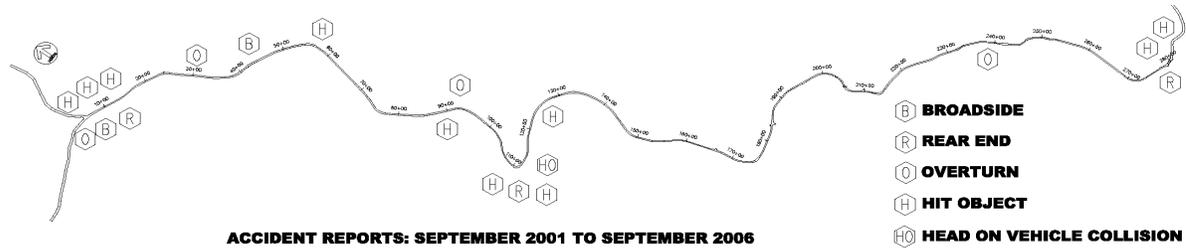
Figure 6: Accident Data

A record of traffic collisions from September 2001 to September 2006 provided by Marin County Traffic Engineering Department indicates that there were 20 reported incidents within the Project Area. During this time period, none of the accidents resulted in a fatality. **Figure 6** illustrates the type and location of each accident. The majority of the

accidents are located at the westerly segment of the roadway which could be a result of the higher rates of speed achieved as the alignment is less constrained. Additionally, numerous accidents occurred at the tight radius curve located at station 110+50.

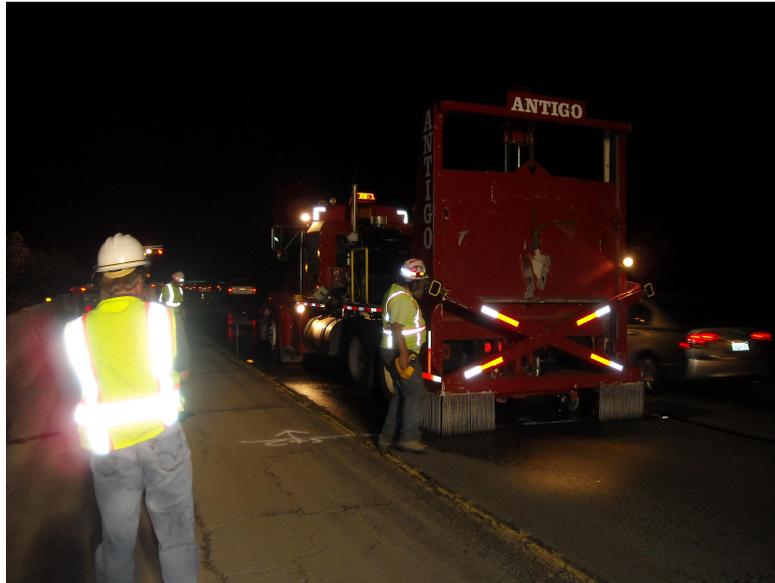
FIGURE 7: Crack and Seat Operation

It is proposed to rehabilitate Segment 1 from Station 100+00 to the Shafter Bridge using the crack and seat technique which re-uses the existing concrete pavement as a base course for a new overlay of asphalt concrete. The method commences by milling all existing asphalt overlay from the concrete pavement. Equipment is then used to apply loads to the existing concrete pavement at one to three feet intervals to break it into smaller panels. After the cracking is complete, a roller is used to compress and interlock the panels into the sub grade. An overlay of at least 3 inches of rubberized asphalt concrete will be applied.

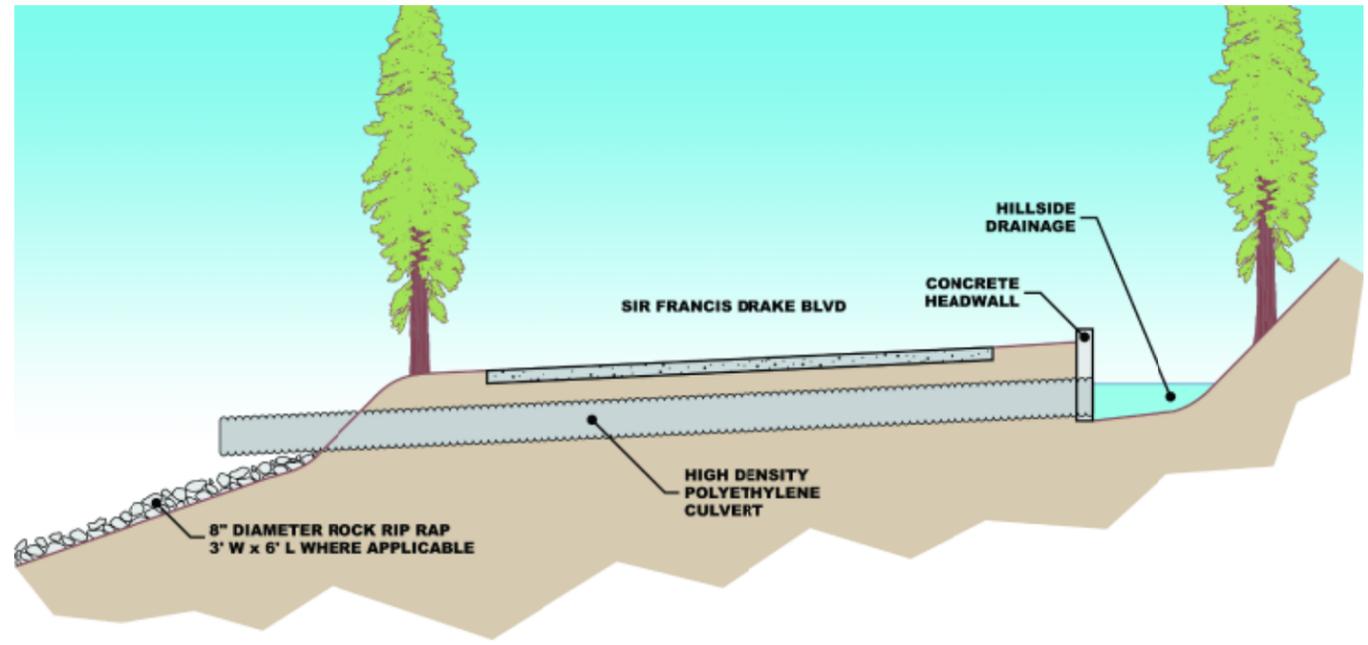
PROPOSED NEW CULVERT

All existing culverts that are composed of corrugated metal or plastic located in the Project Area will be removed and replaced. The culvert will generally be placed in the same alignment and grade as the existing condition. For existing culverts that extend ten or more feet beyond the proposed edge of pavement, only the section within the disturbed area will be replaced. New concrete headwalls will be installed at each

culvert's inlet and outlet. In locations where the culvert discharges onto a natural slope, a properly sized dissipation device consisting of adequately sized rip-rap will be provided. In certain locations, level spreaders may be installed to produce natural sheet flow discharges.

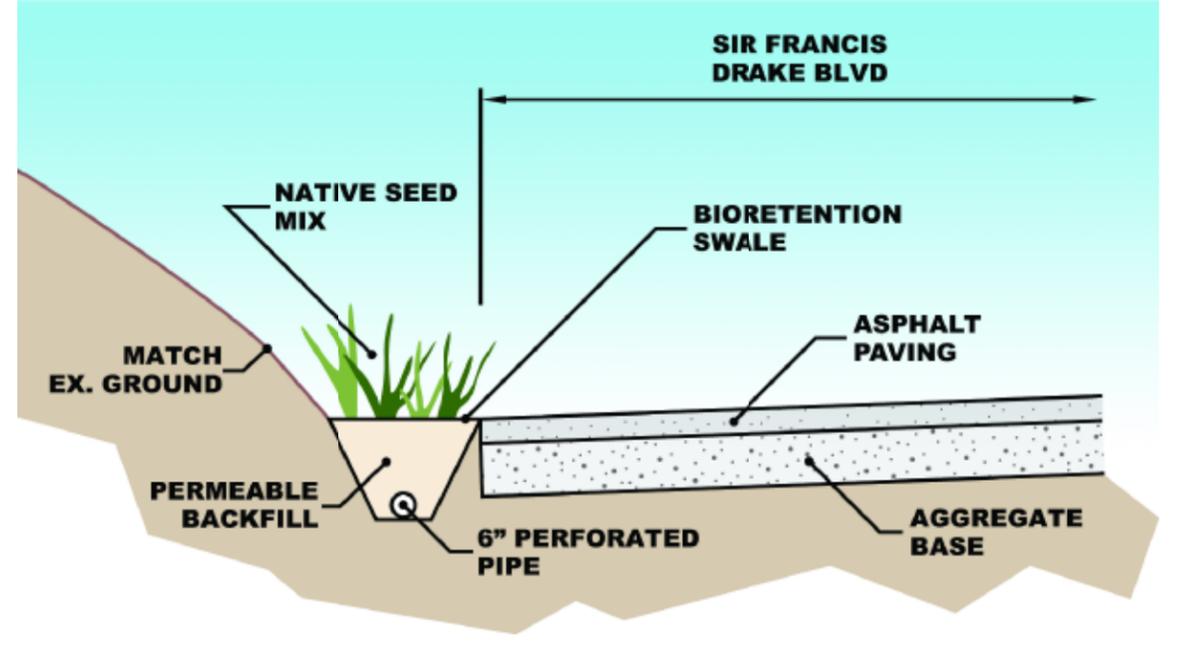
PROPOSED SWALE SECTION

To reduce the inundation of the traveled lanes in locations where the roadway slopes to the existing bank, a sub drain will be installed. As shown in **Figure 8**, a layer of pervious material will allow runoff from the roadway to percolate and be collected into a perforated pipe. The pipe will be connected to the nearest culvert. To reduce the discharge rate from the pipe, a weir or orifice structure may be installed.

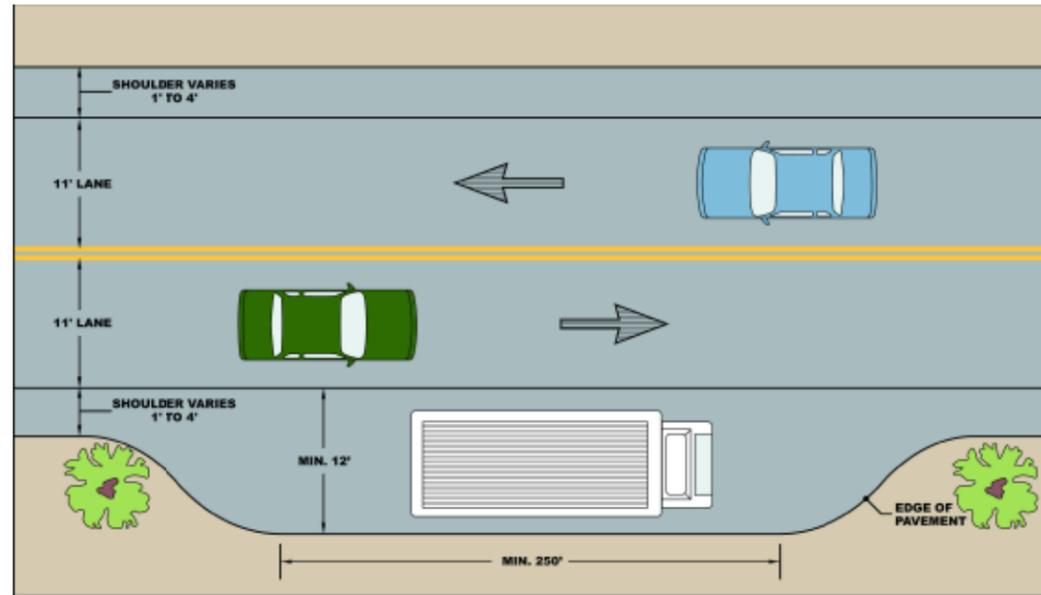
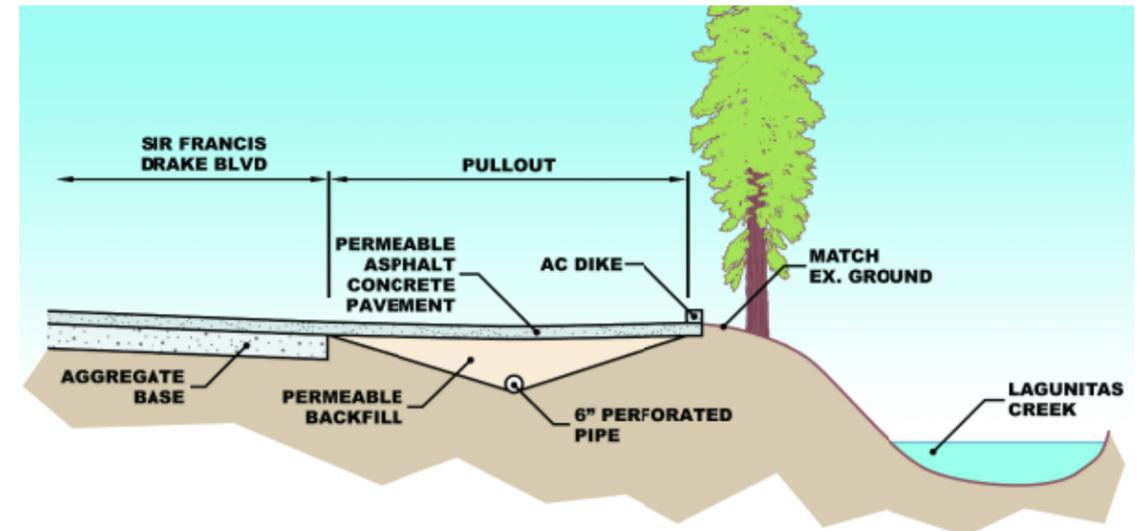
FIGURE 9

TYPICAL PULLOUT

TYPICAL PULLOUT SECTION

To limit sediment discharged from the pullout into the watershed during rainfall, the project proposes to pave these areas with permeable asphalt. Storm water falling on the pullout will percolate through the asphalt, a permeable base, and be collected in a perforated pipe for discharge to the nearest culvert. To reduce the discharge rate from the pipe, a weir or orifice structure may be installed. The parking area at Devil's Gulch will remain in its current condition as an unimproved surface.

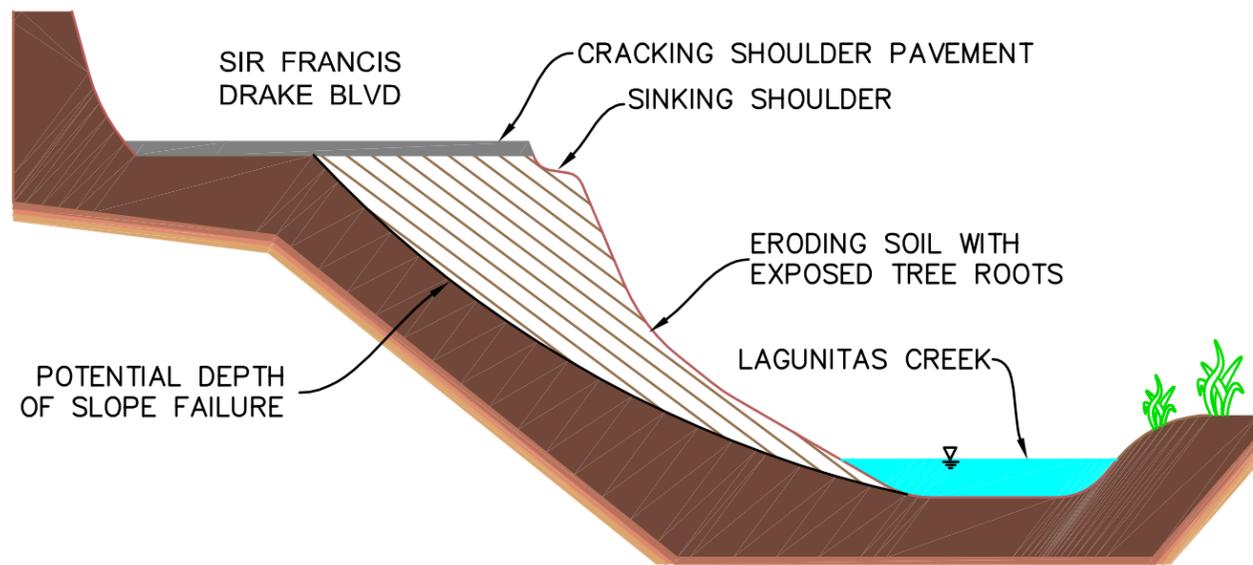
TYPICAL SLOPE FAILURE

At approximate station 270+25, an unstable slope condition is present along SFDB as illustrated in **Figure 10**. Near the toe of slope, erosion can be found which increases instability as illustrated by the sinking shoulder and pavement cracking. The County of Marin Public Works maintenance staff has placed numerous overlays of asphalt but report that the condition has worsened in the last few years.

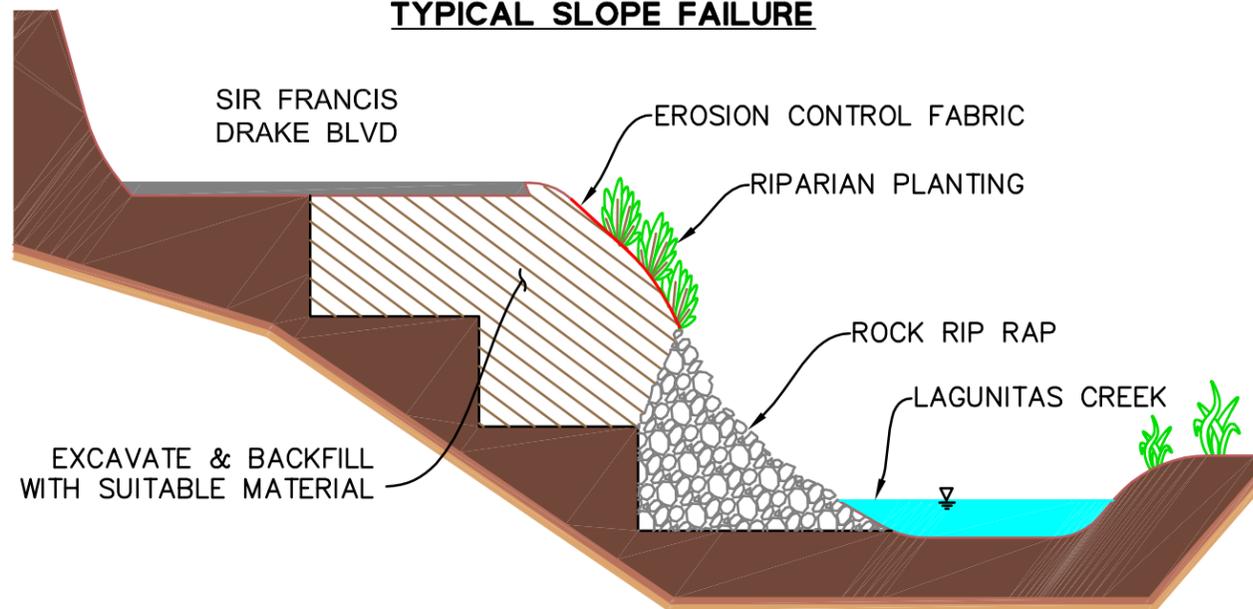
SLOPE REHABILITATION

Much of the erosion appears to be occurring from both an existing culvert that discharges onto the slope and during high flow conditions in Lagunitas Creek. To eliminate the culvert erosion, the culvert will be routed to discharge flow at a lower elevation. Furthermore, the slope will need to be re-constructed to ensure stability. All unstable soil will be excavated to a depth where firm materials are found. Material will be backfilled and compacted in benches as shown in **Figure 10**. It is estimated that 2,000 cubic yards of excavation will be required. Rock rip rap will be placed at the toe

while an erosion control fabric and plants installed along the slope to limit the transport of sediment during high creek flows.

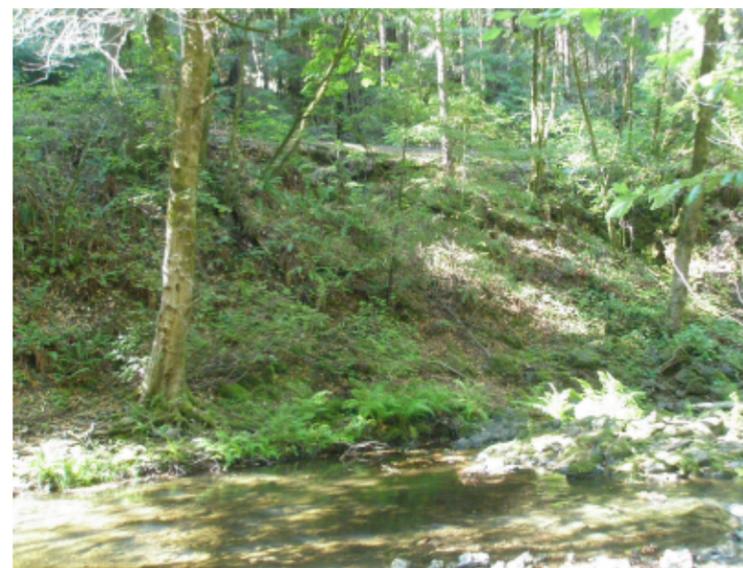
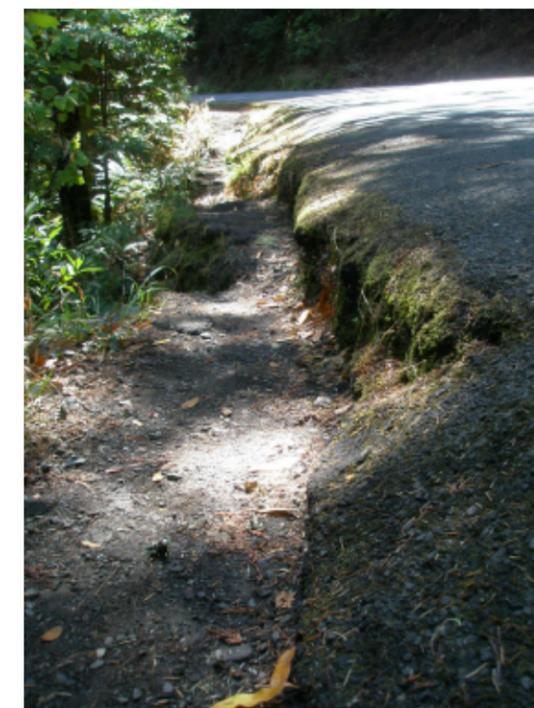
PHOTO 1: SLOPE FAILURE

PHOTO 2: EDGE OF PAVEMENT

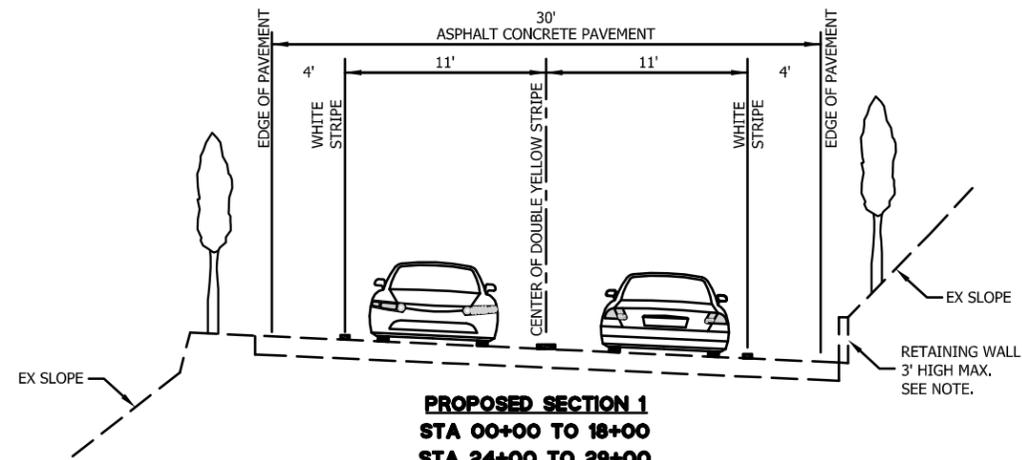
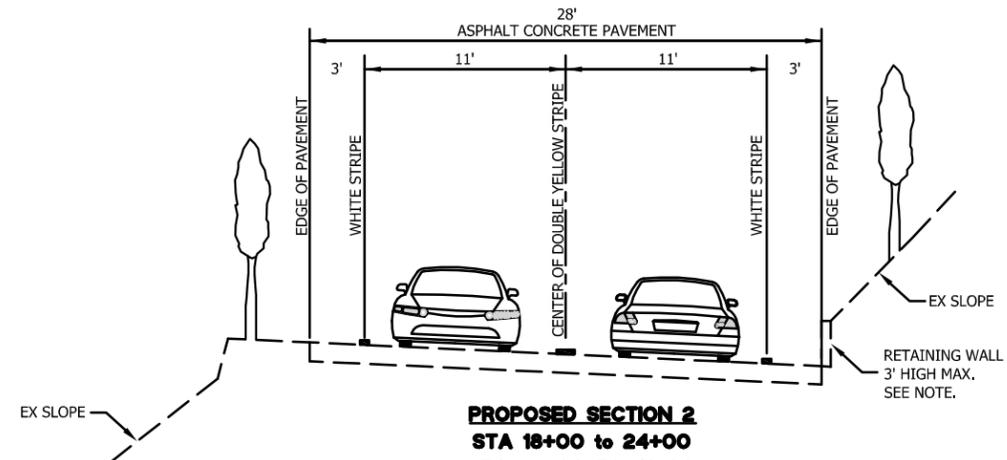
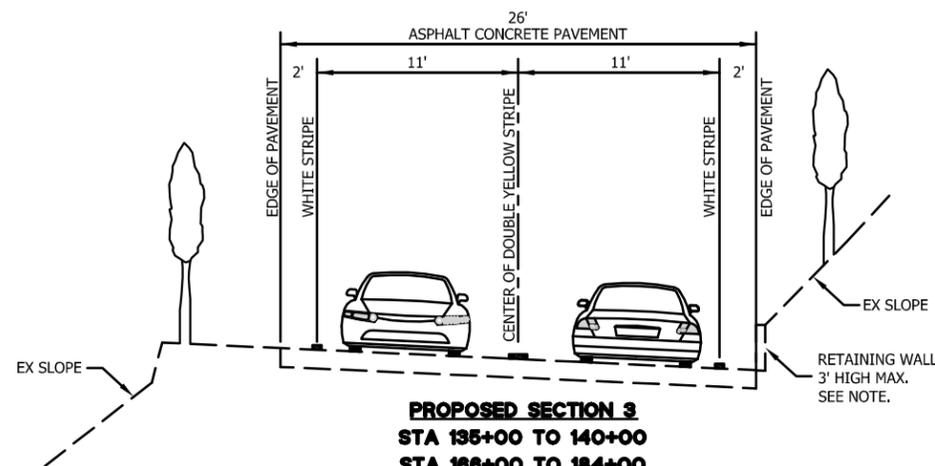
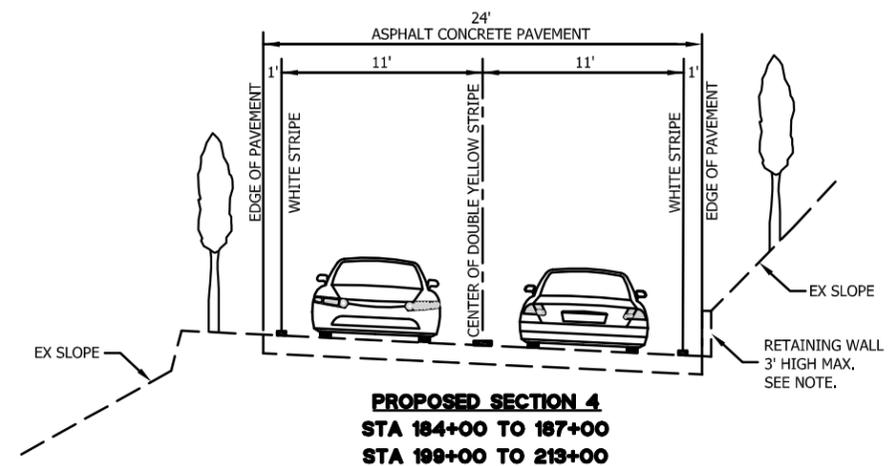
FIGURE 11 PROPOSED PROJECT

PROPOSED SECTION 1
 STA 00+00 TO 19+00
 STA 24+00 TO 29+00
 STA 41+00 TO 50+00
 STA 56+00 TO 68+00
 STA 98+00 TO 135+00
 STA 140+00 TO 157+00

PROPOSED SECTION 2
 STA 18+00 TO 24+00
 STA 29+00 TO 41+00
 STA 50+00 TO 56+00
 STA 68+00 TO 98+00
 STA 157+00 TO 166+00
 STA 187+00 TO 193+00

PROPOSED SECTION 3
 STA 135+00 TO 140+00
 STA 166+00 TO 184+00
 STA 193+00 TO 199+00
 STA 213+00 TO 262+00

PROPOSED SECTION 4
 STA 184+00 TO 187+00
 STA 199+00 TO 213+00
 STA 262+00 TO 280+00

In addition to the pavement rehabilitation, drainage improvements, and pullouts, improvements to the roadway's alignment and width are needed. Where possible, modifications to the horizontal alignment will be made to ensure compliance with design guidelines of the State of California Department of Transportation (CALTRANS) and the American Association of State Highway Transportation Officials (AASHTO). The proposed project improvements are shown in **Figure 11** and summarized in the following table.

This design maintains much of the construction within the existing roadway limits and does not require tree removal or major excavations. To provide for additional shoulder width and to minimize the expansion of the roadway's grading limit, small retaining walls of no more than 3 feet may be provided. The retaining walls could be constructed from concrete or timber lagging.

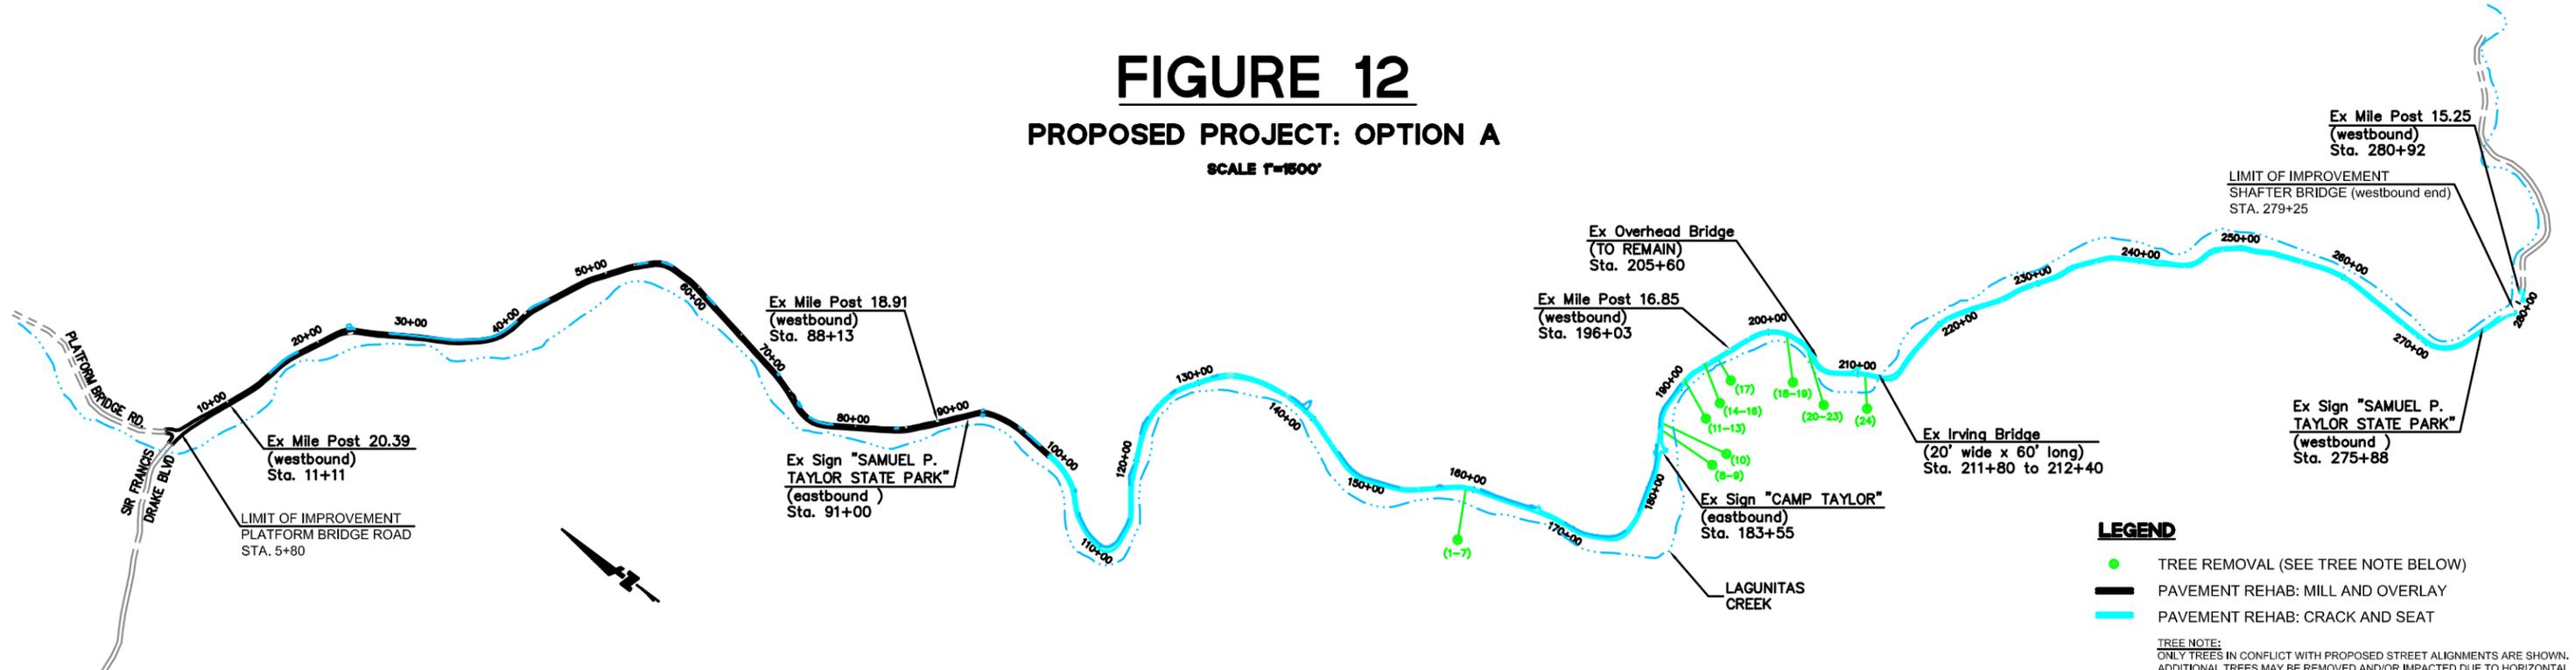
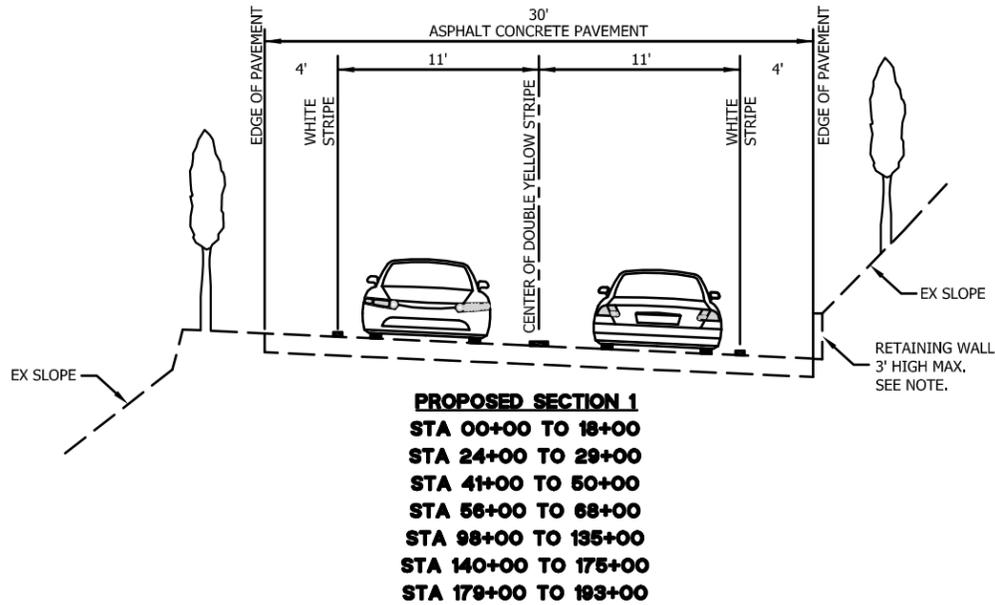
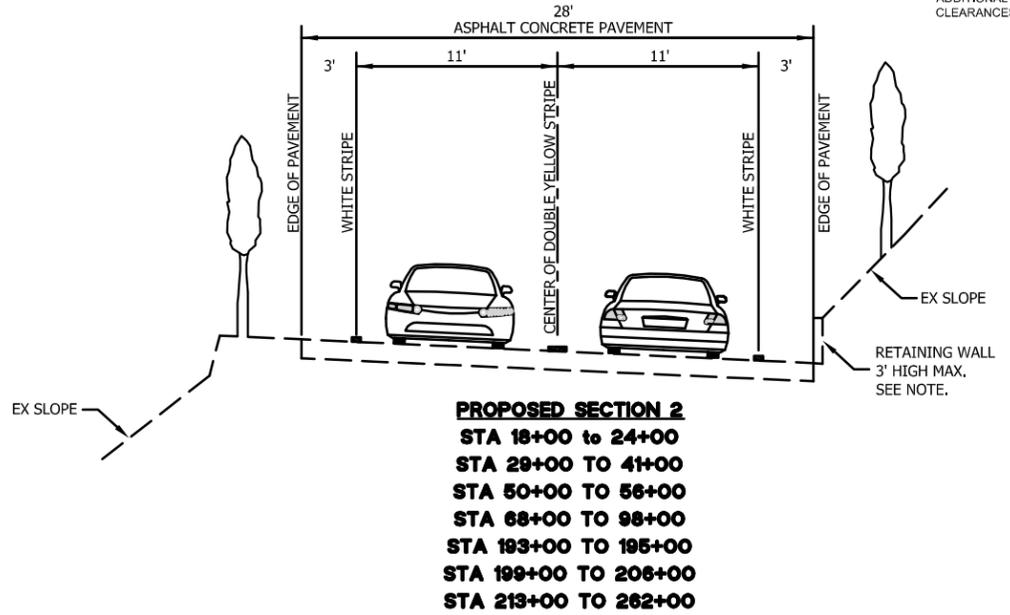
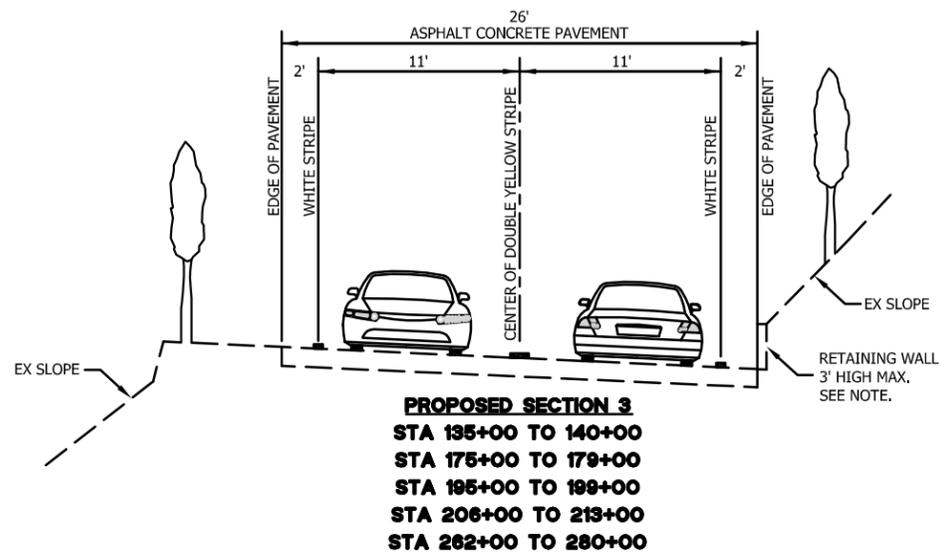
FIGURE 12

PROPOSED PROJECT: OPTION A

To provide additional shoulder area, a more uniform width, and increased sight distance, existing trees located adjacent to the roadway could be removed. If the twenty four trees detailed in **Table 4** were removed, a shoulder width of at least 2 feet could be provided. **Figure 12** illustrates the improvements and is summarized as follows:

To achieve the uniform shoulder width, additional small retaining walls would be required. Additional shoulder width cannot be achieved in other locations along SFDB due to critical topographic constraints. Any further increase in roadway width would create the need to fill portions of Lagunitas Creek and to cut into the existing slopes. As the slopes are very steep, the volume of earthwork would be extensive. Furthermore, this would create the need to remove more existing trees as they would be in conflict with the grading limits.
