Submitted to
Marin County Open Space District
3501 Civic Center Drive
San Rafael, CA 94903

Submitted by
AECOM
1333 Broadway
Suite 800
Oakland, CA 94612
and
Laurel Collins of Watershed Sciences,
Bill Carmen of Carmen Ecological
Consulting, and
Peter Baye of Peter Baye Ecological
Consulting
June 2016

Bolinas Lagoon North End Restoration Project – Site Conditions Report

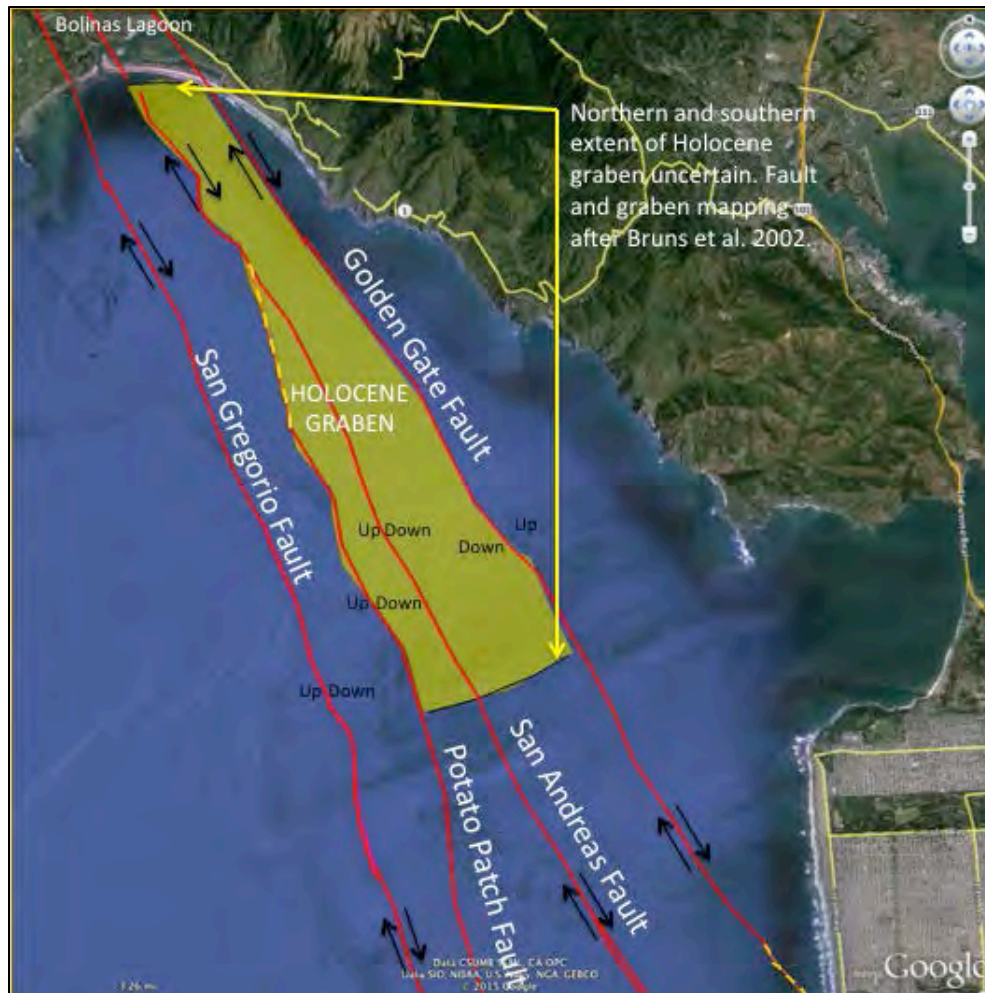
Figure 6. Holocene Graben and Associated Faults

These finding suggest that large local earthquakes induce a "re-set" and deepening of lagoon bottom that increases the depth of the lagoon east of the San Andreas Fault. Byrne and Reidy (2005) report that by year 2050 the combined effects in the north basin of average sedimentation rate (7 mm/yr), auto compaction of sediments (7 centimeters), and sea-level rise (12 centimeters) is not enough to convert the basin to a fresh water marsh.

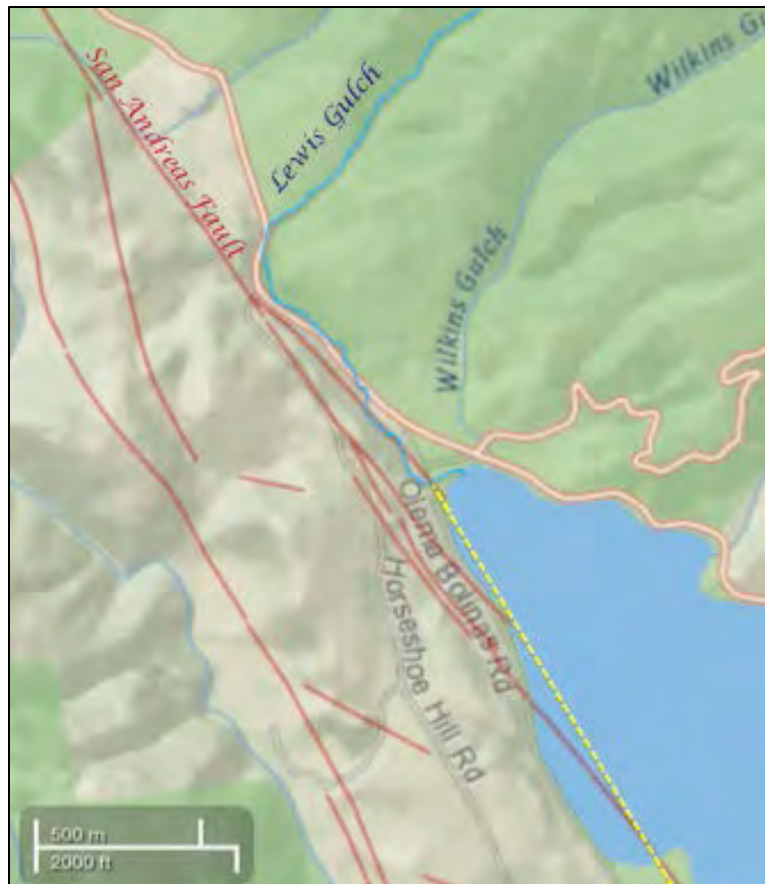
Figure 7. Active Faults near the Study Area

Looking more closely at the geology of the north end of the Bolinas Lagoon, **Figure 7** shows traces of active faults in red as mapped by USGS (2014) near the alignments of SR 1, Olema Bolinas Road, and the crossover road. The alignment of the 1906 fault rupture indicated by Byrne and Reidy (2005) is shown as a yellow dashed line on this map. It does not coincide with the faults mapped by USGS.

The other fault segments shown on **Figure 7** are not named. The exact location of the 1906 rupture of the San Andreas Fault and the Holocene graben is not evident. The locations of faults on this map differ from the other maps shown in this report (and **Attachment B**), indicating that it is unclear where the exact locations of the active and potentially active faults are in the study area. Lewis Gulch Creek has been sketched in **Figure 7**, to show its relation to SR 1 and the fault traces.

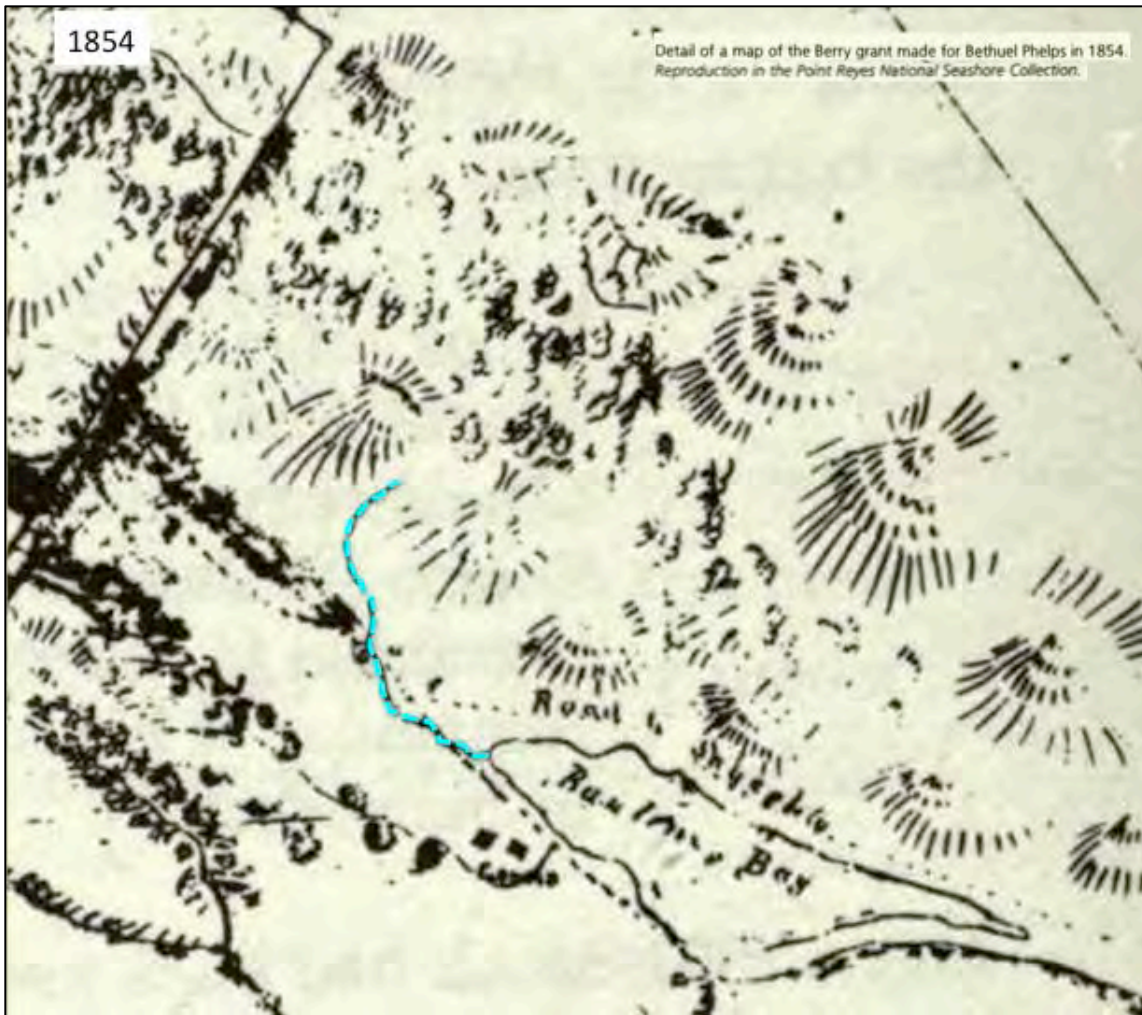
Figure 10. Detail of 1854 Map of the Berry Grant

An enlarged view of an 1854 map (**Figure 10**) shows Lewis Gulch Creek (highlighted in blue) relative to the road to Sausalito. The map indicates that the mouth of the creek was at the northwestern corner of the Bolinas Lagoon), and entered at the head of the alluvial plane that makes up the “Y” area. Analysis of maps and LiDAR imagery suggest that tectonic down-dropping of the graben, and subsequent headward erosion of a previous stream draining into the north end of the Bolinas Lagoon, may be the initial and natural cause of a redirection of Lewis Gulch Creek from a northward flow into present day Pine Gulch Creek and into its current channel. Ruptures along the San Andreas Fault near the head of the Lewis Gulch Creek alluvial fan may also be responsible for redirecting stream flow from the alluvial fan to the present day location against the hillside west of SR 1 where an active fault trace is presumed to be located.

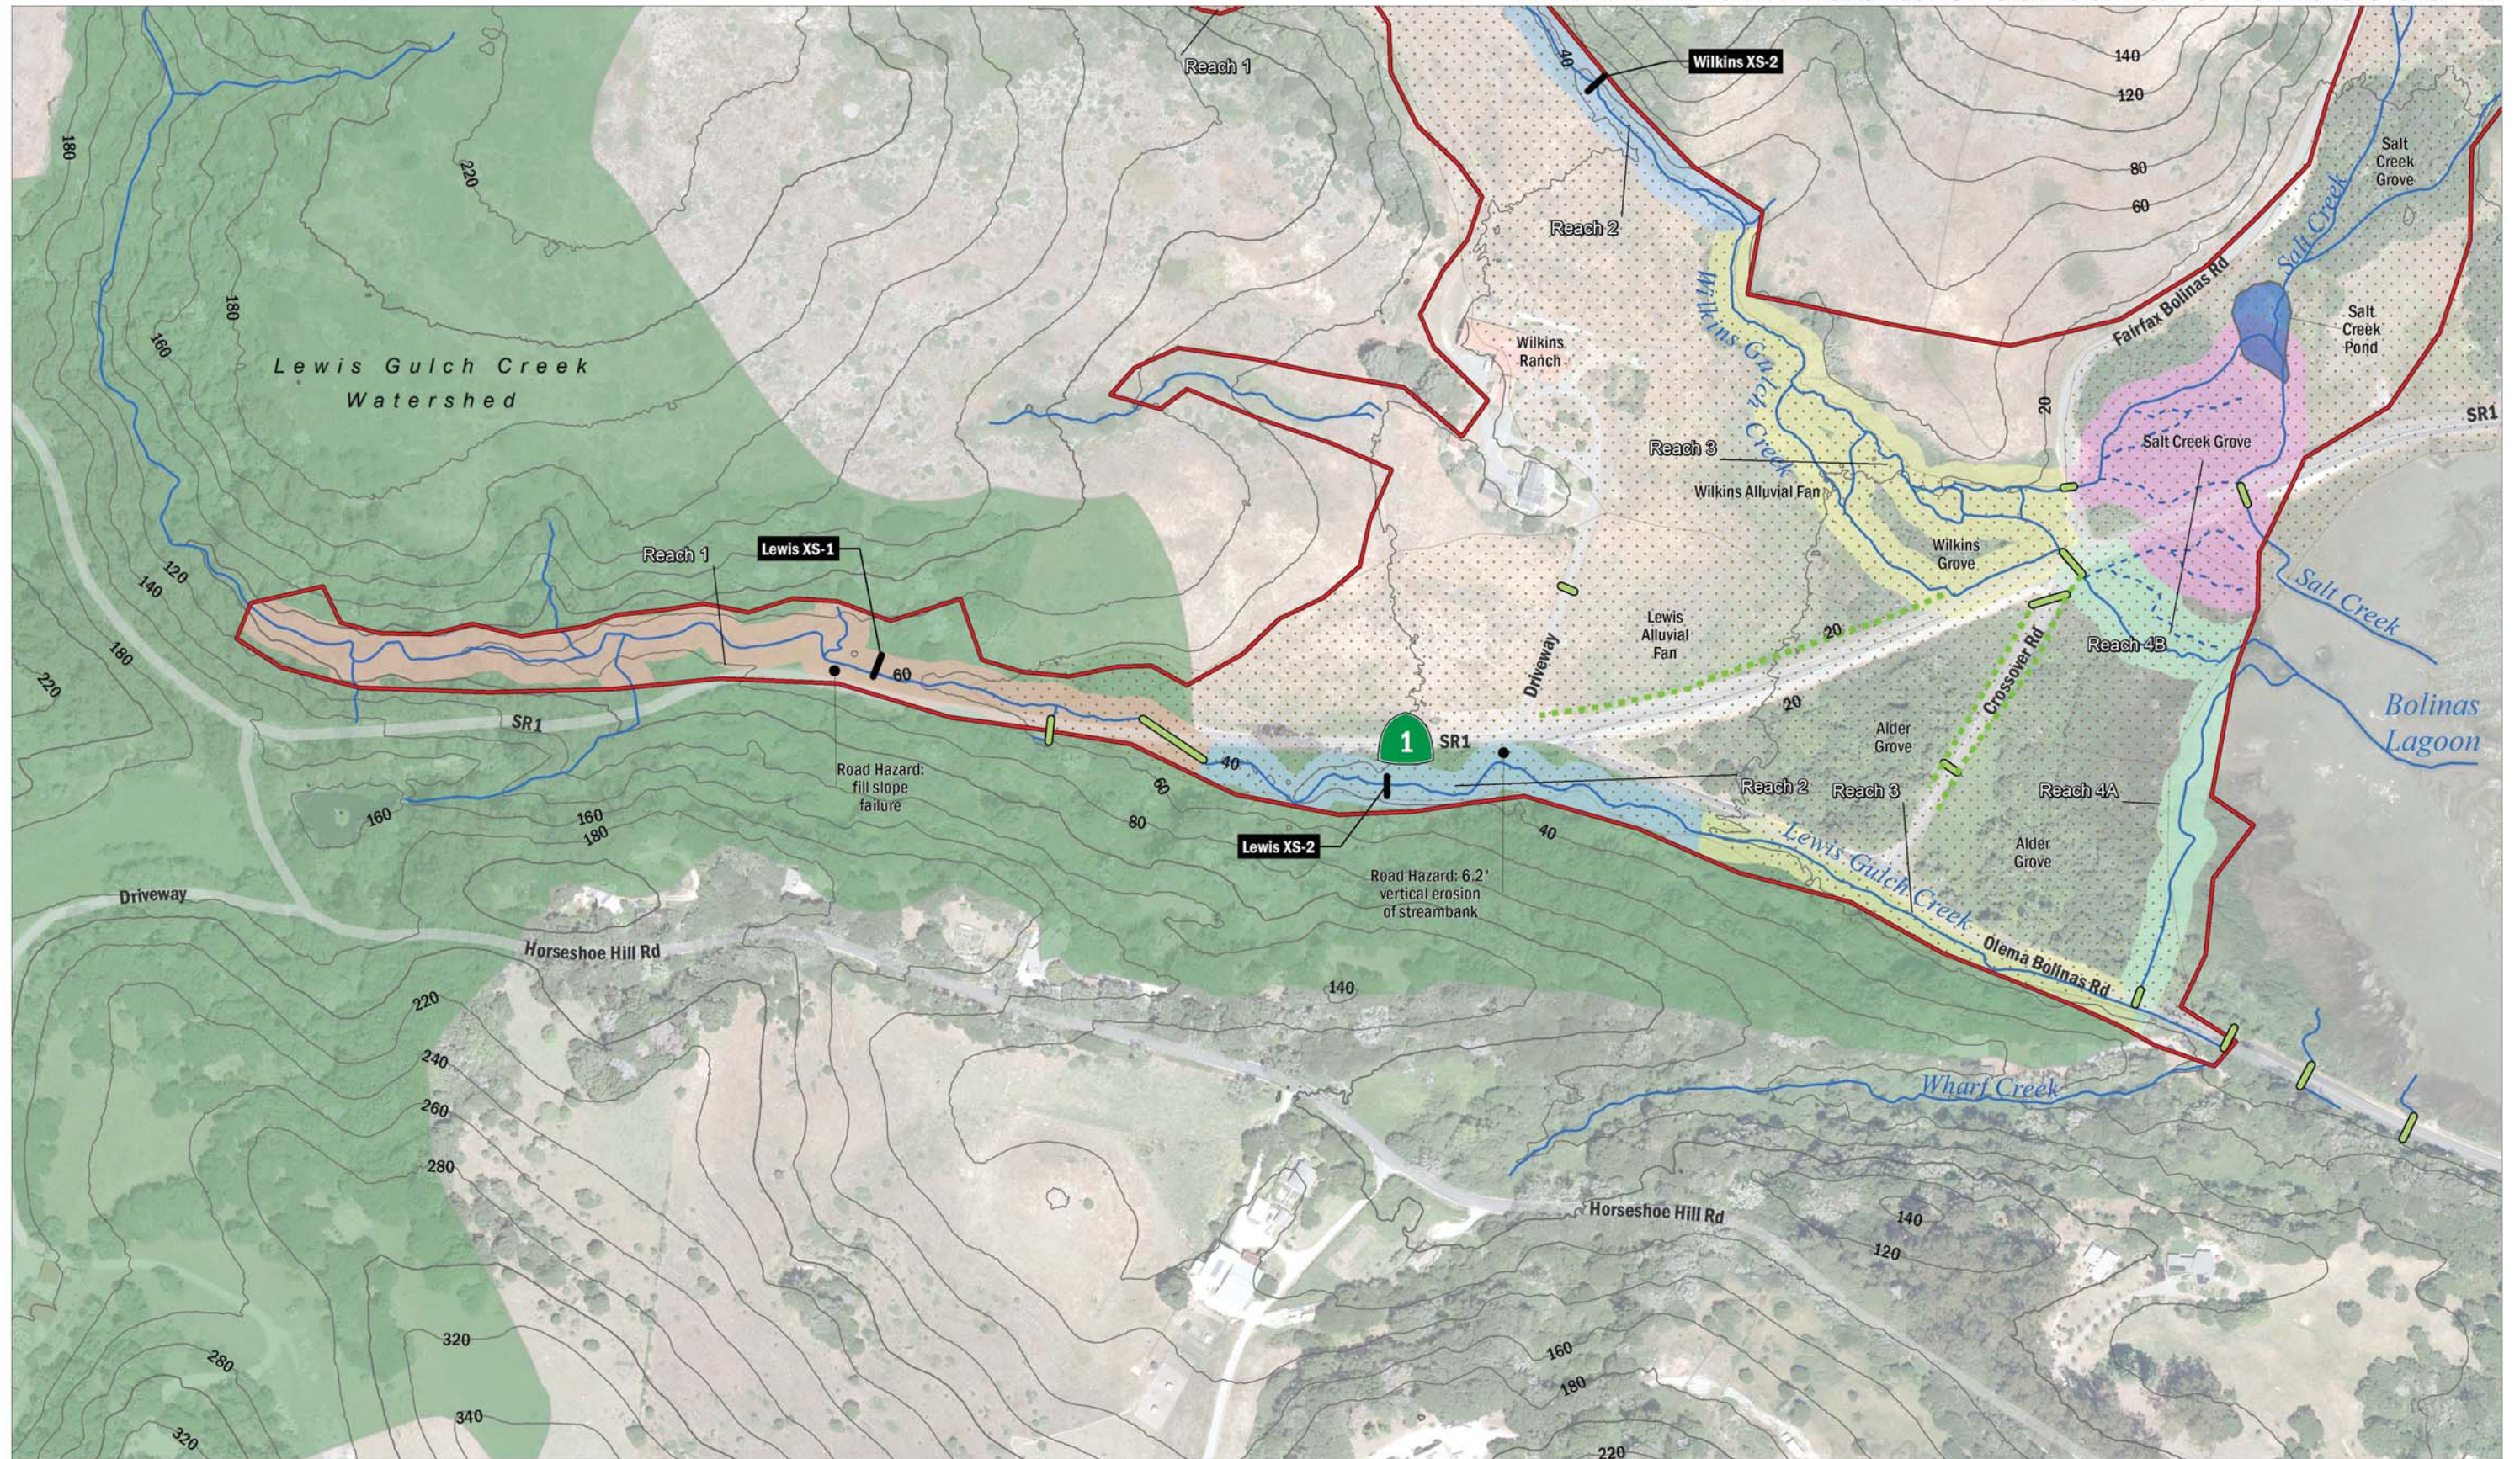
FIGURE 14
Lewis Gulch Creek Watershed

The field survey of Lewis Gulch Creek extended from the Bolinas Lagoon to approximately 1,300 feet upstream of the culvert crossing under SR 1. **Figure 14** shows the stream, the reaches, and other relevant details. The SR 1 culvert crossing is near the head of the inactive alluvial fan. The culvert under SR 1 consists of a 100-foot-long by 58-inch diameter corrugated metal pipe with a paved invert (lined with cement-based slurry). The length of the current creek is divided and described as four reaches.

A cross section and longitudinal profile was surveyed in Reach 1 on Lewis Gulch Creek upstream of the head of the alluvial fan (**Figure 14**). Bankfull hydraulic geometry measurements and discharge calculations based on the survey data are summarized in **Table 5**. The measurements were taken upstream of the alluvial fan to best characterize the stream bankfull flow and hydraulic geometry before streamflow infiltrates into the alluvial fan. Similar to Wilkins Gulch Creek, without the influence of the alluvial fan, the Lewis Gulch Creek field data can be compared to regional stream data or curves. Based on the drainage area upstream of the cross section location, the regional curve data

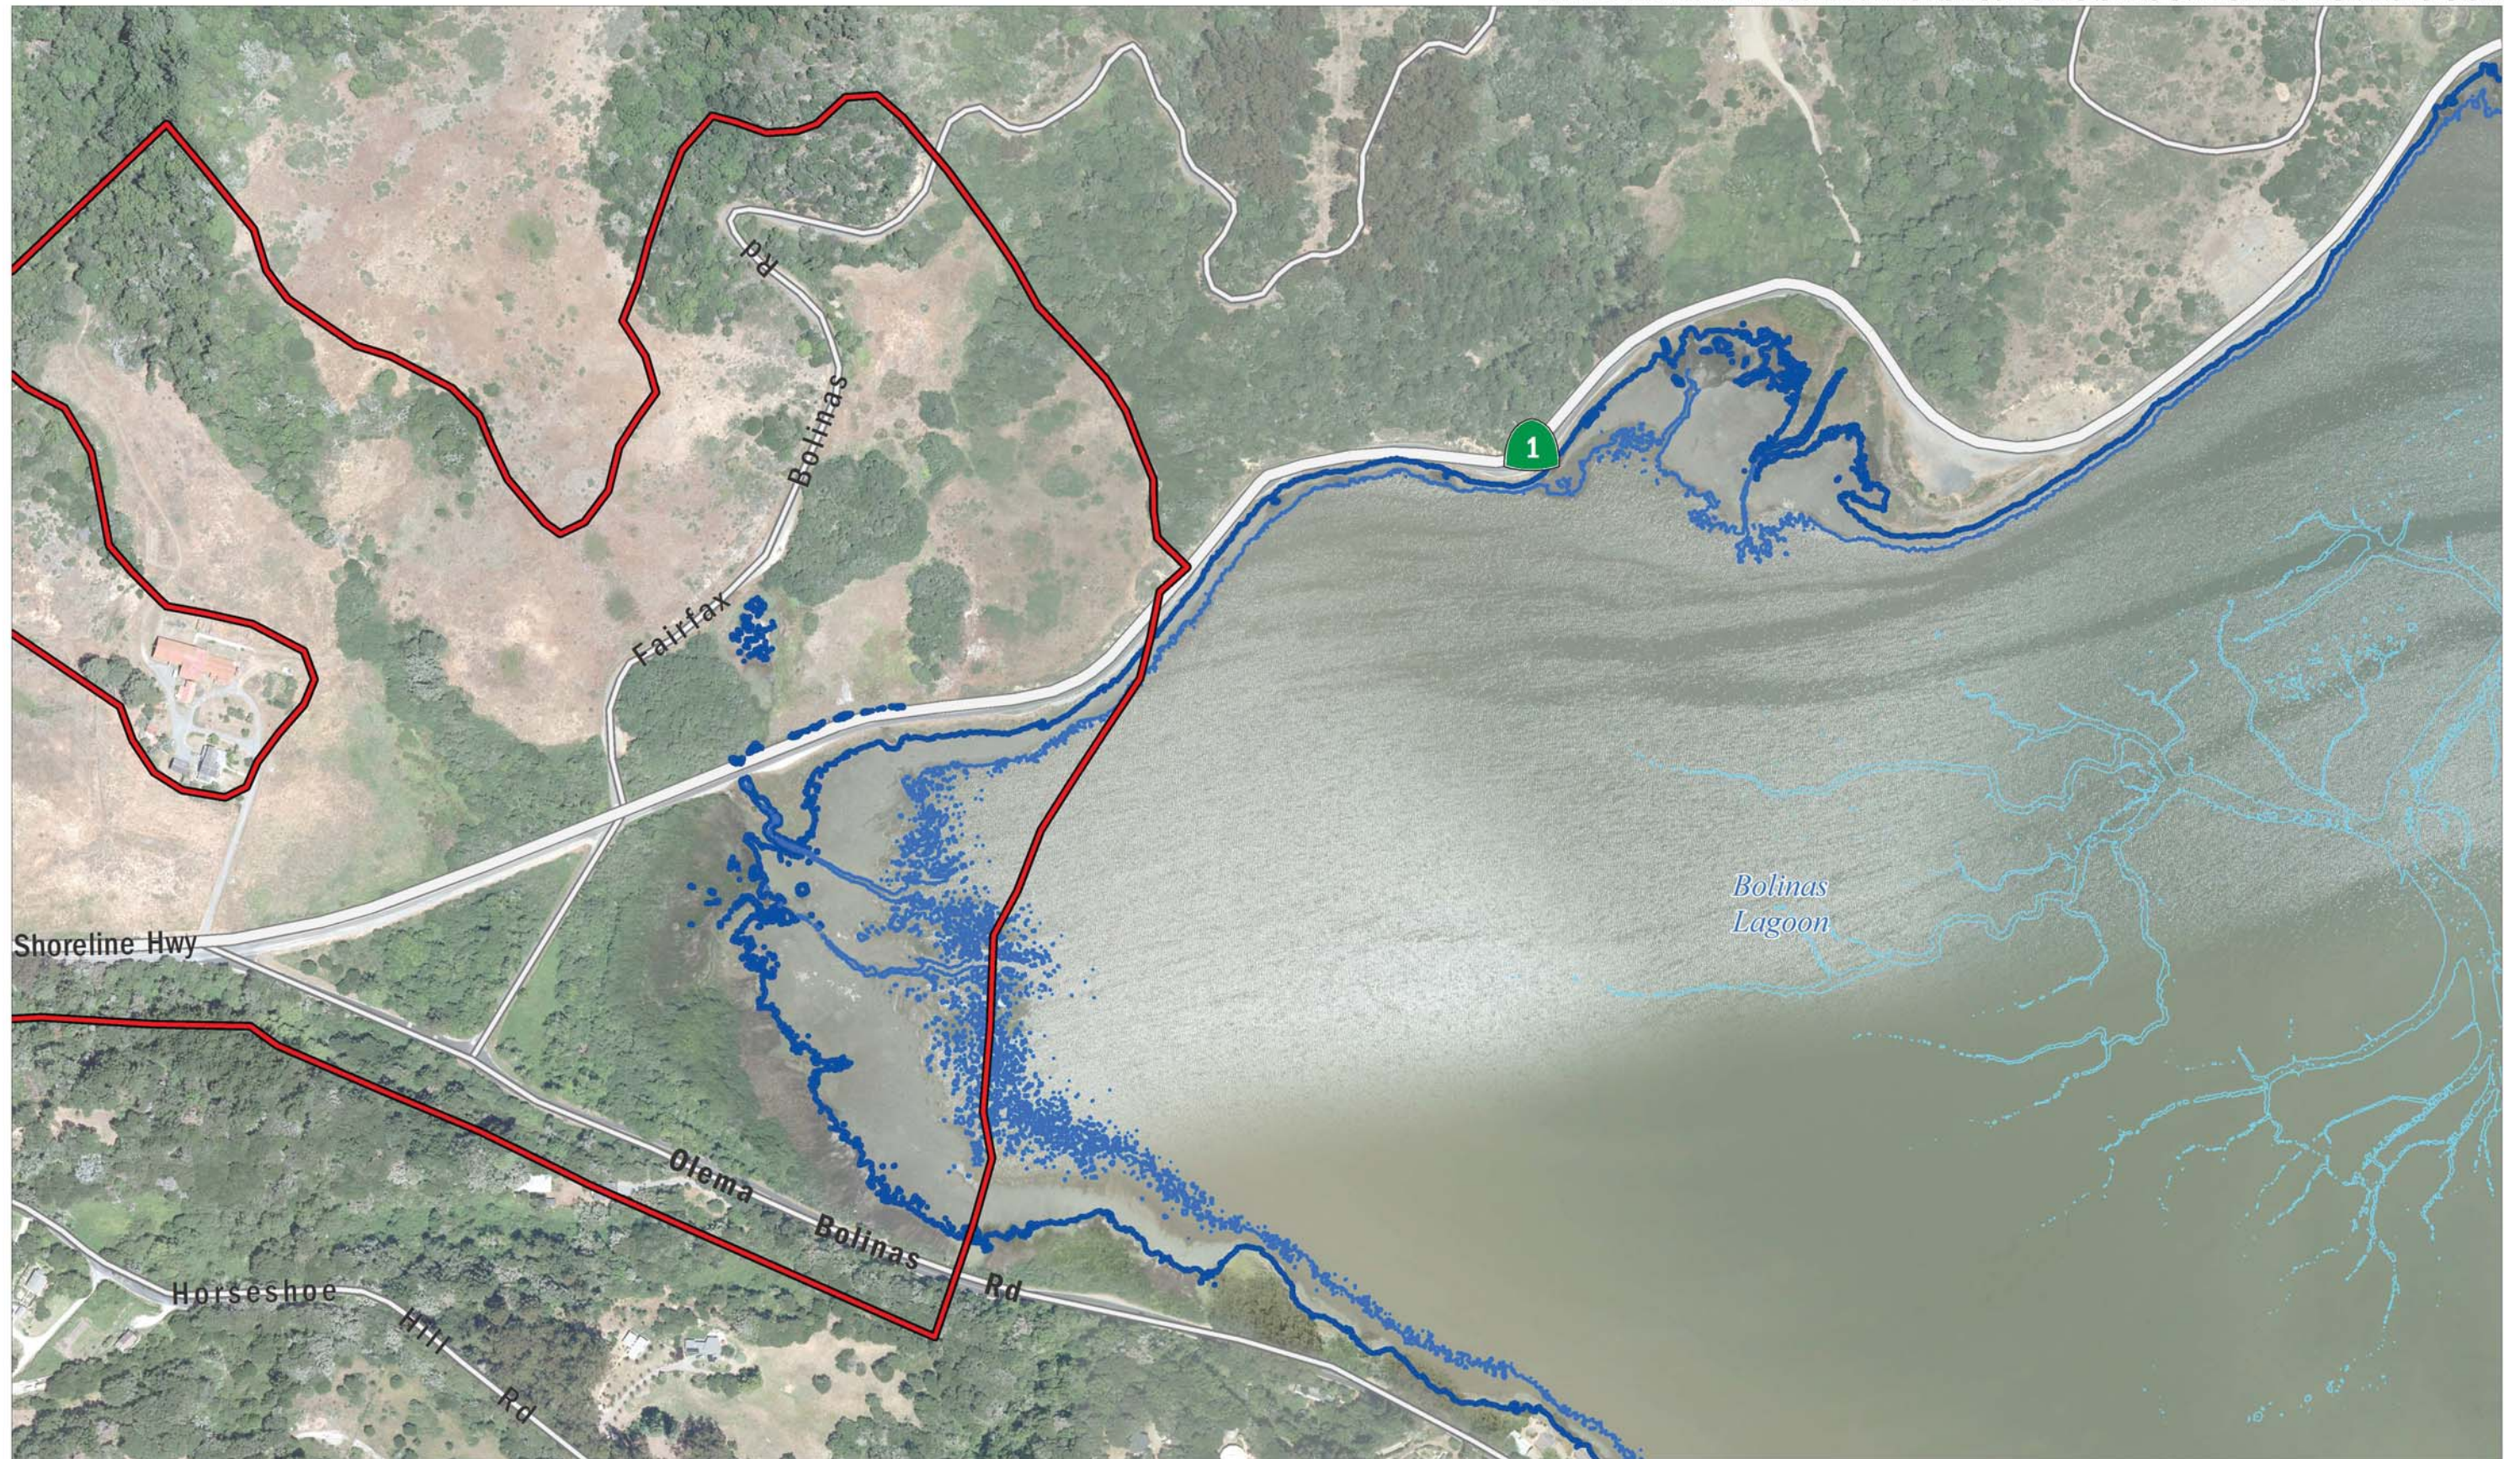
FIGURE 17
Tidal Range

Both tidal range and freshwater inputs influence the habitat types that occur within the study area. The most significant feature within the study area is the Bolinas Lagoon; **Figure 17** shows tidal range, MLLW, MSL, and MHHW within the study area.

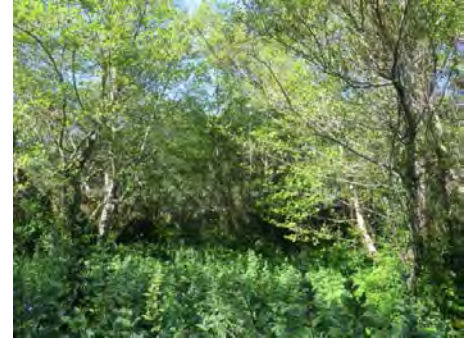
Within the study area, red alder forest is abundant along streams and riparian floodplains northwest of Bolinas Lagoon. It contributes a total of 5.91 acres within the study area (5.76% of the study area) and is the predominant alliance within the Lewis Gulch Creek floodplain. Red alder forest in the study area appears to be moist for most of the year, having saturated soils in summer and containing areas of flowing water into late spring. Red alder forest within the study area often share boundaries with arroyo willow thickets and coast live oak woodland, and are separated as a community wherever alder is the most abundant tree in the highest canopy, generally forming about 35% absolute cover within the community, and 50-100% of the canopy. The red alder forest is ranked as S4, and is not considered a special-status community within the state of California. It is considered a riparian community and protected under Sections 1600-1603 of the State Fish and Game code. It may also be considered a jurisdictional wetland depending upon soil and hydrology conditions.

In this alliance in the study area, red alder (*Alnus rubra*) trees are typically between 8 and 12 inches DBH and co-dominant with arroyo willow (*Salix lasiolepis*), which form the shrub layer. Throughout the study area, the understory of red alder forest is very dense, reaching up to 100% cover, not including the shrub and tree canopy. In addition to smaller willows, the ground layer supports shade-tolerant freshwater marsh species in perennial wetland depressions (small-fruited bulrush, *Scirpus microcarpus*; water pennywort, *Hydrocotyle ranunculoides*; smartweed, *Persicaria punctata*; water-parsley *Oenanthe sarmentosa*) and relatively mesic. Seasonal wetlands under alder canopy support dense stands of stinging nettle (*Urtica doica*), California bee plant (*Scrophularia californica*), California blackberry (*Rubus ursinus*), and rushes (*Juncus* spp.). Open gaps along alder grove margins support white alder (*Alnus rhombifolia*), redroot umbrella sedge (*Cyperus eragrostis*), fringed willowherb (*Epilobium ciliatum*), horsetail (*Equisetum* spp.); and non-native poison hemlock (*Conium maculatum*), wild radish (*Raphanus sativus*), Fuller's teasel (*Dipsacus fullonum*), docks (*Rumex* spp.), and cattail (*Typha latifolia*).

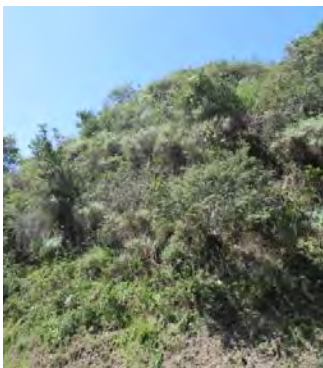
In the study area, California sagebrush scrub is found in patches between grasslands and oak woodland, where it intersperses with the *Baccharis pilularis* shrubland alliance and *Quercus agrifolia* forest alliance. It comprises a total of 1.06 acres within the study area (1.03% of the study area). It is visible on steep cliff sides, including above SR 1, on the eastern side of the study area. The community occurs exclusively within the Coast Ranges of the California Floristic Province. California sagebrush scrub is ranked as S5, and therefore is not a special-status vegetation community in California.

In the study area, vegetation in this alliance is often dense, with as much as 80% absolute cover of all vegetation. Shrubs form about 70% of this vegetation, and 60% of these are California sagebrush (*Artemisia californica*). Other shrub species within the community include non-native French broom (*Genista monspessulana*), toyon (*Heteromeles arbutifolia*), and poison oak (*Toxicodendron diversilobum*). In spite of the presence of French broom, this alliance contains a high diversity of native species within the study area, including California blackberry, woodland strawberry (*Fragaria vesca*), morning glory (*Calystegia* sp.), soap plant (*Chlorogalum pomeridianum*), blue dicks (*Dichelostemma capitatum*), Douglas iris (*Iris douglasiana*), and Galiums (*Galium* spp.). Where it occurs on roadcuts or adjacent to disturbances, the alliance is often surrounded by non-native annual grasses.

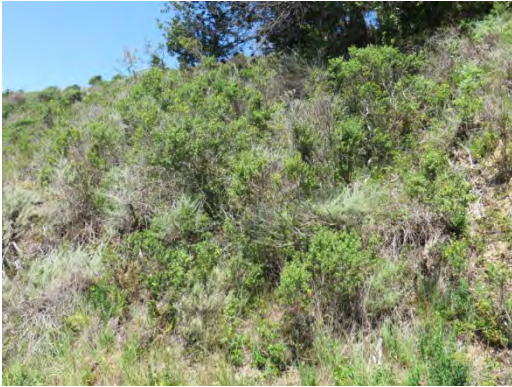
Within the study area, coyote brush scrub is found on ridges, rocky outcrops, and areas between forest and grasslands. In some areas, it may even grow adjacent to wetlands and moist ravines. Coyote brush scrub is ranked S5, and therefore is considered a common plant community within the State of California. It comprises of 5.16 acres of the study area (5.03% of the study area).

In the study area, cover in this community is often dense, forming 90% absolute vegetative cover, of which 75% consists of woody shrubs. Coyote brush (*Baccharis pilularis*) has about 45% absolute cover and covers about 60% of the woody layer. Minor shrubs and forbs found in

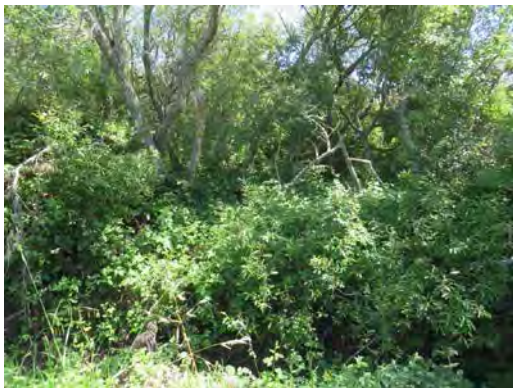
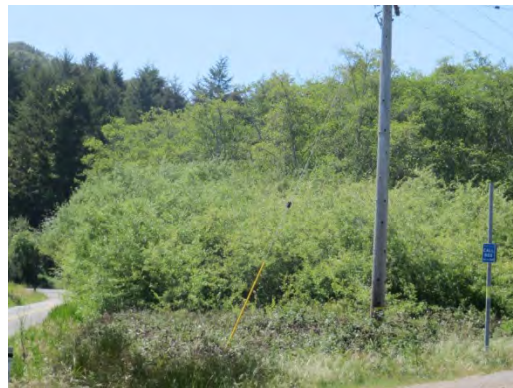
Within the study area, arroyo willow thickets are abundant on riparian floodplains, on the edges of creeks and swales, and fringing the forests west of Bolinas Lagoon. It accounts for a total of 10.30 acres of the study area (10.03% of the study area). Willow thickets also dominate the upper edges of the tidal marsh, behind alkali-bulrush (*Bolboschoenus maritimus*) marsh, within the study area. The alliance often occurs in association with the *Alnus rhombifolia* forest alliance and the *Quercus agrifolia* forest alliance, and intergrades with both. In spite of overlap between the dominant species, the areas of overlap tend to be narrow and arroyo willow groves stand out. This alliance is the most abundant woody community within the study area. *Salix lasiolepis* shrubland is ranked S4, and is not considered a special-status plant community in California.

The arroyo willow thickets in the study area are dense, reaching over 150% absolute cover. Approximately 80% of this cover is in the canopy layer and is almost exclusively composed of arroyo willow ($\leq 75\%$). The canopy layer may contain emergent red or white alder (*Alnus* spp.) (at around 5%); however, these alders are typically immature. By contrast, mature arroyo willows are abundant in the red alder forest alliance understory. Additional species found in the understory in the study area include California blackberry, which forms dense brambles below the willows; or an assortment of hardstem bulrush, sedges (*Carex* spp.), rushes (*Juncus* spp.), redroot umbrella sedge, fringed willow herb, horsetail, sword fern (*Polystichum munitum*), and giant chain fern (*Woodwardia fimbriata*). Non-native poison hemlock, wild radish (*Raphanus sativus*), Fuller's teasel, docks (*Rumex* spp.), and broadleaf cattails (*Typha latifolia*) are common along the margins of the community, where it is adjacent to grassland.

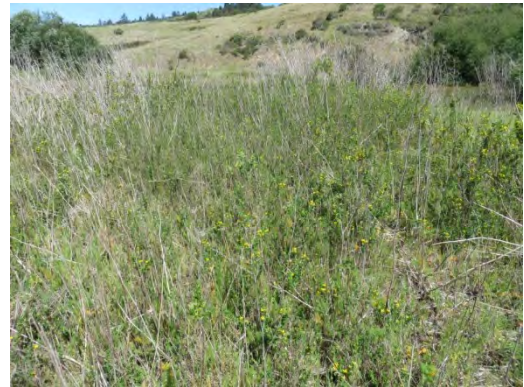
Broom semi-natural shrubland stands within the study area are exclusively dominated by shrubby French broom, and therefore referred to as “French Broom Scrub” (and shown on Figure 5 as “Broom Patches (FBS)”). French broom scrub occurs in disturbed or semi-disturbed areas within the study area, such as above SR 1 on the northern shore of Bolinás Lagoon, and adjacent to ruderal and grassy areas throughout the study area. In total, it accumulates to 0.60 acres of the study area (0.58% of the study area). It has also invaded more interior areas, including hillsides above Wilkins Gulch Creek. French broom is a Cal-IPC High-listed invasive weed, considered to have high potential for negative impact on native ecosystems.

In the study area, French broom forms 65% absolute cover, and 65% relative cover within the French Broom Scrub community. It intergrades with California annual grassland, ruderal habitat, and sometimes coyote brush scrub and coast live oak woodland. The stands contain 95% vegetative cover, mostly consisting of understory species. It is often the sole woody plant within the alliance, composing 65% absolute cover of the canopy and 100% relative cover of weedy broom species. In some cases, Spanish broom (*Spartium junceum*), Scotch broom (*Cytisus scoparius*), coyote brush, and other woody shrubs may occur on the fringes of this alliance. Much of the French broom scrub within the study footprint appears young, not reaching over 100% absolute cover, as it may when the shrubs are mature and overlapping. The understory of the community includes fennel (*Foeniculum vulgare*), and various weedy, non-native species including teasel, biennial flax (*Linum bienne*), soft brome (*Bromus hordeaceus*), big rattlesnake grass (*Briza maxima*), little rattlesnake grass (*Briza minor*), rough cat's ear (*Hypochaeris radicata*), soft cat's ear (*Hypochaeris glabra*), and false broom (*Brachypodium distachyon*). Native salt grass (*Distichlis spicata*), particularly in areas along SR 1, immediately adjacent to the lagoon, where salt grass is dominant, and California ponyfoot (*Dichondra donnelliana*) may be found in densities up to 5% within French broom scrub.

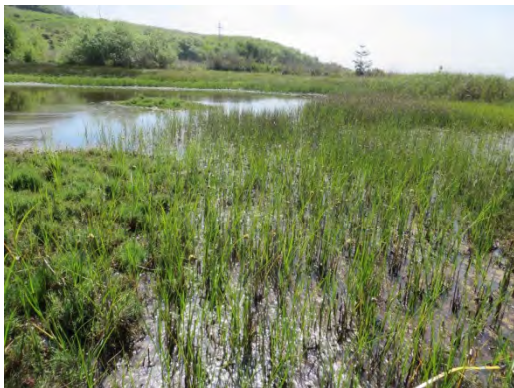
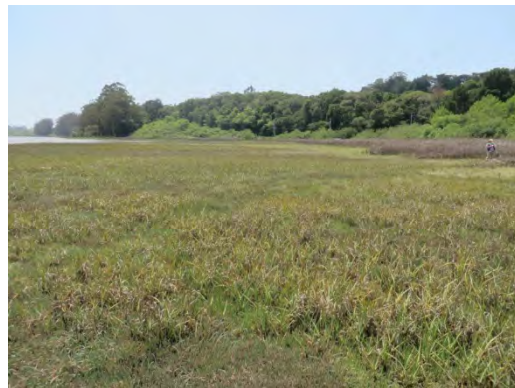
In the study area, salt marsh bulrush marshes are among the most abundant alliances, forming a continuous strip between the more freshwater cattail marsh or arroyo willow thickets to the west and

the more littoral pickleweed mats and salt grass flats. Alkali-bulrush marshes are also found around the pond. A total of 2.54 acres of the study area is considered alkali-bulrush marshes (2.47% of the study area). The alliance is ranked S3 by the State of California and is considered to be a threatened special-status plant community.

Within the study area, the alliance forms comparatively productive, dense, and tall single-species stands, which typically indicate low salinity stress (oligohaline to mesohaline marsh soil porewater salinity). Alkali-bulrush stands elsewhere in Bolinas Lagoon tidal marshes are associated with brackish transition zones of groundwater seepage discharge zones or stream mouths. Vegetative cover within the community, within the study area, is approximately 70%; the remaining 30% is composed of mud or water. The stands are formed almost exclusively of native species, pickleweed (*Salicornia pacifica*), salt grass, dune rush (*Juncus lescurii*), common spikerush (*Eleocharis macrostachya*), and saltbrush (*Atriplex patula*). Salt marsh bulrush is visually dominant (standing anywhere from 1 decimeter to 2 meters tall) and overshadows the vegetation below. An observed minor species and non-native species identified with this alliance is jaumea (*Jaumea carnosa*), and creeping bent-grass (*Agrostis stolonifera*), respectively.

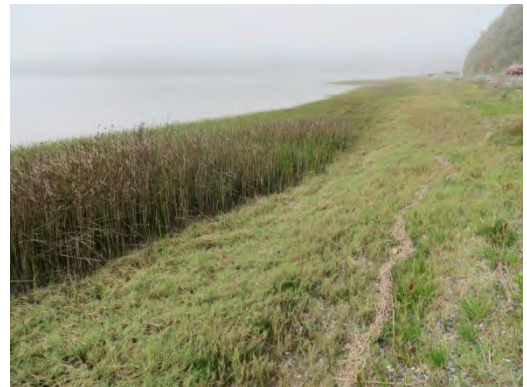
Within the study area, salt grass flats are abundant on the tidal flats of Bolinas lagoon, and the adjacent muddy shores. The community forms discontinuous patches between pickleweed mats and salt marsh bulrush marshes. A small patch of the community is also present at the pond. The extent of salt grass flats within the study area adds up to 1.79 acres (1.74% of the study area). The alliance is ranked S4 by the State of California, and therefore is not a special-status plant community.

Where it was examined in the study area, salt grass flat contained 100% vegetative cover, 90% of which was salt grass (both absolutely and relatively). Salt marsh bulrush, jaumea, pickleweed, silverweed cinquefoil (*Potentilla anserina*; syn. *Argentina egedii*), and fathen were also present in Salt Grass Flats. The density of salt grass flats is variable, as it intergrades freely with pickleweed marshes. Along the fringes, where it is closest to the tidal lagoon, it often occurs in mixed stands with multiple salt marsh or brackish marsh plants.

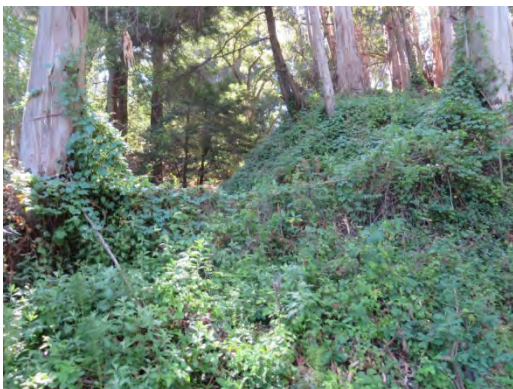
Within the study area, Eucalyptus groves are the dominant community type along SR 1, from the intersection of Horseshoe Hill Road and SR 1 north. The eucalyptus trees in these groves are the largest trees within the study area, both in terms of diameter and height. Trees immediately beside the road averaged in size from 18-30 inches DBH. Larger individuals, measuring more than 40 inches DBH were visible on steep slopes east of Hwy 1 in inaccessible portions of the study area. A total of 1.08 acres of the study area are Eucalyptus groves (1.05% of the study area). Eucalyptus groves are dominated by blue gum (*Eucalyptus globulus*) which is considered to be a moderate threat by Cal-IPC (2006), and therefore is not a special-status plant community.

Eucalyptus groves in the study area contain as much as 120% absolute cover, with blue gum supporting 60% or more of this cover. Although eucalyptus groves typically have a high buildup of litter in the understory (leaves, seeds, and twigs that can suppress growth of understory plants) litter does not appear to persist on the ground in the study area as extensively as in nearby areas. Eucalyptus groves in the study area support an understory that includes some natives, such as California coffeeberry (*Frangula californica*),

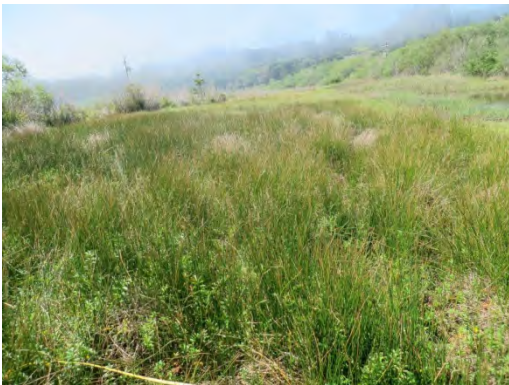
Within the study area, salt rush, Baltic rush, and Mexican rush stands are common in dense patches in brackish tidal marsh edges (*J. lescurii* and *J. balticus*) and seasonal wetlands of adjacent lowland meadows (*J. mexicanus* and *J. balticus*), totaling 0.83 acres of the study area (0.81% of the study area). They tend to have a high vegetative cover (90%), of which the rush comprises 60% absolute cover, and over 50% relative cover. A fair amount of persistent standing leaf litter is present and covers up to 10% of the community. Many rush stands are nearly single-species or single-dominant vegetation. Associated species include water parsley, silverweed cinquefoil, docks (*Rumex* spp.), water smartweed (*Persicaria* sp.), and (in upland areas), annual and perennial grasses and sedges. Baltic and Mexican rush marshes is ranked as S4, and is therefore not considered a special-status plant community.

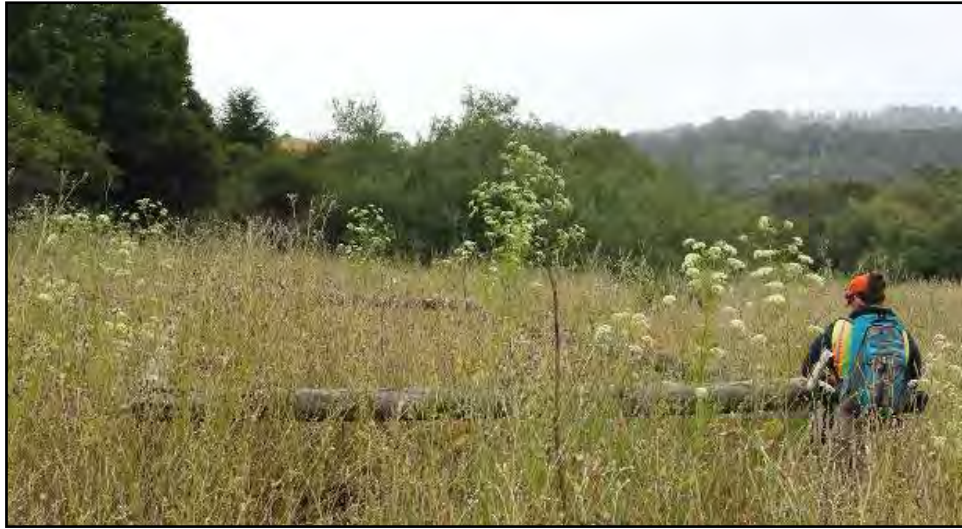
Photo 1. Wooden corral (NorthEnd#1)

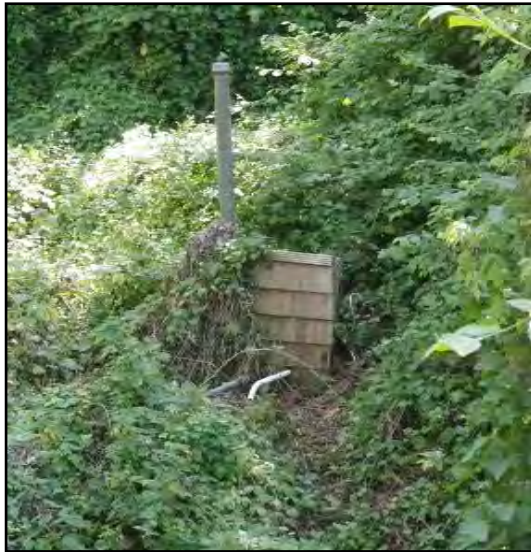
Photo 2. Pump house (NorthEnd#2)

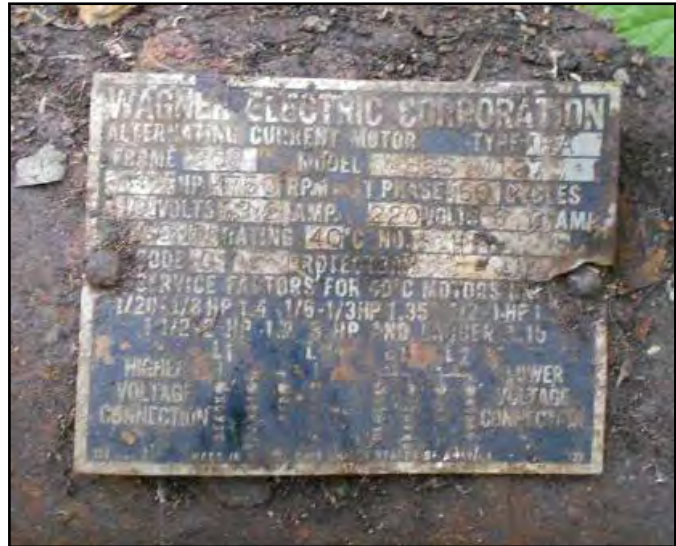
Photo 3. Face plate on pump motor (NorthEnd#2)

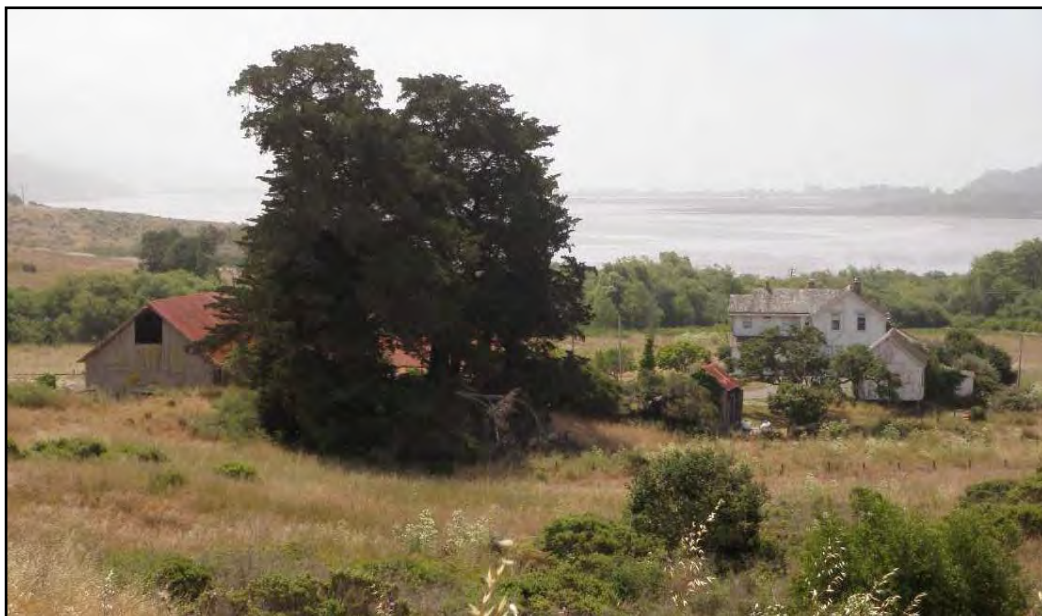
Photo 7. Wilkins Ranch (NorthEnd#6)

- **Wilkins Ranch, which is outside the current study area, but within the viewshed of the study area (NorthEnd#6, Photo 7):** NorthEnd#6 is the Wilkins Ranch, located between Wilkins Creek and SR-1, north of the Bolinas "Y" (Photo 7). The ranch complex, which includes a farmhouse, several barns, and other outbuildings was constructed in the late 1800s (Livingston 1995:79).

The Wilkins Ranch (NorthEnd#6), which is outside the current study area and was not formally surveyed or documented, is within the viewshed of the future project. The ranch complex—with the original barn built in 1866 and the main ranch house built in 1875 (Livingston 1995)—is one of the oldest extant ranch complexes in the area, and is directly associated with the early lumber and farming history of the Bolinas/Dogtown area. As such, it may qualify for inclusion in the CRHR or NRHP. Development of the future project design and alternatives should carefully consider the potential for indirect (visual, vibration, etc.) effects to the Wilkins Ranch complex. Although the

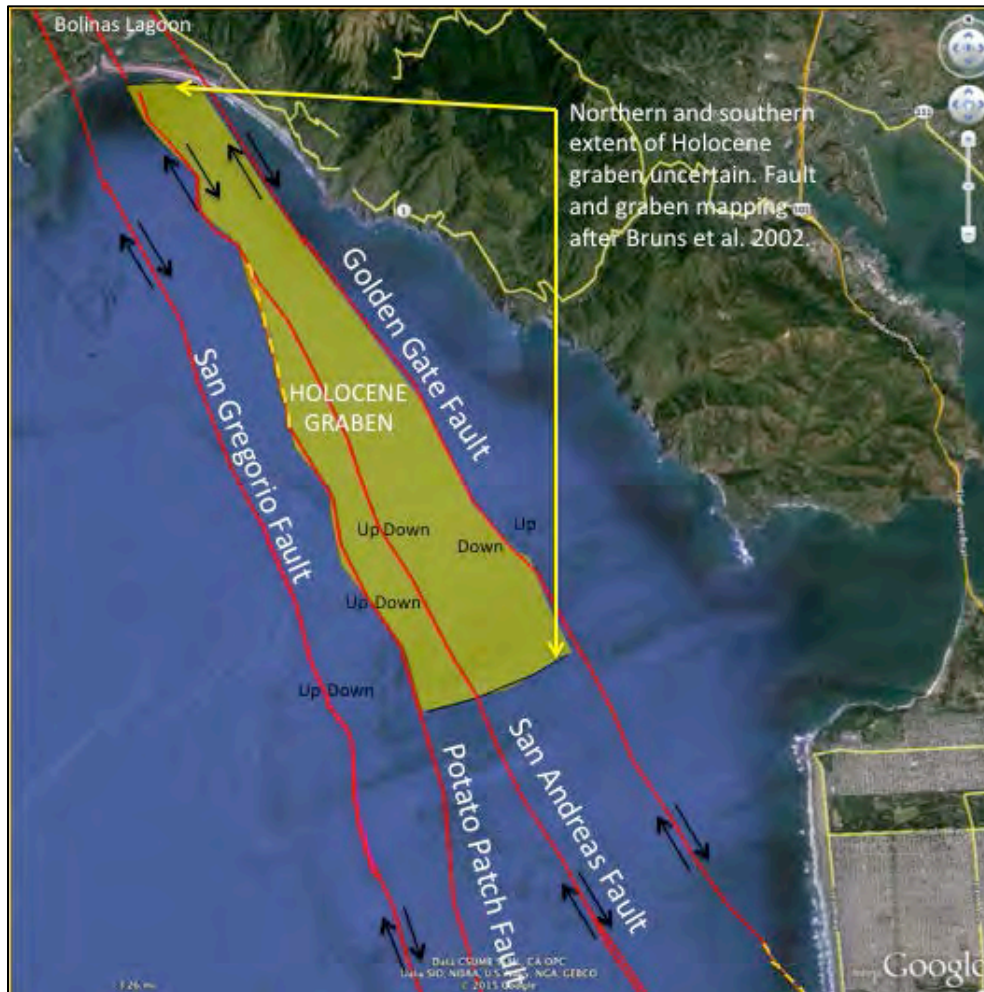
Figure 8. Holocene Graben and Associated Faults

Some researchers, including Bruns et al. (2002), have postulated that the complex convergence of faults in Drake's Bay and faults projecting into Bolinas Lagoon (and the study area itself) moving at different rates and with some directionally different compression has created a graben in relatively recent geologic history (the Holocene epoch, the last 11,700 years). **Figure 8** shows a simplification (derived from Bruns et al. 2002) of the Holocene graben and associated faults offshore of the Golden Gate. The yellow-green polygon (as labeled) is the area of the graben that has been mapped by subsurface exploration and is known to be down dropping (Bruns et al. 2002). The red lines are known fault traces, whereas yellow dashed lines are inferred. The northern and southern extents of the Holocene graben are indicated as uncertain. Up and down motions are shown in black text labels on the figure; directions of horizontal motion of the faults are indicated by black arrows. The idea is that subsidence between the major faults is creating a surface and near-surface graben from the Golden Gate to Bolinas Lagoon. Bruns et al. suggest that several different faults (including the Potato Patch, San Pedro, and San Andreas Faults) could be transfer faults that enable a strike-slip motion from the San Gregorio to the Golden Gate Fault, creating the graben. It is unknown whether the eastern extent

of the downward-dropping block in the northern part of Bolinas Lagoon or through Stinson Beach has ever been defined. Although 1 to 2 feet of down-dropping on the east side of the San Andreas Fault has been well documented, the literature reviewed did not provide information on the northern extent of the down-dropped block along the eastern side of the lagoon. Therefore, the hypotheses presented here is that the northern Bolinas Lagoon is within the Holocene graben that pinches out northward in the Lewis Gulch Creek drainage.

fault locations as interpreted from lineations seen in the LiDAR imagery and from the information associated with the graben presented in this report. The eastern trace of the yellow line that is south of the white arrow might coincide with the Golden Gate Fault as shown in **Figure 8**. Although there are no apparent indications that this fault has been active since or during the 1906 quake, Bruns (2006) considered it active within the Holocene epoch. The actual status of seismic activity and exact location of all the faults depicted in the study area in **Figure 12**, is presently unclear; however, it is evident that there are several locations where SR1, the crossover road and Olema Bolinas Road could be influenced by future fault offsets.

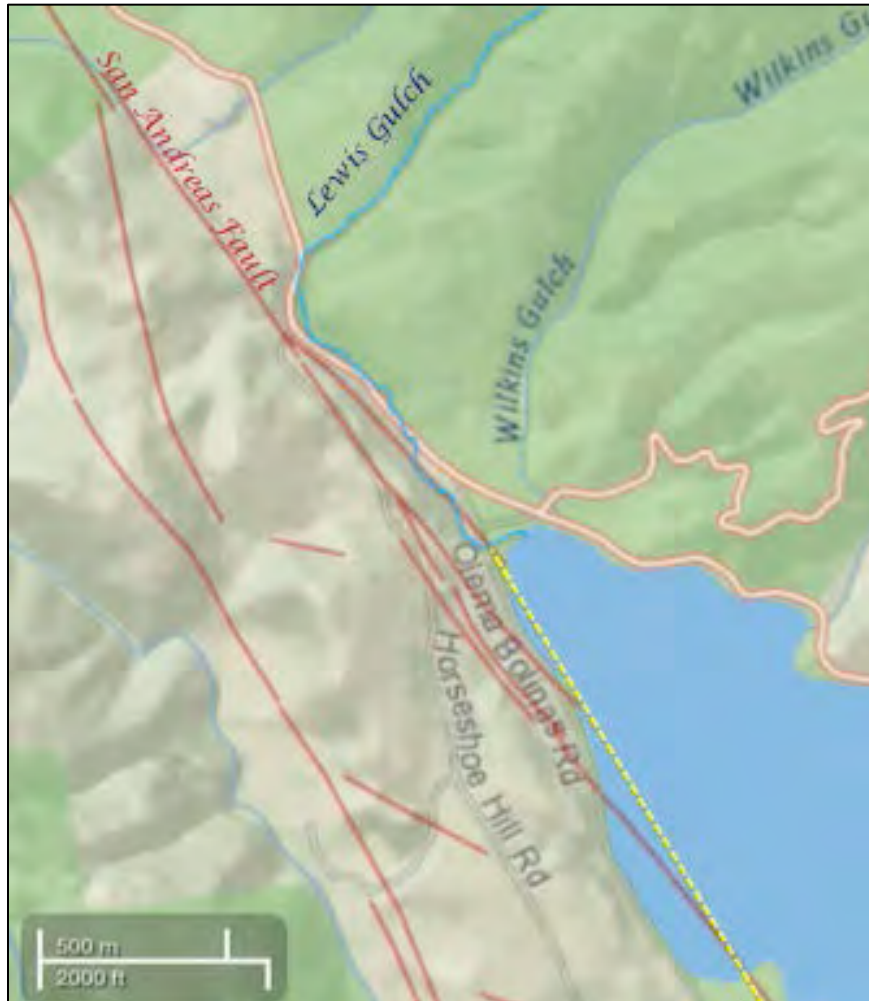
Figure 11. Active Faults near the Study Area

are not depicted; however, other maps show one or the other of them as active (Bruns et al. 2002; Galloway 1977; Gartner et al. 2007). The alignment of the 1906 fault rupture indicated by Byrne and Reidy (2005) on **Figure 10** is shown in yellow dashed line on this map. It does not coincide with the faults mapped by USGS.
