Submitted to
Marin County Open Space District
3501 Civic Center Drive
San Rafael, CA 94903

Submitted by
AECOM
1333 Broadway
Suite 800
Oakland, CA 94612
and
Laurel Collins of Watershed Sciences,
Bill Carmen of Carmen Ecological
Consulting, and
Peter Baye of Peter Baye Ecological
Consulting
June 2016

Bolinas Lagoon North End Restoration Project – Site Conditions Report

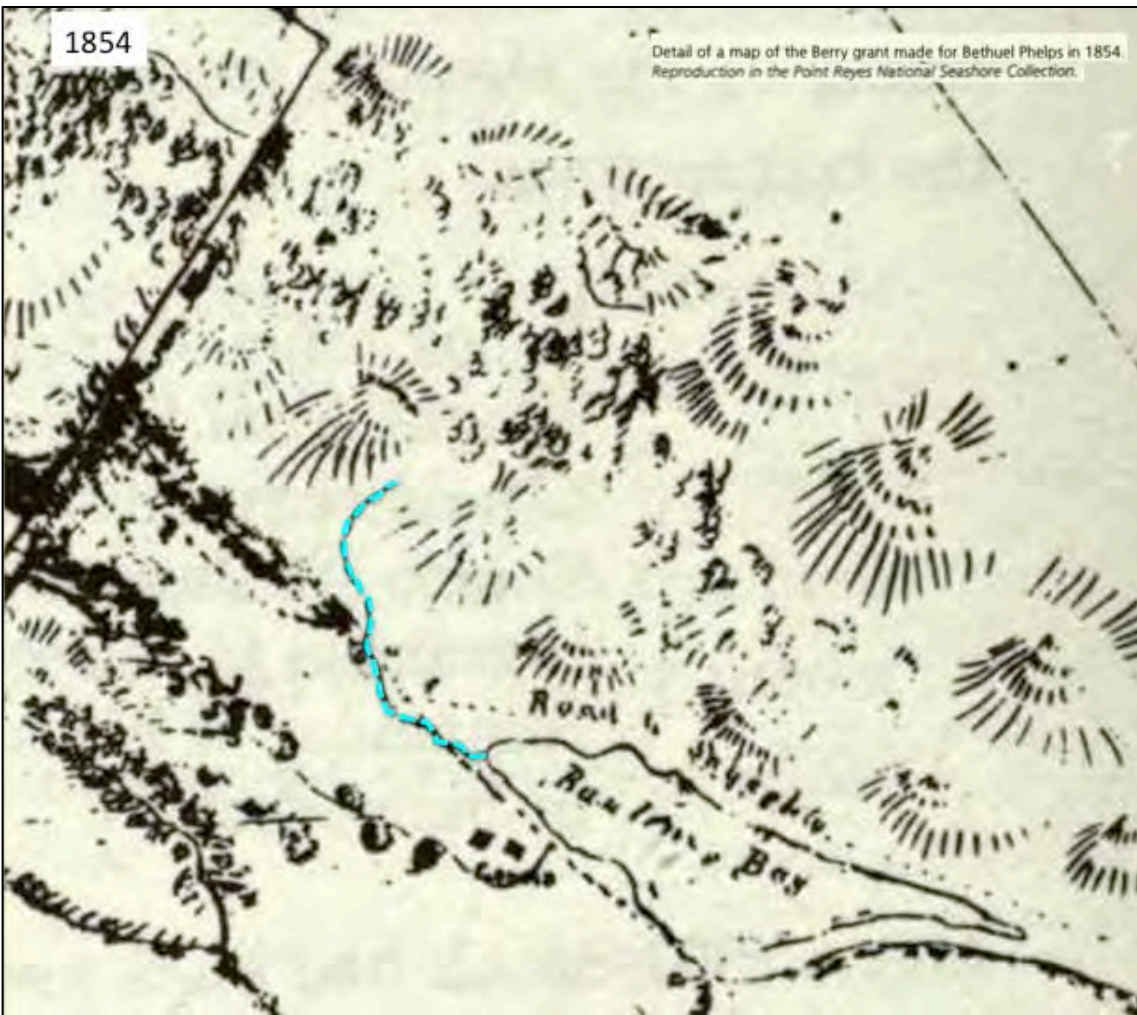
Figure 17. Detail of 1854 Map of the Berry Grant

This 1854 detail of the Berry Grant Map in **Figure 17** made for Bethuel Phelps (Livingston 1995) shows Lewis Gulch Creek (highlighted in blue) relative to the road to Sausalito, which is a black dotted line, and the Olema Bolinas Road, which is a black dashed line. The dotted line probably represents the orange line showing the trail that skirted the wetlands in **Figure 13**. The map indicates that the mouth of the creek was at the northwestern corner of the Bolinas Lagoon (then referred to as "Baulinas Bay"). There were two crossings on Lewis Gulch Creek. The lower crossing might have been located near the vicinity of the present intersection between SR 1 and Olema Bolinas Road. The other was further up the drainage. The white rectangles shown on **Figure 16** indicate the possible locations of these two crossings depicted in **Figure 17**. At some later time, the creek was probably

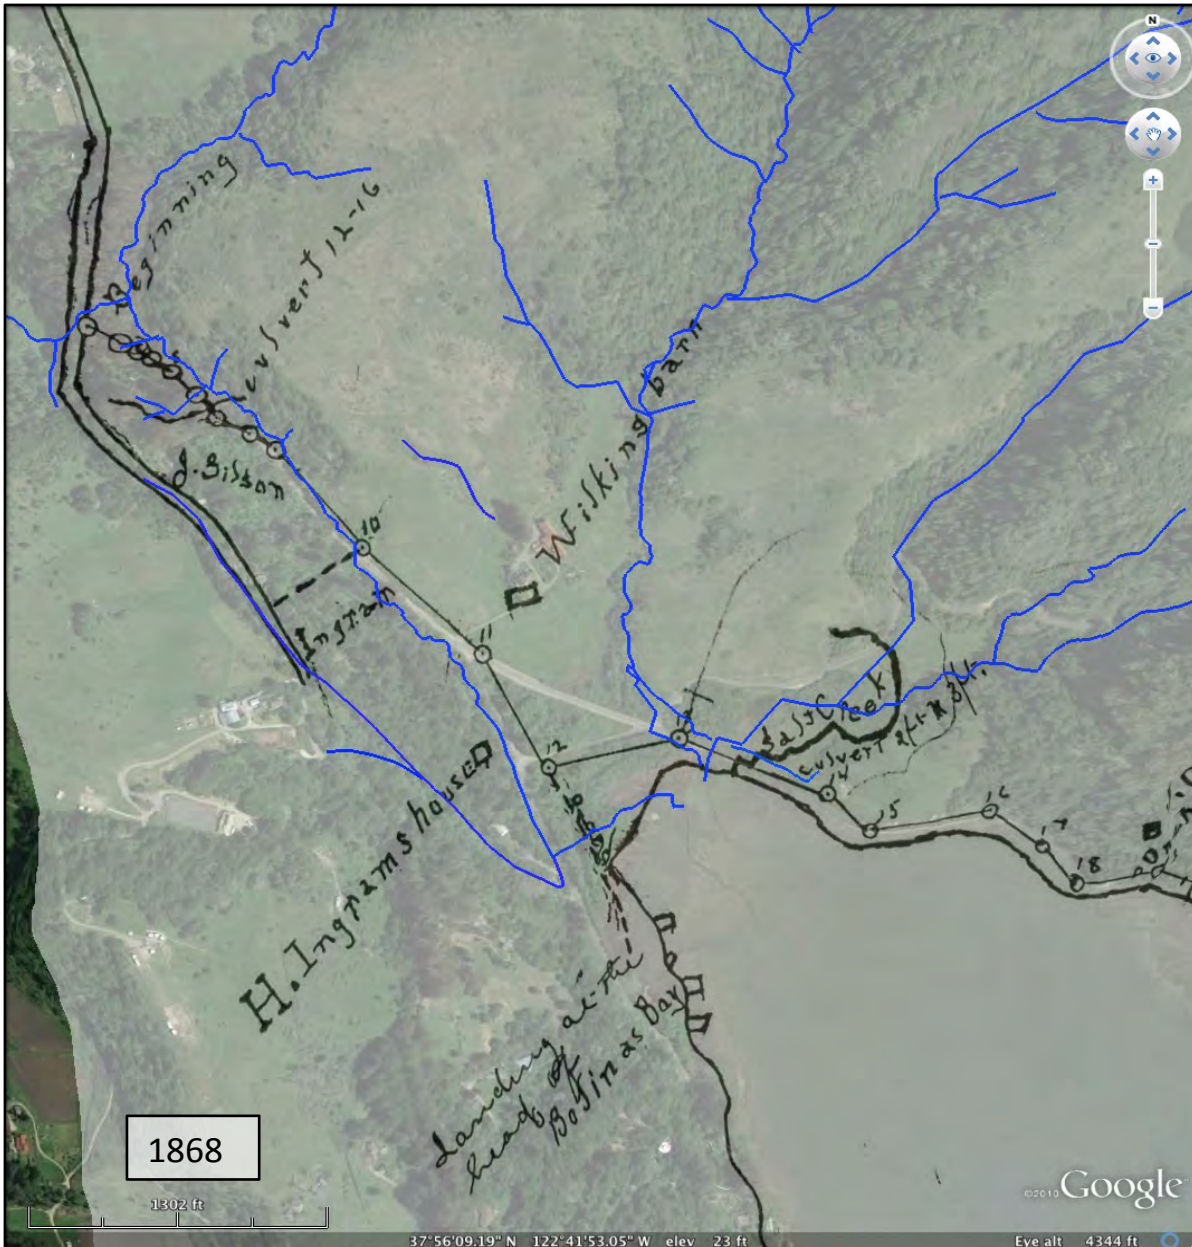
Figure 19. Detail of Eskoot's 1868 County Records Survey

This image shows a portion of an 1868 County Records Survey from Alfred Eskoot (Livingston 1995) projected onto a 2013 Google Earth image. The map shows historical features in black and the current stream alignments in blue. The map also shows the Wilkins barn, H. Ingram's House, a landing at the head of the Bolinas Bay, and Salt Creek. It does not show Lewis Gulch or Wilkins Gulch Creeks. There is no indication of a creek mouth at the location of the "landing at the head of the Bolinas Bay", possibly indicating excessive sedimentation in the area, or that the creek had been moved. Much of the current alignment of SR 1 is shown to be surveyed. It also shows the location of proposed culverts on Salt Creek and upper Lewis Gulch Creek. This may have been the reconnaissance survey for initial construction of the road to Sausalito along the Bolinas Lagoon that was constructed in 1870. It was later designated as SR1. Later maps, such as **Figure 20**, show the crossover road continuing northwestward uphill (red line on **Figure 20** and connecting to a ridge road (Horseshoe Hill Road) that parallels Lewis Gulch Creek. This implies that the present day SR1 alignment north of the crossover road was not completed until sometime following 1973.

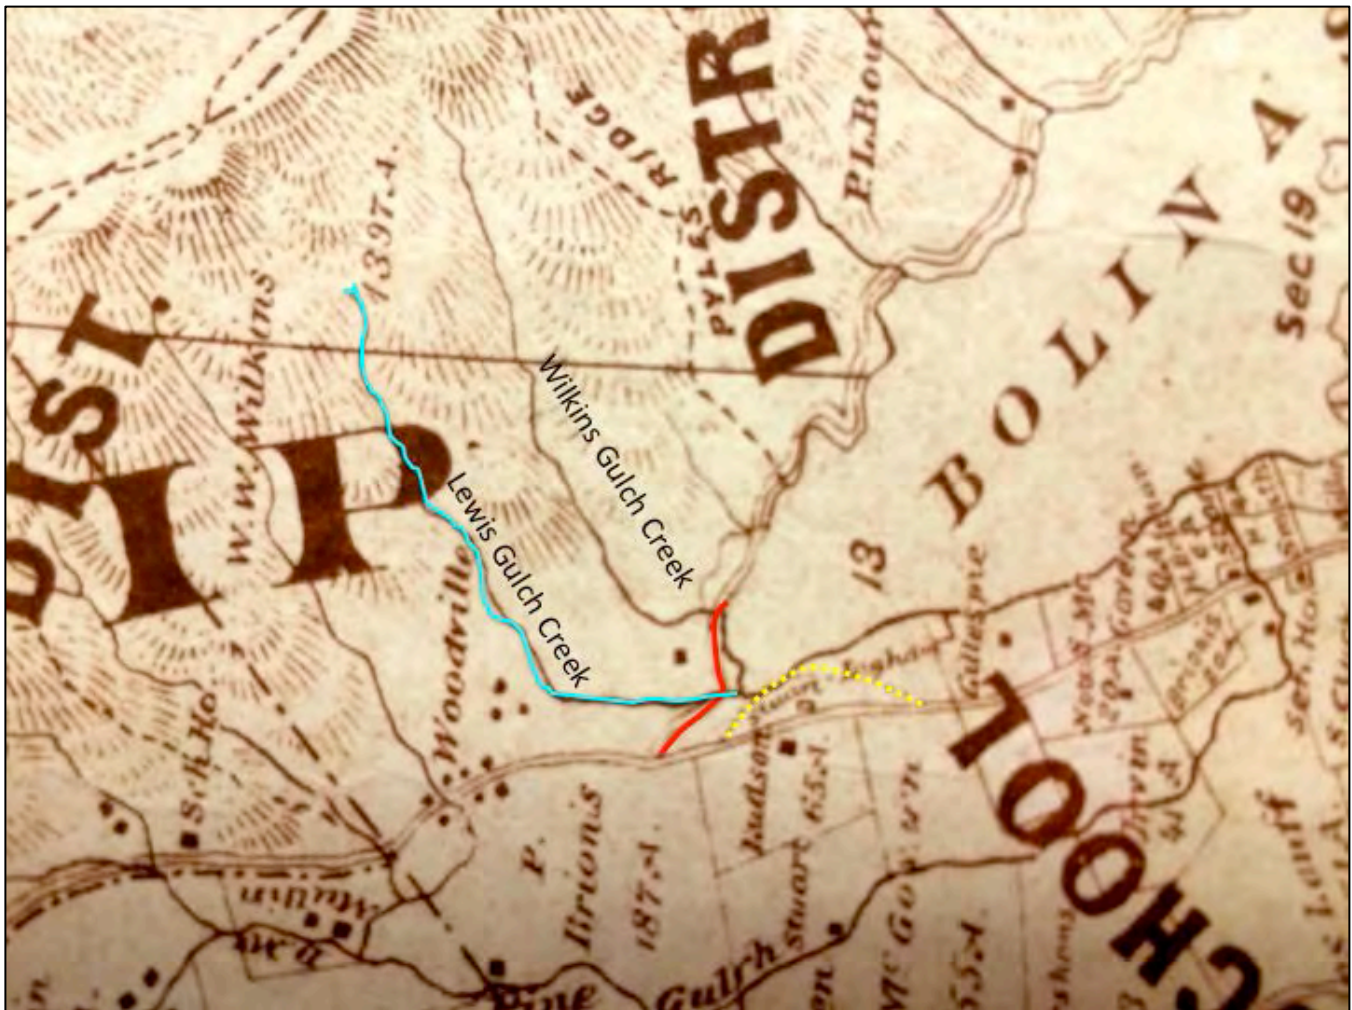
Figure 20. Map of Marin County, Austin and Whitney 1873

Figure 20 shows that the mouth of Lewis Gulch Creek was just beyond what is now the intersection of the crossover road and Olema Bolinas Road. The building shown just north of the crossover road is likely the Wilkins barn that was documented as being close to the embarcadero and used to house milled lumber. The Wilkins Ranch residence was not built until 1875. Wilkins Creek can be seen to be

This map in **Figure 25** (Source: Livingston 1995) shows Lewis Gulch Creek continuously on the north side of the Olema Bolinas Road. It also shows a spur road crossing the Lewis Gulch Creek. The spur road might be the driveway into the Wilkins House. The building between the spur road and the crossover road also appears in the 1873 map in **Figure 20**. It is unclear what became of the building.

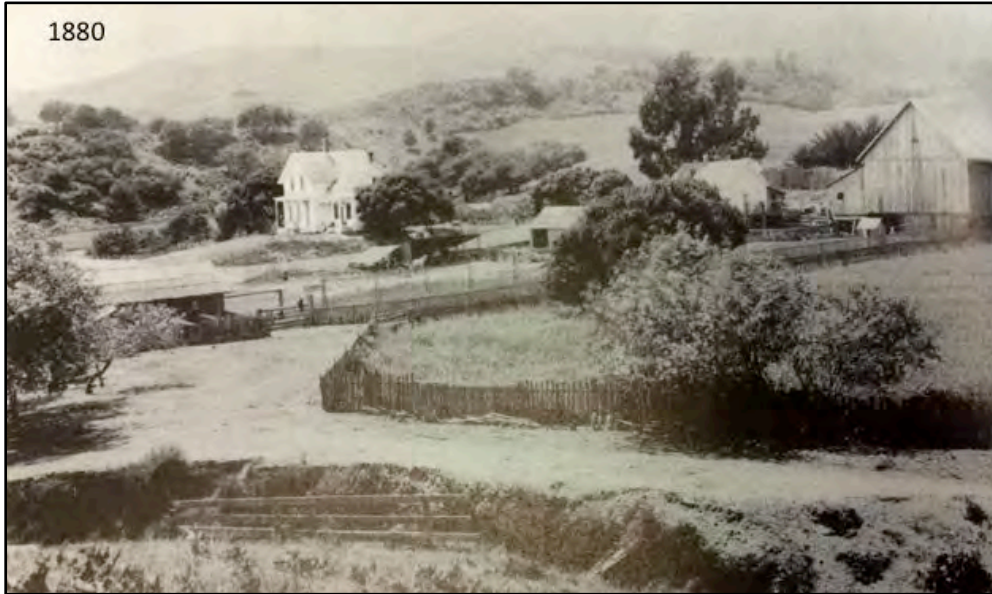
Figure 22. Wilkins Ranch Photograph, 1880

The photo in **Figure 22** (Livingston 1995) shows the Wilkins Ranch looking from the east side of Wilkins Gulch Creek towards the west. In the lower left corner of the creek banks are evident with a lack of vegetation and the eroding dirt road. The creek has the appearance of a possible old ditch undergoing incision and bank erosion at this location.

Figure 23 is a photo collage of the Wilkins Ranch area in 2015. Image (A) shows a 2015 view from approximately the same location as shown in **Figure 22** photographed in 1880; yet, it was taken in front of the creek because willows growing along the stream course now block the viewshed. The 2013 Google Earth Image (B) shows the vantage point of the 1880 photo. Image (C) shows the view from the fence location (blue arrow) shown in the foreground of **Figure 22**. The Wilkins Gulch Creek channel is more incised and wider now than it was in the 1880s. The creek is now a braided channel through the willow grove at this site.

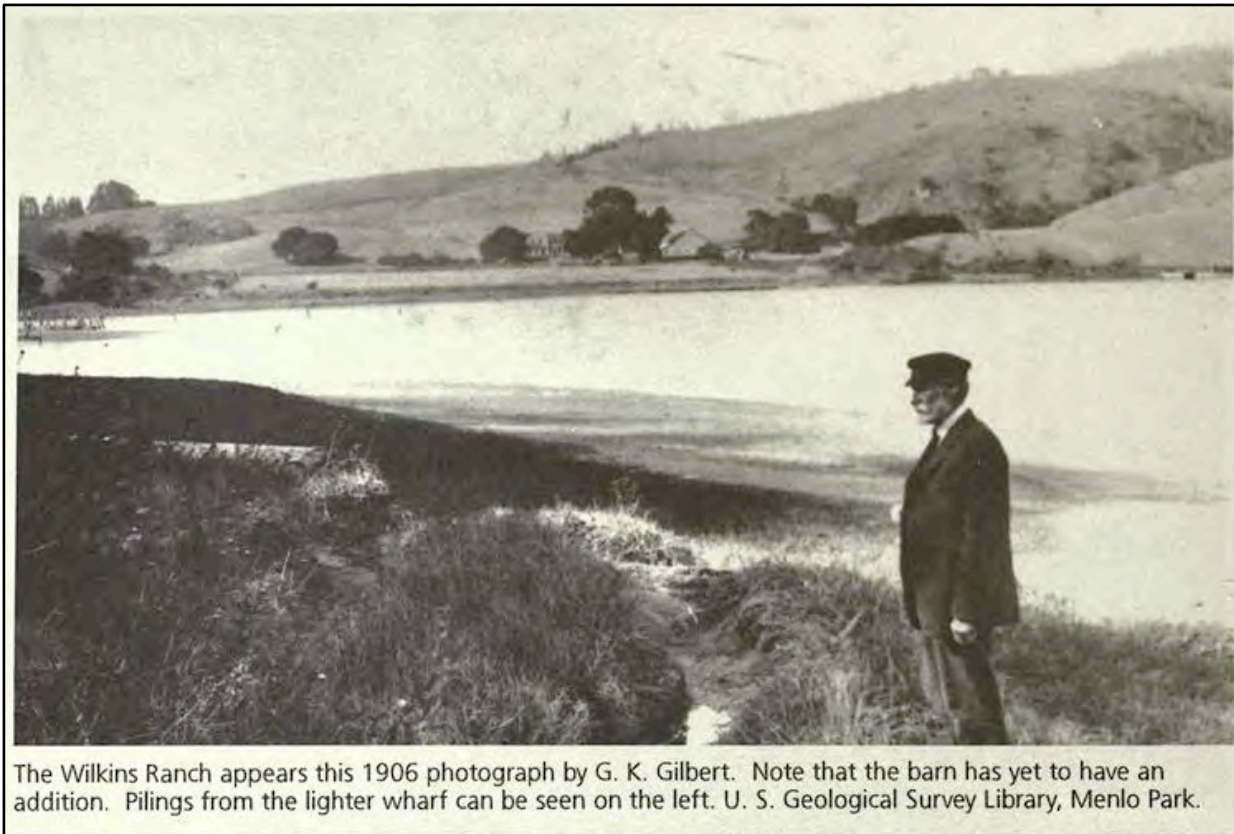
Figure 24. Wilkins Ranch Photograph, 1906

The photo in **Figure 24** shows the Wilkins Ranch from the north end of the Bolinas Lagoon (Livingston 1995). Note the lack of trees along the margin of the shoreline in the area that is now considered the Y, except along the riparian corridor of Lewis Gulch Creek just upstream of the lighter wharf in the left side of the photo. The willow groves along the downstream end of Wilkins Gulch and Salt Creeks can also be seen toward the right central part of the photo. The hillsides are primarily grasslands with little brush or tree cover. The trees in the background hillsides look like snags; perhaps they reflect the fires of 1890 and 1904, which burned through parts of the Wilkins Ranch and destroyed bridges and culverts along the Fairfax Bolinas Road (Fraser 1880; Livingston 1995). Fires would have accelerated sediment supply and sedimentation rates to the lagoon.

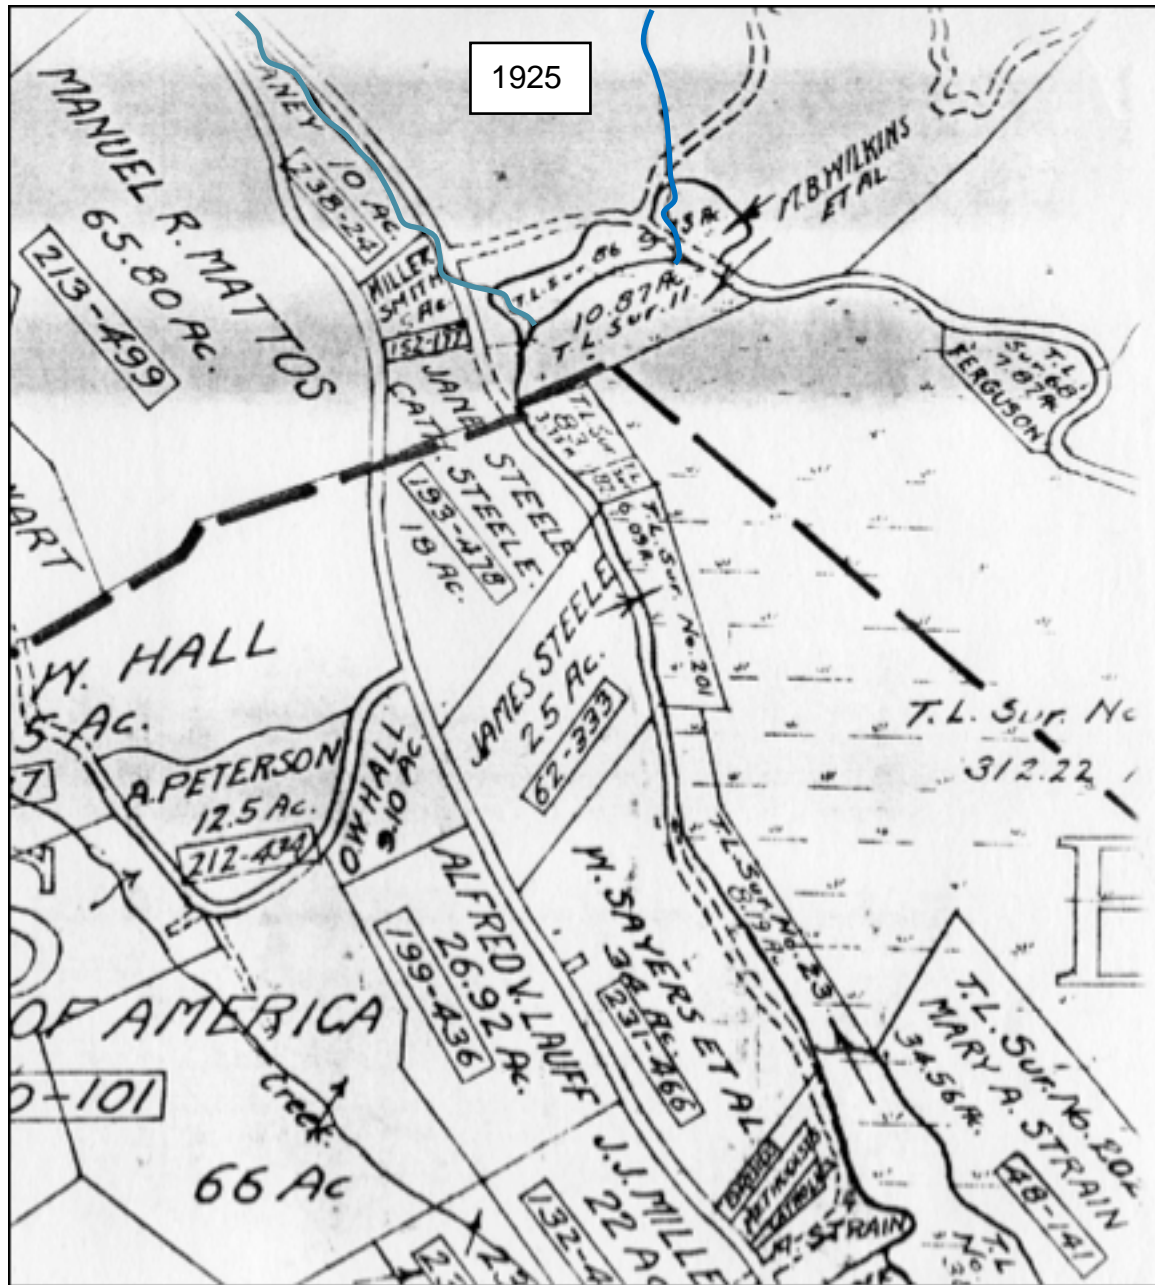
Figure 26. Detail of 1925 County Surveyor's Parcel Map

The 1925 County Surveyor's Parcel Map in **Figure 26** (Livingston 2015) shows Lewis Gulch Creek highlighted in light blue and Wilkins Gulch Creek in dark blue. Lewis Gulch Creek is flowing toward the intersection of the crossover road and Olema Bolinas Road, but north of the crossover road, it is on the western side of Olema Bolinas Road as opposed to the eastern side as shown in **Figures 17, 20, and 25**. Wilkins Gulch Creek is shown to be directed into the Salt Creek embayment and crossing both the Fairfax Bolinas Road and SR 1. If mapping of the creek is correct on the 1910 (**Figure 25**) and the 1925 maps, this indicates that Wilkins Gulch Creek was ditched and diverted to the wetlands in Salt Creek before 1925. It is not known if the diversion was made to bring freshwater to the site or to transport sediment to help fill the embayment.

Additional manipulation of lower Wilkins Gulch Creek is evident when comparing changes between the 1910 (**Figure 25**) and 1925 (**Figure 26**) maps. The creek was ditched to flow to the east side of Bolinas Fairfax Road and then under SR1 at the current-day culvert location. It is possible that the culvert or lack of a culvert near the junction with the crossover road (where the creek flowed previously) had failed or the road was being flooded. The culvert at SR1 may have been newer or larger at the time and so seemed like a better location to convey the flow of Wilkins Gulch Creek to the lagoon. Another hypothesis is that Wilkins Gulch Creek flow was used to deliver freshwater to the pond east of Bolinas Fairfax Road to flush it of salty water for cattle usage. Fill appears to have been placed around the west edge of the pond on Salt Creek prior to 1957 as interpreted from the photos in **Figures 30 and 31**. This may have been done to provide a staging area for the SR 1 construction. Fill may have been placed around the east side of the pond in an attempt to increase farmable or grazing land.

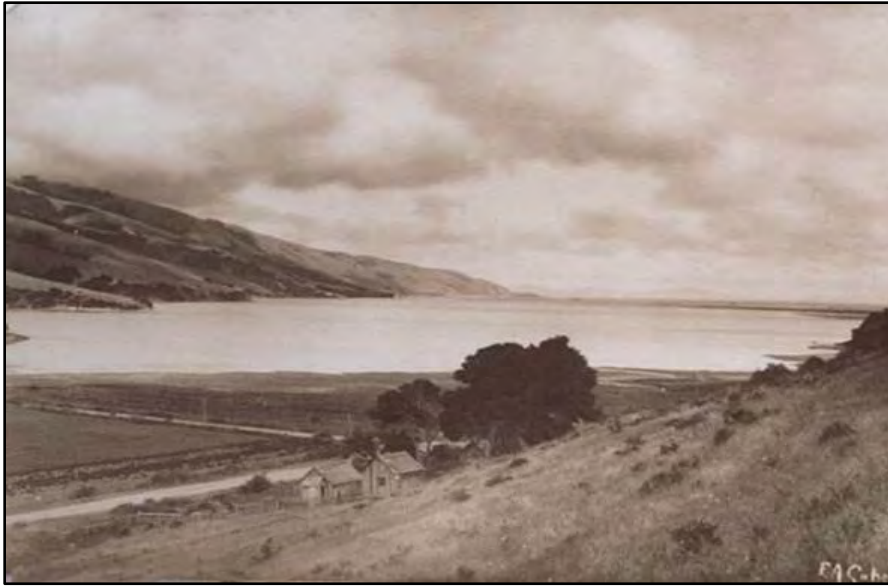
Figure 27. Photo of Olema Bolinas Road

Figure 27 is an undated photo (E.A. Cohen and Stinson Beach Historical Society) that shows the Olema Bolinas Road and the original SR1 alignment now referred to as the crossover road. When the road was constructed, it was built up on a berm above the average elevation of the land to reduce the potential for flooding. Ultimately the road berm slowed the conveyance of floodwaters to the lagoon, eventually increasing backwater flooding and sediment deposition upstream of the road. Lewis Gulch Creek appears to be on the east side of the Olema Bolinas Road and only grasses and herbs appear to be growing north of the crossover road.

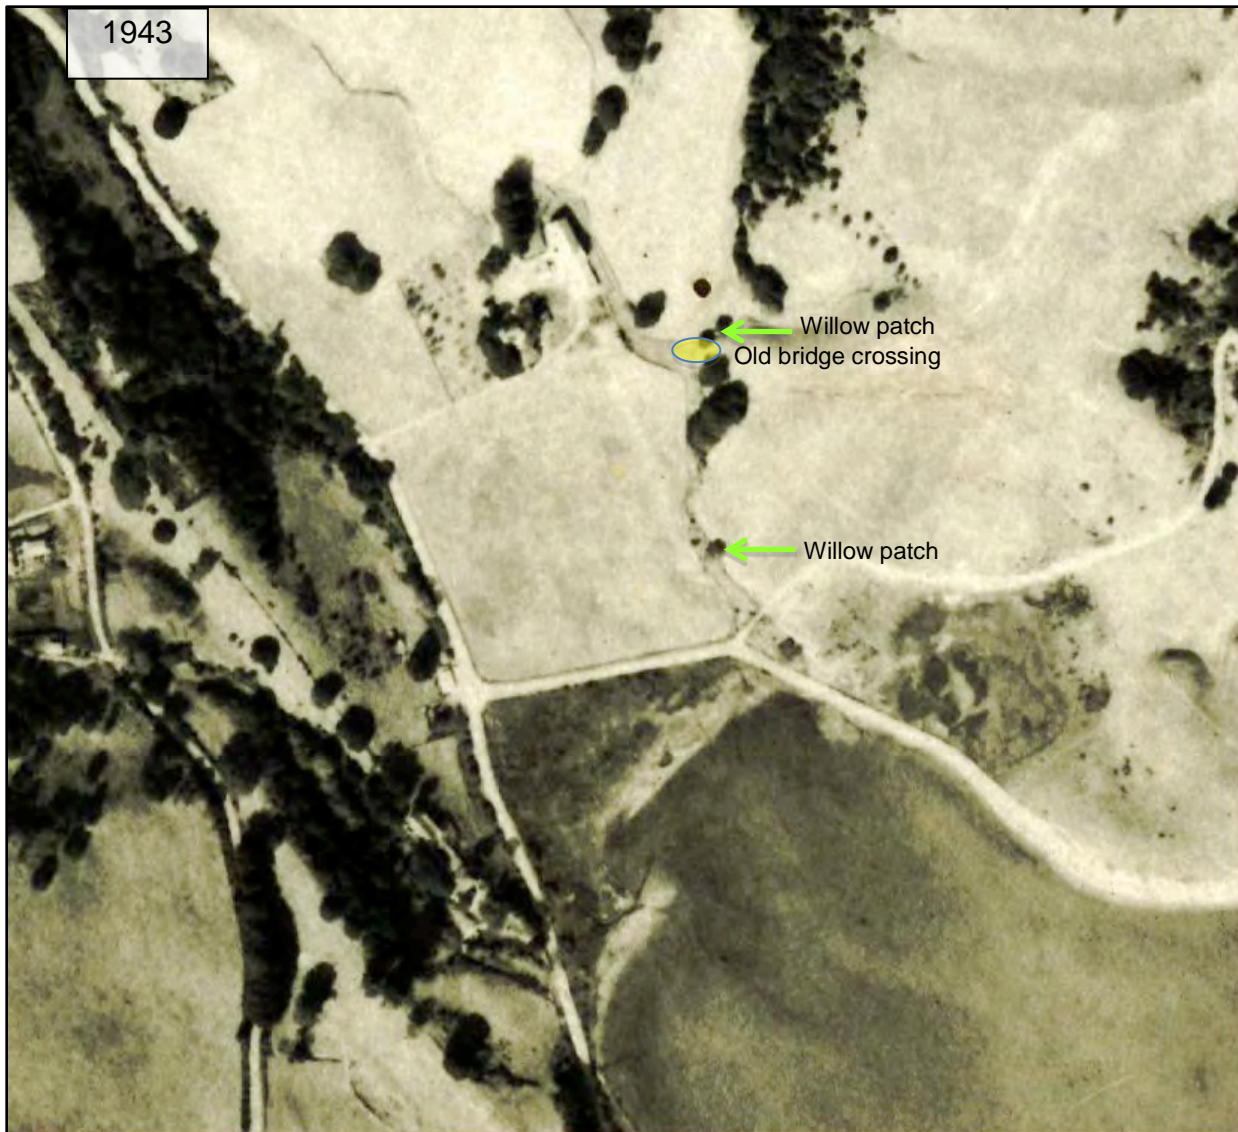
Figure 29. Aerial Photo, 1943

The October 1943 aerial photo in **Figure 29** (Marin County Geographic Information System Department) was projected onto Google Earth. The photograph shows the two distributary ditches at the lower end of Wilkins Gulch Creek, and it shows that neither the alder forest north of the crossover nor the willow grove at the lower end of Wilkins Gulch Creek has not yet developed, but two smaller patches exist upstream. One patch has taken hold at the position of the creek in the 1906 photo point (shown in **Figure 22** and **Figure 23**). Based on the mapping of the older ranch roads, the upstream edge of the willow patch coincides with an area just upstream of an early bridge crossing used to access Wilkins Ranch. It is probable that the bridge structure contributed to the bank erosion and channel widening that occurred at the creek site pictured in 1906 (**Figure 24**). The grove of willows at Salt Creek has not yet developed, but the pond area still has large areas of open water that

were probably becoming decreasingly tidal and increasingly brackish. A few alder trees are starting to appear on the far south side of the crossover road.

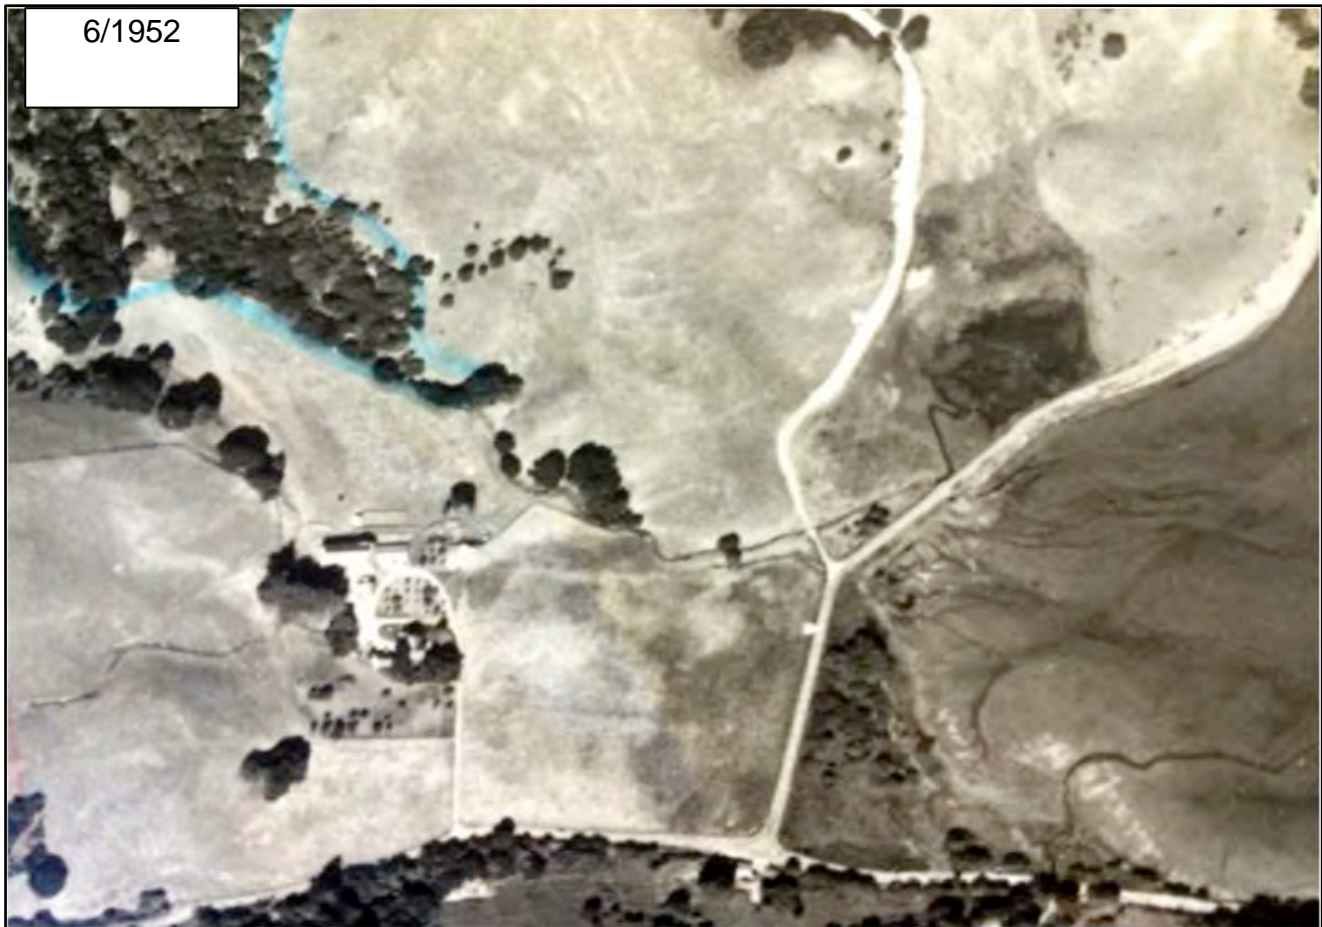
Figure 30. Detail of 1952 Aerial Photo

Figure 30 is an excerpt of a photo taken in June 1952 that may have been taken a few years before the current alignment of SR 1 was constructed to extend through the lower Wilkins Ranch (Marin History Museum). This photo shows the crossover road as still the only connection to the Olema Bolinas Road as similarly mapped in 1892 (**Figure 21**) and 1910 (**Figure 25**). The Y does not exist yet. The alder forest is continuing to expand on the north margin of the Bolinas Lagoon. Lower Salt Creek has been ditched, probably to provide better drainage. The dark color of the land just north of the crossover road may indicate a higher groundwater table along the toe of the alluvial fans of Wilkins Gulch and Lewis Gulch Creeks.

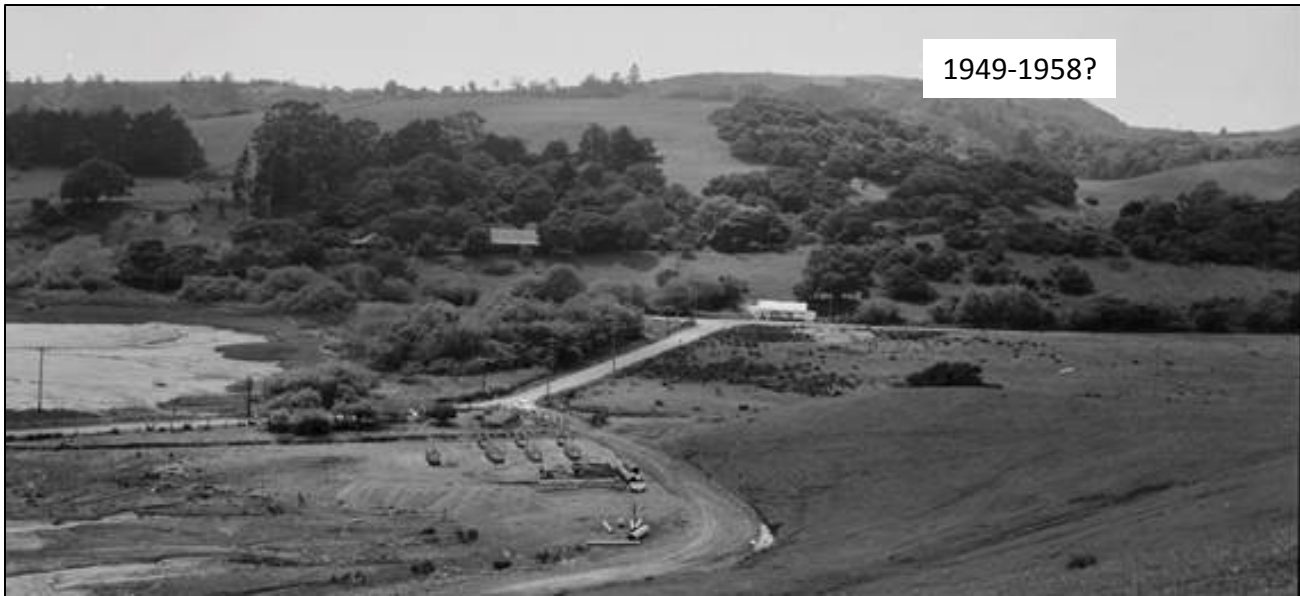
Figure 31. Detail of Foley's Wilkins Ranch

Figure 31 is an undated excerpt of a larger photograph (Bolinás Museum) taken southwest of the intersection of SR 1, the crossover road, and Fairfax Bolinás Road. The person who supplied the photo believed the photo was taken sometime around 1949–1952 (Photo by Jim Foley). It may have been taken about 1957, during preparations for extending SR 1 through lower Wilkins Ranch. These might have been rushes, which would indicate a high water table. Note the establishment of dark colored vegetation on the north side of crossover road. Note also the location of the Oyster House at the end of crossover road.

The September 1959 photo shown in **Figure 32** (Livingston 2015) shows the new SR 1 extension through the lower Wilkins Ranch. The two distributary ditches of Wilkins Gulch Creek are shown as a dashed light blue line, and the small patches of willows pointed out on **Figure 31** are evident and indicated in yellow-green. The alder forest, shown as a sage green polygon, has become well developed south of the crossover road, but it still has not taken hold in the north side of the Y. The Salt Creek pond does not appear to have a willow grove yet, except perhaps one just beginning to form at its eastern margin along the toe of the alluvial fan.

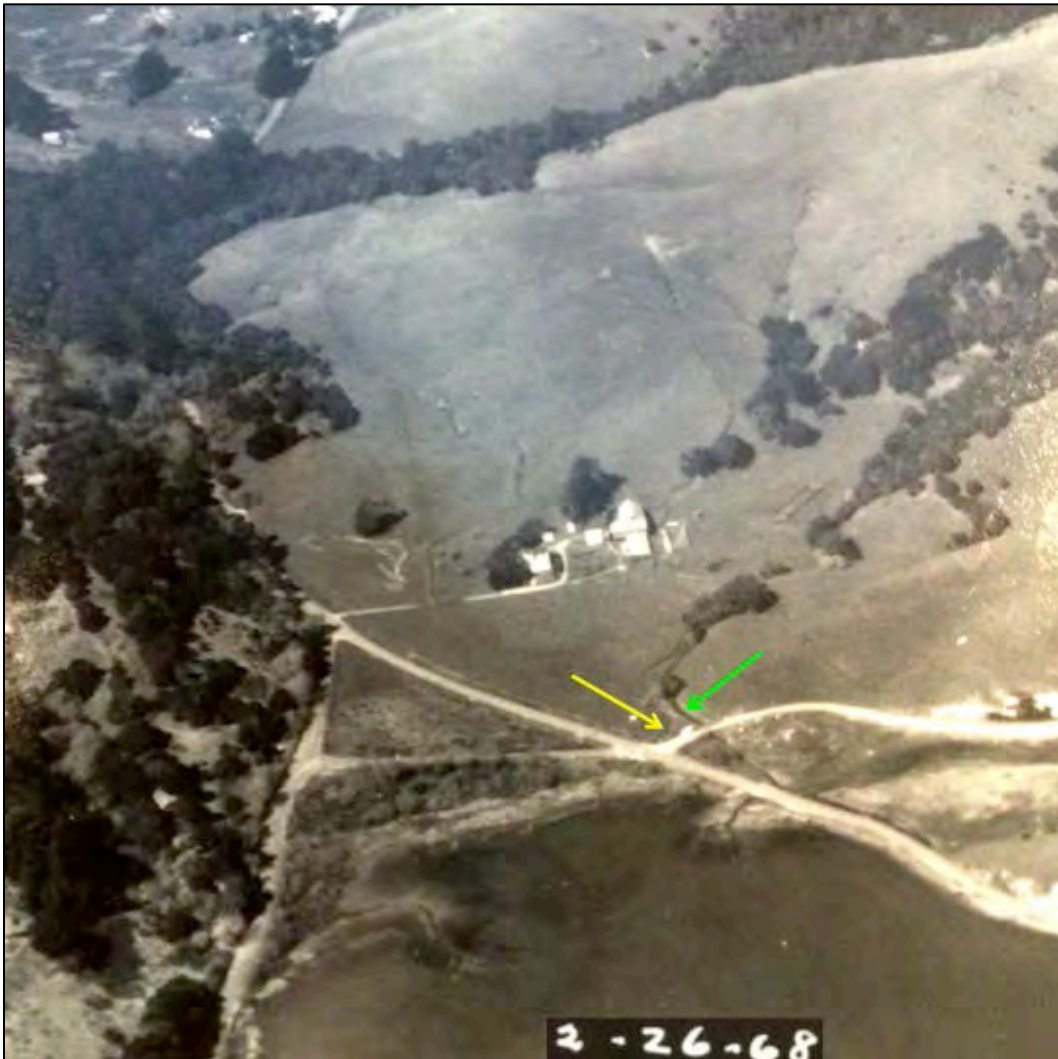
Figure 33. 1968 Aerial Photograph

Figure 33 is a photograph from February 1968 that (Source: Marin County Geographic Information System Department) shows the same grouping of alders seen in the 1959 image in **Figure 32**. The western distributary ditch of Wilkins Gulch Creek at the yellow arrow is less pronounced than the eastern one at the green arrow, potentially indicating that the western one is starting to become abandoned due to sedimentation. This is consistent with its current status.

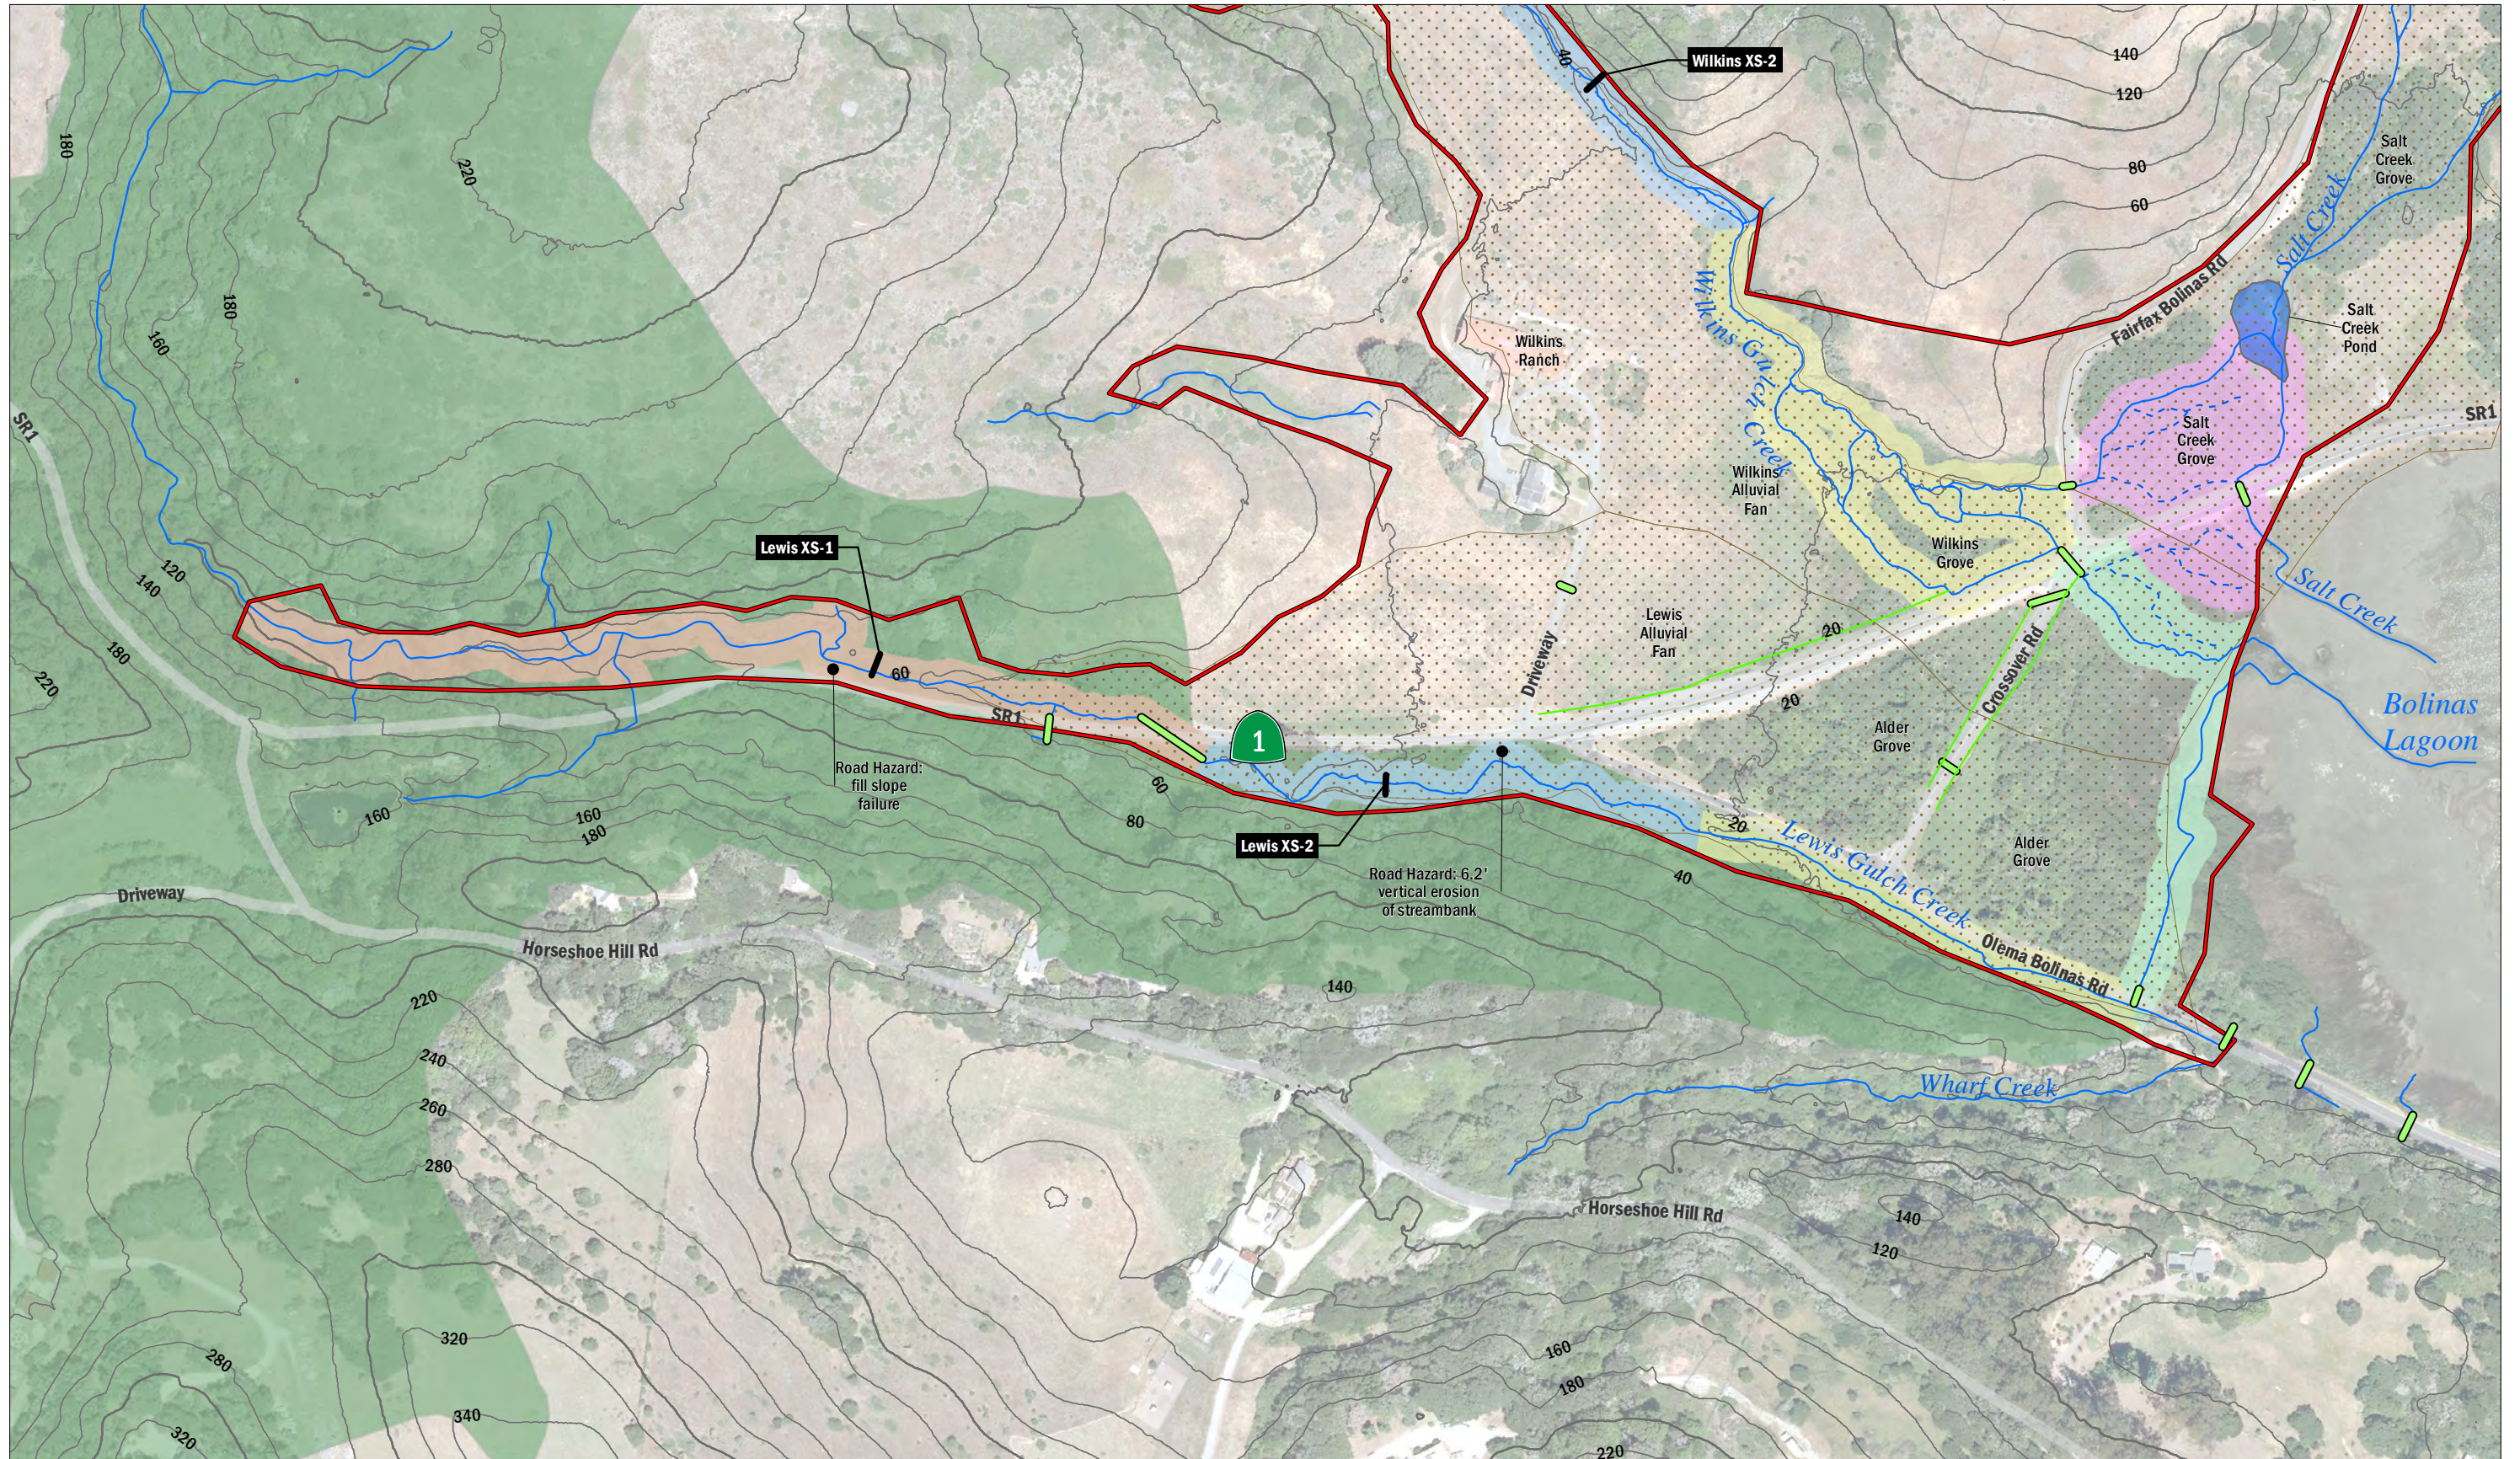
FIGURE 36
Lewis Gulch Creek Watershed

As shown on **Figure 36**, Lewis Gulch Creek drains from the hills east of SR 1 into an incised channel that parallels the northeast side of SR 1, crossing beneath it in a 58-inch-diameter corrugated metal culvert about 0.11 mile north of the SR 1 and Olema Bolinas Road intersection. The creek then flows another 1.8 miles in an inboard ditch along the southwest side of Olema Bolinas Road and makes an abrupt eastward turn into a 5-foot-wide by 4-foot-tall box culvert beneath Olema Bolinas Road. At the inlet of the box culvert, Lewis Gulch Creek is joined by Wharf Creek via a roadside ditch.

The field survey of Lewis Gulch Creek extended from the Bolinas Lagoon to approximately 1,300 feet upstream of the culvert crossing under SR 1. **Figure 36** shows the stream, the reaches, and other relevant details. The SR 1 culvert crossing is near the head of the inactive alluvial fan. The culvert under SR 1 consists of a 100-foot-long by 58-inch diameter corrugated metal pipe with a paved invert (lined with cement-based slurry). The length of the assessed creek is divided and described as four reaches.

Sediment sources along the reach appear to be predominantly from landslide slumps and bank erosion of older terrace deposits. At least three slumps were observed along the left bank (looking downstream). Most of the slumps extend 10 feet up the slope and 15 to 20 feet along the stream bank. The stream appears to be actively eroding the toe of the west-facing hillslope on the meander bends, thus leading to small slope failures. At the upper extent of the reach, three gullies run down the hillslope from the highway to the creek. Two appear to be older and no longer flow. The third appears to convey runoff from SR 1 and possibly Horseshoe Hill Road. One of the gullies has been filled with riprap. There is one location where the creek meanders from the east side of the valley to the west side, where bank erosion is compromising a portion of SR 1 road fill that has a scarp in the bank next to the road. **Figure 36** identifies the road hazard.

Sediment input in the reach is largely from bank erosion of the terraces at a couple of locations where the channel meanders against the hillslope and roadway. Midway in the reach, the channel has meandered laterally to the point where the 6-foot-high eroded stream bank is within 5 feet of the edge of the SR 1 pavement. It is identified as a road hazard on **Figure 36**.

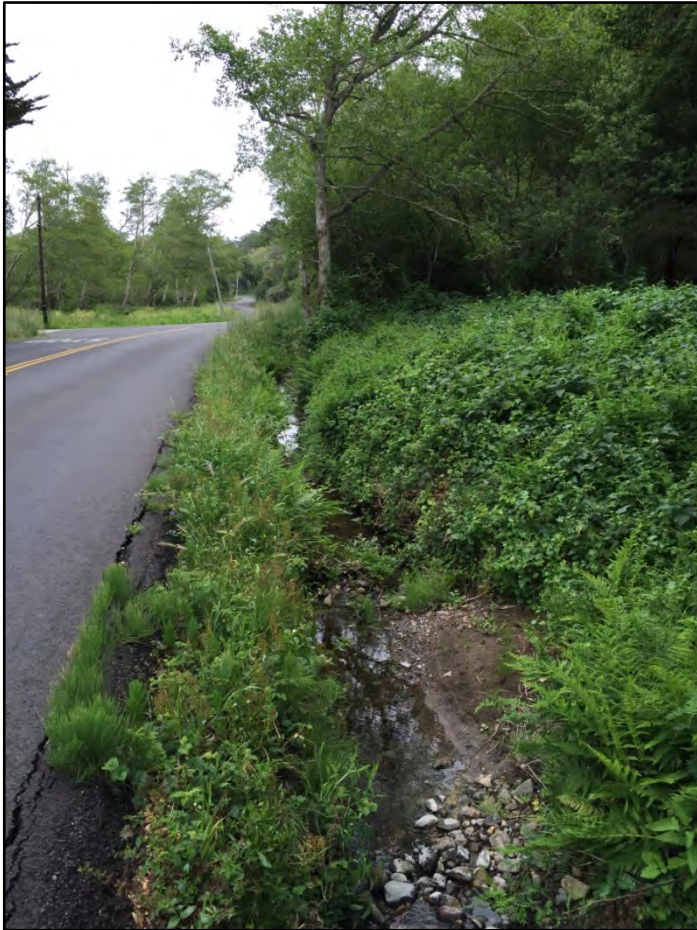
Figure 41. Aggradation of Stream along Olema Bolinas Road

Reach 3 runs approximately 750 feet along Olema Bolinas Road to the culvert leading to the lagoon. The stream has been channelized and straightened to a narrow area between the road and the adjacent hillslope to the west (**Figure 41**). This reach is mostly an F4/G4-type channel. Because the channel lacks the competence and capacity to carry the bedload, the reach is prone to aggradation. Marin County Public Works periodically dredges accumulated sediment in this reach as it fills the channel and begins to more frequently flood the roadway. It is believed that much of the larger gravel transported downstream is deposited in this reach. This reach lacks mature riparian vegetation unlike the other reaches, partially due to the frequent stream clearing following storm damage. At the time of the field survey, streamflow was not visibly present until shortly before the culvert inlet.
