Submitted to
Marin County Open Space District
3501 Civic Center Drive
San Rafael, CA 94903

Submitted by
AECOM
1333 Broadway
Suite 800
Oakland, CA 94612
and
Laurel Collins of Watershed Sciences,
Bill Carmen of Carmen Ecological
Consulting, and
Peter Baye of Peter Baye Ecological
Consulting
June 2016

Bolinas Lagoon North End Restoration Project – Site Conditions Report

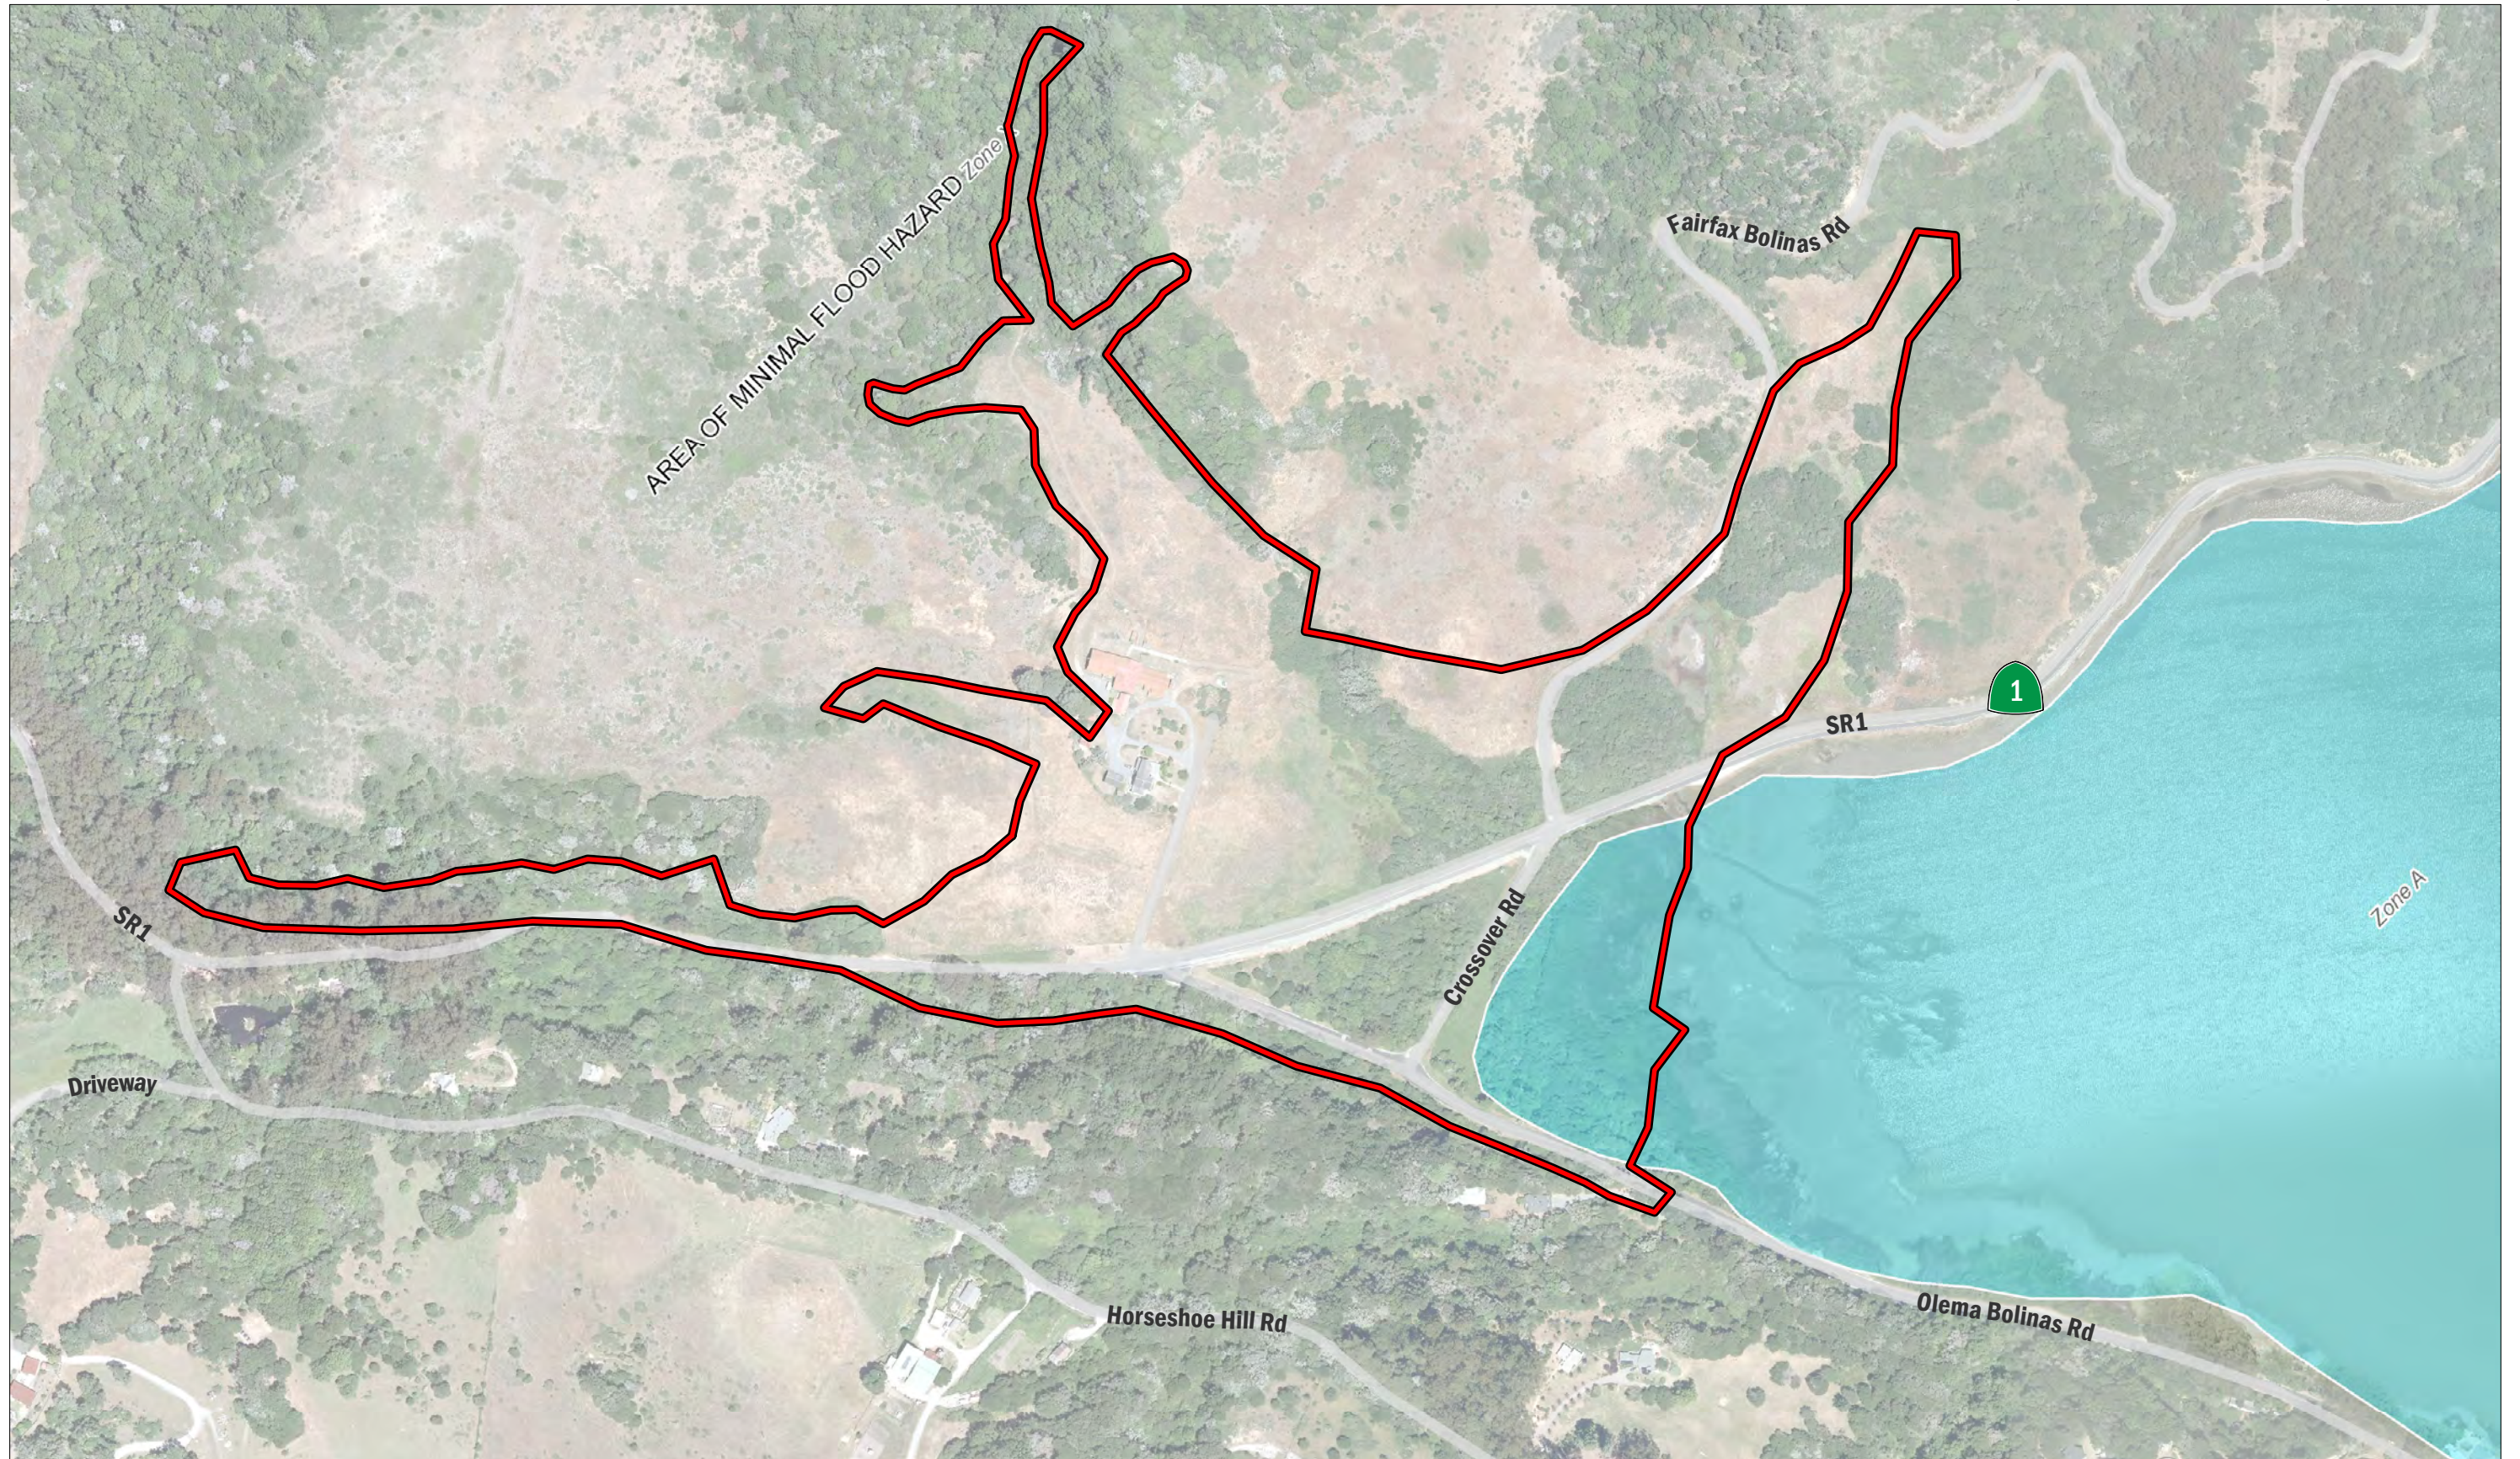
FIGURE 45
FEMA Flood Hazard Zones

Interestingly, portions of the mid- and end-century SLR projections along the margin of the lagoon bounded by paved roads do not look radically different than the Federal Emergency Management Agency (FEMA) existing Flood Hazard Zone 1 boundary that presently is reported to have a one percent chance of flooding from stream flows (**Figure 45**). The main difference is that FEMA (2015) does not show flooding upstream of the Salt Creek culvert in the Salt Creek watershed. The implication is that stream flooding coinciding with projected SLR is very likely to push the flood boundary well upstream of the projected tidal elevations in **Figure 43** and **Figure 44**.

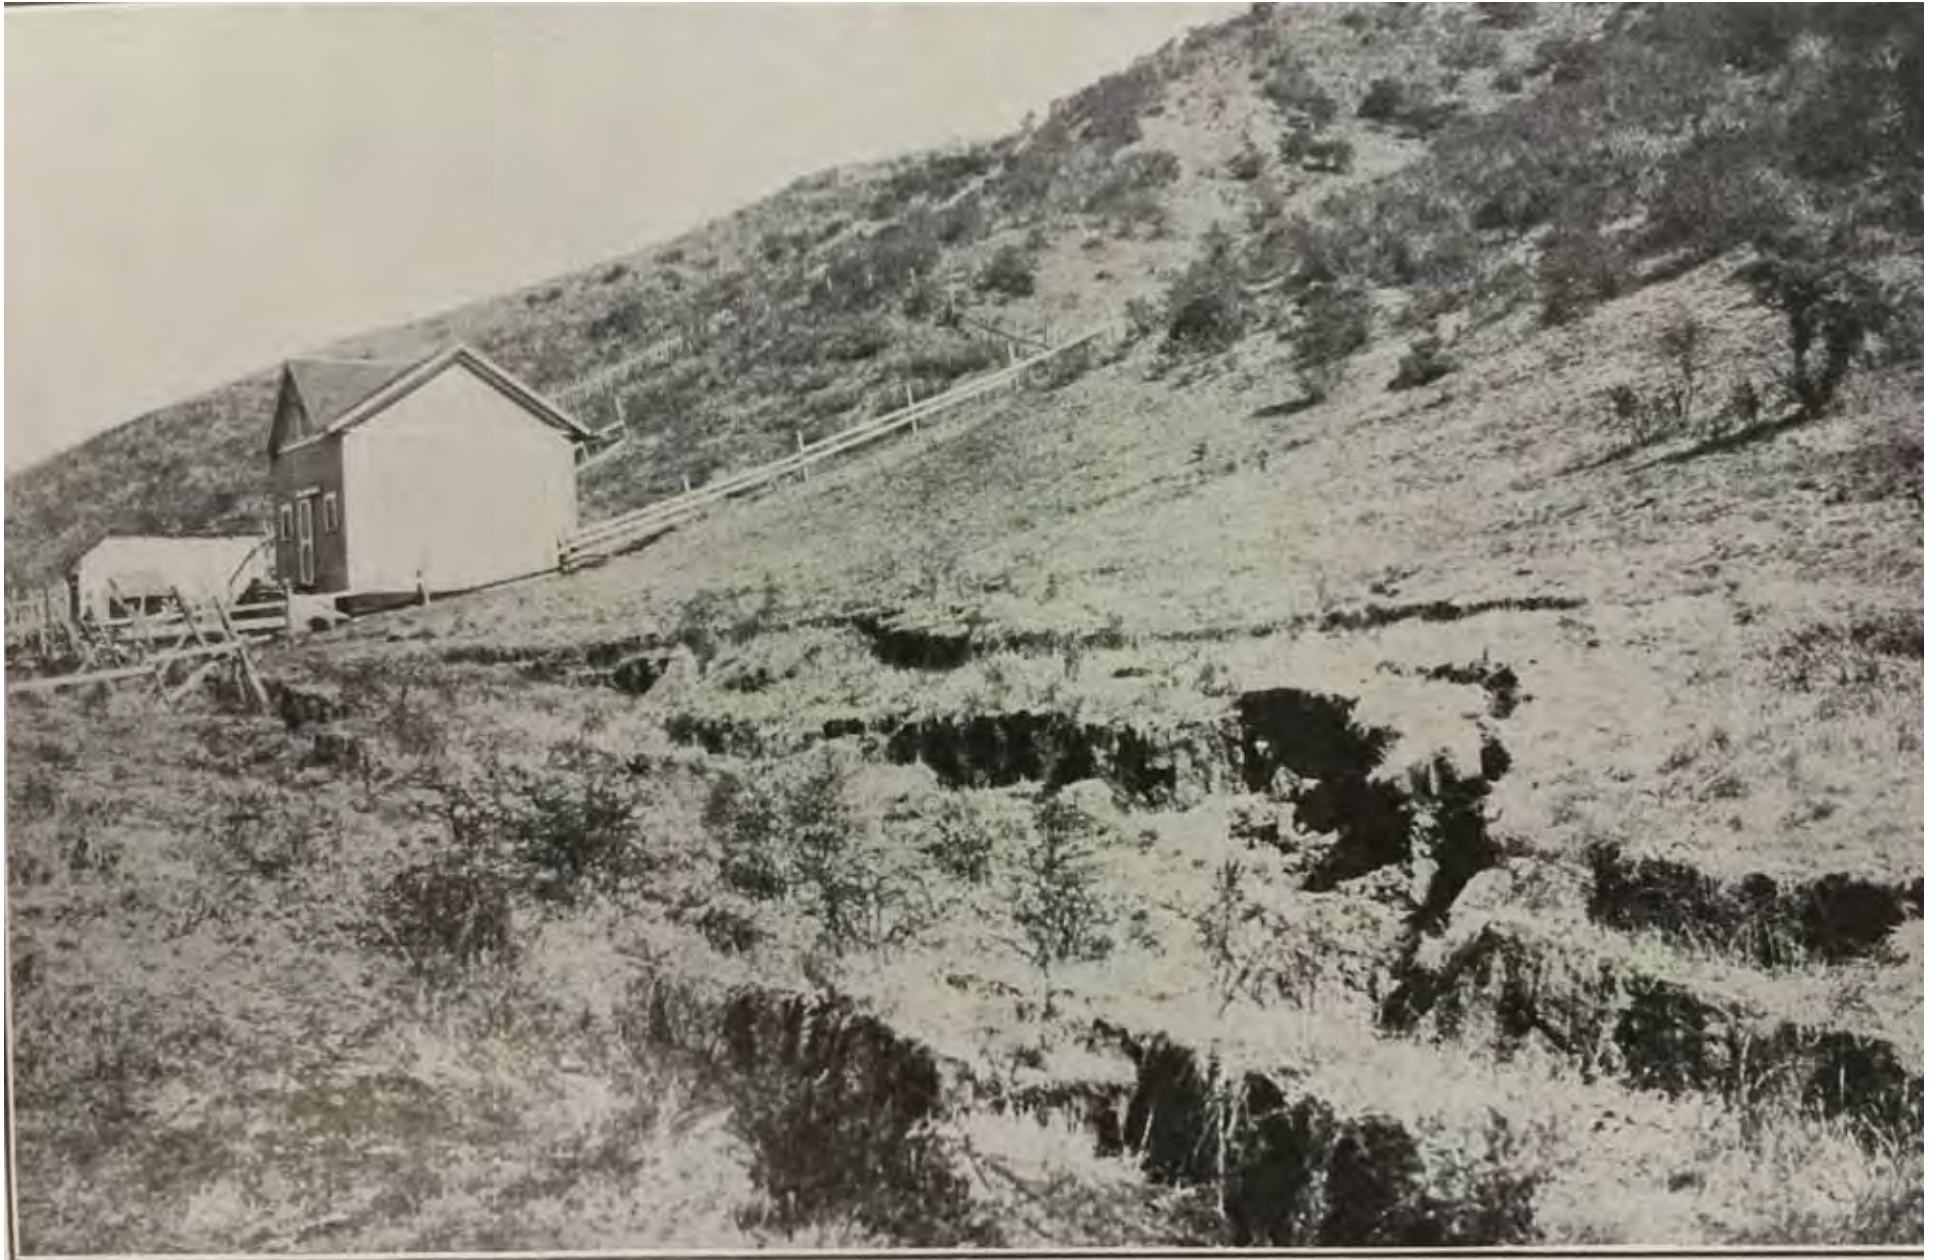
Secondary cracks with settling, Bolinas. Photographed by G.K. Gilbert. From: San Francisco Earthquake and Fire of April 18, 1906 and their effects of structures and structural materials, reports by Karl Gilbert, Richard Lewis Humphrey, John Stephen Sewell, and Frank Soule, Washington Government Printing Office, 1907.

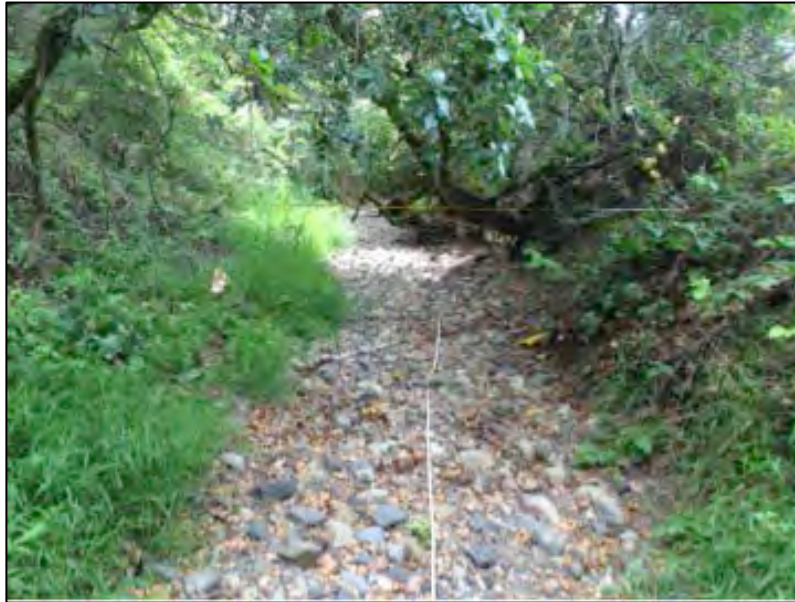
Figure C-5. Photograph of Wilkins Gulch Creek Cross Section 2 looking downstream.

The smaller channel at Cross Section 2 is an entrenched F4 stream type influenced by gravel and smaller cobble. The streambed is overly wide compared to its floodprone width. From the observations made during the field survey, the site appears to have undergone sequential periods of incision, followed by excessive bank erosion and subsequent sediment deposition. This sequence is probably due to the over-widened condition but also to the waning discharge that seems to continue, as indicated by smaller cross-sectional area downstream. The survey team's hypothesis of what started the initial channel incision is that some portion of Wilkins Gulch Creek was diverted into a man-made ditch at the side of the alluvial fan. The ditch was probably not sized appropriately and a head cut propagated upstream into naturally formed reaches.

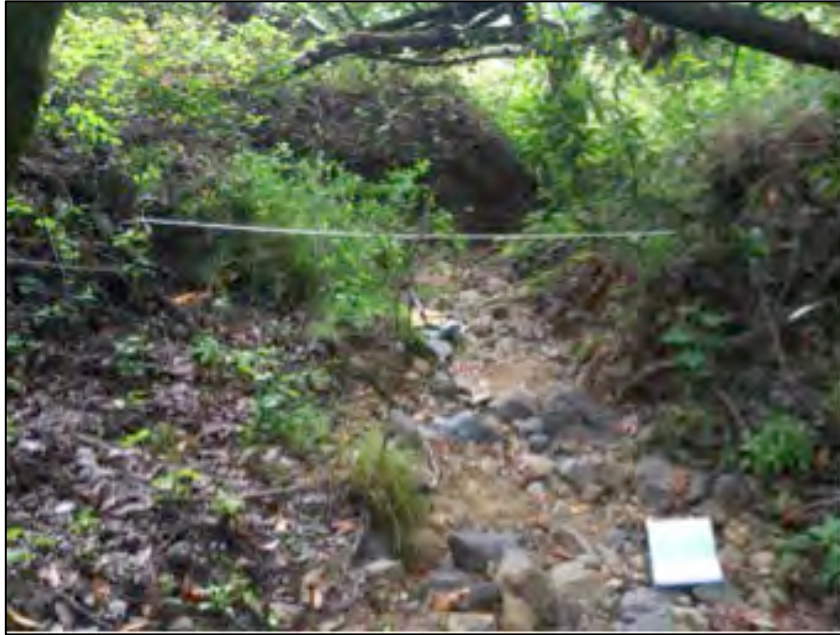
Figure C-9. Looking downstream at North Tributary of Wilkins Gulch Creek

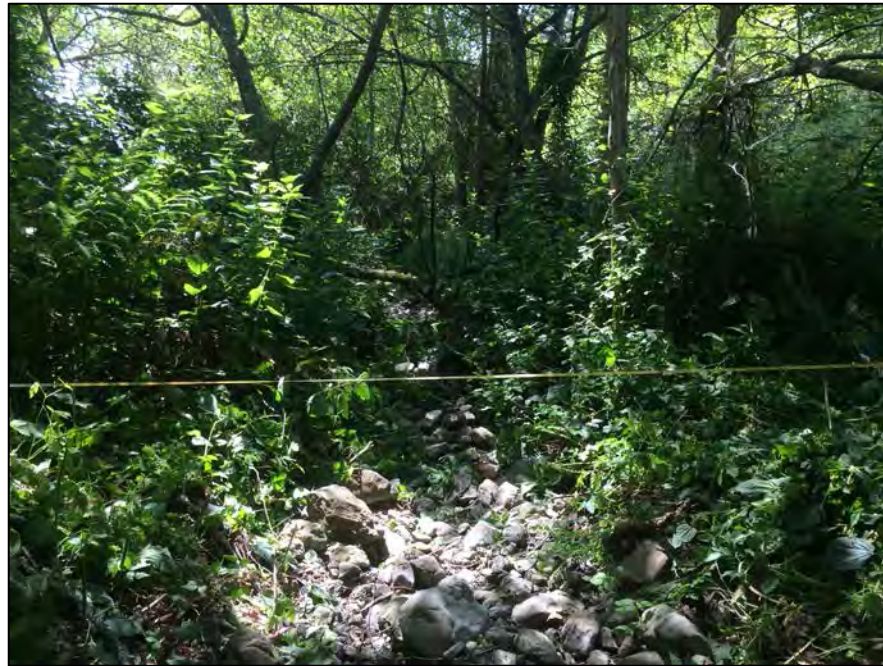
Figure C-13. Looking downstream at Cross Section 1 of Lewis Gulch Creek.

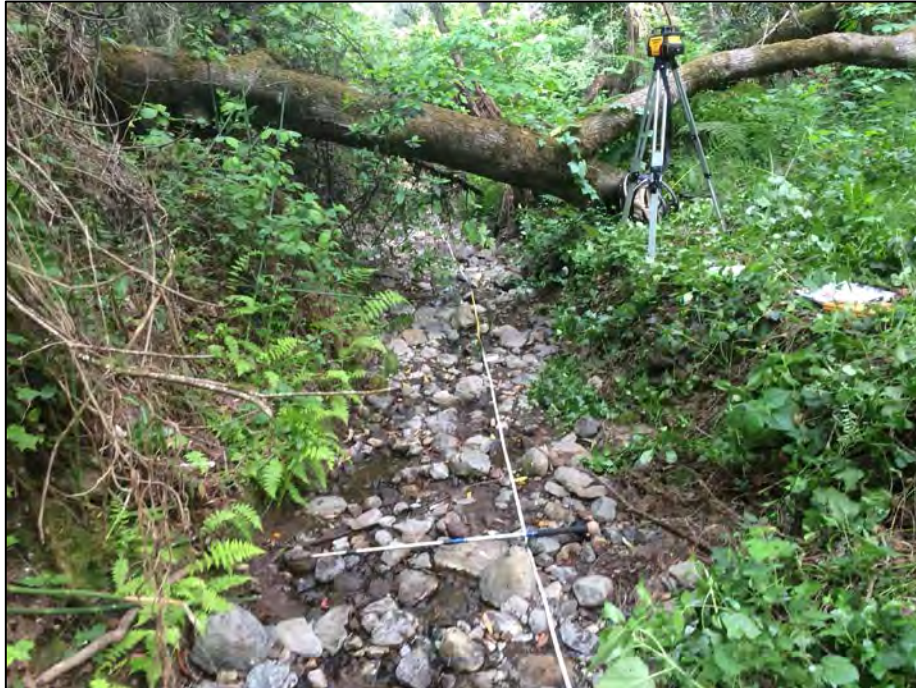
Figure C-17. Lewis Gulch Creek Cross Section 2 looking downstream

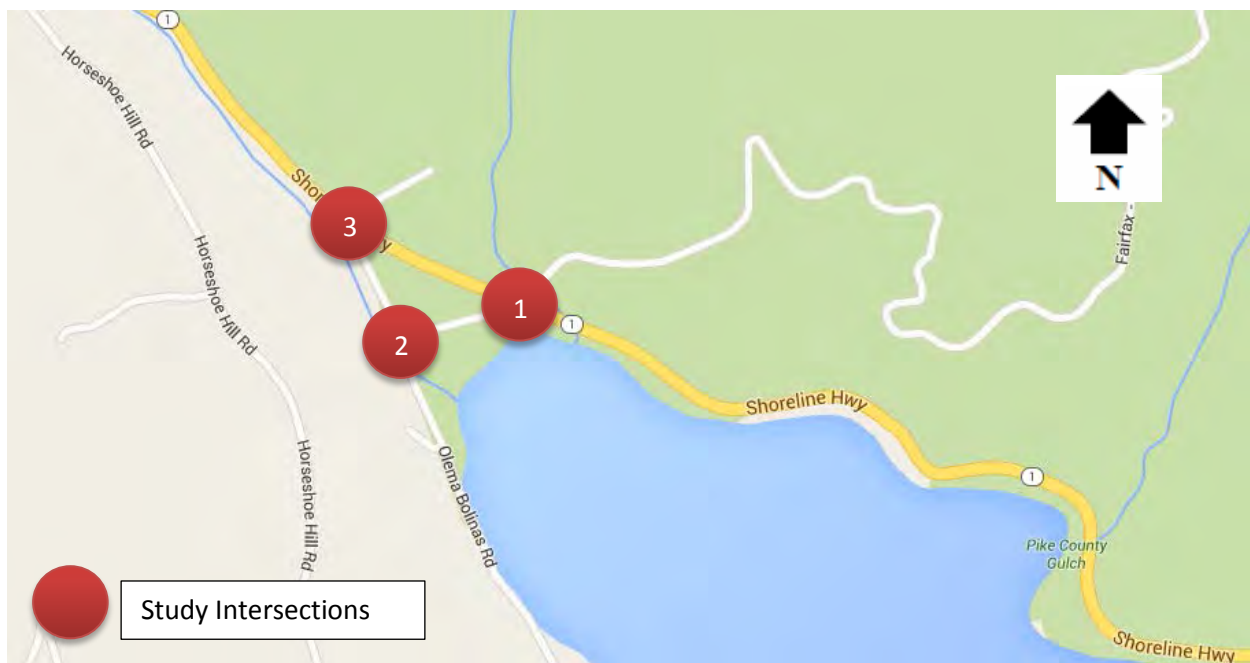
Project Vicinity and Location of the Study Intersections

This memo documents the traffic analysis completed for Bolinas Lagoon North End Restoration Project in unincorporated Marin County near the community of Bolinas. Part of that project involves considering a number of changes to the existing roadways, and the traffic counts and level of service analysis summarized here serve to inform future decisions about possible changes to the roads and intersections. The figure below shows the vicinity of the project and the three study intersections identified for the analysis.

The study included traffic counts and analyses of three intersections under three scenarios:
