Re: Updates to the May 13, 2014 Response to the Civil Grand Jury Report,
Recycling by the Marin County Government: Walking the Talk

2014 Diversion Report

Marin Civic Center Executive Summary

Waste Audit

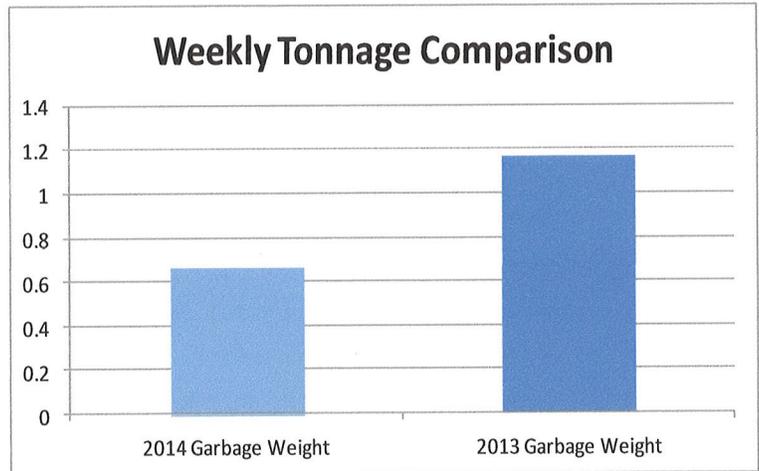
Figure 14. Weekly Tonnage of Waste Comparison

Weights were taken from a week in 2013 (second week in October) and compared to the weight from the same time in 2014. There was a noticeable reduction in the amount of waste generated totaling almost half a ton.

The box diversion rate was then applied each weekly tonnage and a total amount of garbage generated in a week was established.

The difference between the two years is due to the source separation of cardboard, food waste, and better source reduction policies.

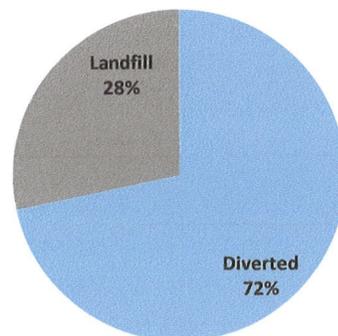
Figure 14. Waste audit results

The 72% diversion figure (Figure 14) was derived from converting the 18 yard box into a gallon equivalent and combining that with the total amount of gallons or recycling services throughout the Civic Center (Figure 13). The County jail was not included into these figures because they have their own compactor and recycling services.

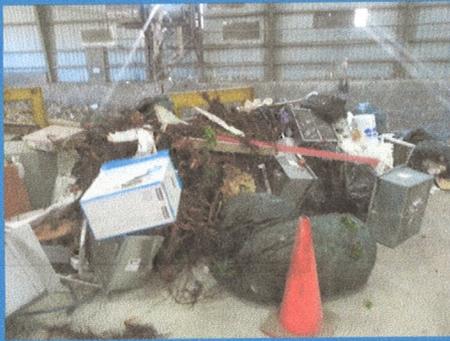
Figure 1. Pre-sort right side of box.

On Wednesday October 8th, Marin Sanitary Service (MSS) Auditors performed a waste audit of the 18 yard R/O box at the Marin County Civic Center (Figures 1-3). The process lasted about 2 and a half hours and was documented by photos and data collection. The entire box was sorted and grouped into 8 categories by diversion methodology: Bagged Material, Open Refuse, Scrap Metal, Cardboard, Blue Cart Material, Brown Cart Material, Yard Waste, and E-Waste (Figure 4).

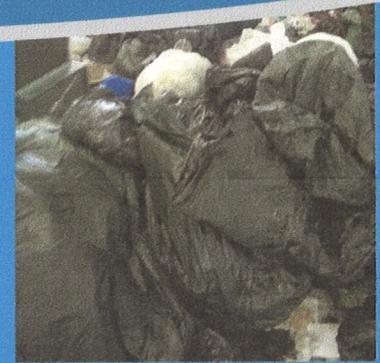
Figure 5. Bagged Refuse.

Bagged Material: 30%

Due to potential health hazards to our facility staff, tied plastic bags are not opened and sorted at the Marin Resource Recovery Center. All material in these tied bags will be sent straight to the landfill and not sorted (Figure 5).

Source separation is always the best way to divert material. However, if the material cannot be sorted, staff should be directed to empty the black garbage bags into the 18 yard box as long as there is some type of recoverable material inside. Bags from restrooms should remain tied.

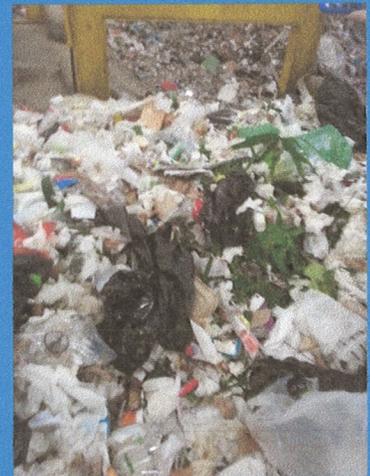
Figure 6. Open Refuse.

The loose materials in the Civic Center box consisted primarily of waste paper, plastic bags, and lunch waste (Figure 6). A large amount of bioplastic containers from the cafeteria was also present. These cannot be composted or recycled within the MSS system.

Food waste and small pieces of yard waste will not be sorted from the mix and will be sent to the transfer station prior to disposal at the landfill. Source separation of the food waste and yard waste will ensure they are recovered.

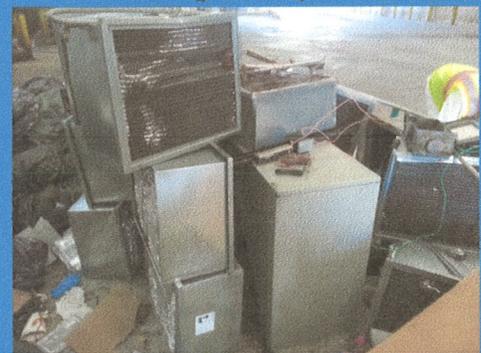
Figure 7. Scrap Metal.

There was a large amount of ventilation ducts present in the box (Figure 7). This material can be fully recycled and is easy to pull out of the 18 yard box. Scrap metal can also be brought to the Marin Recycling Center to be sold at market value.

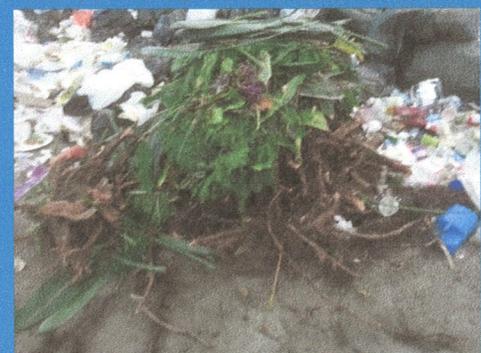
Figure 8. Yard Waste.

There was an abundance of yard waste found in the box. The material seems to have come from landscaping that occurred during the audit period (Figure 8). This majority of this material will be sorted from the 18 yard box, but small pieces may not be diverted.

Installing a Yard Waste box at the Civic Center would ensure that all clean yard waste would be diverted.

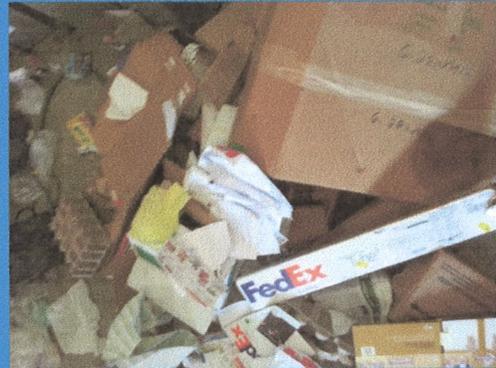
Figure 9. Cardboard

The percentage of Cardboard in the 18 yard bin dramatically decreased thanks to the addition of a 3 yard Cardboard bin that is serviced 6 days a week by Marin Sanitary Service (Figure 9). The majority of the cardboard found in the container were pieces that most likely came from offices that did not have direct access to the cardboard containers. Directing these offices to place the material into the a paper recycling bin would alleviate this problem.

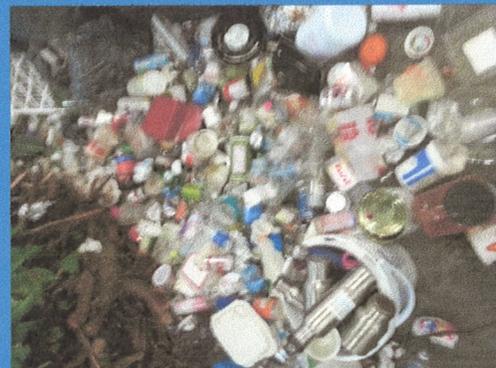
Figure 10. Bottles and Cans.

Recyclable materials such as glass, aluminum and plastic containers placed in the 18 yard container can be sorted at the Material Recovery Facility (MRF) but not at the same recovery rate as those containers collected in the source separated MSS brown carts (Figure 10). To ensure that these resources are diverted fully, source separation is key.

MSS auditors also noticed multiple bags full on containers that ended up in the 18 yard box. These bags were closed and normally would not be opened.

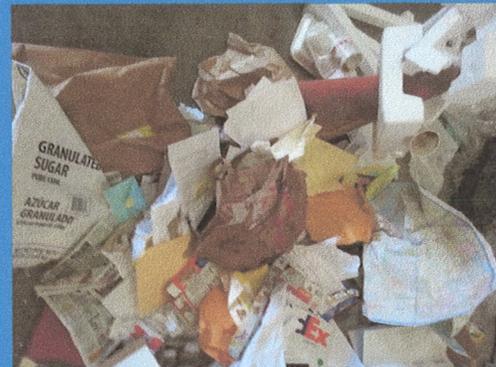
Figure 11. Paper.

When paper is added to a mixed material box it becomes contaminated with glass, liquids, and other materials that decrease its value as a commodity. All paper should be sorted inside the facility in the appropriate MSS blue carts. A MSS representative picks these carts up internally and brings the paper back to MSS to be processed and recycled.

Most of the paper products found were unusual commodities such as bags, envelopes, and books (Figure 11).

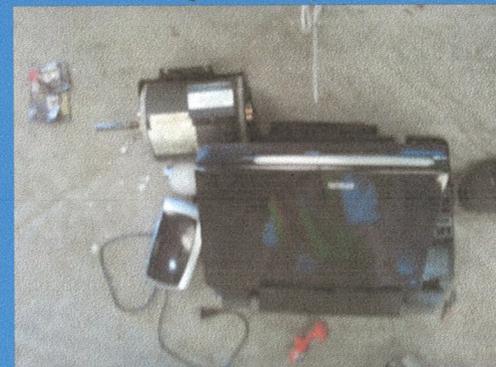
Figure 12. Electronic Waste

During the audit, MSS auditors found small pieces of electronic (or hazardous) waste. No HHW should be disposed of in MSS collection containers. Staff should be educated that these items should be set aside and disposed of properly at the Marin Household Hazardous Waste Facility. Notable items were a printer, a digital alarm clock, batteries, and one CFL light bulb (Figure 12).
