Special Update: **Gross Field Airport Runway Rehabilitation** *Project Status - October 24, 2017*

Gross Field Pavement Project

Marin County Airport
Novato, CA

October 20, 2017 Friday
Monitoring / Air Sampling for
Construction

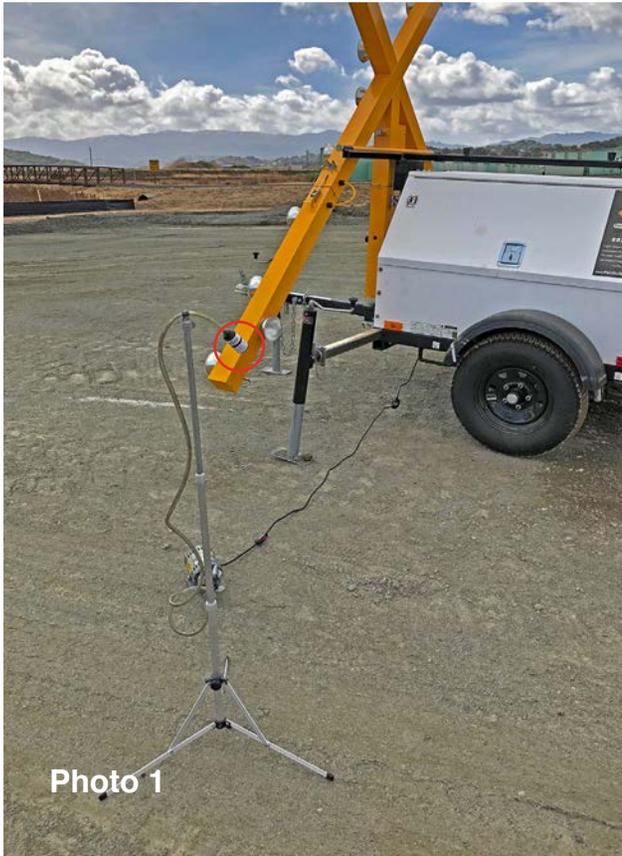
Photo 1 shows the site of sample DVO-02 at the South end of the runway at the field closed marker. The red circle show the air filter.

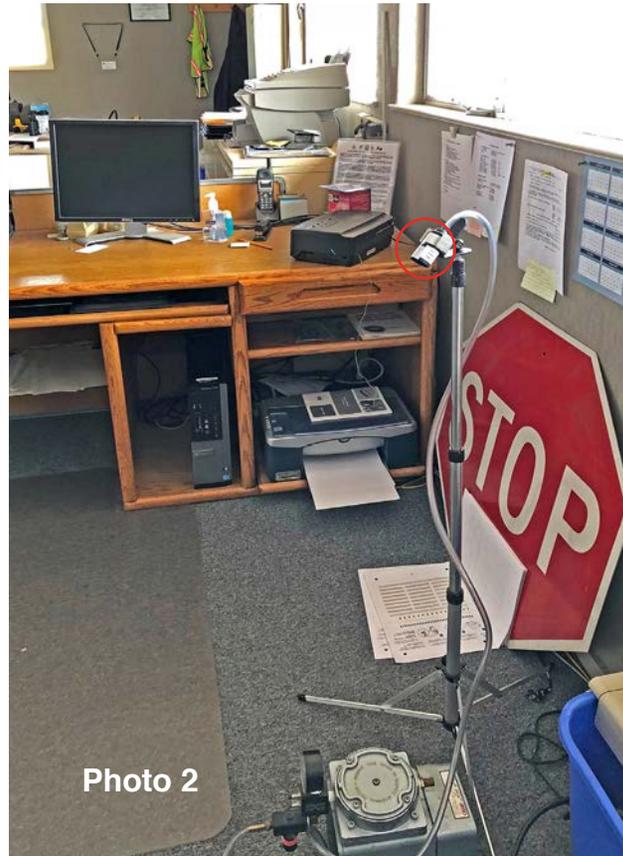
Photo 2

Photos 2 show the air sampling pump and filter inside the manager's office. All of the samples were below the level of 0.016 s/ cc and are all acceptable. The winds at the time of the testing were variable from 270° to 300°, averaging 9 knots, with gusts to 17 knots.

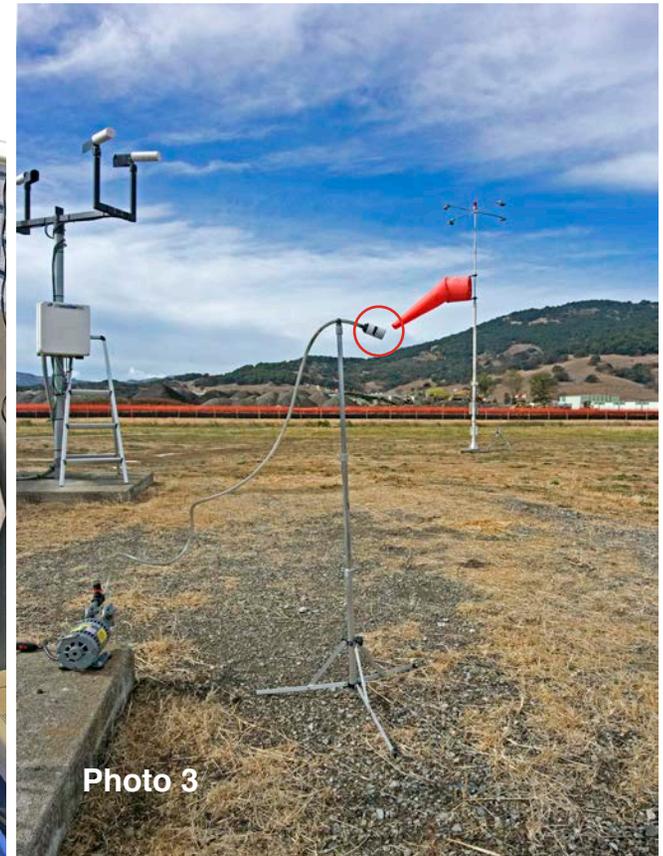
Photo 3 shows the site of sample DVO-01 at the AWOS weather station on the East side of the field.
