A.P. 60-08

CORNER RECORD

L6 - Monument per map 8 R.M 104
C1 - Monument origin unknown - Tie: 8 R.M. 104
AP 60-081-21-22
L6 - Near #92 and #94 Lagoon Road, City of Belvedere
C1 - Near #36 Cove Road, City of Belvedere AP 60-081-03

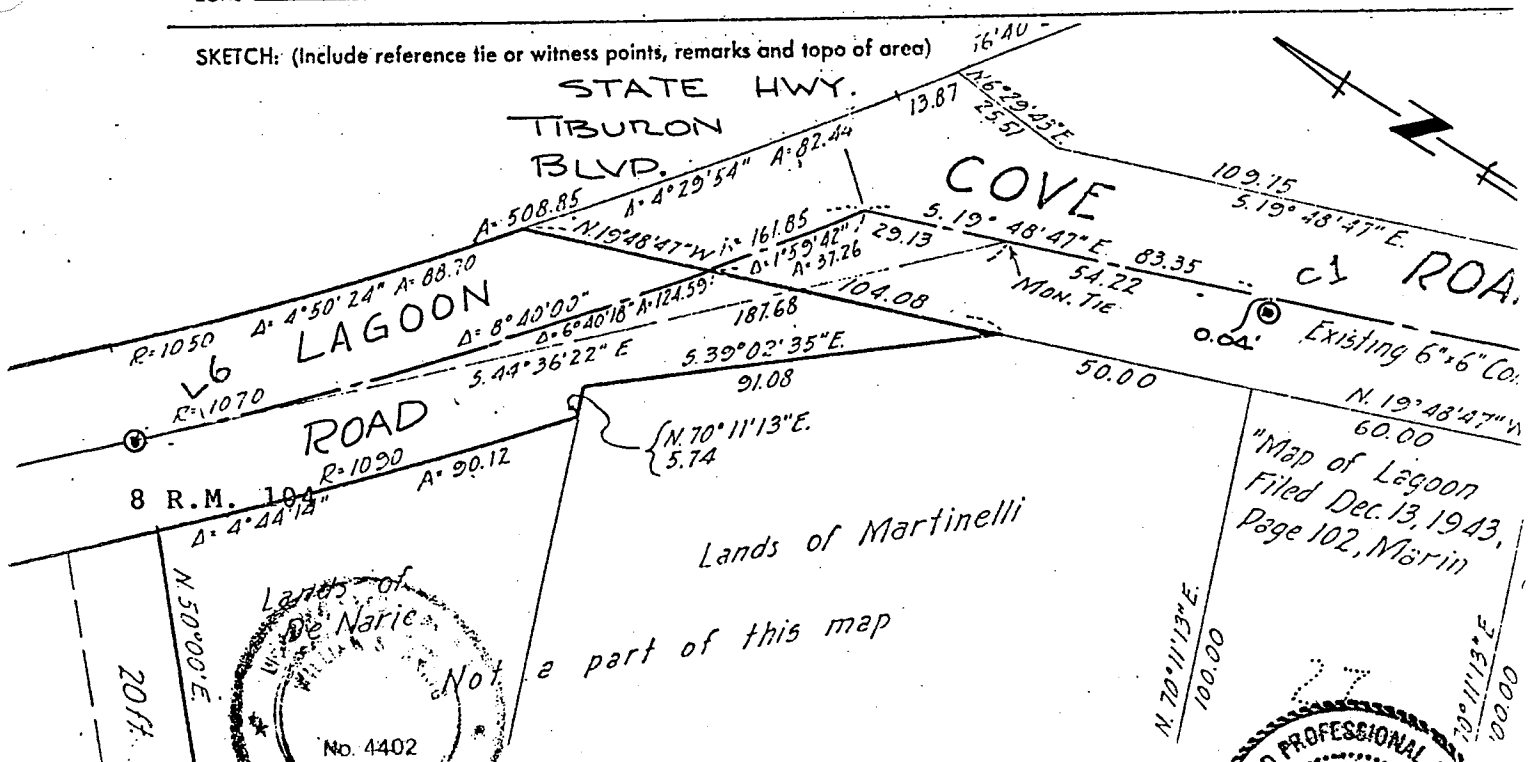
SKETCH: (Include reference tie or witness points, remarks and topo of area)

L6 - Found 1" pipe with tag L.S. 2488
Offset during repaving

C1 - Found standard street monument
Raised after repaving

Original position perpetuated, distances not verified

Standard cast iron street monument
