**MARIN COUNTY HOME PROGRAM PROPOSAL
2014-15**

1. **Project Name: Fairfax Vest Pocket Community**

This Physical Needs Assessment (PNA) is prepared at the request of the Marin Housing Authority (MHA). The purpose of the report is to identify and document the building systems as conditions and to make recommendations for improvements.

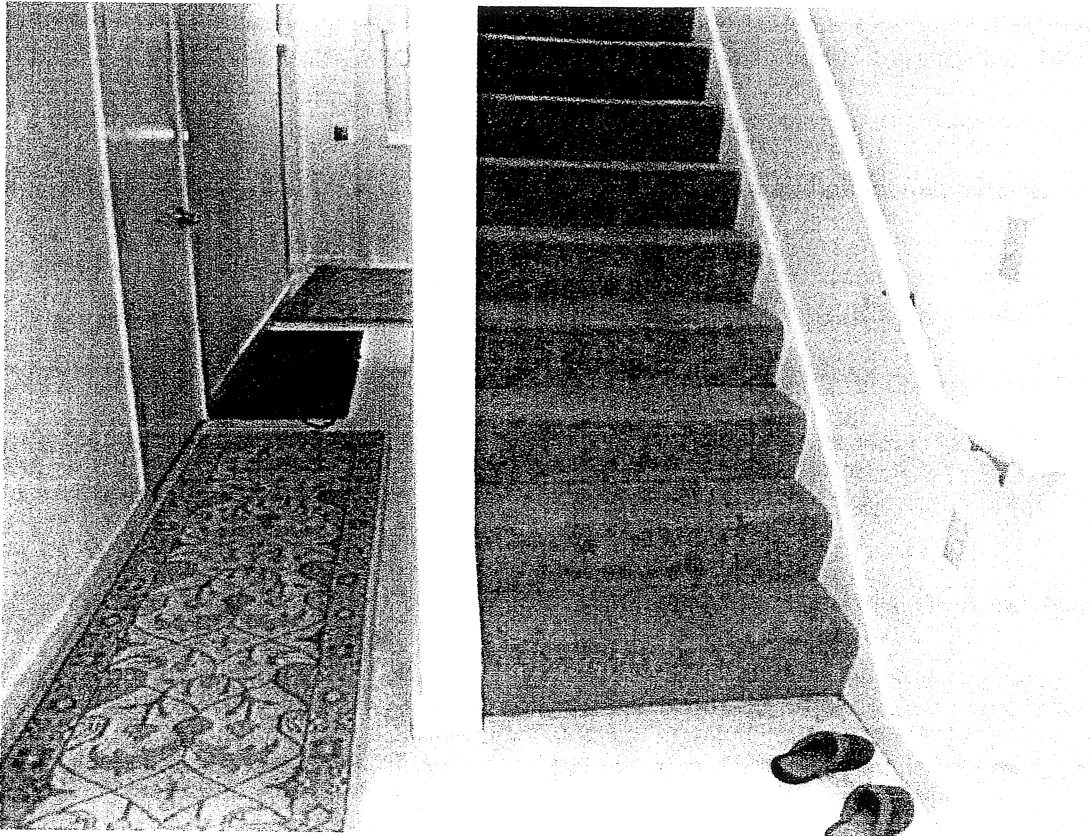
Vinyl flooring at ground floor; carpet at stairs – typical

When sheet vinyl is replaced in the future, it is recommended that a commercial sheet vinyl product should be used when replacing kitchen and bathroom floors, with a minimum 50 mil thickness which will hold up better in the long term. The manufacturer will guarantee replacement vinyl flooring for a minimum of five years. Bathrooms should continue to use sheet vinyl flooring. Vinyl composition tile or sheet vinyl flooring may be utilized at the kitchen areas. The use of bamboo flooring should be considered if funds are available since it is very durable material and it is typically harvested from sustained forests.

Replacement carpet should comply with HUD/FHA materials bulletin "UM44C," and carpet padding should comply with "UM72-80." Furthermore, Replacement carpet should comply with CRI Green Label Plus Carpet Testing Program.

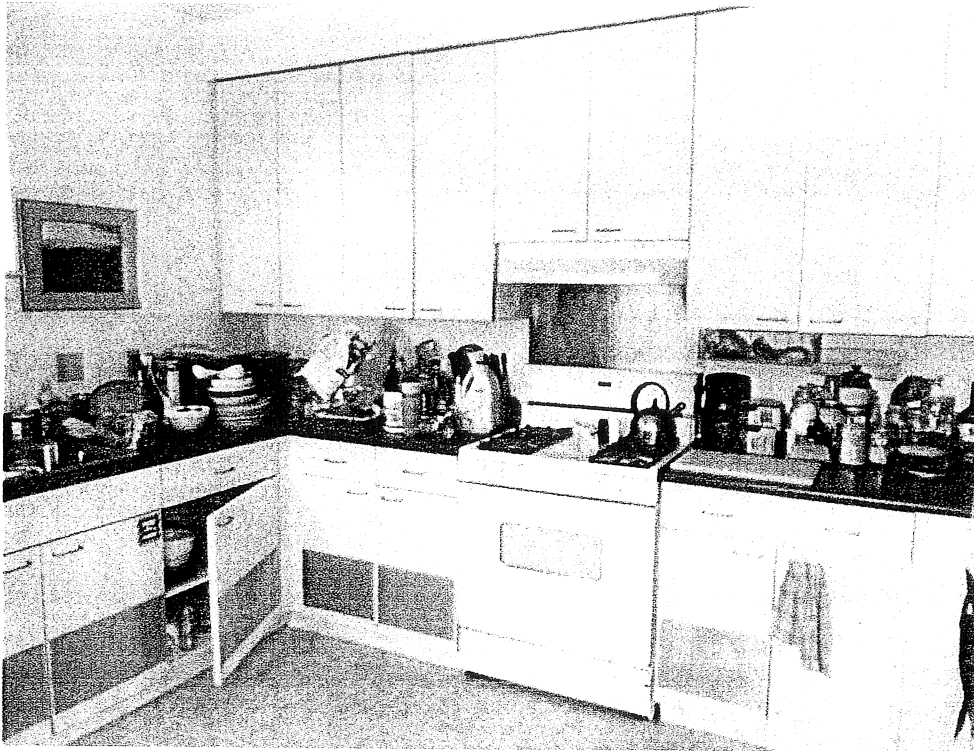
The condition of the appliances in all buildings is good or fair. Stoves and range hoods are original, with refrigerators in some units having been replaced. Replacements for appliances are listed in the Unit Matrix.

Typical kitchen (84 Park Road shown)

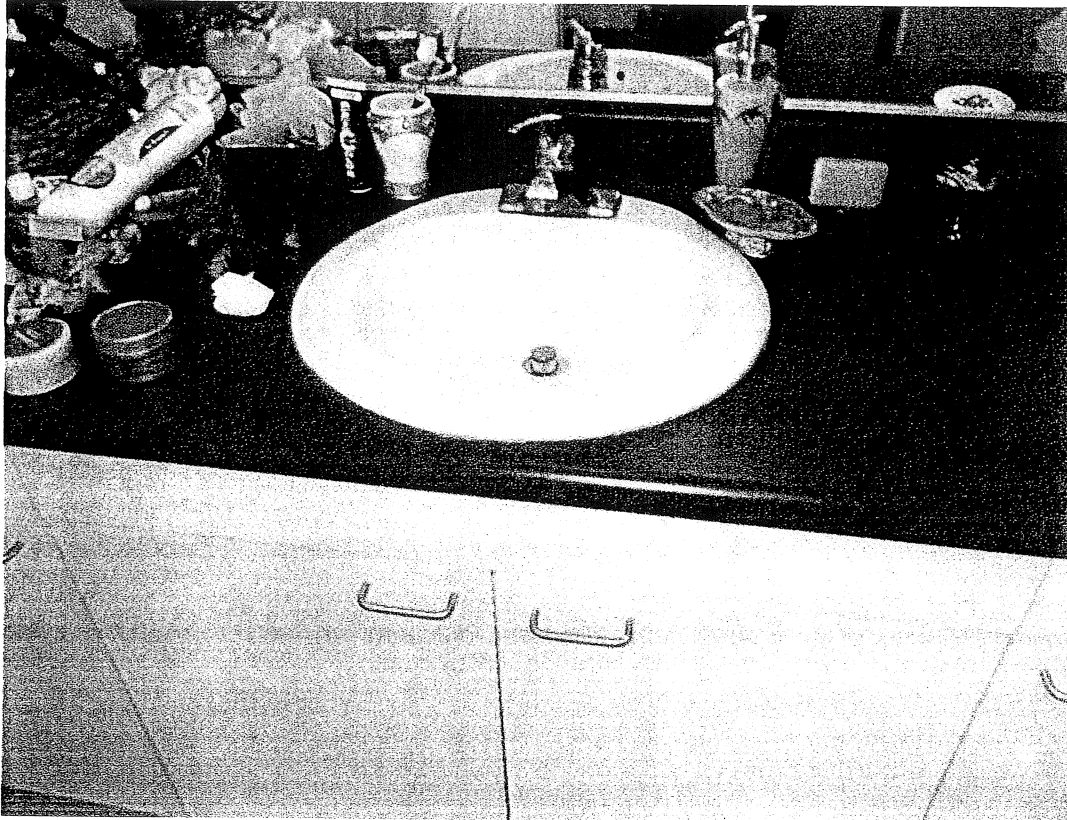
Bathroom cabinet and sink

Future cabinet replacements should comply with minimum cabinet specifications equivalent to WIC (Woodwork Institute of California) Custom Grade Specifications. Cabinets should be paint/stain grade wood, low or high-pressure laminates. Equivalent WIC Economy Grade cabinets are also acceptable.³

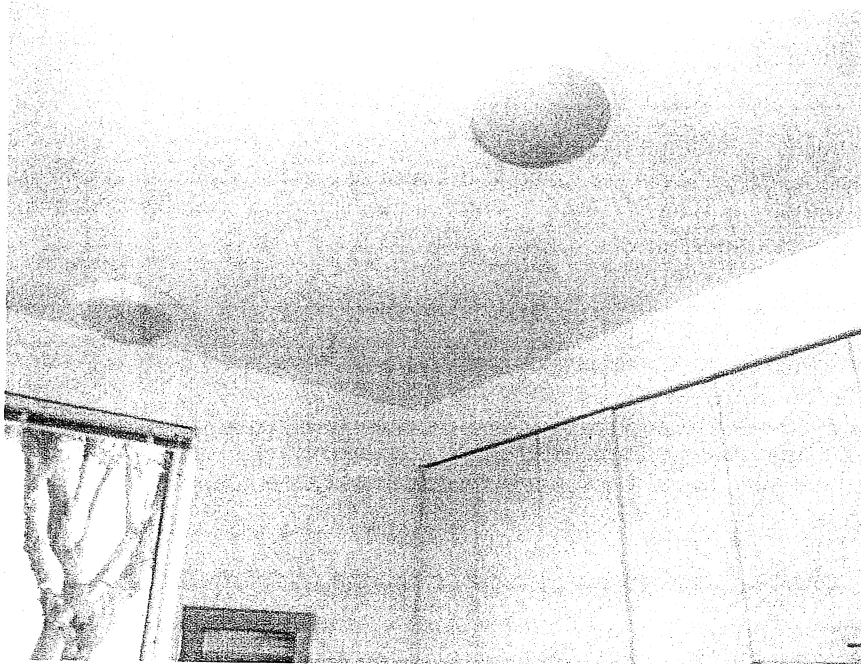
Typical ceiling fixtures at kitchen

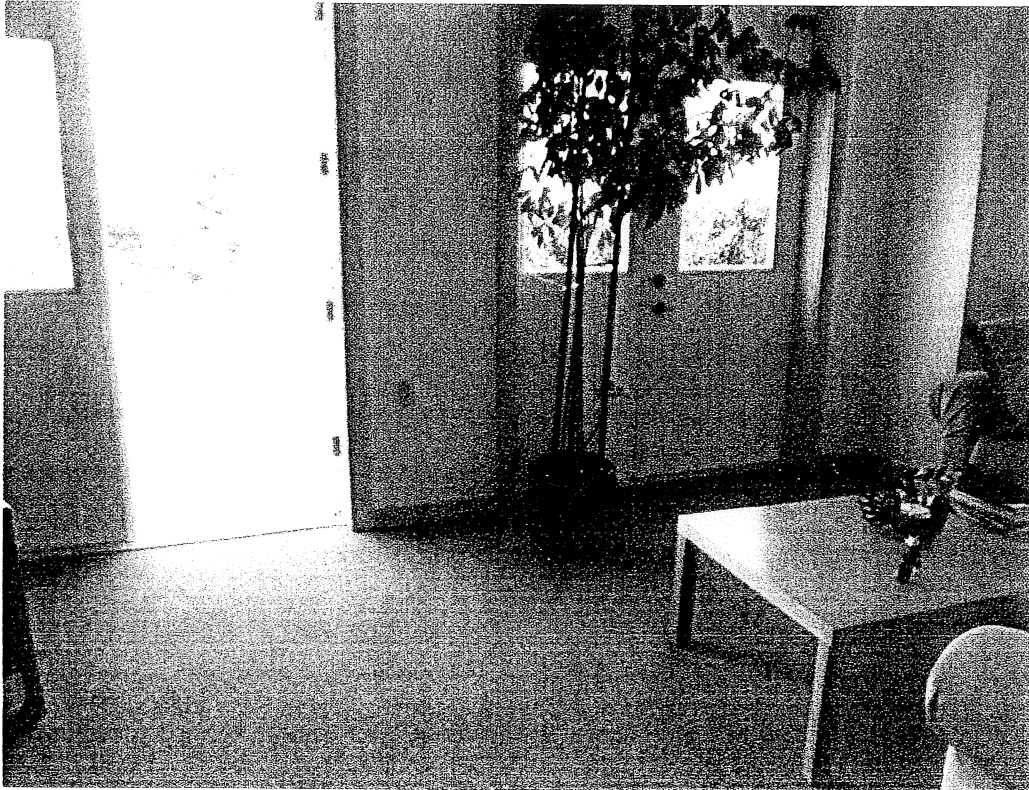
Community Room leading out to patio

The condition of the finishes at the community room is good and no updates are recommended.
