# CHARACTER-DEFINING FEATURE STUDY

## GOLDEN GATE VILLAGE, MARIN CITY, CA

**September 2019**

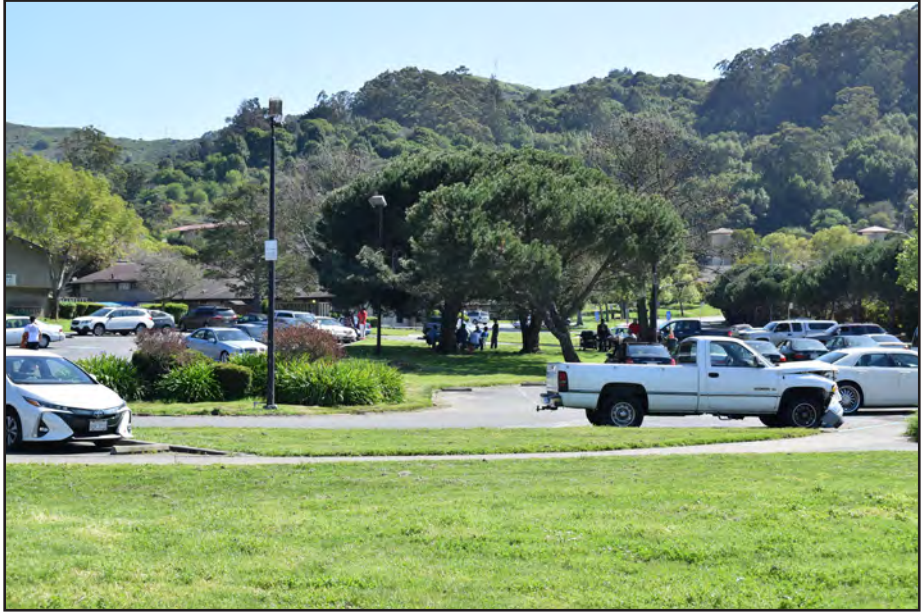
The natural topography of the site varying from flat to steeply sloped, due to southern property line abutting against hillsides of Marin Headlands.	N/A	High
				Date Altered	Condition
				N/A	Good
Landscape Characteristic	Feature	Photo	Description	Date Built	Integrity
Spatial Organization	Irregular plan

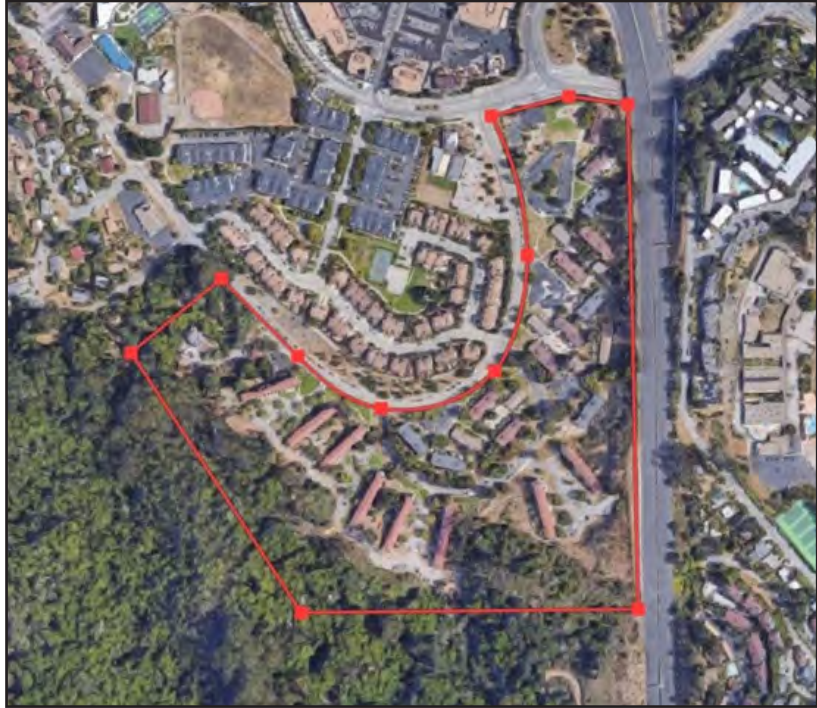
<p>Source: Google Maps, 2019.</p>	The irregular shaped lot and layout of the property in response to the topography and pre-existing infrastructure at the site.	1955	High
				Date Altered	Condition
				1992	Good

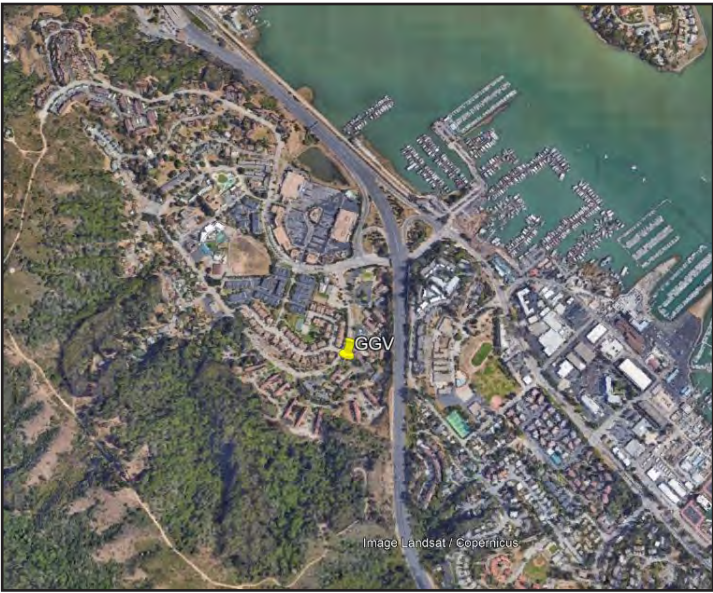
<p>Source: Google Earth Pro, 2019.</p>	<p>Location of the property nestled into the base of the hilly terrain known as the Golden Gate National Recreation Area (GGNRA) to its southwest, and opening up to Richardson Bay to its northeast.</p>	1955	High
				Date Altered	Condition
				N/A	Good
Landscape Characteristic	Feature	Photo	Description	Date Built	Integrity
Spatial Organization	Building locations

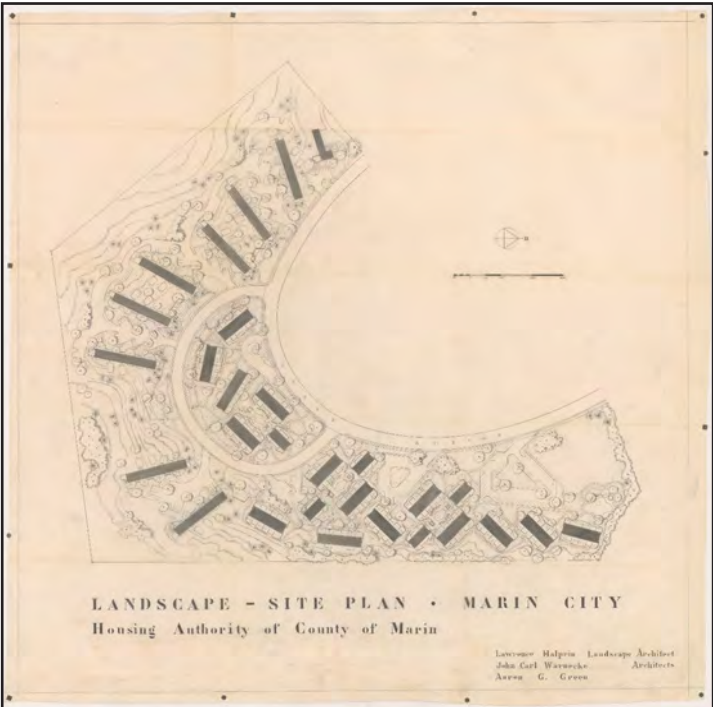
<p>Source: Halprin Collection, University of Penn. Architectural Archives.</p>	<p>The design of the site responding to its topography/location, with taller buildings and structures built into the hilly slopes of the southwest, and shorter buildings and landscaped open spaces located to the northeast closer to Richardson Bay.</p>	1959	High
				Date Altered	Condition
				N/A	Good

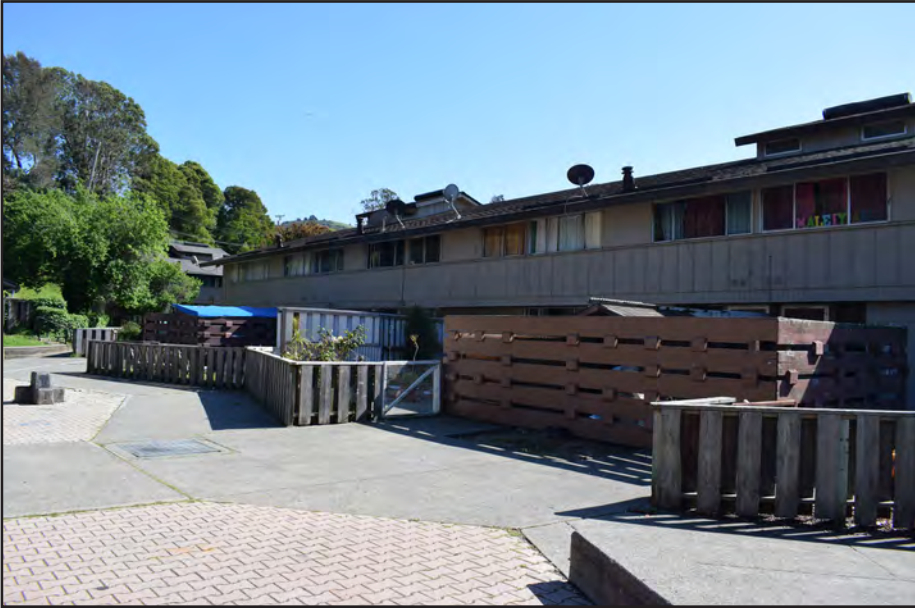
Both private outdoor space (terraces or balconies) and shared gathering outdoor spaces.	1959	Medium
				Date Altered	Condition
				1992	Good
Landscape Characteristic	Feature	Photo	Description	Date Built	Integrity
Spatial Organization	Shared outdoor areas

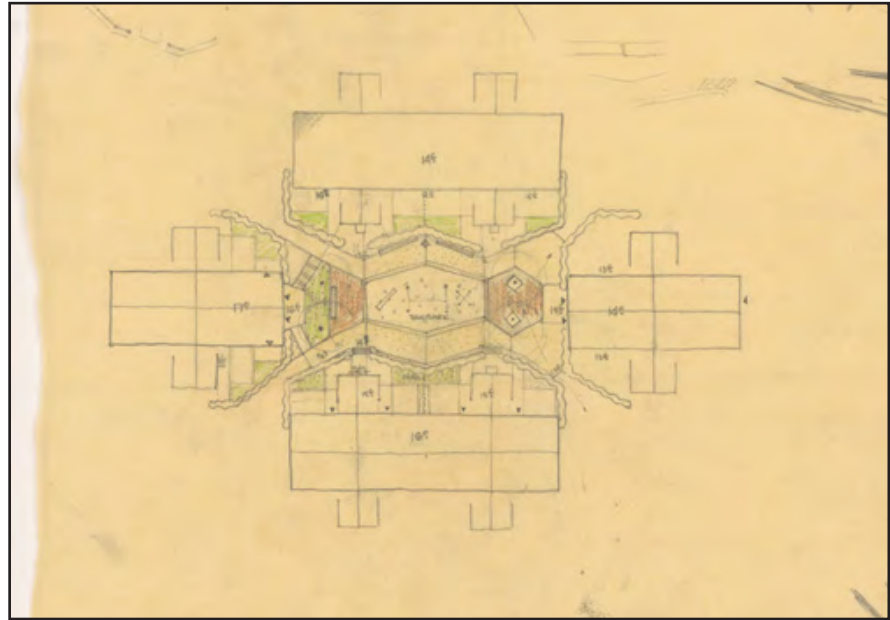
Interspersed shared areas: courtyards, terraces, parking, play areas.	1959	Medium
				Date Altered	Condition
				1992	Fair
Source: Halprin Collection, University of Penn. Architectural Archives.

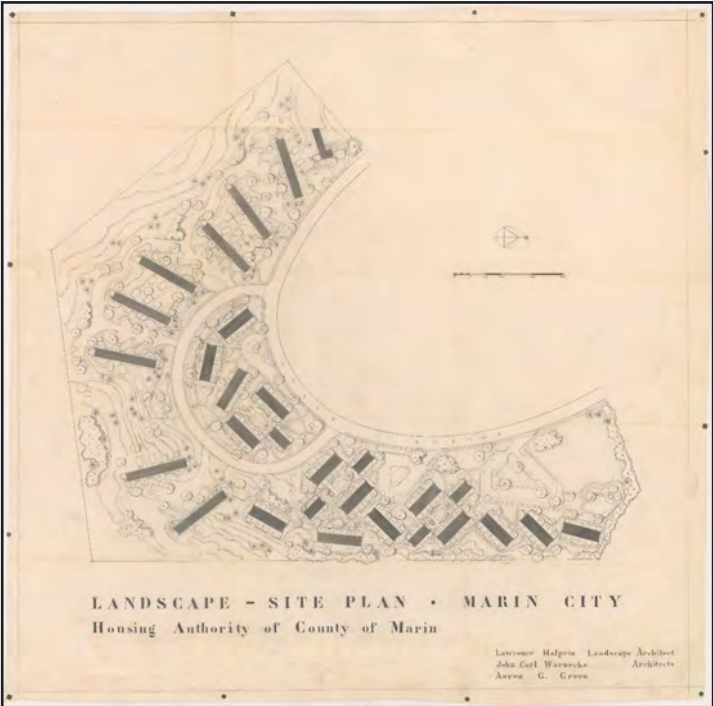
<p>LANDSCAPE - SITE PLAN • MARIN CITY Housing Authority of County of Marin Landscape Architect: Lawrence Halprin Architects: John Carl Warneke, Assoc. G. Green</p> <p>Source: Halprin Collection, University of Penn. Architectural Archives.</p>	High-rise buildings arranged in a radial pattern, emerging from the hillside so that each retains its relationship at 90-degrees to the contours.	1959-1961	High

Date Altered	Condition
				N/A	Good

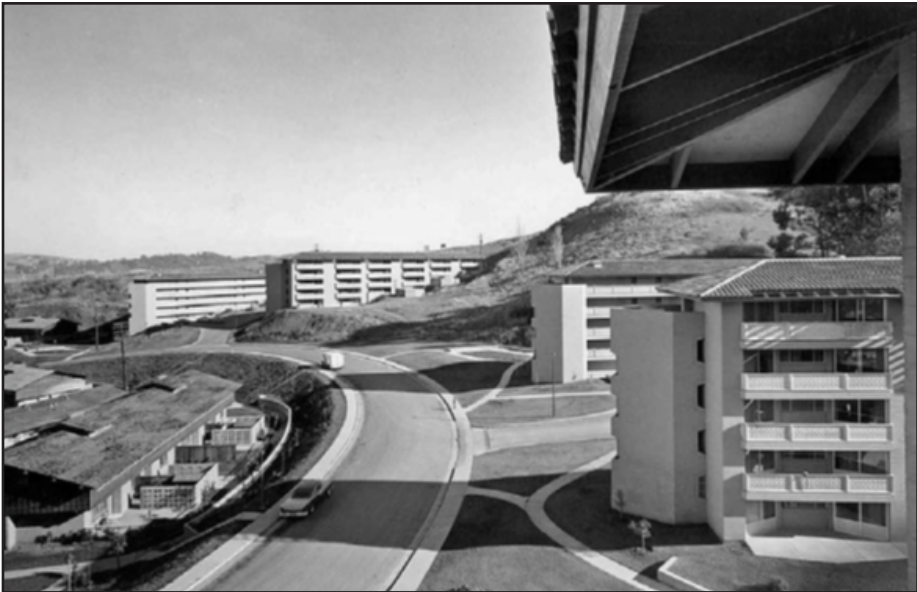
<p>Source: Ruark, 2017.</p>	The location, design and spatial organization of the high-rise cluster.	1959-1961	High
				Date Altered	Condition
				N/A	Good
Landscape Characteristic	Feature	Photo	Description	Date Built	Integrity
Cluster Arrangement	Low-rise cluster

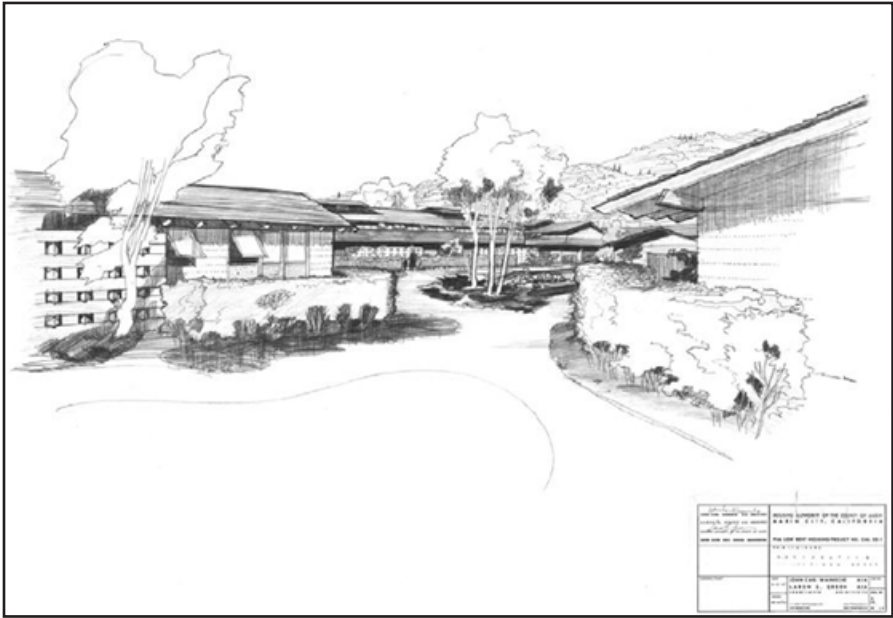
<p>Source: Ruark, 2017.</p>	The location, design and spatial organization of the low-rise cluster.	1959-1961	High
				Date Altered	Condition
				N/A	Good

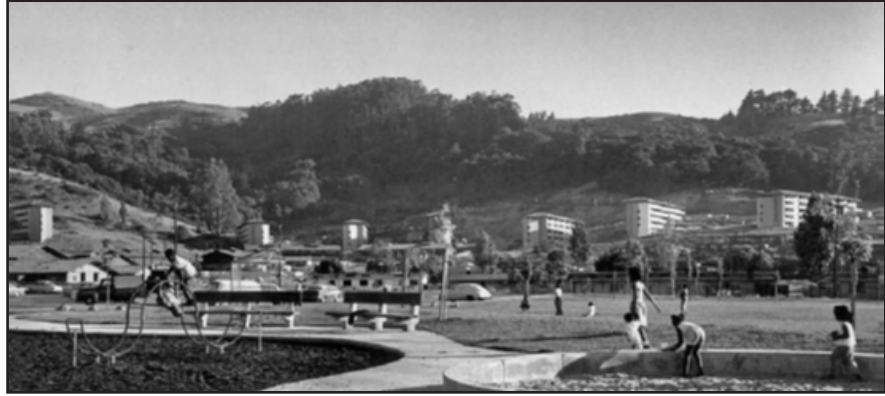
The location of the Recreation cluster. The design and spatial arrangement have been altered.	1959-1961	Medium	
				Date Altered	Condition	
				1992	Good	
		Source: Ruark, 2017.

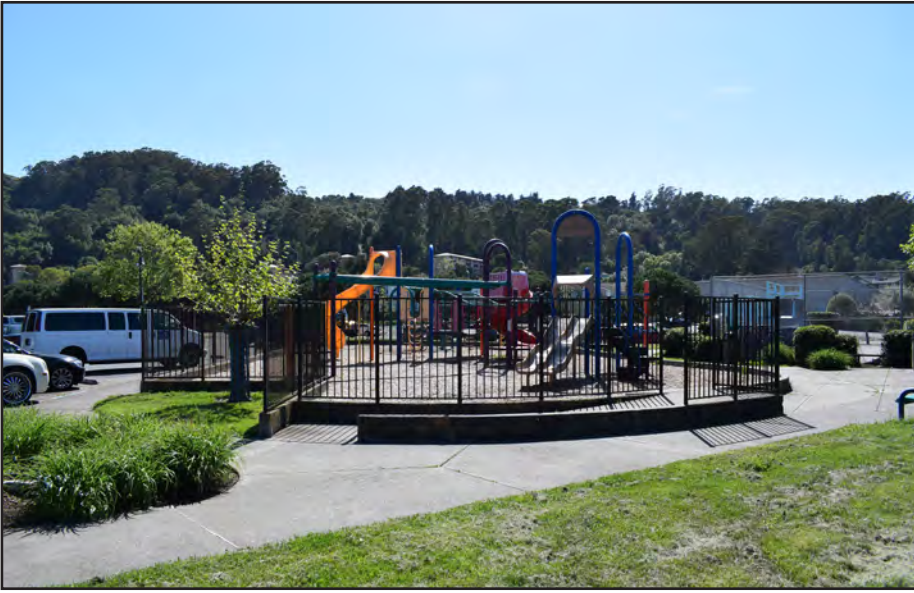
<p>Shared spaces (courtyards, terraces, play grounds, recreational fields) were intended to create a sense of community for tenants who lived at the property.</p>	1959-1961	Medium
				Date Altered	Condition
				1992	Good
Landscape Characteristic	Feature	Photo	Description	Date Built	Integrity
Land Use	Administration and maintenance use

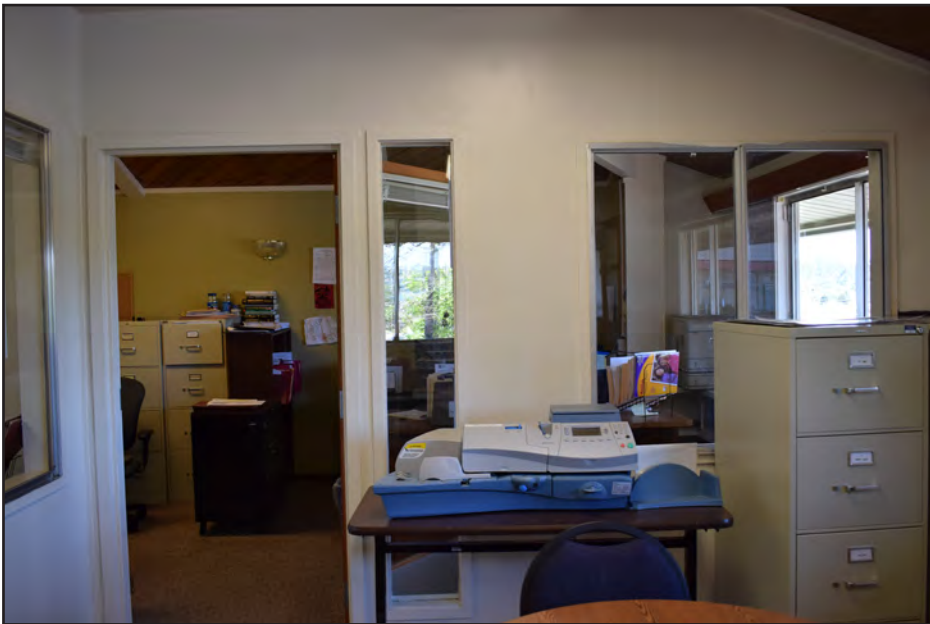
<p>The Admin building was built to house MHA's central administration offices and maintenances facilities for Golden Gate Village. MHA moved their central offices off-site in the 1990s, but the building still houses administrative offices and maintenance facilities for Golden Gate Village.</p>	1959-1961	Medium
				Date Altered	Condition
				1900s	Fair

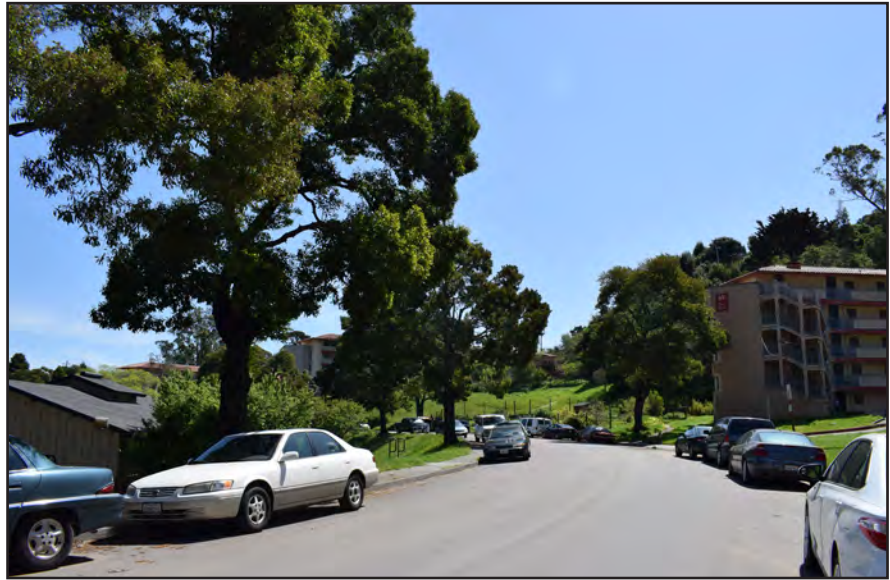
The U-shaped alignment of Cole Drive.	1955	High
				Date Altered	Condition
				N/A	Good

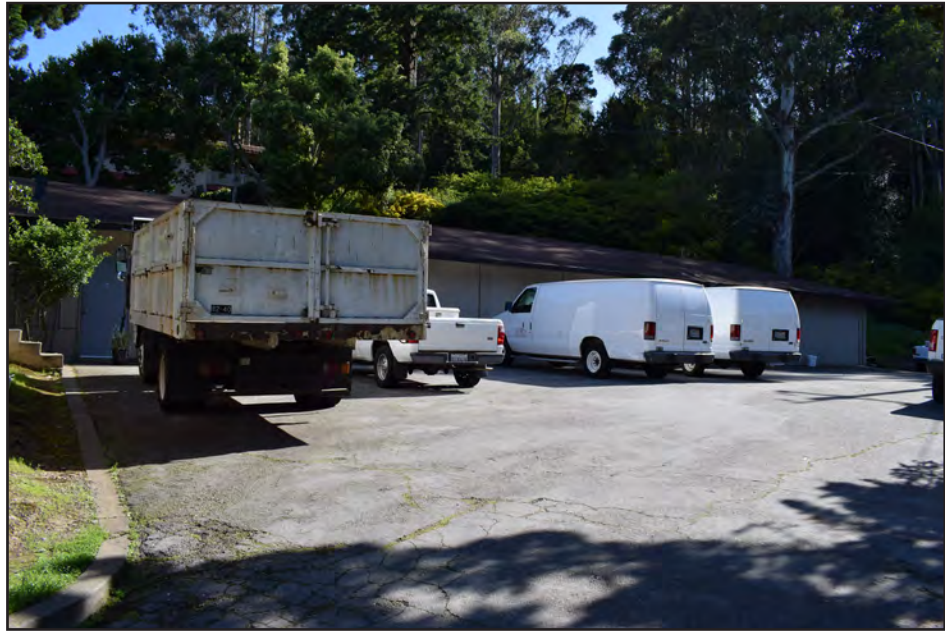
The alignment of the Maintenance Service Road adjacent to the Administration building.	1959-1961	High
				Date Altered	Condition
				1985	Good

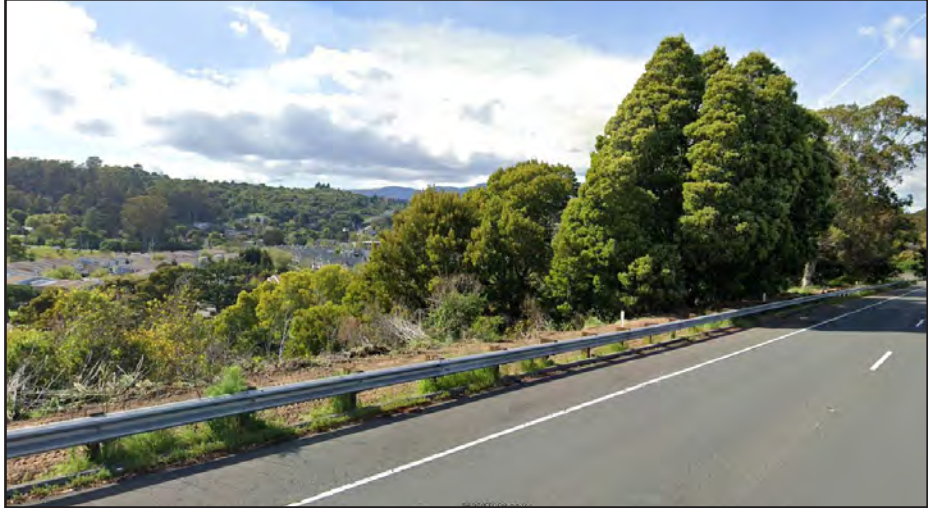
<p>Source: Google Earth Pro, 2019.</p>	Densely planted buffer including groupings of trees, shrubs and a groundcover along eastern boundary of property along Highway 101. Image is looking northwest from U.S. HW 101 into Golden Gate Village with vegetated buffer.	1959-1961	Medium
				Date Altered	Condition
				1979	Fair
Landscape Characteristic	Feature	Photo	Description	Date Built	Integrity
Vegetation	Row of coniferous trees along northern property boundary

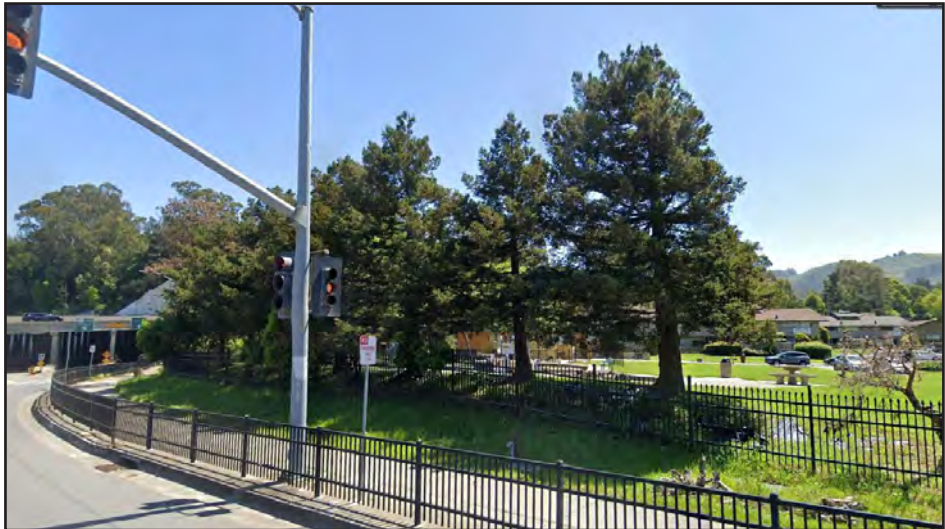
<p>Source: Google Earth Pro, 2019.</p>	Dense row of coniferous trees along northern edge of recreation area (where remaining). Image is looking southeast into Golden Gate Village site from north of site boundary.	1974	Medium
				Date Altered	Condition
				1992	Good

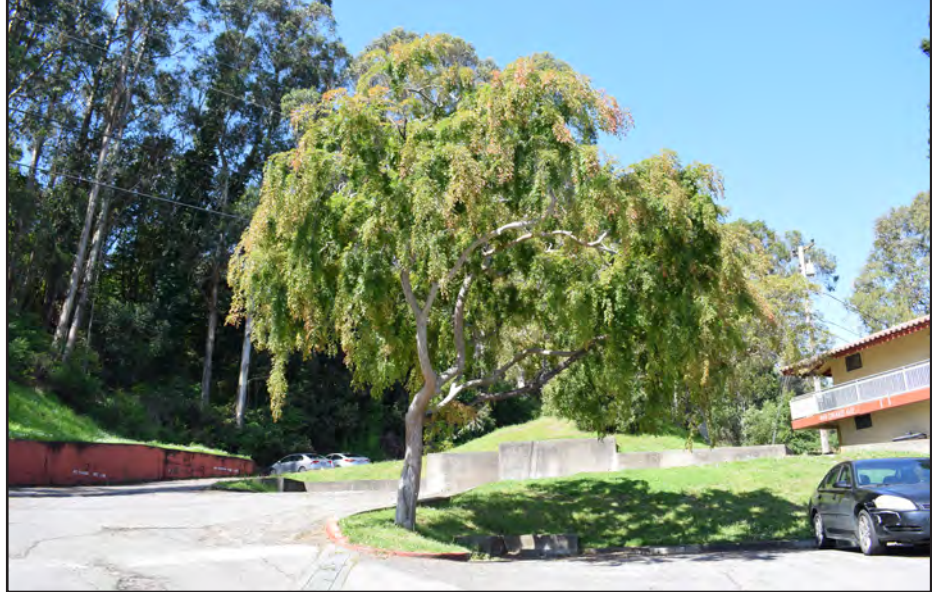
Chinese Elm ( <i>Ulmus parvifolia</i> ) and species of Plum trees alternating along length of driveways in high-rise cluster.	1974	High
				Date Altered	Condition
				N/A	Good

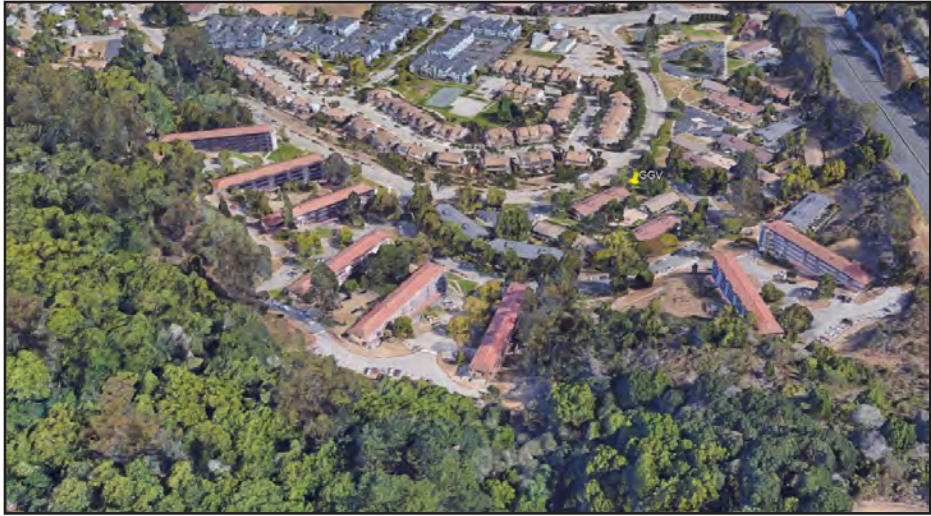
<p>Source: Google Earth Pro, 2019.</p>	Dense tree and shrub cover along the southern and southwestern edges of the site, where the property shares a boundary with GGNRA, and extending southward between buildings 69 and 59, extending the feeling of a woodland setting from the Marin Headlands. The image shows the tree and shrub cover south and southwest of the site that extends from this shared boundary.	1959-1961	Medium
				Date Altered	Condition
				1974	Fair
Landscape Characteristic	Feature	Photo	Description	Date Built	Integrity
Vegetation	Vegetation within fenced enclosures of tenants

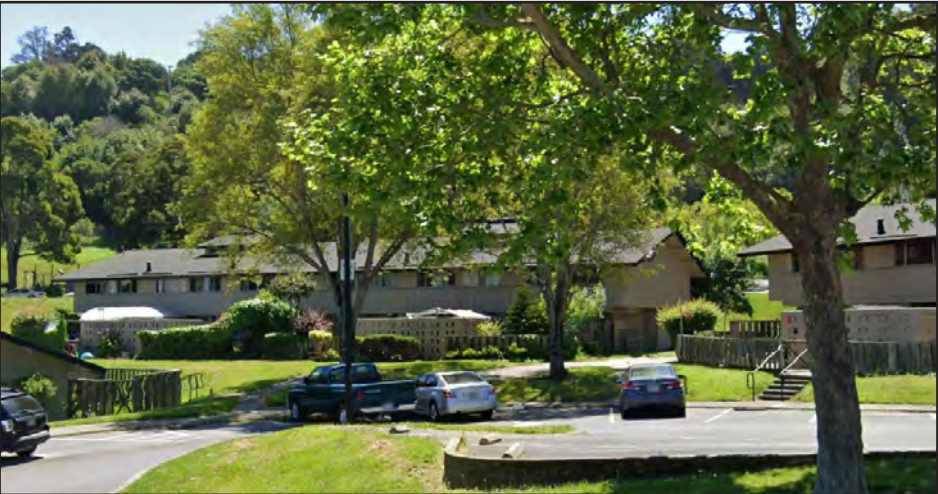
Vegetation located within fenced enclosures of low-rise building units unique to each tenant. The image shows tenant gardens located within the fence enclosures, which was intended by the landscape architect.	1961	Medium

Date Altered	Condition
				On-going	Fair

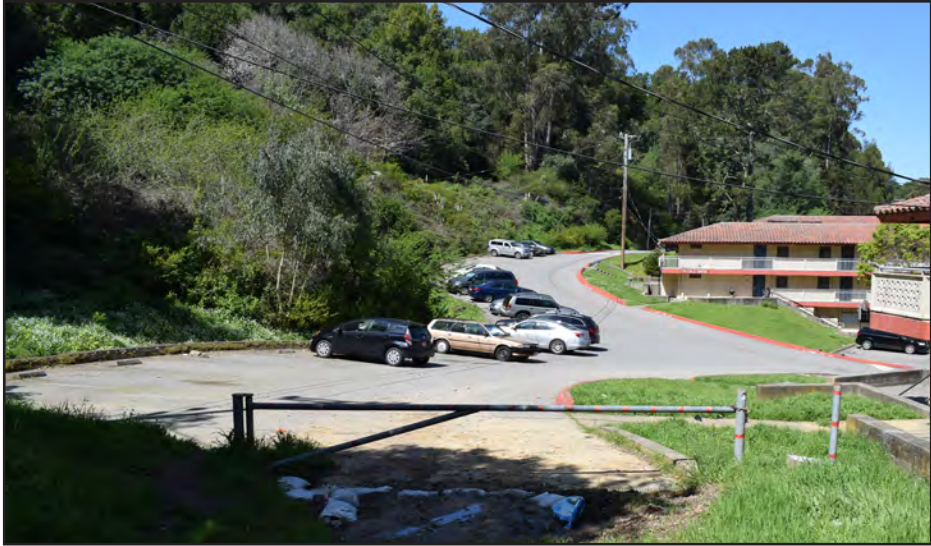
Views south or west towards the Marin Headlands.	1959-1961	High
				Date Altered	Condition
				N/A	Good
Landscape Characteristic	Feature	Photo	Description	Date Built	Integrity
Views and Vistas	Vistas between high-rise buildings

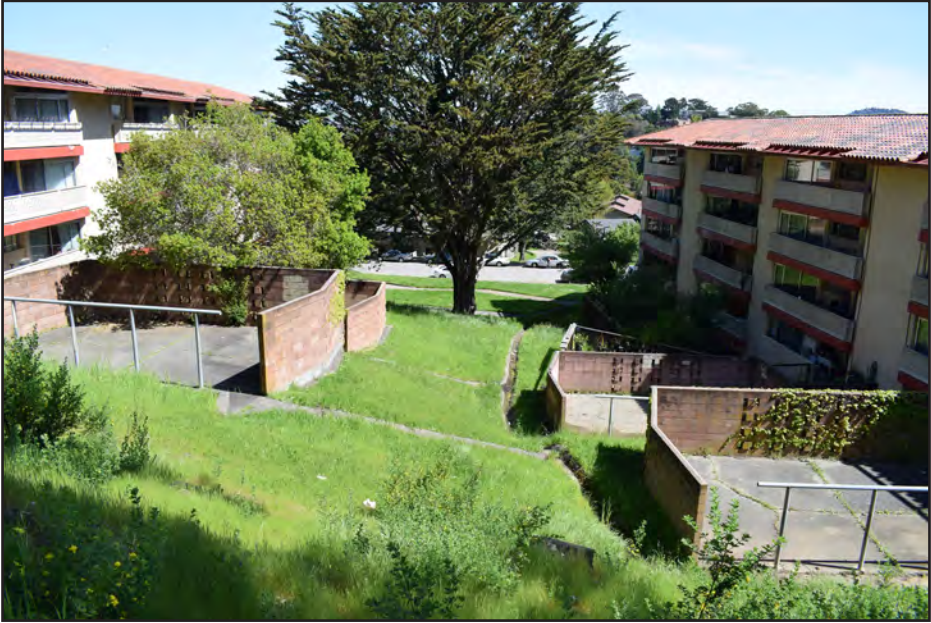
Narrowing and expanding vistas between the high-rise buildings.	1959-1961	High
				Date Altered	Condition
				N/A	Good

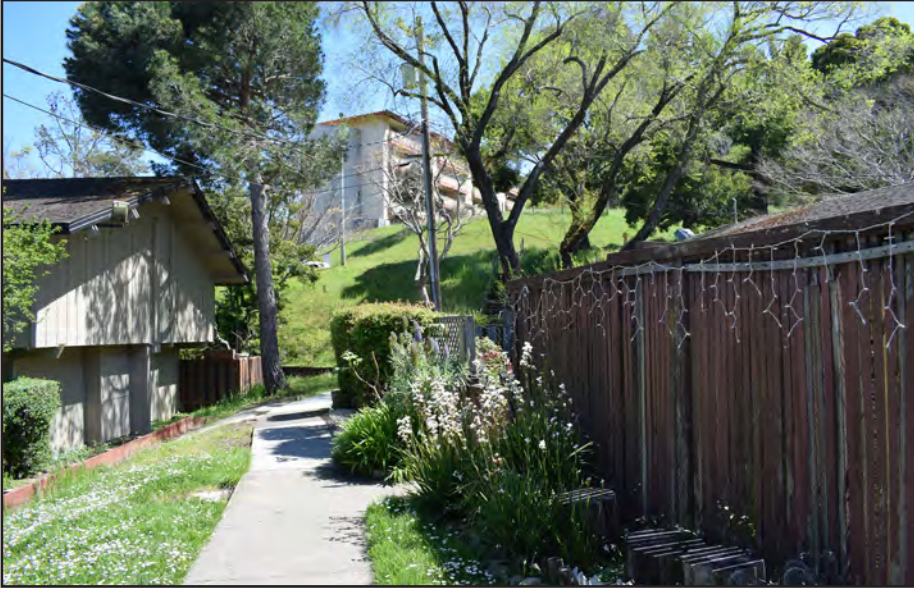
Broad views from the low-rise cluster towards the high-rise cluster.	1959-1961	High
				Date Altered	Condition
				N/A	Good
Landscape Characteristic	Feature	Photo	Description	Date Built	Integrity
Views and Vistas	Long views towards recreation cluster

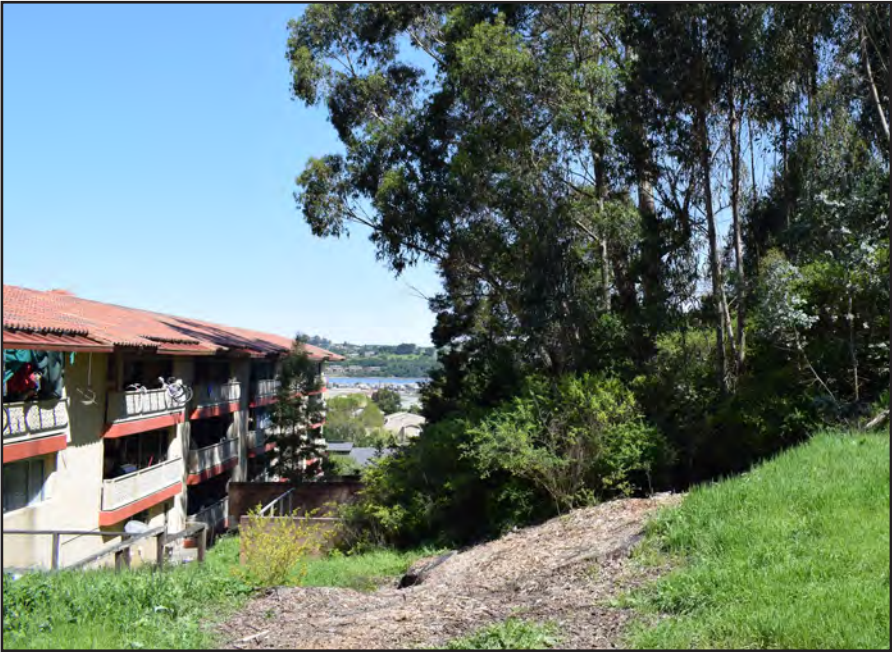
Views from the high-rise cluster over the low-rise buildings towards the recreation area cluster. Alterations to the recreation cluster have resulted in changes to this viewshed.	1959-1961	Medium
				Date Altered	Condition
				1974, 1992	Good

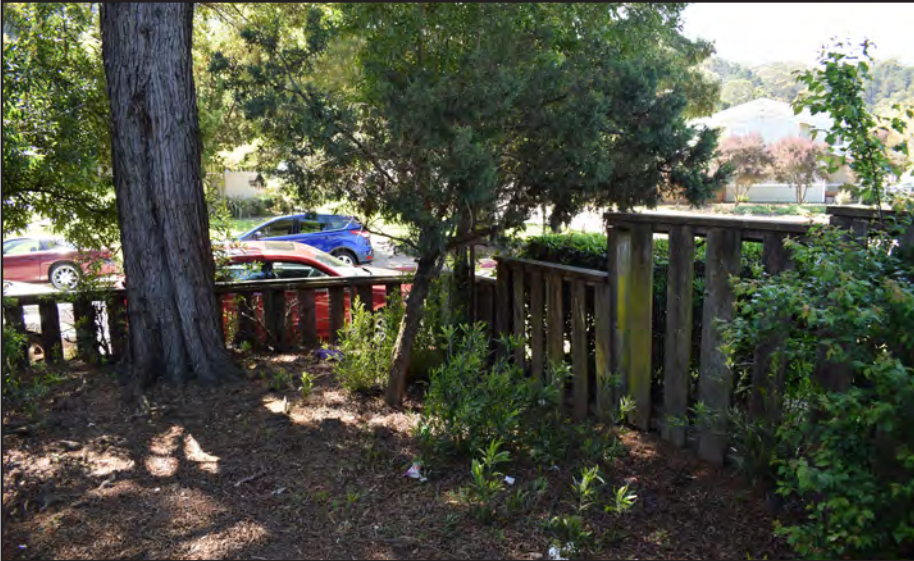
Views within tenants' private patios in the low-rise buildings constrained from privacy screens using fences and vegetation. Tenants have altered the vegetation over-time, in keeping with the original intention of the landscape architect.	1959-1961	High	
				Date Altered	Condition	
				On-going	Good	
Landscape Characteristic	Feature	Photo	Description	Date Built	Integrity	
Constructed Water Feature	Unlined interceptor ditch

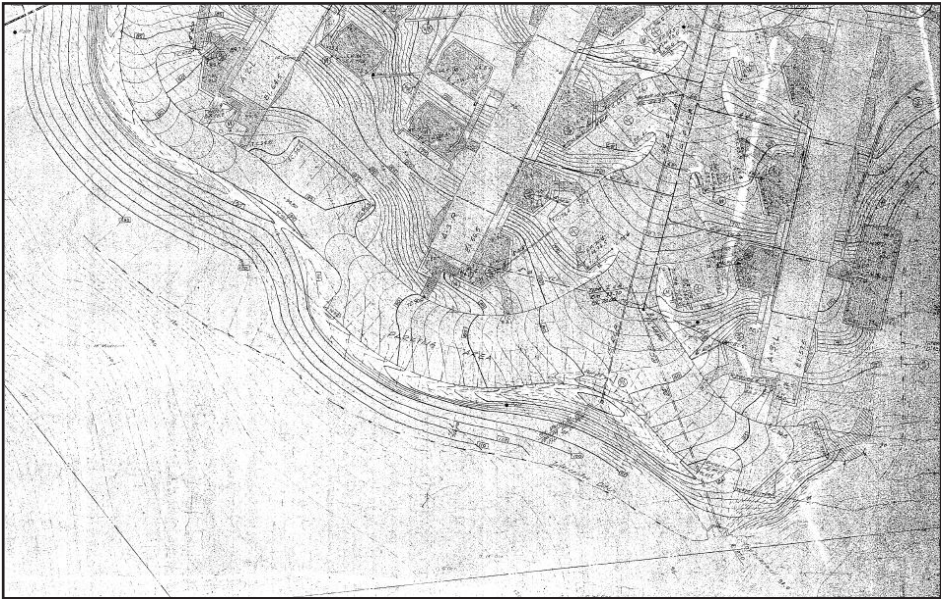
Unlined interceptor ditch located in sloped area south of Service Rd and east of building 69 Cole Drive along the flood zone area. The image is a portion of the 1959 civil plan showing the location of the unlined interceptor ditch along the southern slope.	1959-1961	High	
				Date Altered	Condition	
				N/A	Fair	
		Source: MHA Archives, 1959.

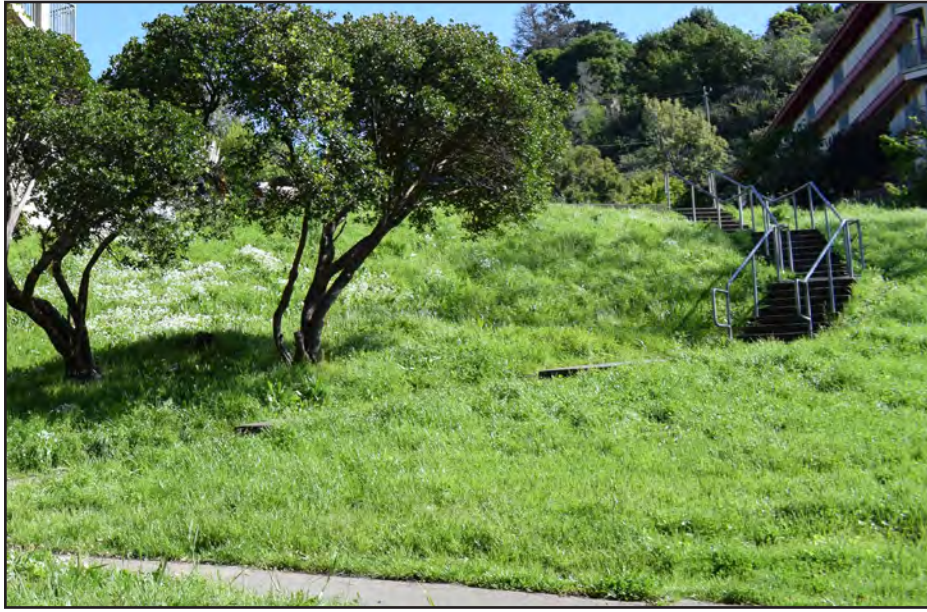
Metal pipe handrails associated with concrete staircases.	1959-1961	Medium
				Date Altered	Condition
				1993	Good
Landscape Characteristic	Feature	Photo	Description	Date Built	Integrity
Small Scale Feature	Fence and enclosure types in low-rise cluster

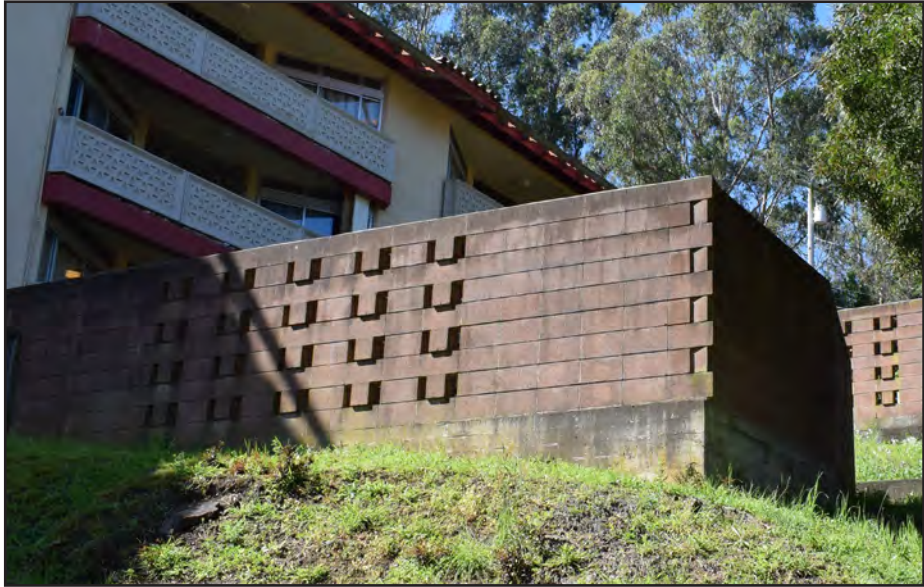
Masonry screens in high-rise cluster surrounding laundry areas.	1959-1961	High
				Date Altered	Condition
				N/A	Good
Landscape Characteristic	Feature	Photo	Description	Date Built	Integrity
Small Scale Feature	Concrete retaining walls	 	Concrete retaining walls and seat walls.	1959-1961	High
				Date Altered	Condition
				N/A	Good

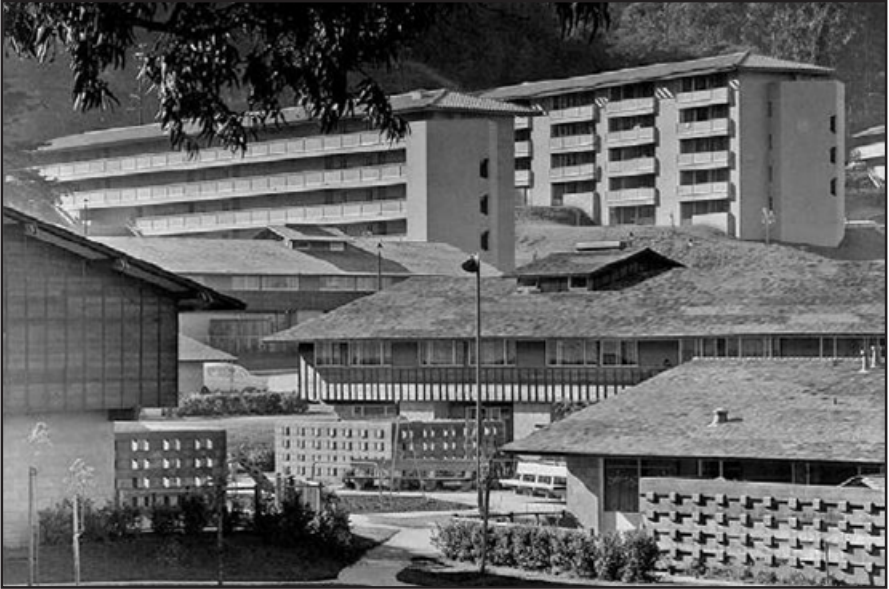
<p>Source: Ruark, 2017.</p>	Hipped roofs clad in red clay tile.	1959-1961	High
				Date Altered	Condition
				N/A	Good
Landscape Characteristic	Feature	Photo	Description	Date Built	Integrity
Buildings and Structures	Precast concrete guardrails (High-rise buildings)

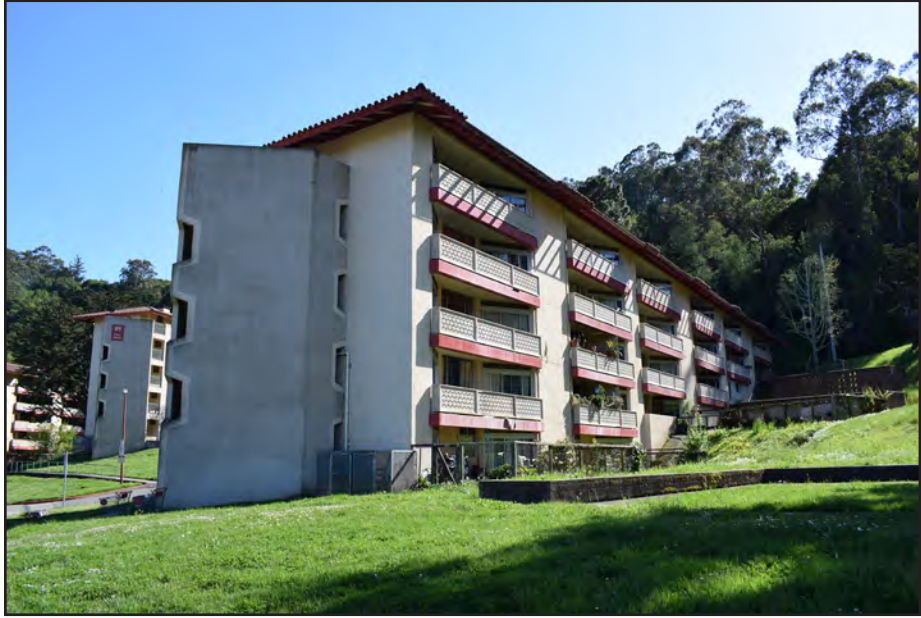
Concrete stairways at both ends of the high-rise buildings.	1959-1961	Low
				Date Altered	Condition
				2002	Good
Landscape Characteristic	Feature	Photo	Description	Date Built	Integrity
Buildings and Structures	Location of doors and windows (High-rise buildings)

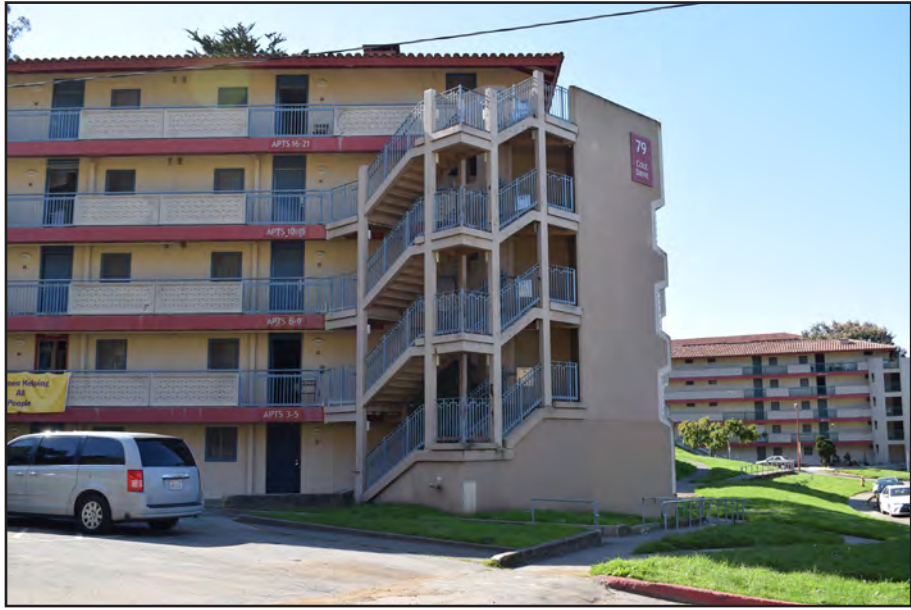
The locations of the doors and windows. The fenestration has been replaced in large part over time, and some doors have been widened to accommodate ADA improvements.	1959-1961	Medium
				Date Altered	Condition
				2005	Medium

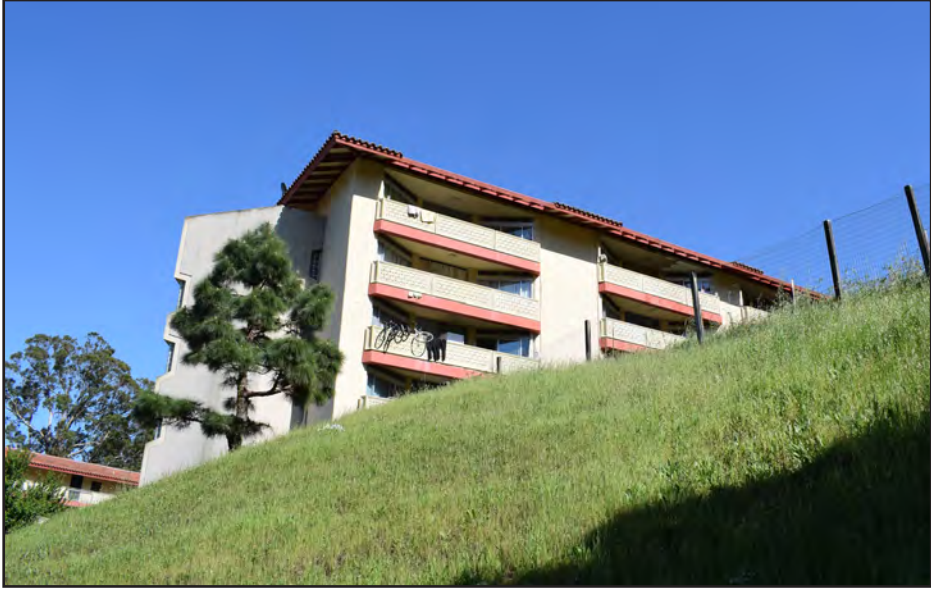
Exposed redwood roof rafters (sometimes referred to as "trellises") over the balconies at the rear façades of high-rise buildings. Portions have been replaced in-kind.	1959-1961	High
				Date Altered	Condition
				N/A	Good
Landscape Characteristic	Feature	Photo	Description	Date Built	Integrity
Buildings and Structures	Sliding doors for balcony access (High-rise buildings)

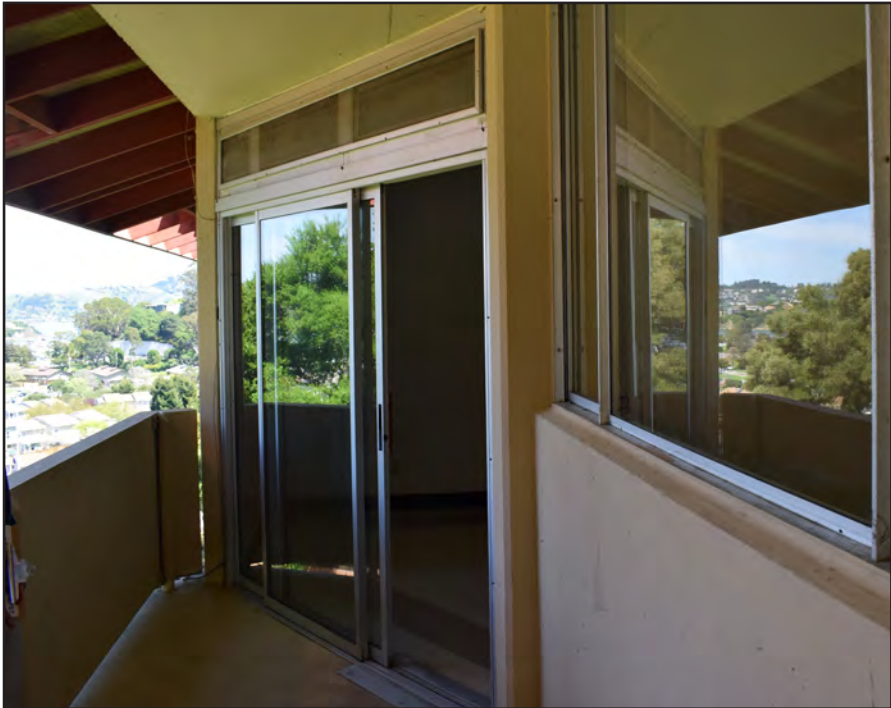
Two sets of sliding doors, separated by a window, that provide access to the private balconies in the high-rise units. The sliding doors are replacements.	1959-1961	Medium
				Date Altered	Condition
				N/A	Good

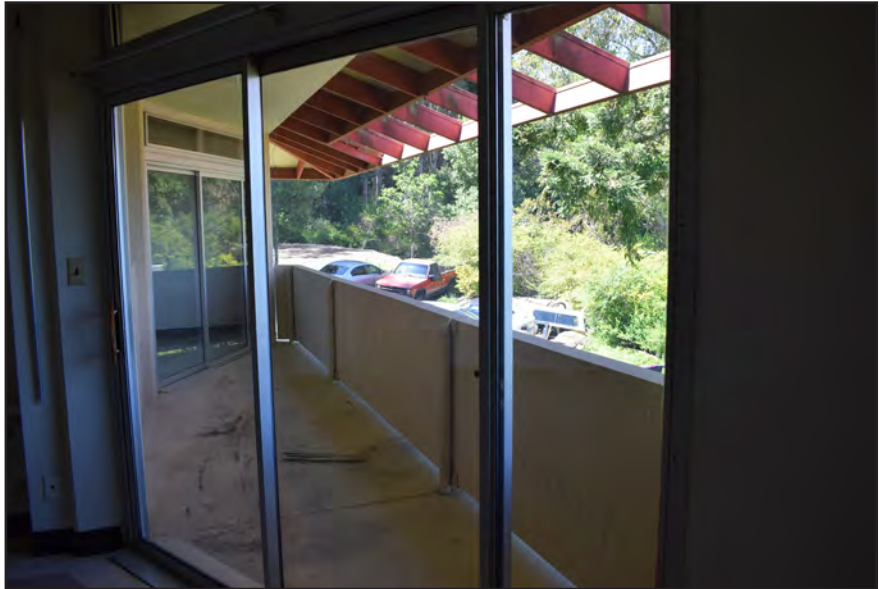
Landscape Characteristic	Feature	Photo	Description	Date Built	Integrity
Buildings and Structures	Adjoining private spaces (High-rise buildings)

Adjoining private space at every unit, located at the rear facades of the high-rises.	1959-1961	High
				Date Altered	Condition
				N/A	Good
Landscape Characteristic	Feature	Photo	Description	Date Built	Integrity
Buildings and Structures	Metal mailboxes (High-rise buildings)

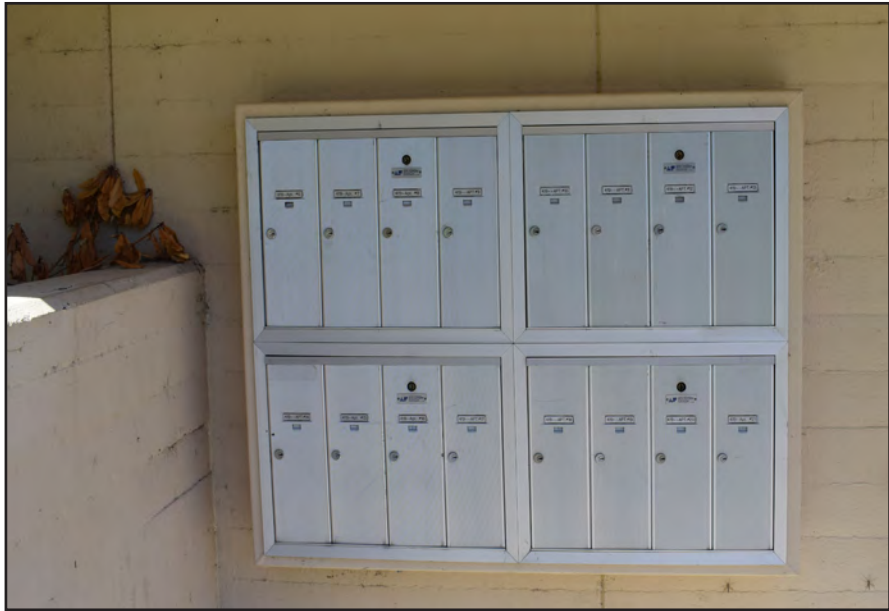
Metal mailboxes affixed to the buildings' primary facades.	1959-1961	High
				Date Altered	Condition
				N/A	Good

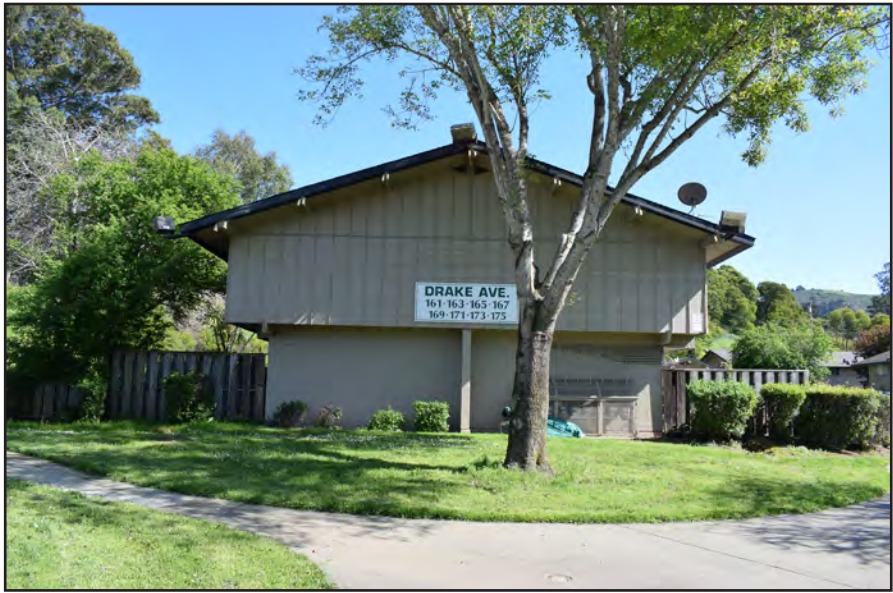
Landscape Characteristic	Feature	Photo	Description	Date Built	Integrity
Buildings and Structures	Gabled roofs with exposed rafters (Low-rise buildings)

End gabled roof form with exposed rafters, the original wood shingles have been replaced with composite shingles.	1959-1961	Medium
				Date Altered	Condition
				1993	Good
Landscape Characteristic	Feature	Photo	Description	Date Built	Integrity
Buildings and Structures	Ridge vents (Low-rise buildings)

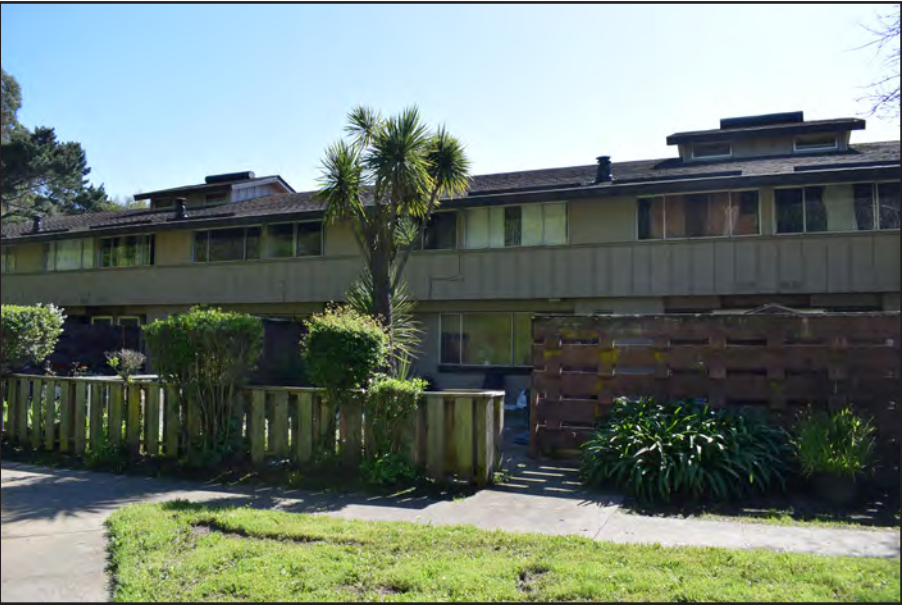
Two clerestory ridge vents at each Type B building. The shingles on the clerestories have been replaced.	1959-1961	Medium
				Date Altered	Condition
				1993	Good

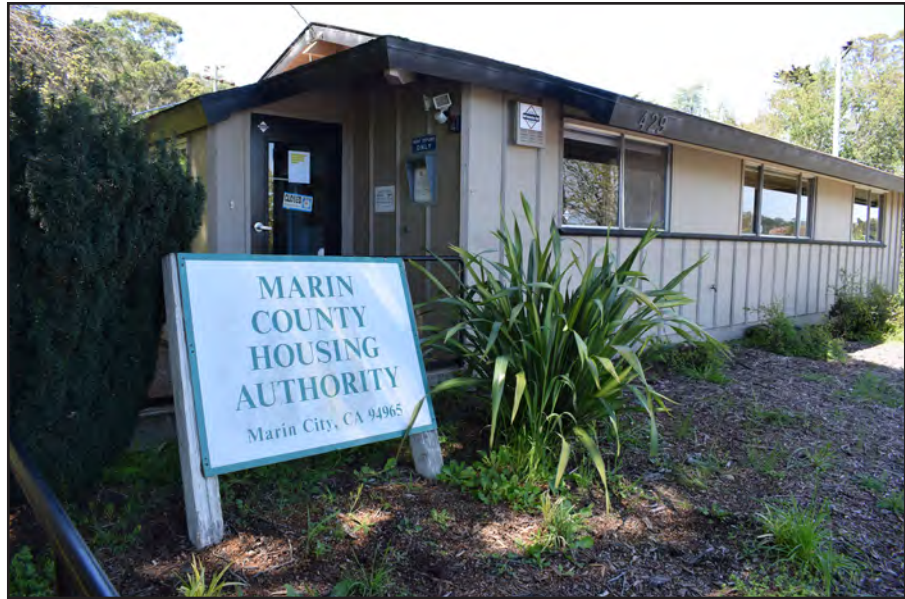
Landscape Characteristic	Feature	Photo	Description	Date Built	Integrity
Buildings and Structures	Redwood siding (Admin building)

Redwood siding with vertical battens.	1959-1961	High
				Date Altered	Condition
				N/A	Good
Landscape Characteristic	Feature	Photo	Description	Date Built	Integrity
Buildings and Structures	Location of garage doors (Admin building)
