# CHARACTER-DEFINING FEATURE STUDY

## GOLDEN GATE VILLAGE, MARIN CITY, CA

**September 2019**

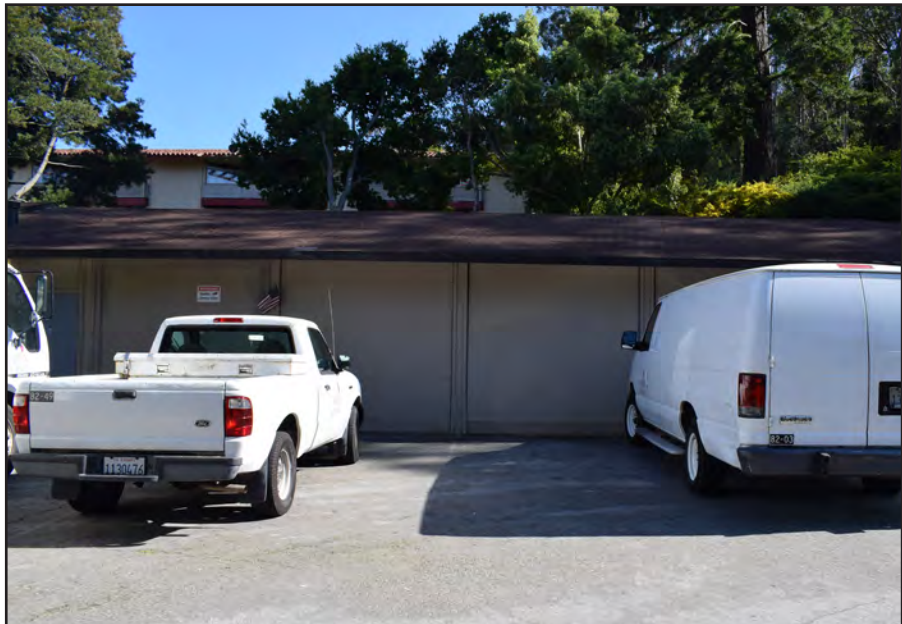
The location of four garage doors along the rear wing of the Administration and Maintenance building. The doors have been replaced.	1959-1961	High
				Date Altered	Condition
				1985	Good
