## Arborist Report

1495 San Antonio Road  
Marin County, CA

May 28, 2020

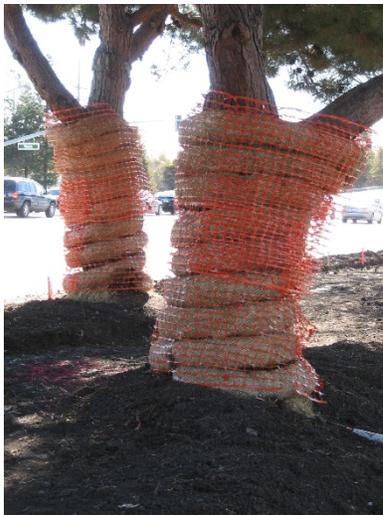
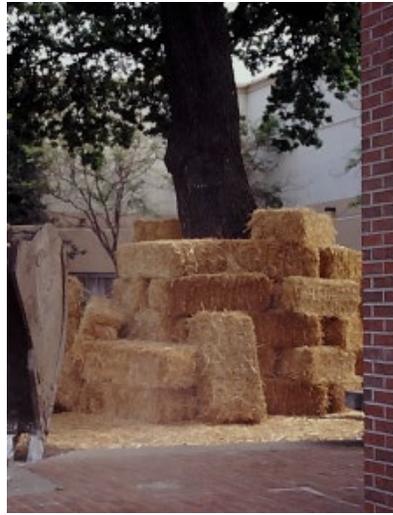
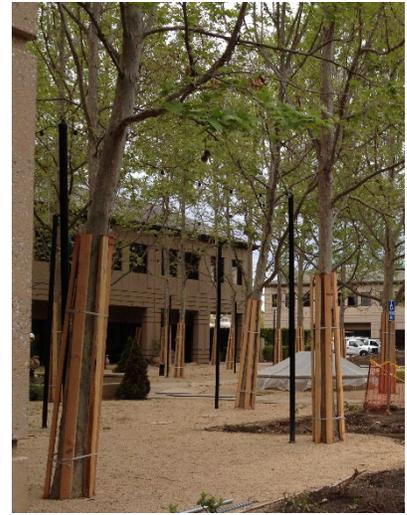
3. Fences are to remain until all grading and construction is completed. Where construction must occur close to trees, install trunk protection devices such as winding silt, sock wattling around trunks, or stacking hay bales around tree trunks. Do not retain wattling around tree trunks for more than 2-3 weeks to avoid damaging trunks from excess moisture.
