GEOLOGY & GEOLOGIC HAZARD UPDATE & PRELIMINARY GEOTECHNICAL STUDY

BOLINAS MARINE FIELD STATION FACILITY

Geosphere Project No. 91-55182-PW
23 September 2020

MARIN COMMUNITY COLLEGE DISTRICT
835 College Avenue
Kentfield, CA 94904

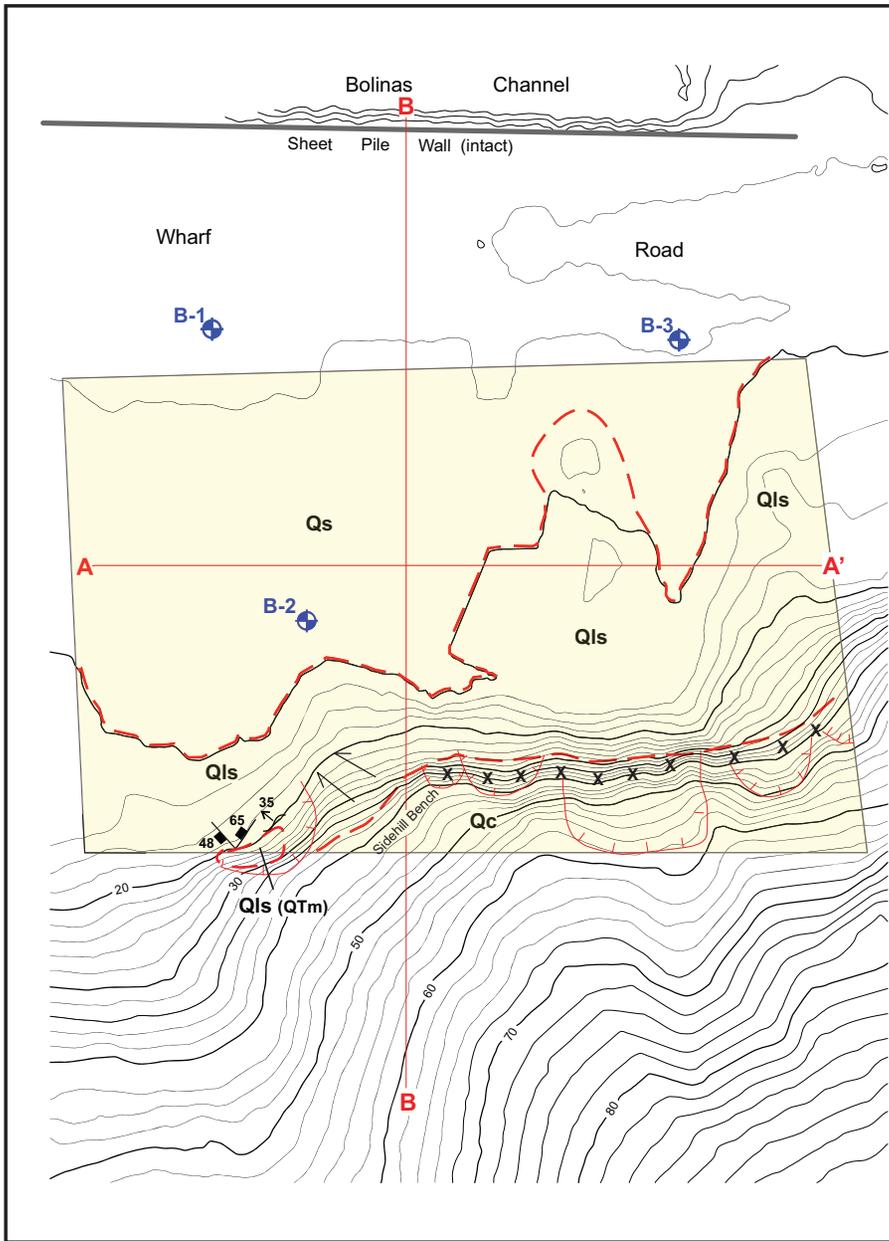
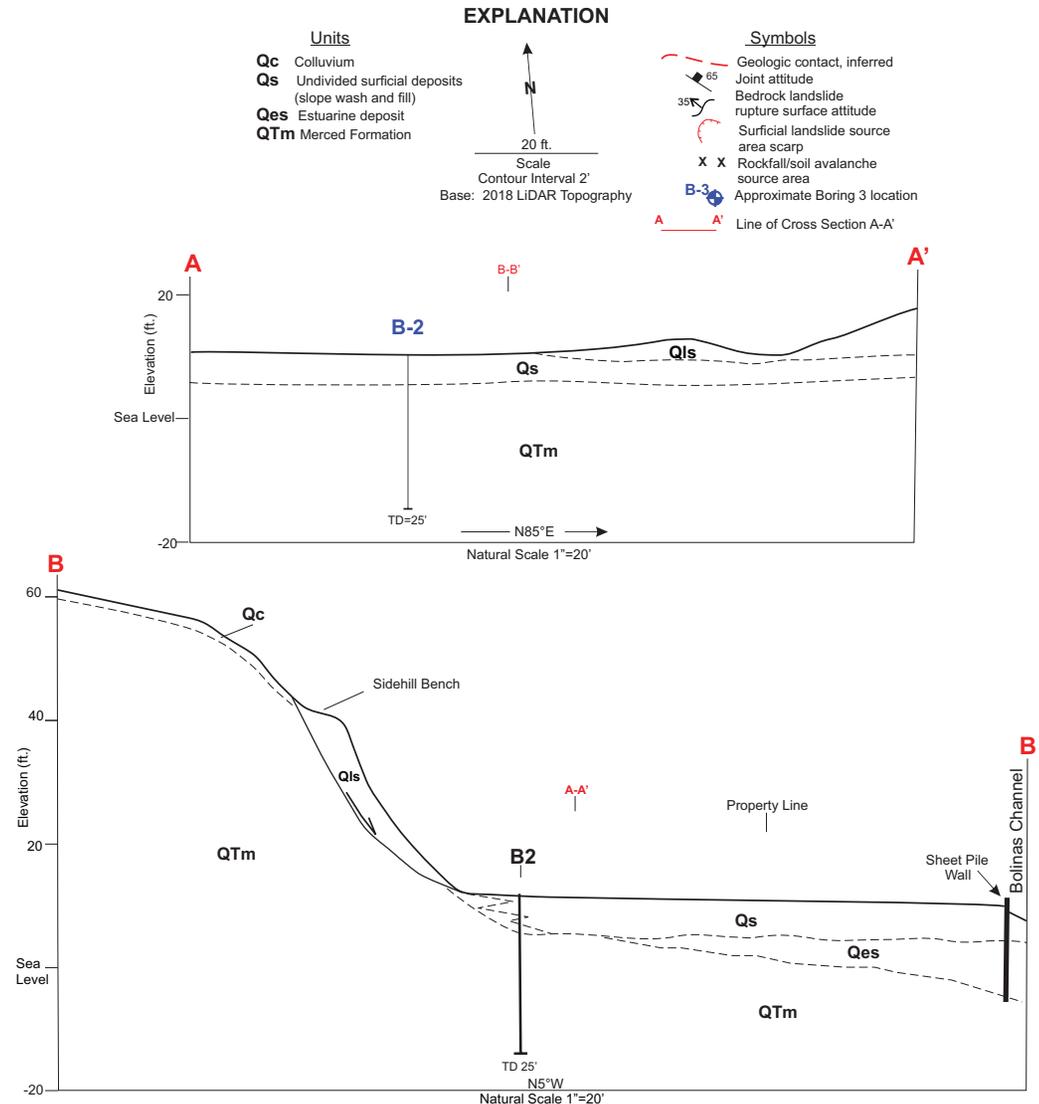
<p>Geosphere Consultants, Inc.</p>	Job No.: 91-55182-PW	<p>ENGINEERING GEOLOGIC MAP, CROSS SECTIONS A-A' & B-B'</p> <p>Bolinas Marine Field Station College of Marin 72 Wharf Road Bolinas, California</p>	<p>Plate 6</p>
	Approved: JEB		
	Date: 08.13.2020

Moderately weathered to very severely weathered siltstone bedrock was encountered below the surficial soils at approximate depths of 11 and 6 feet in Borings B-1 and B-3, respectively, and below the slope wash soils at a depth of 5 feet in Boring B-2, which was advanced near the toe of the ascending slope at the rear of the property. Interpretive cross section across the width and along the length of the property are included in Plate 6.

A local exposure of the massive Merced Formation mantled by a thin veneer of erodible sandy silt with clay colluvium was mapped at the base of the cut slope in the southeast corner of the property. It was composed of very weathered to severely weathered, closely fractured sandy siltstone with a steep, dilated pervasive, adverse southwest dipping joint set and a low-angle northwest dipping wavy shear surface interpreted as an old landslide failure surface. Merced Formation in a scar of an apparent recent debris slide event was observed in the cut slope on the neighboring property from a distance and captured in a drone image (Plate 3, Photo 4). We suspect the debris flow runout on the east side of the property is in part derived from that source area. Evidence of global slope instability affecting the site was not detected.

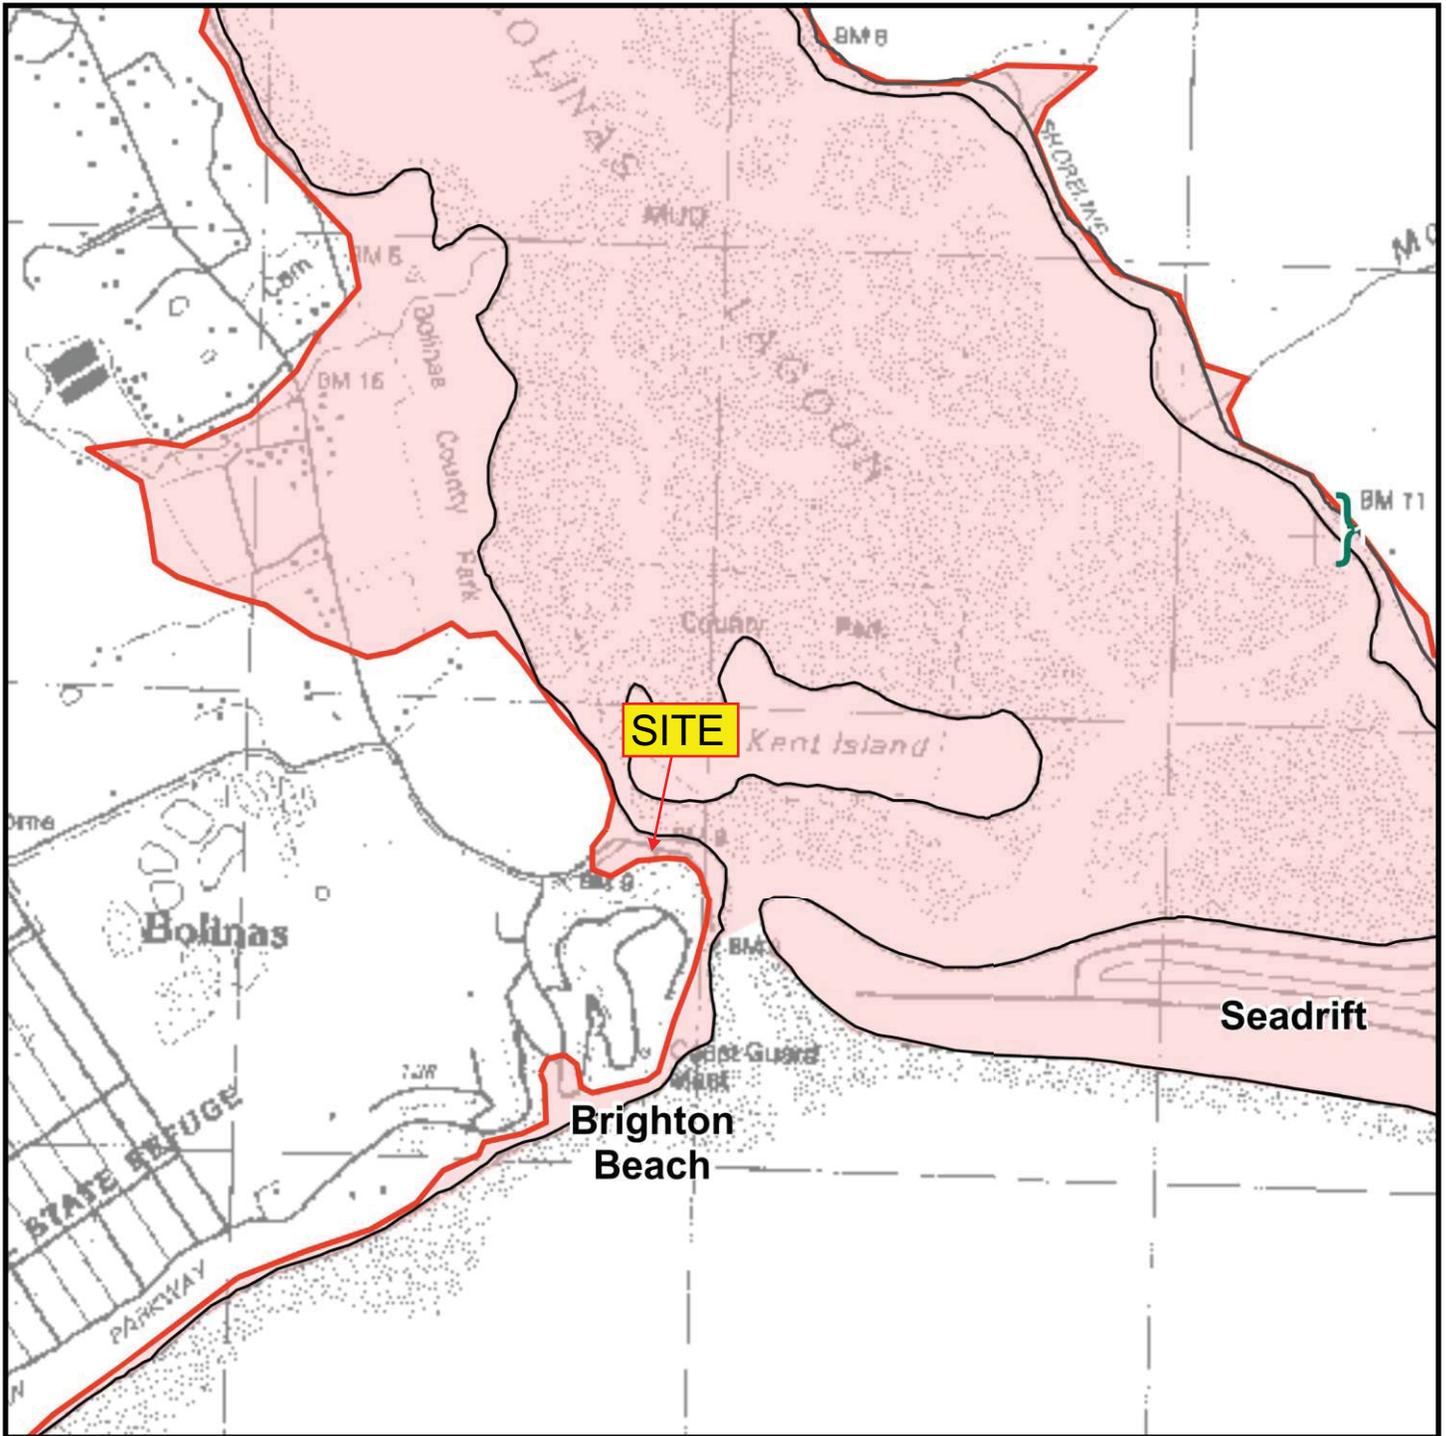
The site lies within an area which can become quickly flooded in the event of tsunami, as indicated on Plate 12, *Tsunami Inundation Map*.
