January 14, 2021
Project No. 3372-1L1 *Revised*

**RE: LIMITED PRELIMINARY GEOTECHNICAL
FEASIBILITY STUDY,
NEW RESIDENCE,
21 CALLE DEL ONDA,
MARIN COUTY, CALIFORNIA**

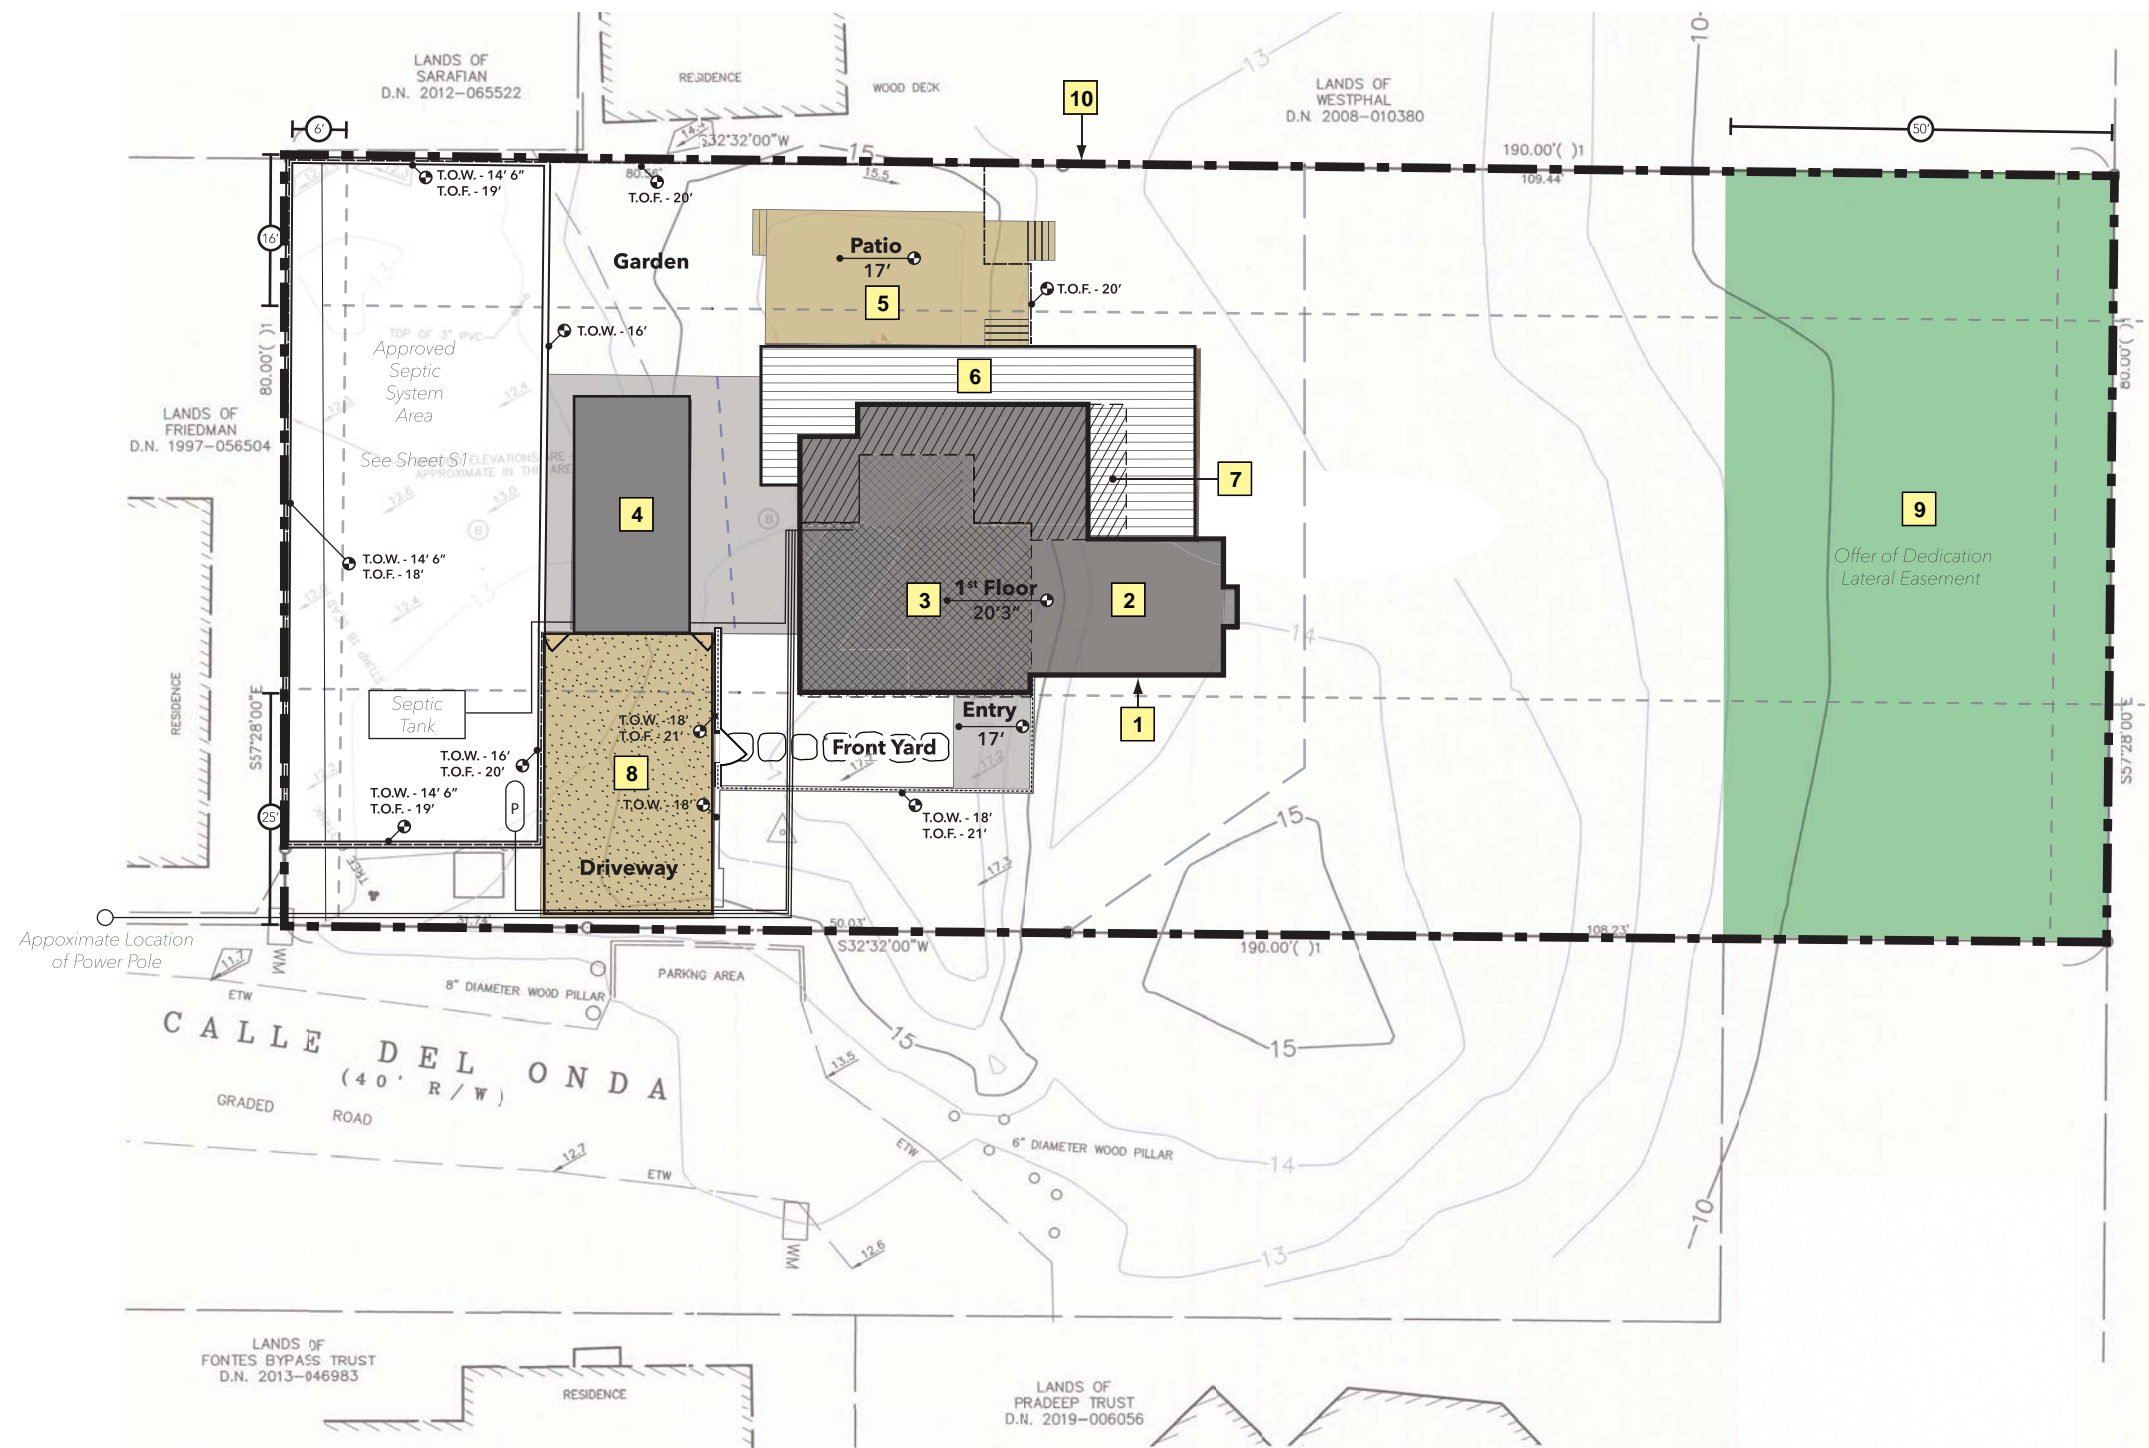
SITE PLAN
NEW RESIDENCE 21 CALLE DEL ONDA MARIN COUNTY, CALIFORNIA		
PROJECT NO. 3372-1L1	JANUARY 2021	FIGURE 2

Base: Site Plan by CivicKnit, dated September 10, 2020
 Approximate Scale: 1 inch = 20 feet

northwest side of the residence. First- and second-level decks are planned on the southeast side of the residence. Additional site improvements will include a detached 288-square foot garage on the northeast side of the residence, a permeable paver patio on the southeast side of the residence, a driveway, patios/walkways, and landscaping. The layout of existing site improvements is shown on the attached Site Plan, Figure 2.
