**GEOTECHNICAL INVESTIGATION  
PROPOSED RESIDENTIAL DEVELOPMENT  
RENOVATION AND IMPROVEMENTS  
POINT REYES COAST GUARD HOUSING  
POINT REYES STATION, CALIFORNIA**

July 14, 2022  
Project No. 21-2050

Subject: Final Report  
Geotechnical Investigation  
Proposed Residential Development Renovation and Improvements  
Point Reyes Coast Guard Housing  
Point Reyes Station, California

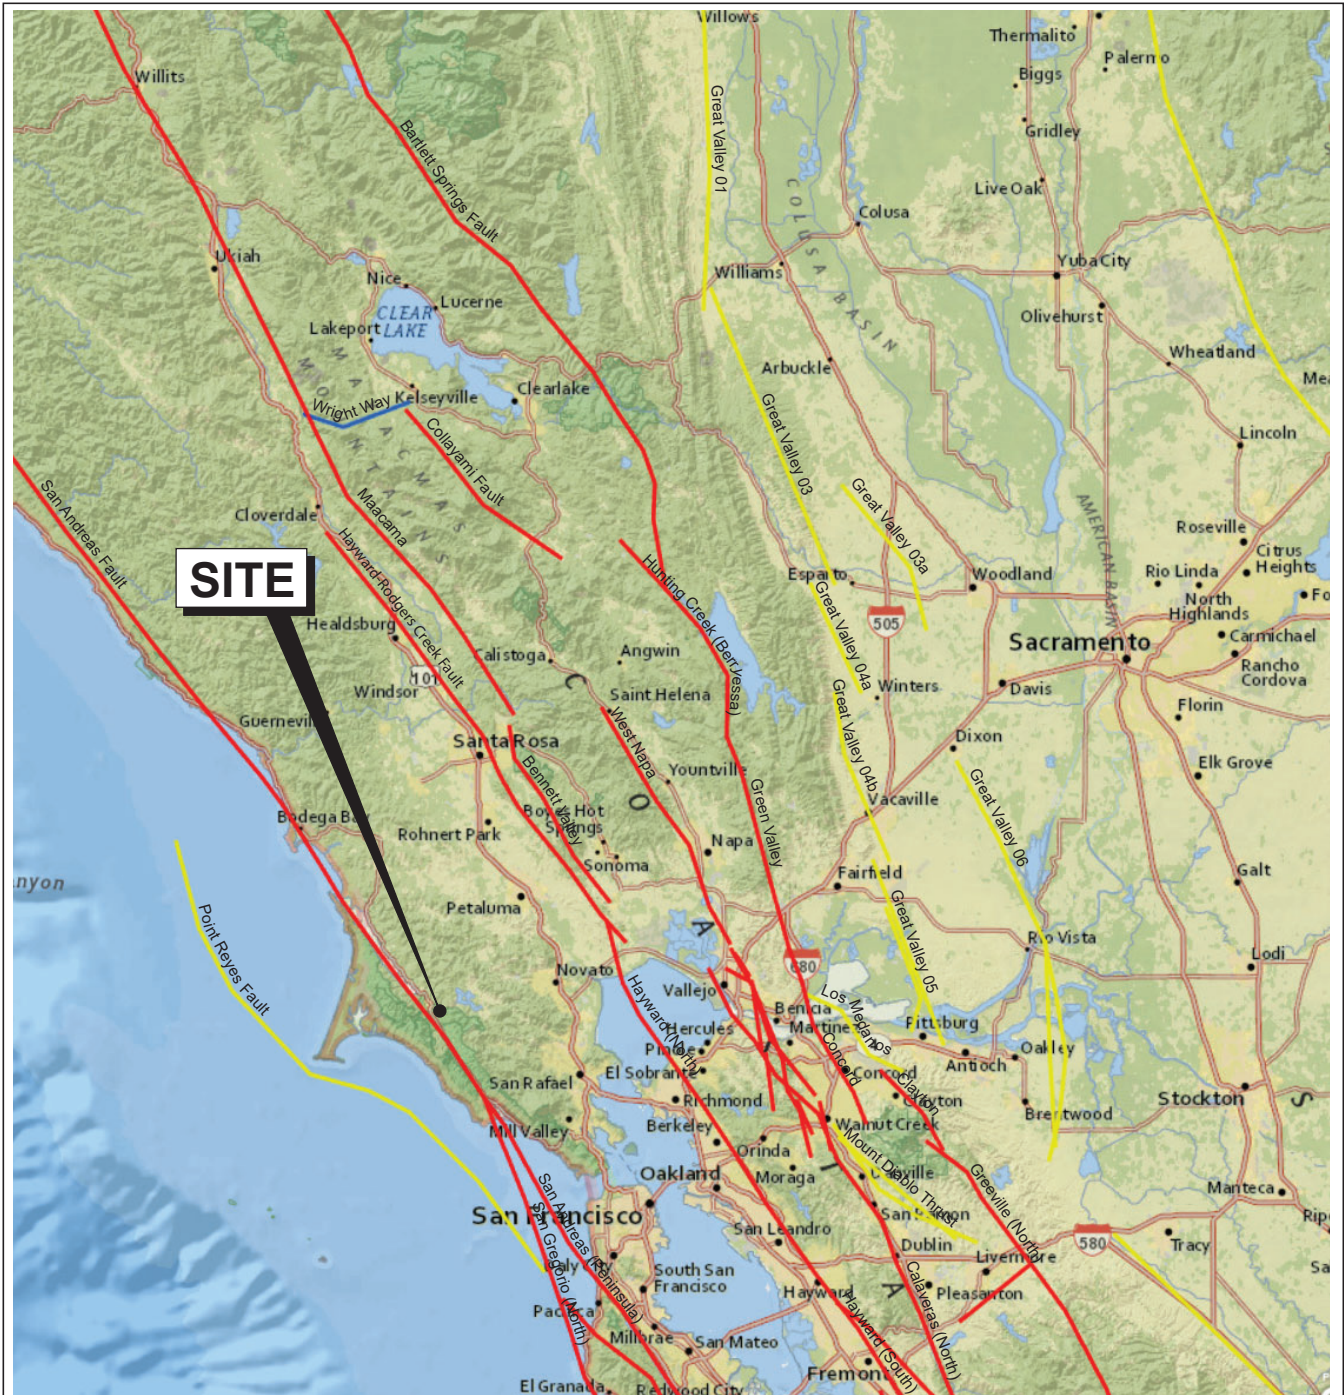
**REGIONAL FAULT MAP**

Base Map: U.S. Geological Survey (USGS), National Seismic Hazards Maps - Fault Sources, 2014.

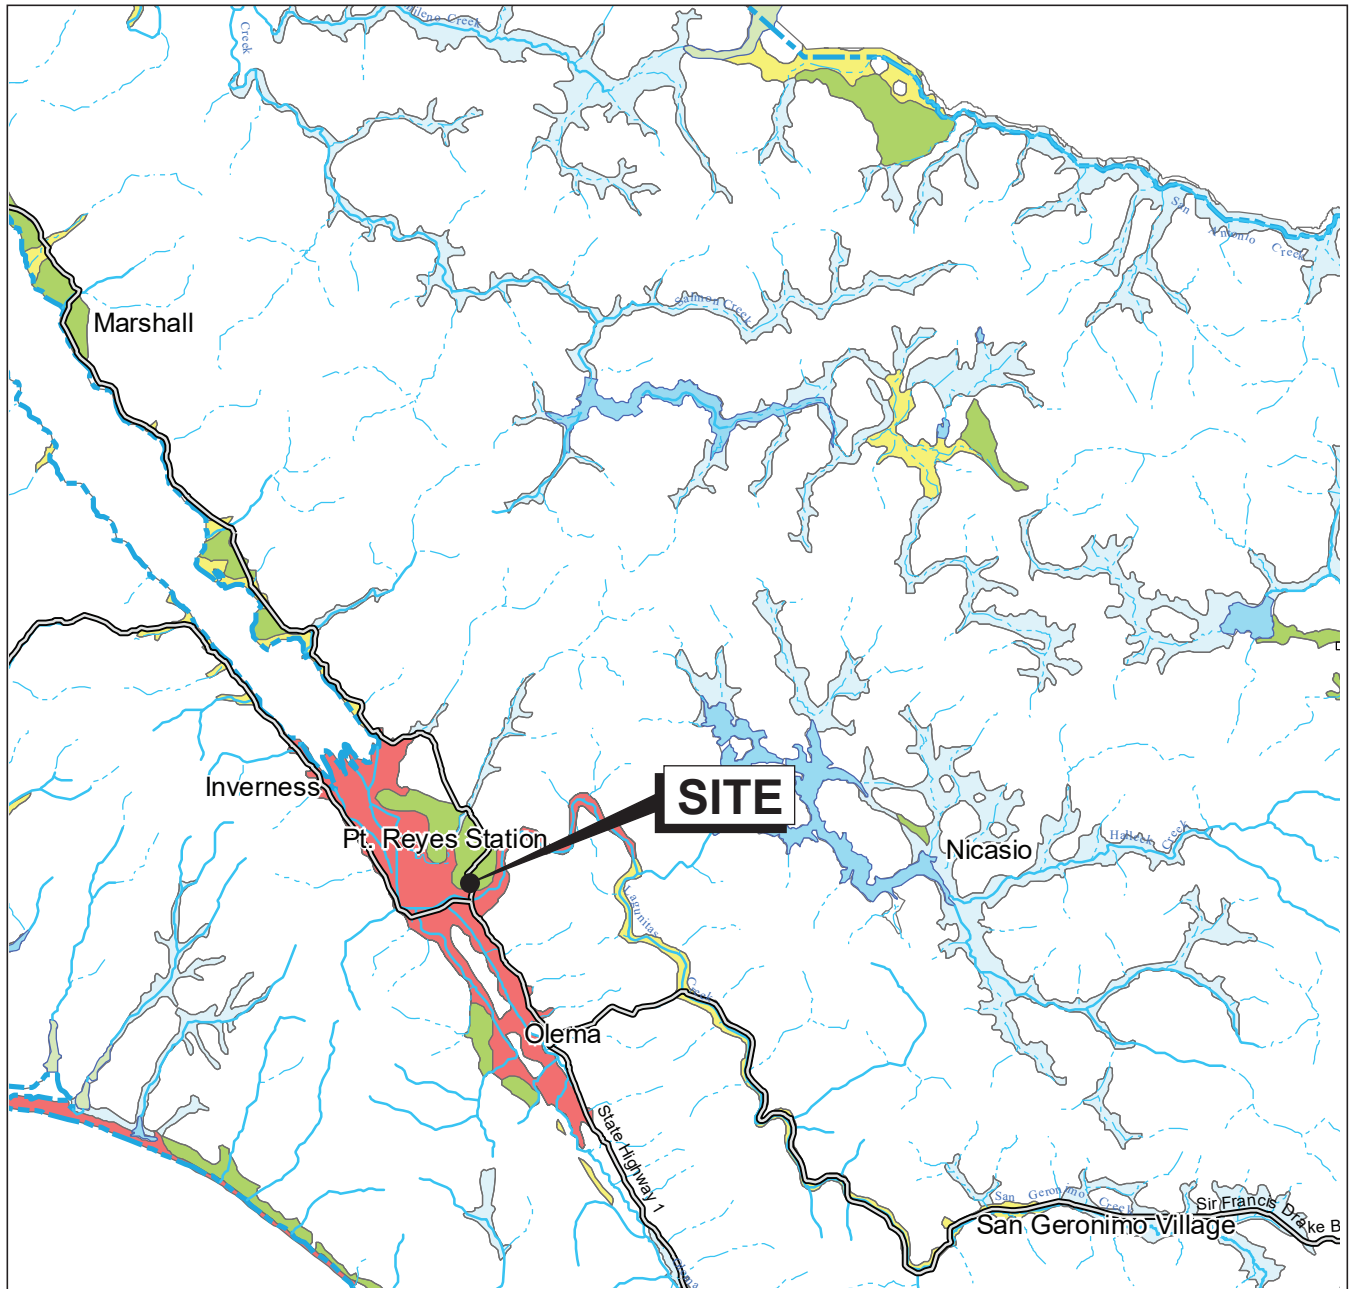
Reference:  
 Liquefaction Susceptibility Hazards Map 2-11  
 San Francisco Bay Region, California:  
 A Digital Database, Open-File Report 00-44,  
 Online Version 1.0, U.S. Geological Survey, 2000.

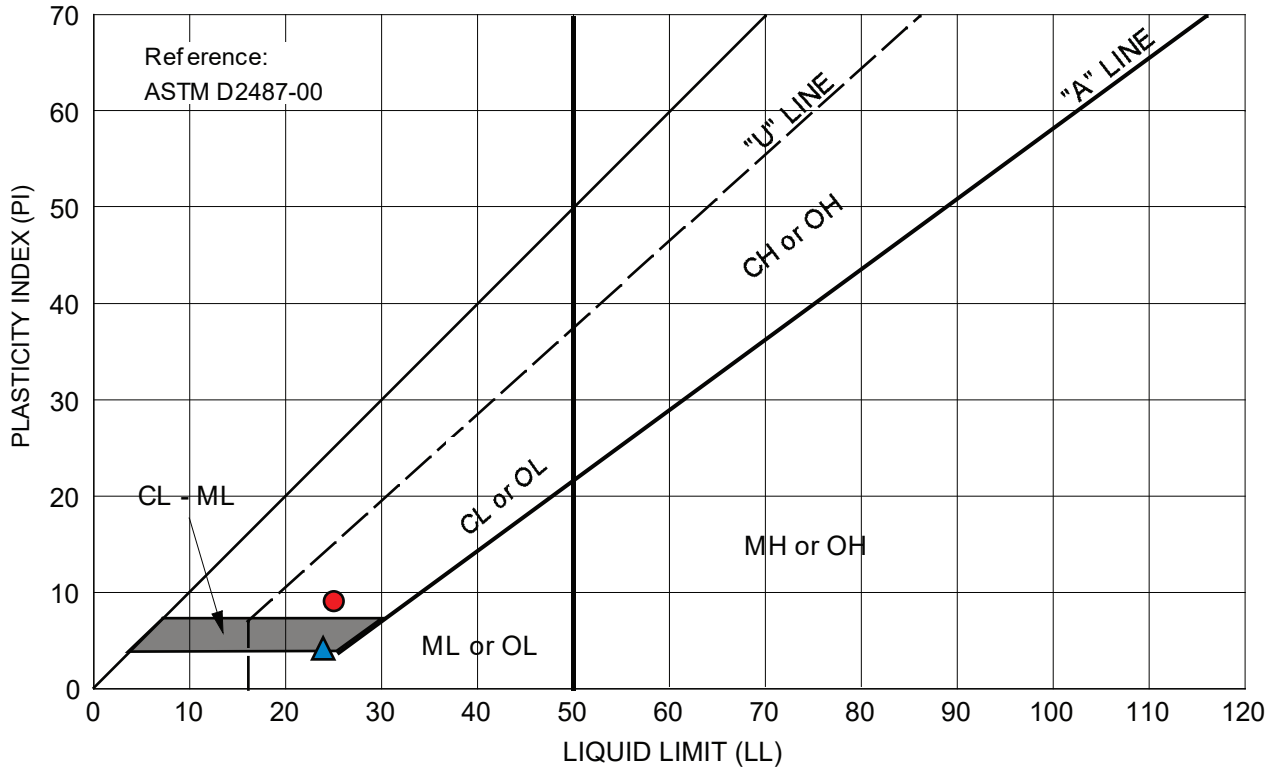
**PLASTICITY CHART**

Symbol	Source	Description and Classification	Natural M.C. (%)	Liquid Limit (%)	Plasticity Index (%)	% Passing #200 Sieve
●	B-2 at 4.0 feet	SANDY CLAY (CL), dark brown with trace red veins	11.8	25	9	--
▲	B-3 at 2.0 feet	SILTY CLAY with GRAVEL (CL-ML), brown to yellow-brown with light brown	7.6	24	4	--

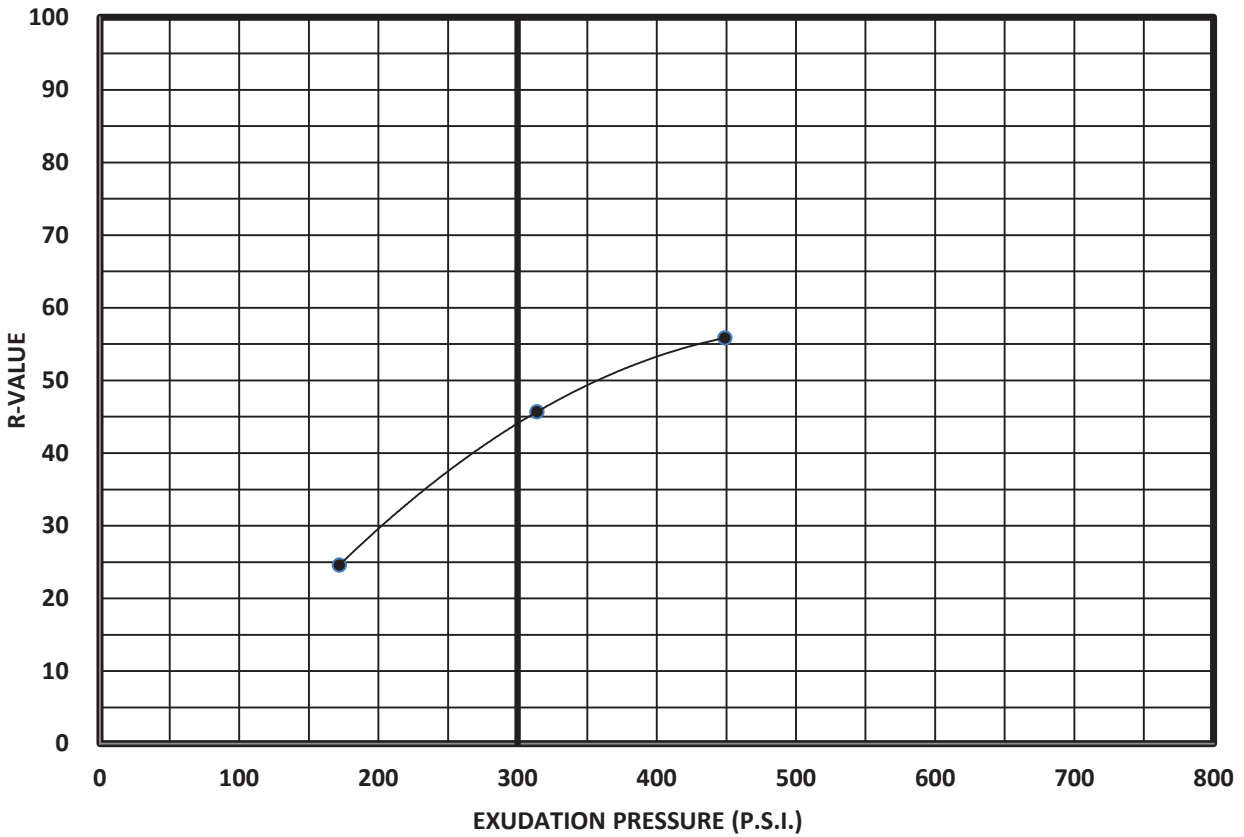
## R-VALUE CAL-TEST 301

Exudation (psi)	Compaction (psi)	Expansion (0.0001")	Expansion (psf)	Moisture %	Dry Density	Resistance Value
449	295	65	281	16.4	110.5	56
314	218	60	260	17.8	110.1	46
172	155	30	130	19.5	104.8	25

Test Results		Material Description	
R-Value at 300 psi exudation pressure = 44		SANDY CLAY (CL), dark brown with trace red veins	
		Sample Source: B-2 at 0.5-5 feet	
<b>POINT REYES COAST GUARD HOUSING</b> <b>100 COMMODORE WEBSTER DRIVE</b> Point Reyes Station, California		<b>RESISTANCE VALUE TEST REPORT</b>

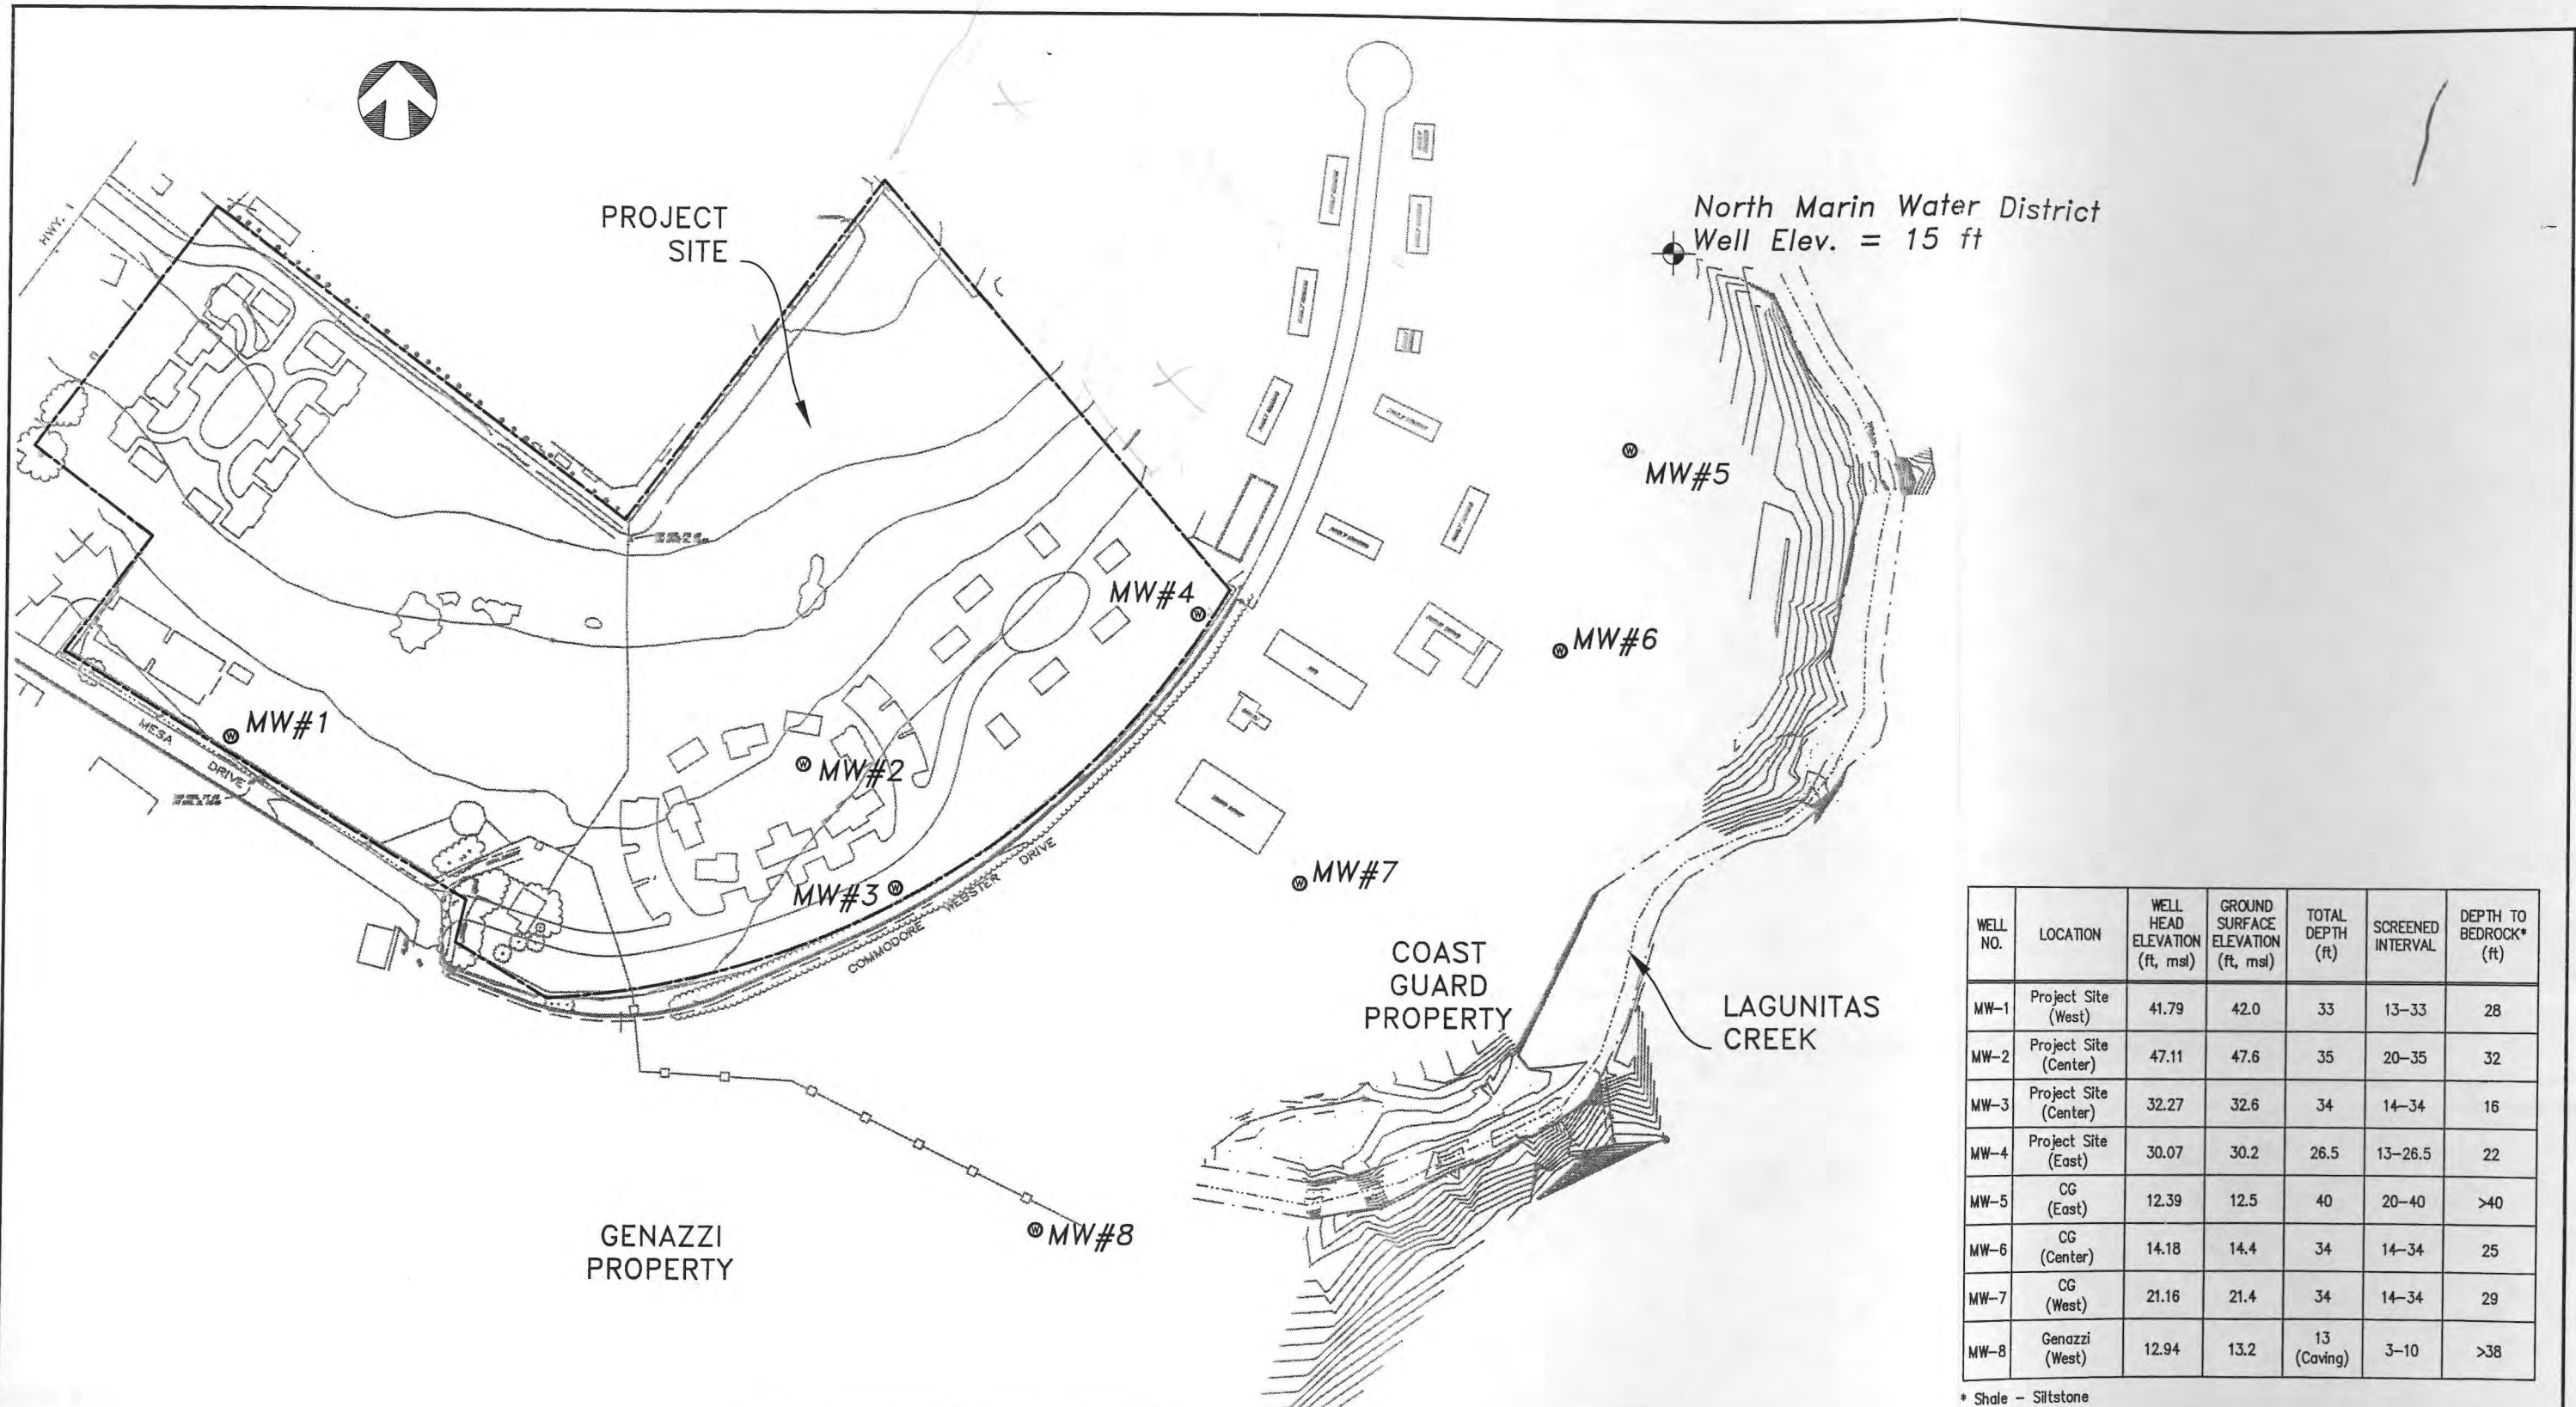
FIGURE  
**2**

**MONITORING WELL LOCATIONS**  
 POINT REYES AFFORDABLE HOUSING PROJECT  
 POINT REYES STATION, CALIFORNIA

Questa Engineering Corporation (Questa) previously performed subsurface investigations at the site in November 2000 and December 2020. Questa's investigation in 2020 included drilling four test borings to depths ranging from 21 to 40 feet below the ground surface (bgs). In 2000, Questa installed seven monitoring wells to depths ranging from 13 to 40 feet bgs. Monitoring wells MW-1 and MW-2 were drilled east and northeast of the project site, respectively, and were not considered for our investigation. The approximate locations of Questa's test borings and monitoring wells MW-3 through MW-7 are shown on Figure 2. The logs of the borings and monitoring wells are attached in Appendix C.

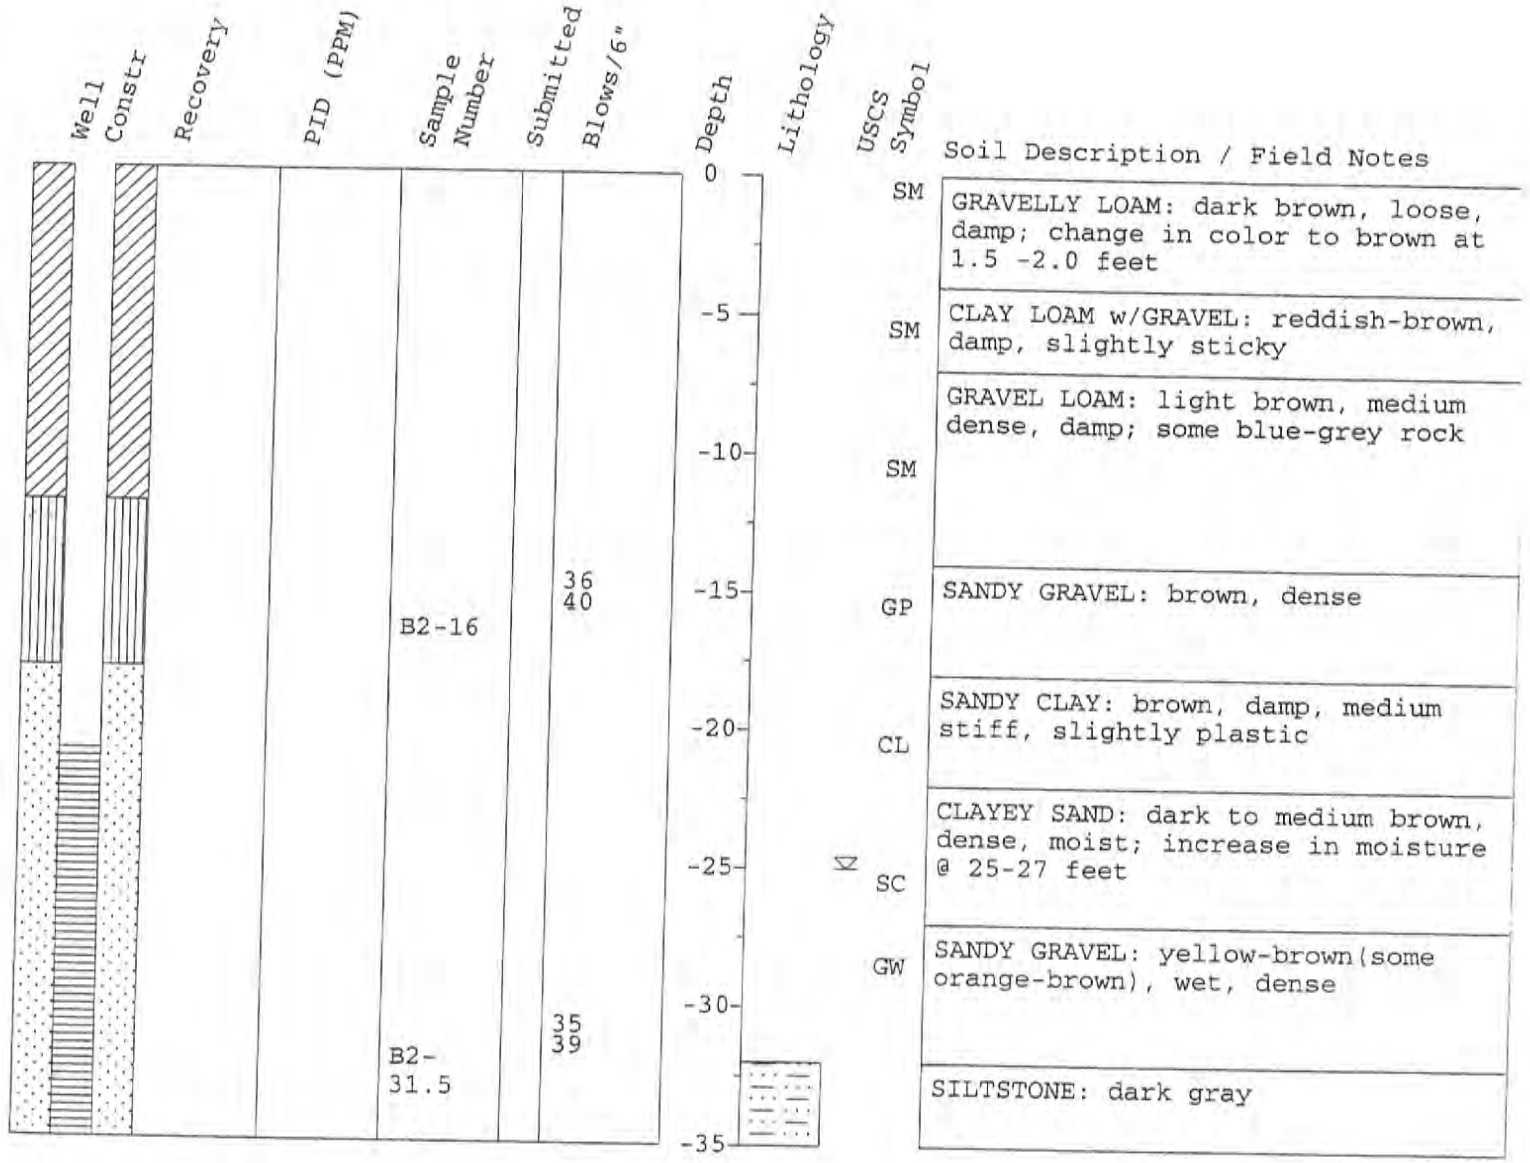
FIGURE  
**A-2**

**Log of Monitoring Well 2**  
 Pt. Reyes Affordable Housing Proj.  
 Point Reyes, California

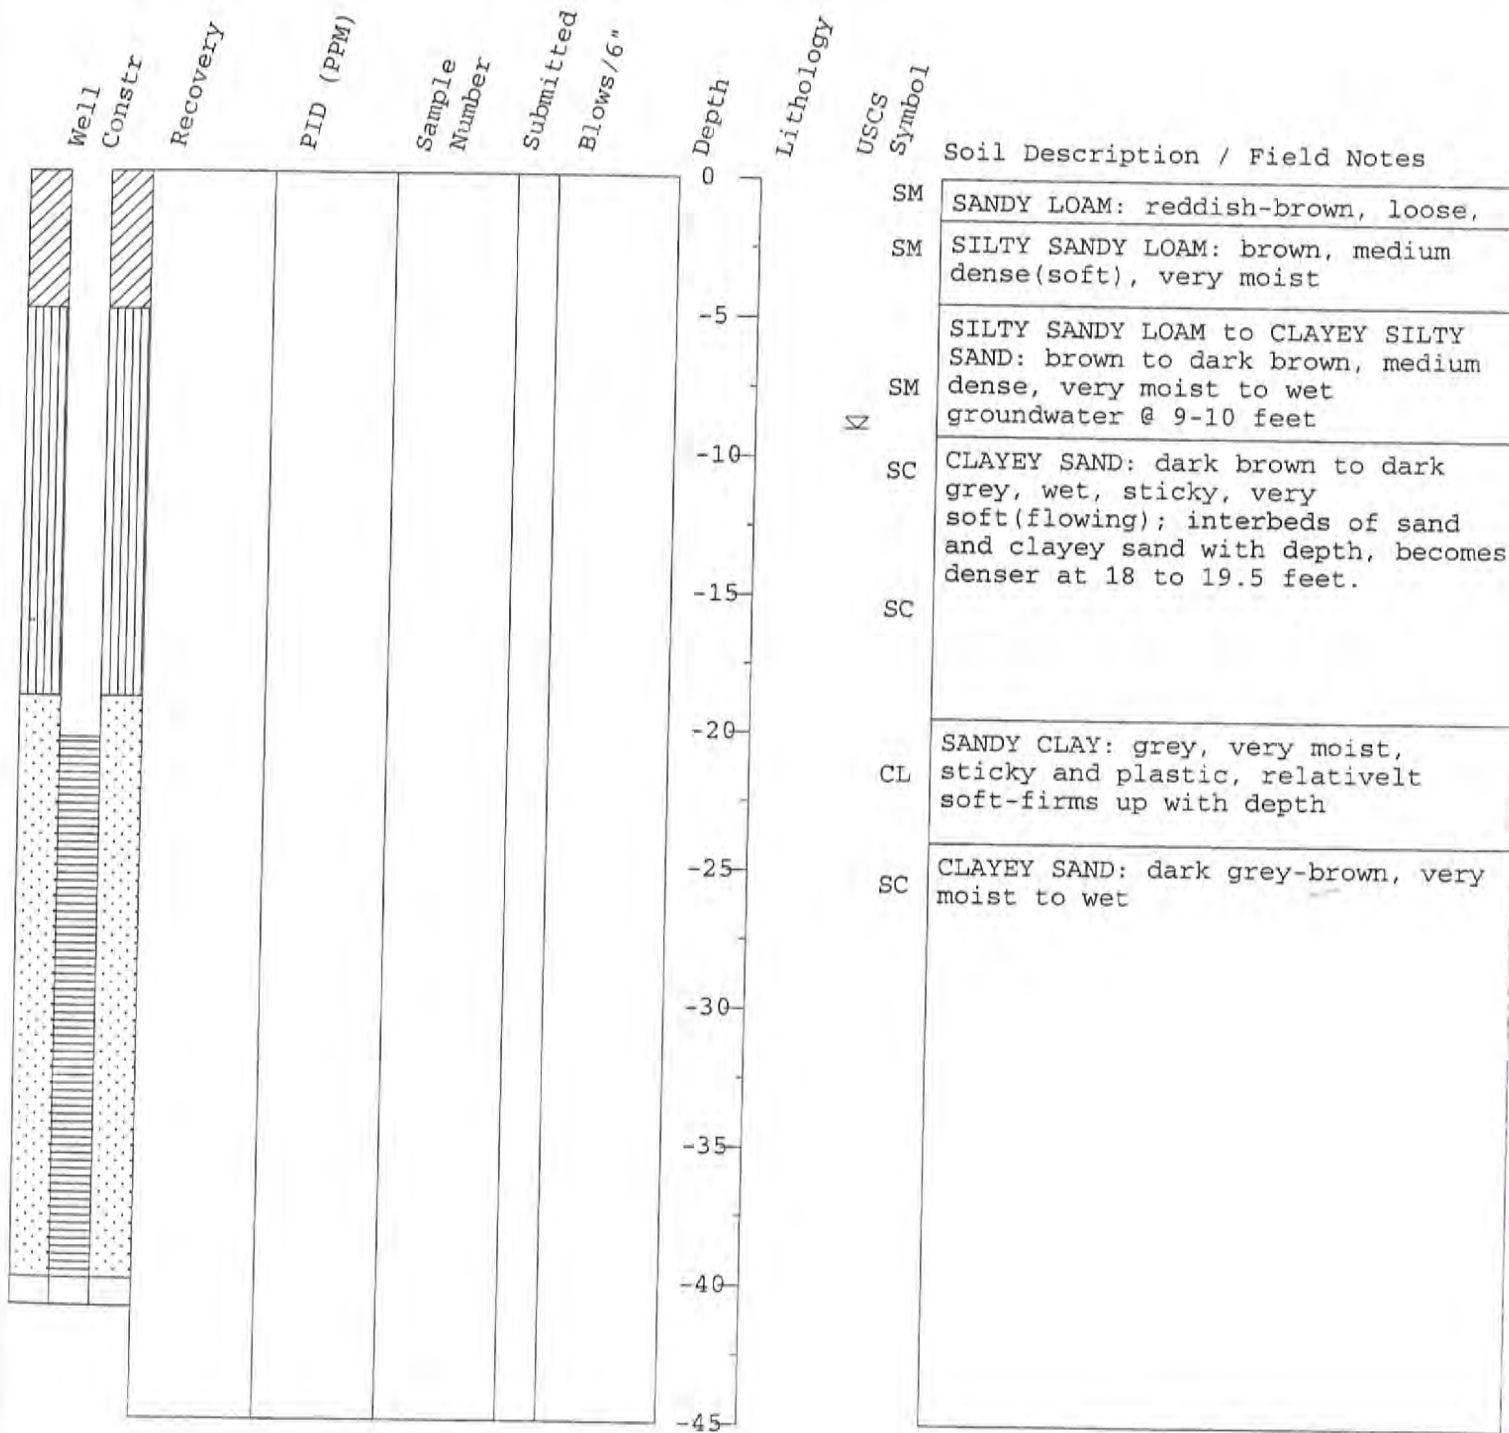
FIGURE  
**A-5**

**Log of Monitoring Well 5**  
 Pt. Reyes Affordable Housing Proj.  
 Point Reyes, California

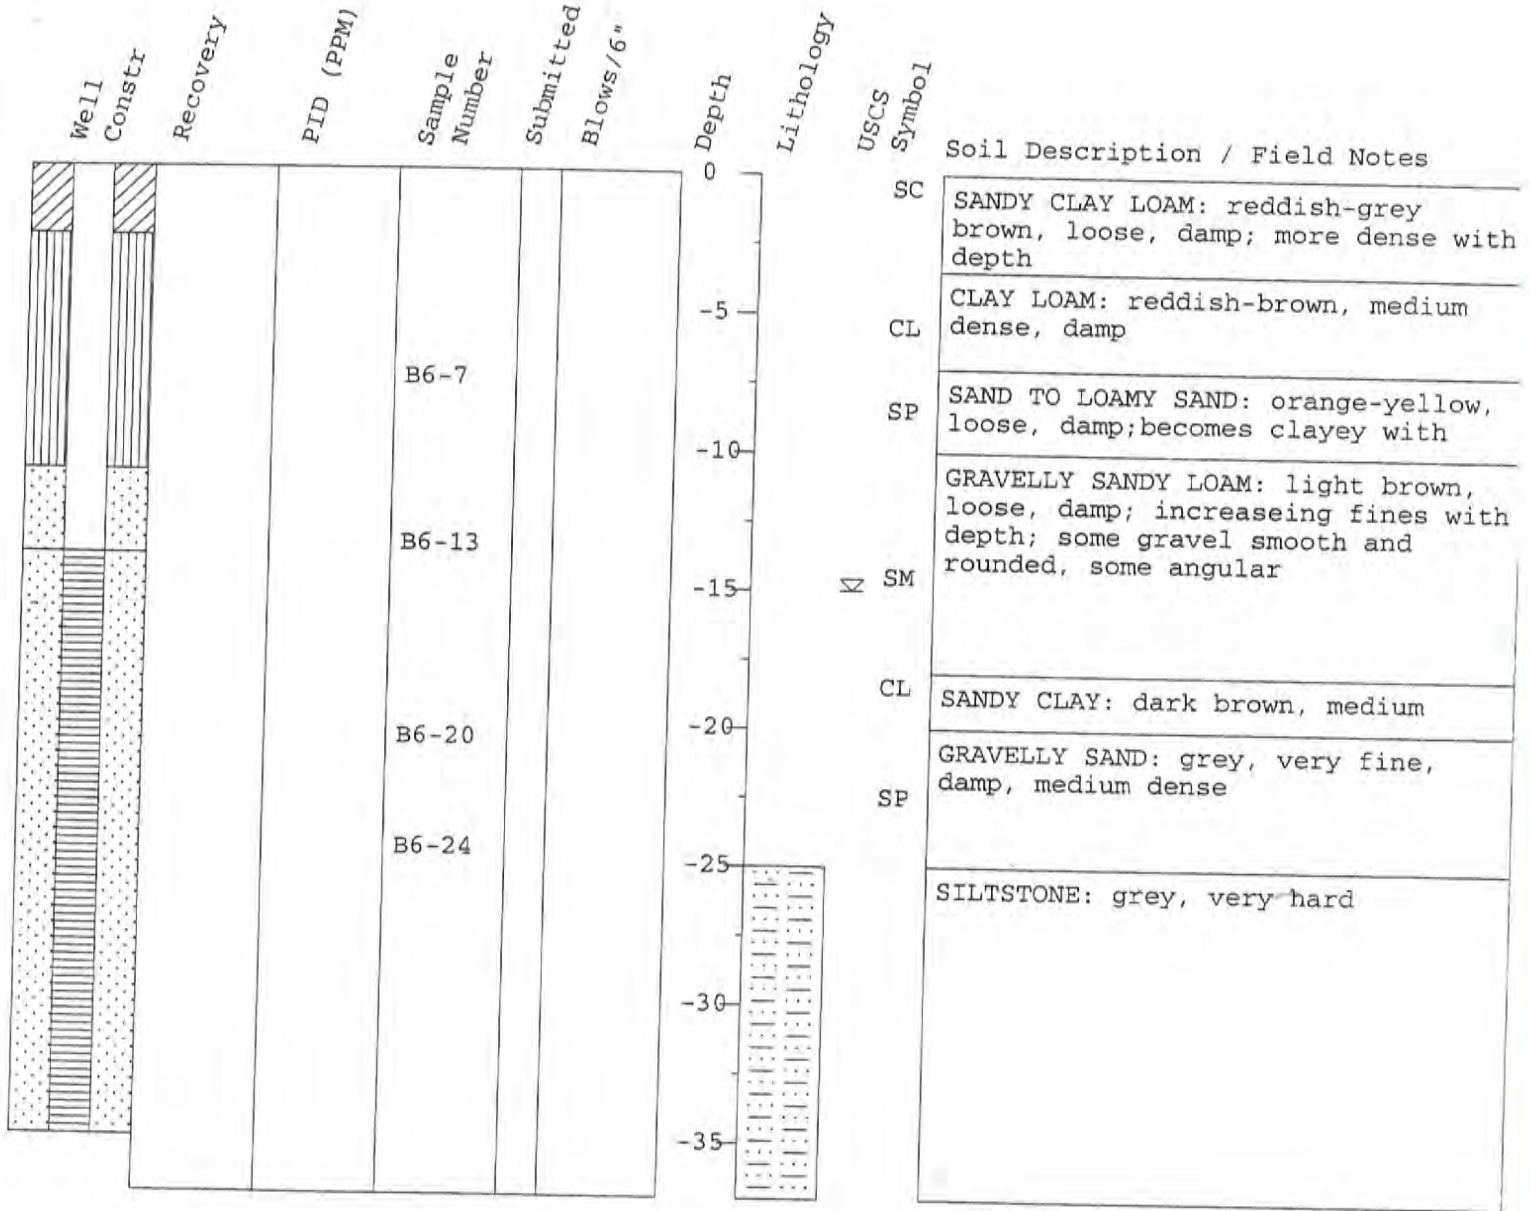
FIGURE  
**A-6**

**Log of Monitoring Well 6**  
 Pt. Reyes Affordable Housing Proj.  
 Point Reyes, California

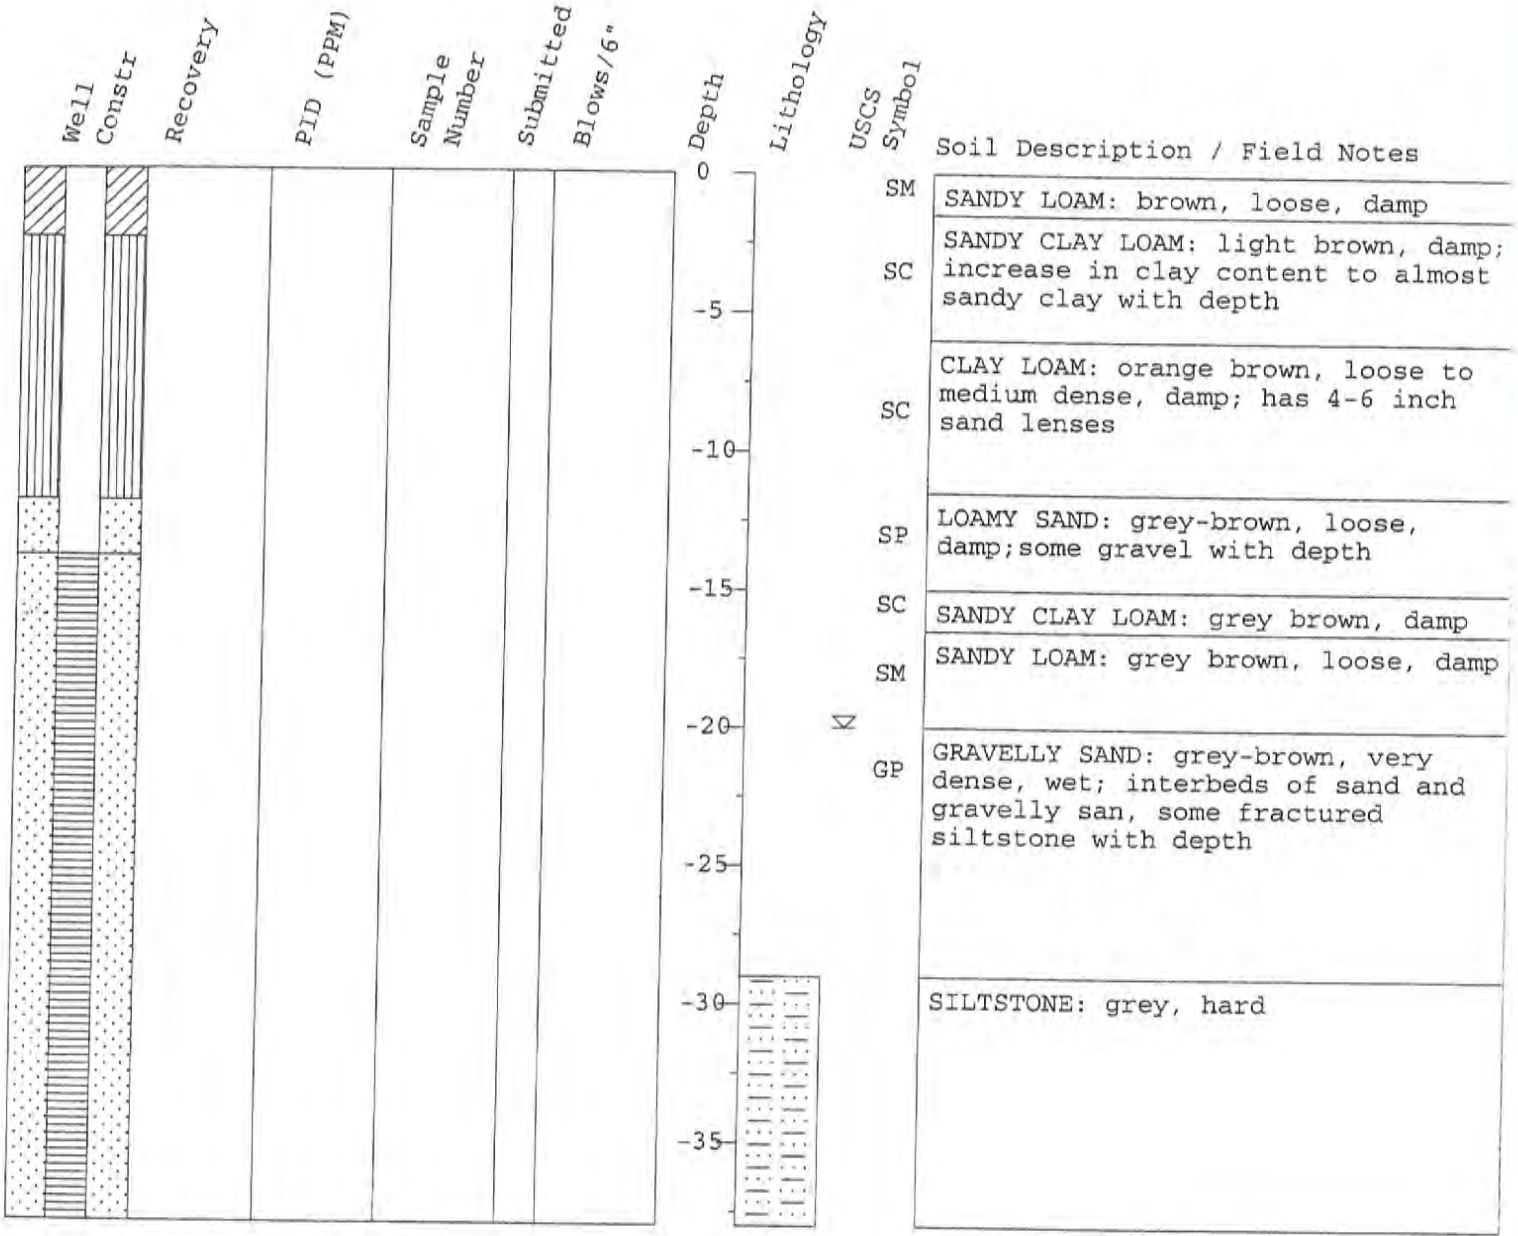
FIGURE  
**A-7**

**Log of Monitoring Well 7**  
 Pt. Reyes Affordable Housing Proj.  
 Point Reyes, California
