FINDING OF EFFECT MEMORANDUM

Prepared by ICF at the request of Marin Housing Authority in partial fulfillment of Section 106
Review requirements

Historic Property: Golden Gate Village

Project Name: Defensible Space Vegetation Removal

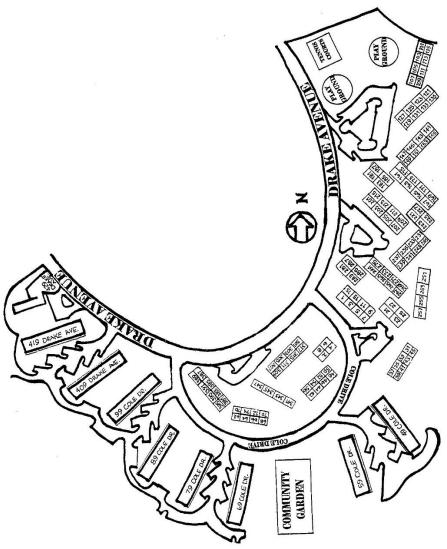
Image 1: A site plan illustration of Golden Gate Village. North is up, Highway 101 is to the east; not to scale. Courtesy: Marin Housing Authority.

In this memorandum, locations within the property are referred to by their proximity to a building or apartment number (e.g., "behind 343" refers to apartment 343 in the low-rise building that includes apartment units 341–347). The numbers refer to individual addresses along Drake Avenue or Cole Drive. A small site plan is included on the following page to illustrate the layout of the complex (Image 1); please reference Attachment 1 for a higher-resolution version of this site plan with legible building and apartment numbers.

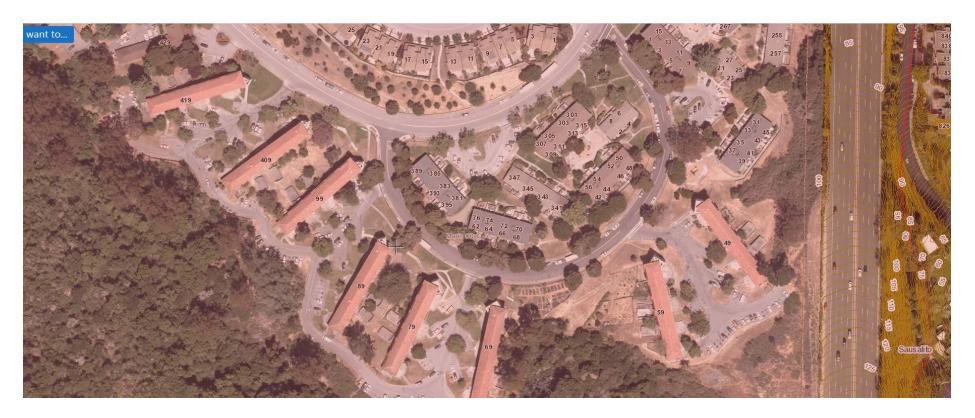
Attachment 3.3 - Fire Inspection #3 (13 August 2018)

- 1. Remove broom between 419 Drake and office at 429.
- 2. Knock down and spread out chip piles behind 419
- 3. Remove dead and down material immediately above retaining wall consider erosion control and minimize ground disturbing
- 4. Remove brush, broom 10' from block wall behind 49 Cole
- 5. Cut broom and brush between 49 Cole and Appt. 39 to "old cut line"

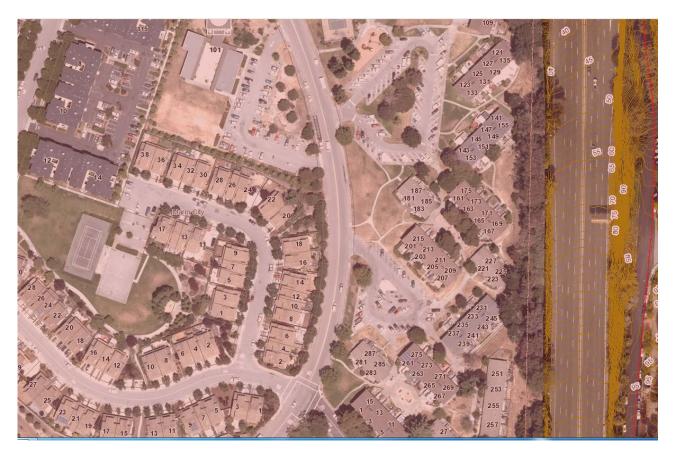
- 6. Work with residents to clean up behind 251-257 Cole dr. remove licorice plant and yard debris
- 7. Ensure adequate fuel reduction behind building off 100 and 200 lot adjacent to Freeway. Combination of residents cleaning up yard and yard debris cutting back brush/broom at least 10' from fence lines.

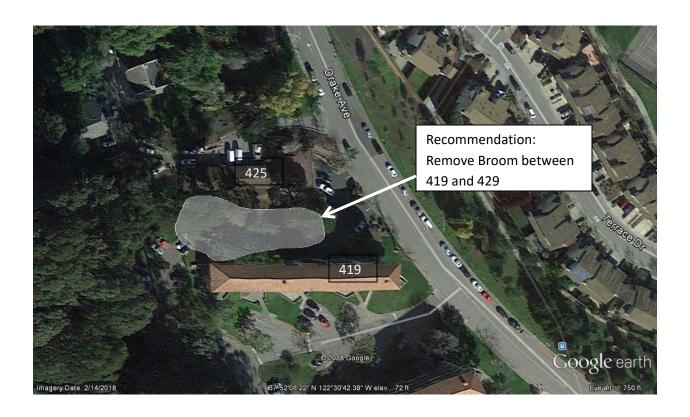
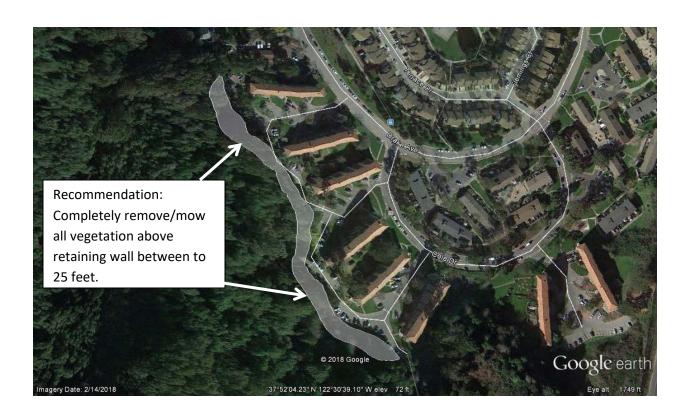
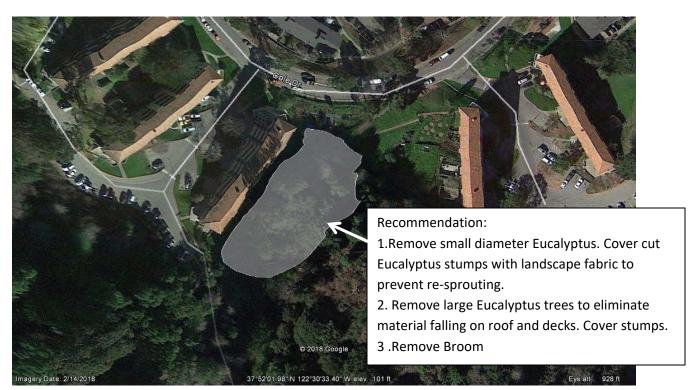
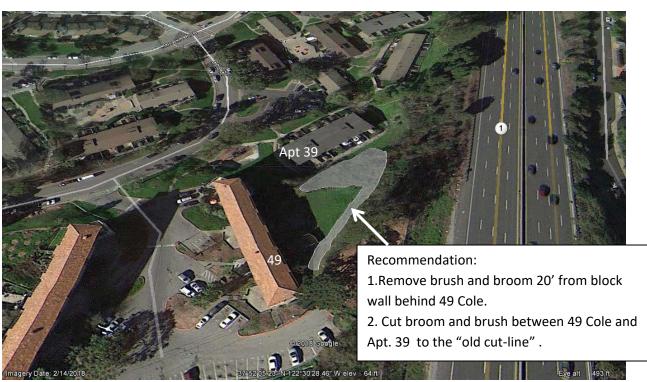
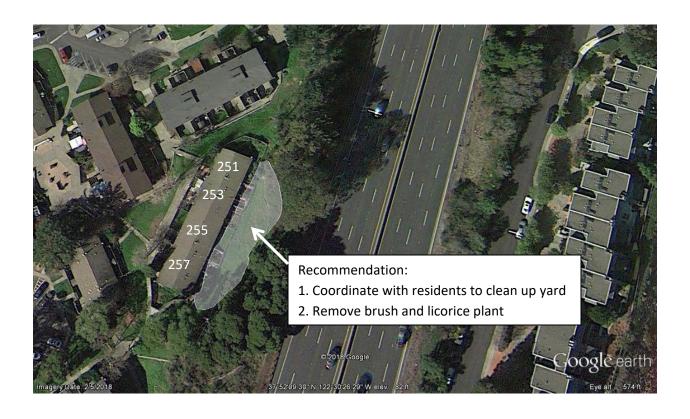
The following maps contain general recommendations for vegetation removal for specific areas on the property. Along with these recommendations the importance of regularly maintaining these areas and continuing defensible space work is critical to help better protect the GGV from wildfire. Please contact the MCFD if any clarifications or discussions on these recommendations are required .

⁵ These recommendations are included verbatim from the inspection report. [Parenthetical] description was added by ICF for clarity. Please reference the site plan in Attachment 1 and the photos in Attachment 3.2-3.4 for further illustration including photos and annotated aerial views.
