**UPDATED GEOLOGIC AND GEOTECHNICAL INVESTIGATION
88 VISION ROAD (APN 112-141-03/04)
INVERNESS, CALIFORNIA**

March 4, 2021

Job No. 2626.002

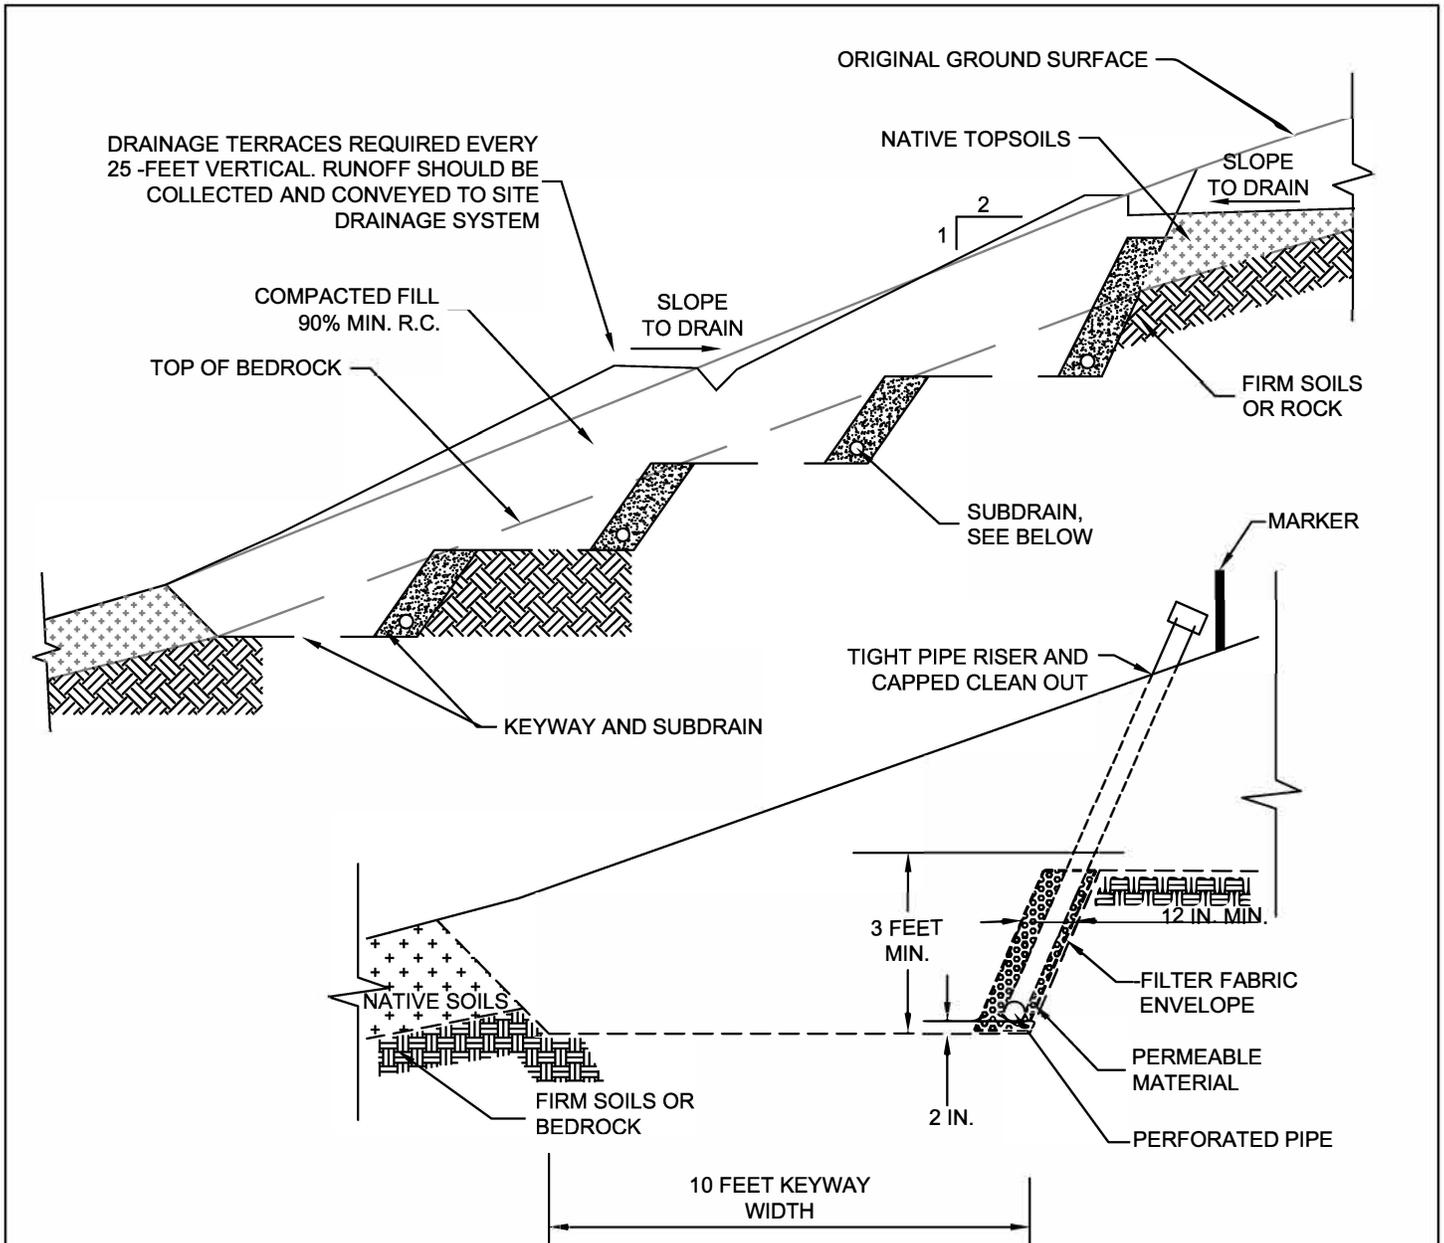
6
FIGURE

1. Subdrain drainage should consist of clean, free draining 3/4 inch crushed rock (Class 1B Permeable Material) wrapped in filter fabric (Mirafi 140N or equivalent) or Class 2 Permeable Material.
2. Perforated pipe shall be SCH 40 or SDR 35 for depths less than 20 feet. Use SCH 80 or SDR 23.5 perforated pipe for depths greater than 20 feet. Place pipe perforations down and slope at 1% to a gravity outlet, with tight pipe to gravity discharge.
3. Clean outs should be installed at the upslope end and at significant direction changes of the perforated pipe. Additionally, all angled connectors shall be long bend sweep connections.
4. All work and materials shall conform with Section 68, of the latest edition of the Caltrans Standard Specifications.

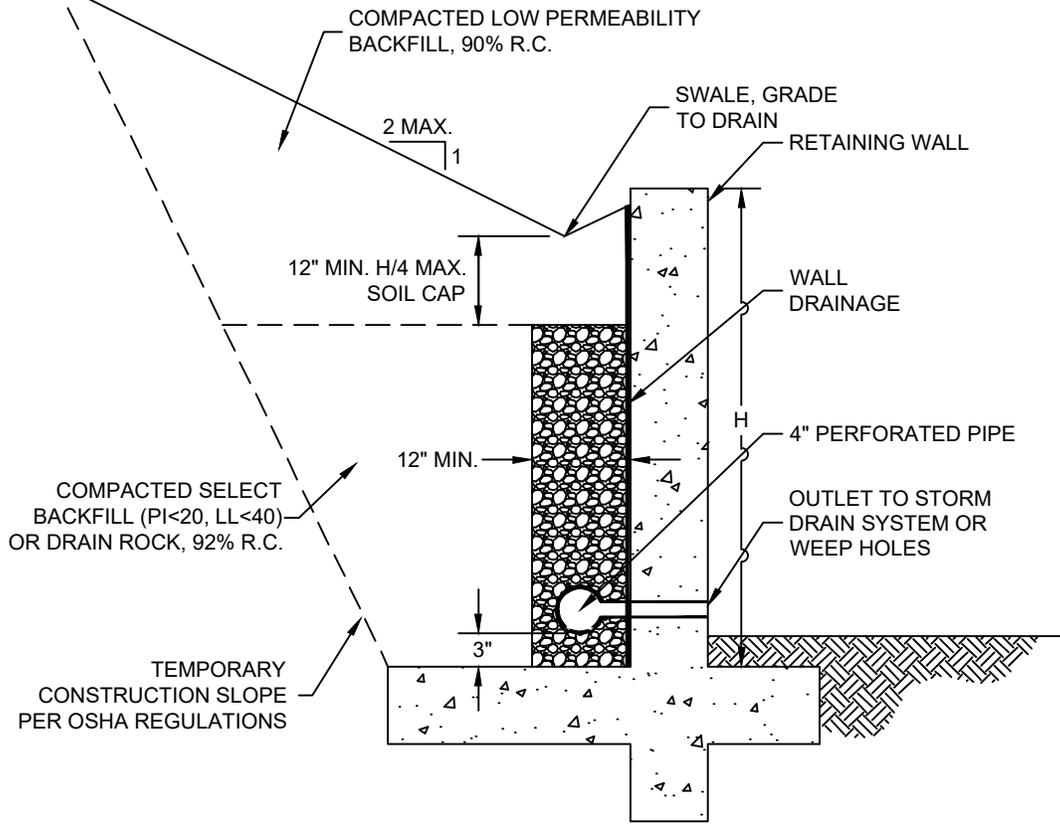
7
 FIGURE

1. Wall drainage should consist of clean, free draining 3/4 inch crushed rock (Class 1B Permeable Material) wrapped in filter fabric (Mirafi 140N or equivalent) or Class 2 Permeable Material. Alternatively, pre-fabricated drainage panels (Miradrain G100N or equivalent), installed per the manufacturers recommendations, may be used in lieu of drain rock and fabric.

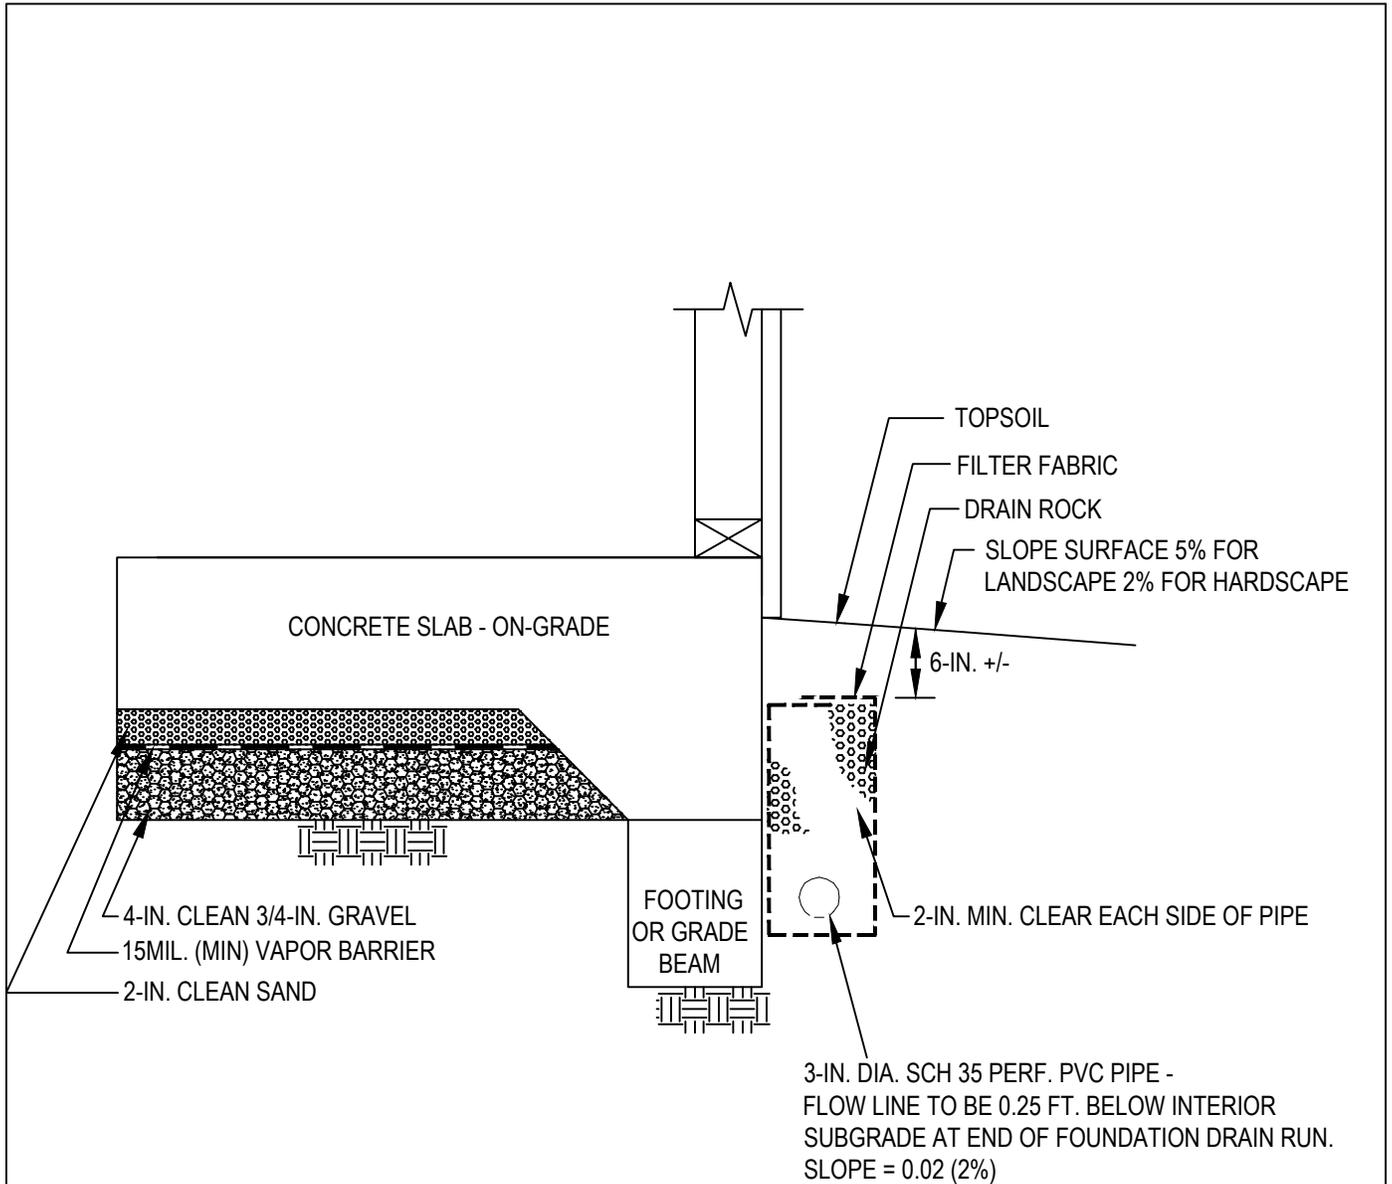
- (1.) DO NOT CONNECT DOWNSPOUT LEADER TO FOUNDATION DRAIN
- (2.) DISCHARGE THROUGH 4-IN DIAM., SCH 35, NON-PERFORATED PIPE, SLOPE 0.02 (2%) UNLESS OTHERWISE SPECIFIED

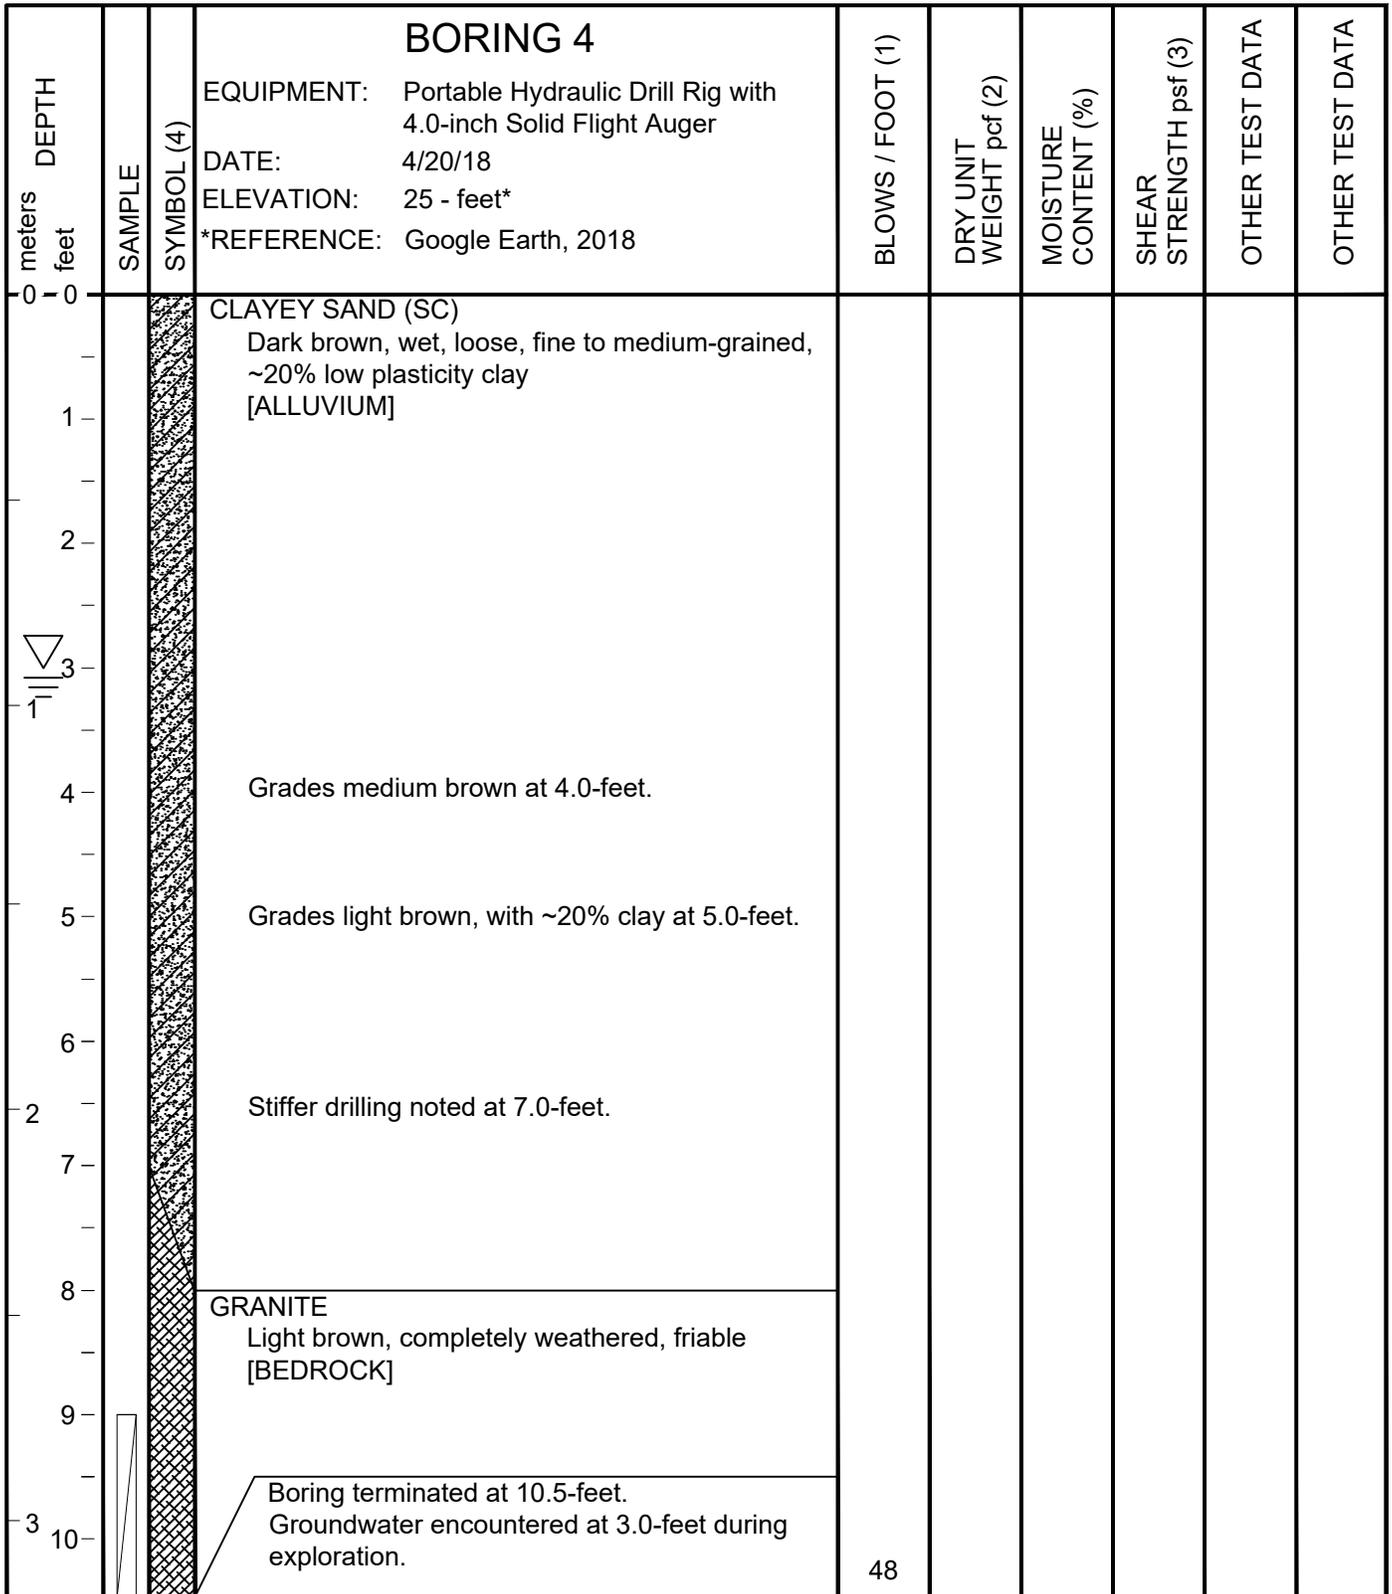
NOTES: (1) UNCORRECTED FIELD BLOW COUNTS
(2) METRIC EQUIVALENT DRY UNIT WEIGHT $\text{kN/m}^3 = 0.1571 \times \text{DRY UNIT WEIGHT (pcf)}$
(3) METRIC EQUIVALENT STRENGTH $(\text{kPa}) = 0.0479 \times \text{STRENGTH (psf)}$
(4) GRAPHIC SYMBOLS ARE ILLUSTRATIVE ONLY

Our subsurface exploration generally confirms the mapped geologic conditions at the site (California Division of Mines and Geology, 1977). Based on our subsurface exploration, the site is generally underlain by a thin mantle of silty to sandy residual soil (decomposed granite) over shallow granitic rock. Borings 1 and 2, drilled on the slope at the approximate location of the potential eastern footprint for the planned residence, each encountered about 5-feet of residual soil/decomposed granite composed of loose sand with silt. Each boring encountered highly to completely weathered granite bedrock at a depth of about 5-feet, which generally graded harder and stronger. Borings 1 and 2 were terminated at depths of 8.5 and 8.75-feet, respectively.

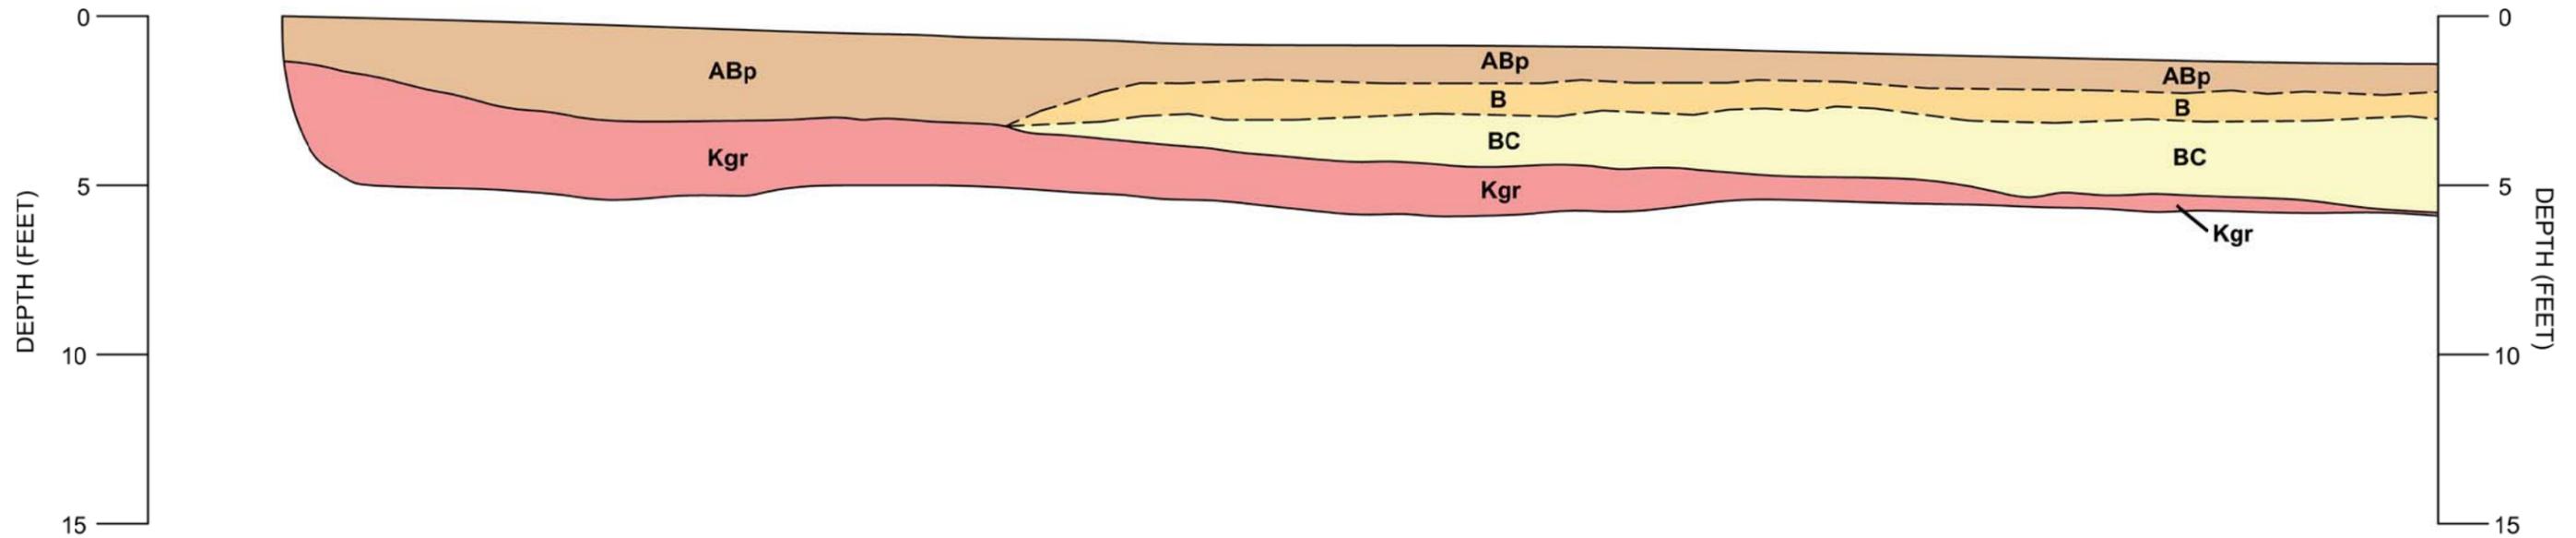
STRATIGRAPHIC COLUMN AND KEY TO LOG SYMBOLS

- ABp** SILTY SAND - (Late Holocene)
Brown (7.5YR 4/2) to Dark Grayish Brown, loose to medium dense, dry to moist, faint platy structure, abundant roots, locally contains man-made debris, garbage [MIXED FILL/COLLUVIUM]
- B** SAND WITH SILT (Late Holocene)
Light gray (7.5YR 7/1), medium dense, faint granular to platy structure, abundant random tubular pores, some rootlets, note upper contact marked by stone line of occasional brown weathered granite cobbles [MIXED COLLUVIUM/ALLUVIUM]
- BC** CLAYEY SAND (Late Pleistocene to Late Holocene)
Dark gray (2.5Y 4/1) with local brown and orange mottling, medium dense to dense, wet, rare fine granular granite gravels, faint horizontal lamination [ALLUVIUM]
- Kgr** GRANITE (Cretaceous)
White to light gray, mottled brown and orange, completely weathered, friable. Note minor perched groundwater at upper contact. [SALINIAN BLOCK BEDROCK]

Groundwater was encountered in Borings 3, 4 and 5 at about 3 feet below ground surface. Minor groundwater seepage was encountered near the soil/bedrock contact in the fault trench excavation. Because the borings and fault trench were not left open for an extended period of time, a stabilized depth to groundwater may not have been observed. Based on the site's location at the base of steeply-sloping areas underlain by relatively pervious weathered granite, we anticipate groundwater may exist within 3-feet of the ground surface throughout the year, and could be higher during the winter months, particularly in the lower-lying parts of the site.

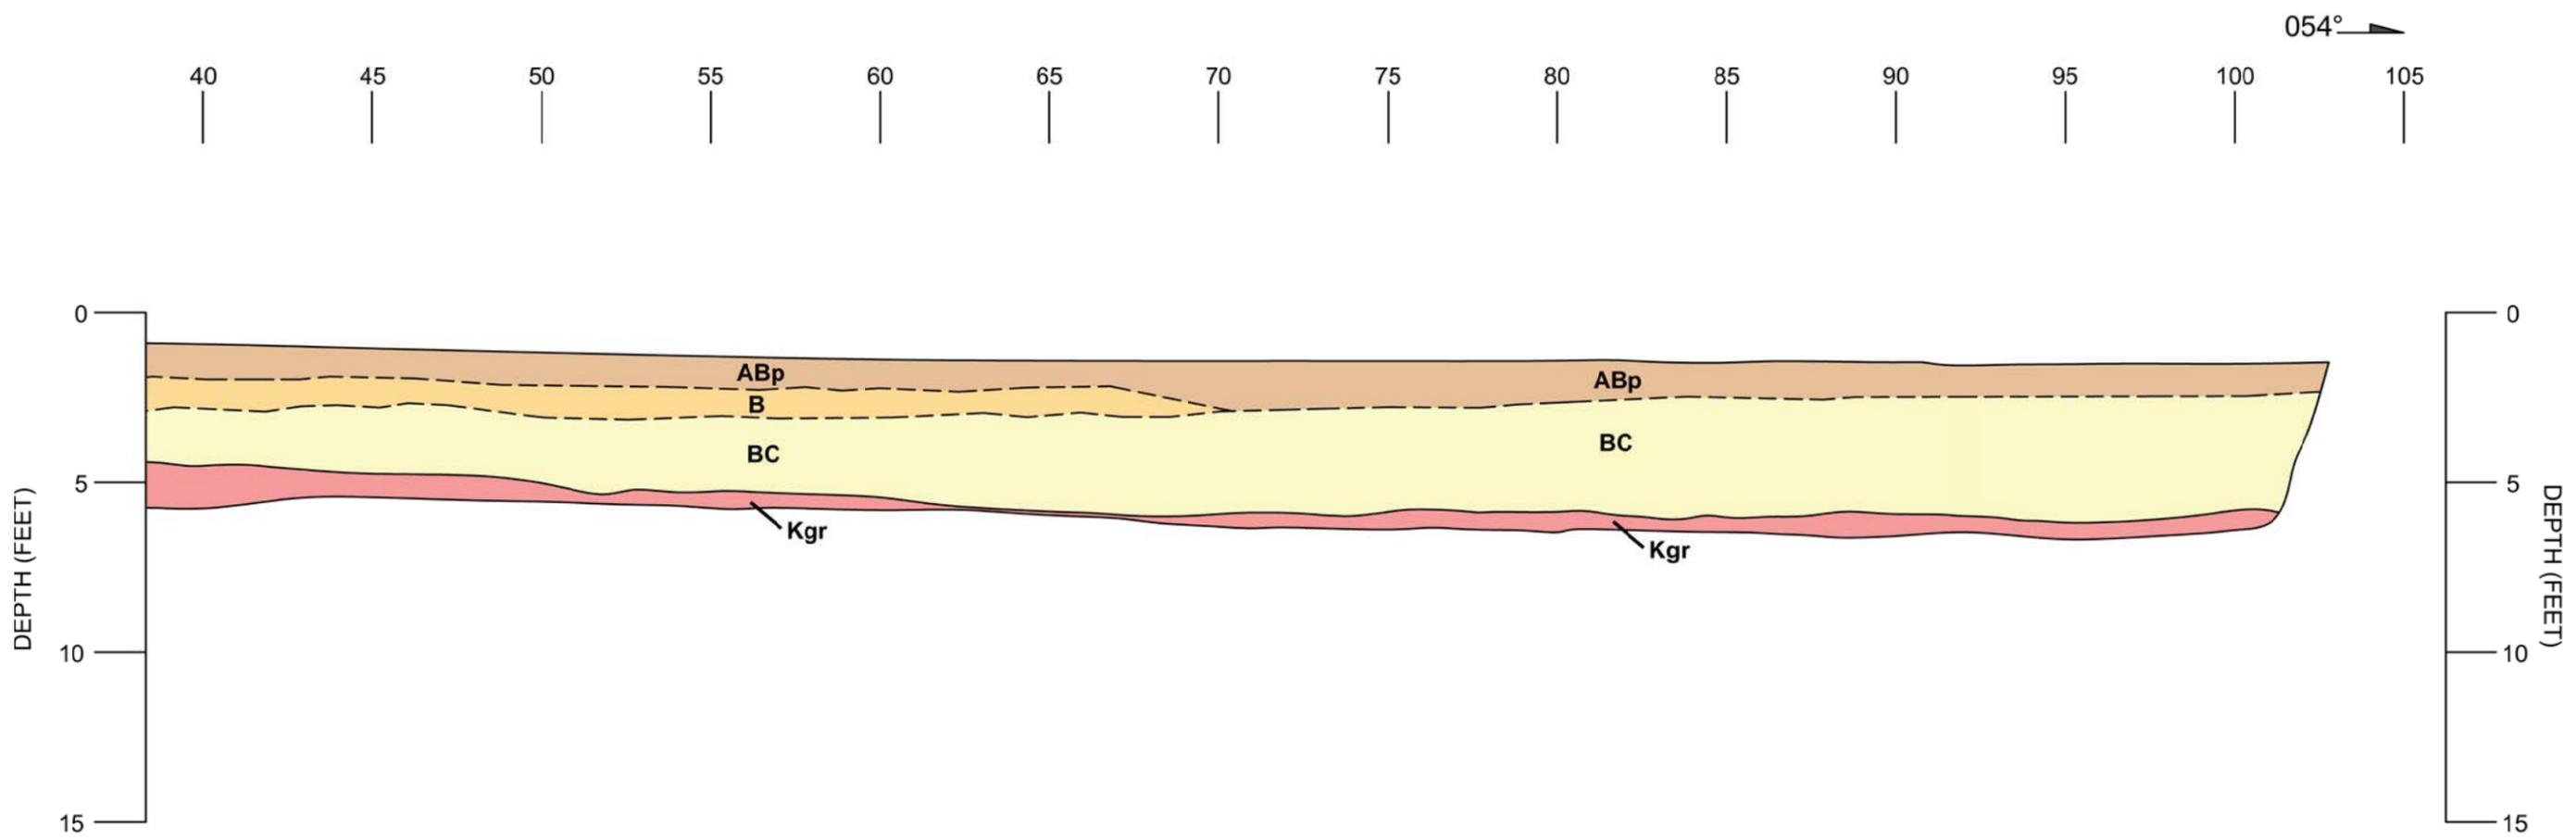
STRATIGRAPHIC COLUMN AND KEY TO LOG SYMBOLS

- ABp** SILTY SAND - (Late Holocene)
Brown (7.5YR 4/2) to Dark Grayish Brown, loose to medium dense, dry to moist, faint platy structure, abundant roots, locally contains man-made debris, garbage [MIXED FILL/COLLUVIUM]
- B** SAND WITH SILT (Late Holocene)
Light gray (7.5YR 7/1), medium dense, faint granular to platy structure, abundant random tubular pores, some rootlets, note upper contact marked by stone line of occasional brown weathered granite cobbles [MIXED COLLUVIUM/ALLUVIUM]
- BC** CLAYEY SAND (Late Pleistocene to Late Holocene)
Dark gray (2.5Y 4/1) with local brown and orange mottling, medium dense to dense, wet, rare fine granular granite gravels, faint horizontal lamination [ALLUVIUM]
- Kgr** GRANITE (Cretaceous)
White to light gray, mottled brown and orange, completely weathered, friable. Note minor perched groundwater at upper contact. [SALINIAN BLOCK BEDROCK]
