GEOTECHNICAL INVESTIGATION GARAGE/OFFICE ADDITION 18876 STATE ROUTE 1 MARSHALL, CALIFORNIA

February 16, 2022

Job No. 3206.001

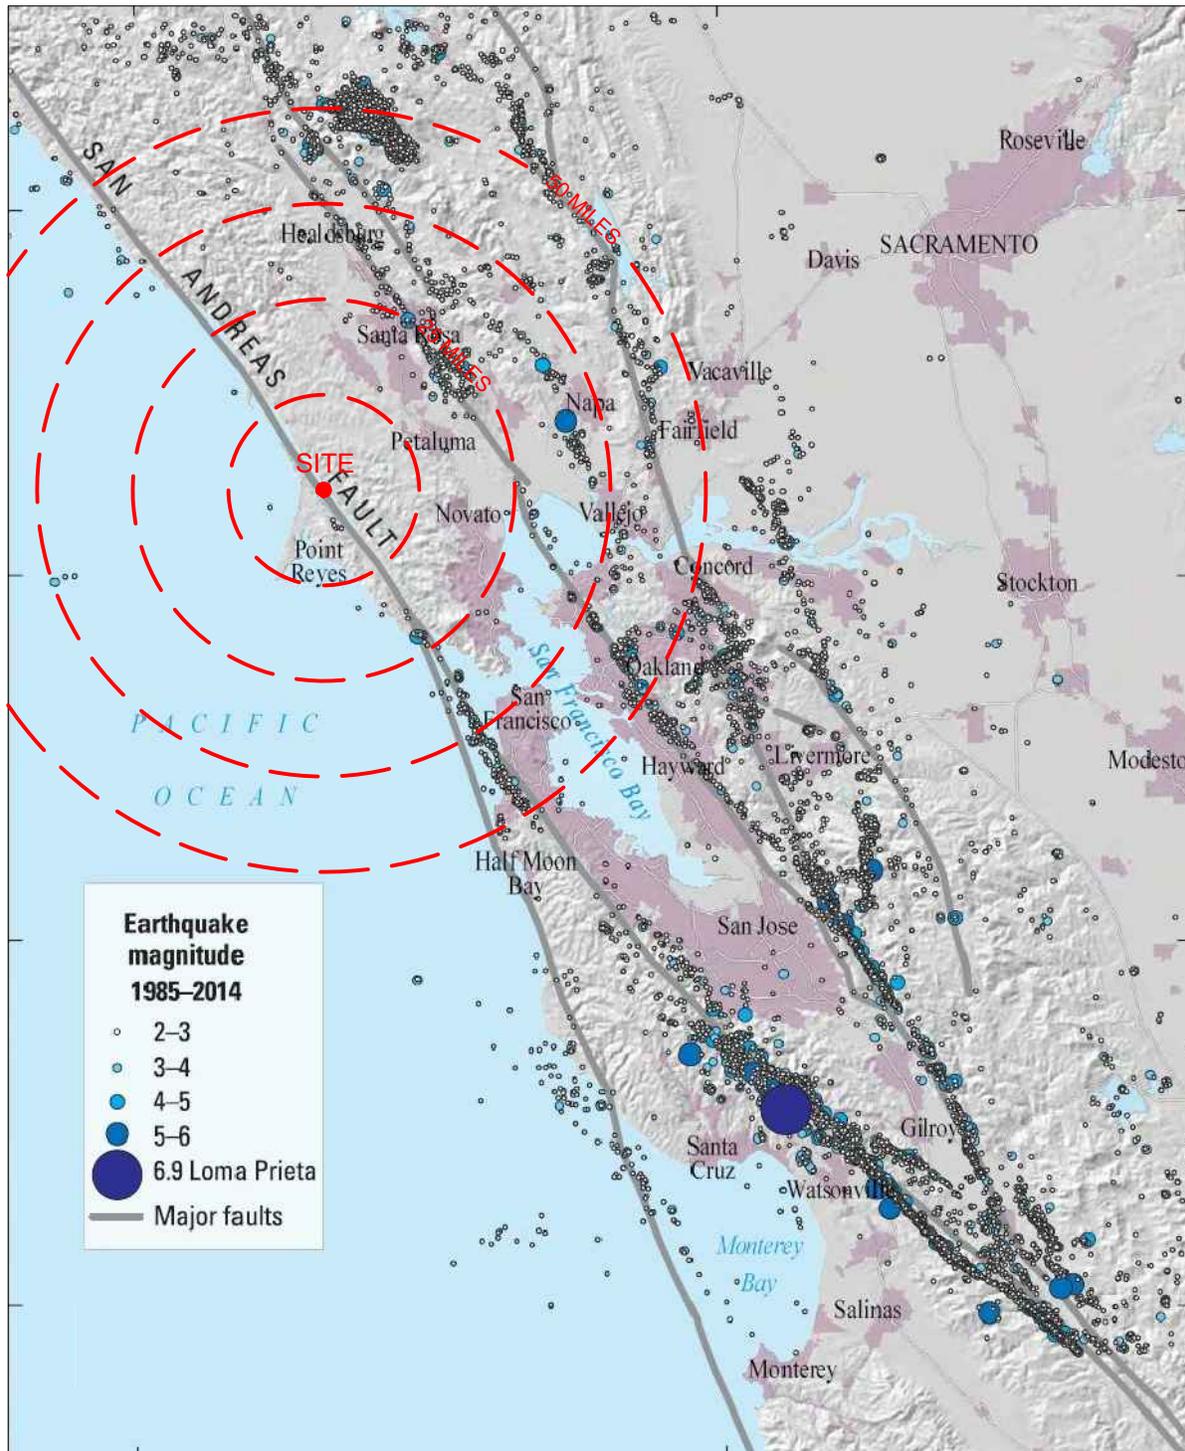
5
 FIGURE

1) U.S. Geological Survey, U.S. Department of the Interior, "Earthquake Outlook for the San Francisco Bay Region 2014-2043", Map of Earthquakes Greater Than Magnitude 2.0 in the San Francisco Bay Region from 1985-2014, Fact Sheet 2016-3020, Revised August 2016 (ver. 1.1).

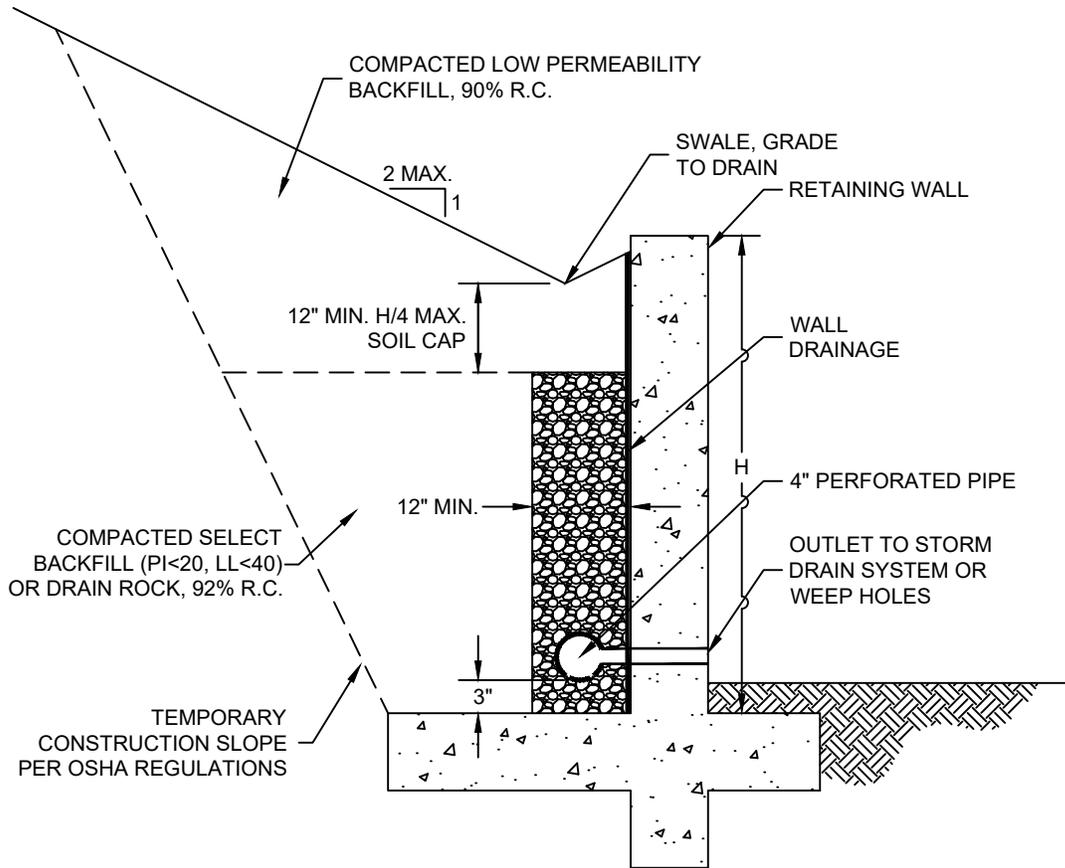
1. Wall drainage should consist of clean, free draining 3/4 inch crushed rock (Class 1B Permeable Material) wrapped in filter fabric (Mirafi 140N or equivalent) or Class 2 Permeable Material. Alternatively, pre-fabricated drainage panels (Miradrain G100N or equivalent), installed per the manufacturers recommendations, may be used in lieu of drain rock and fabric.

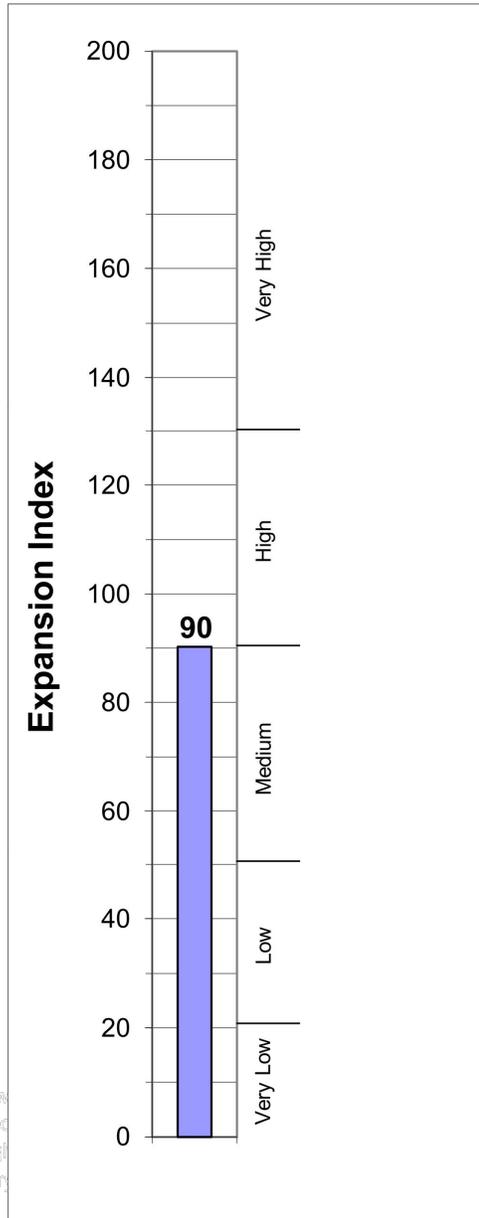
EI₅₀: 90

Potential Expansion Medium to High

20.5 Low
50.5 Med
90.5 High
130.5 Very

Laboratory testing of soil samples from the exploratory borings included determination of moisture content, dry density, unconfined compressive strength and expansion index. The results of our laboratory tests are presented on the boring logs with the exception of the expansion index testing which is shown on Figure A-5 and our laboratory testing program is discussed in greater detail in Appendix A.
