**GEOLOGIC AND GEOTECHNICAL INVESTIGATION
75 HORSESHOE HILL ROAD
BOLINAS, CALIFORNIA**

Job No. 3281.002

Prepared For:
Scott Weiss
260 Horseshoe Hill Road
Bollinas, California 94924

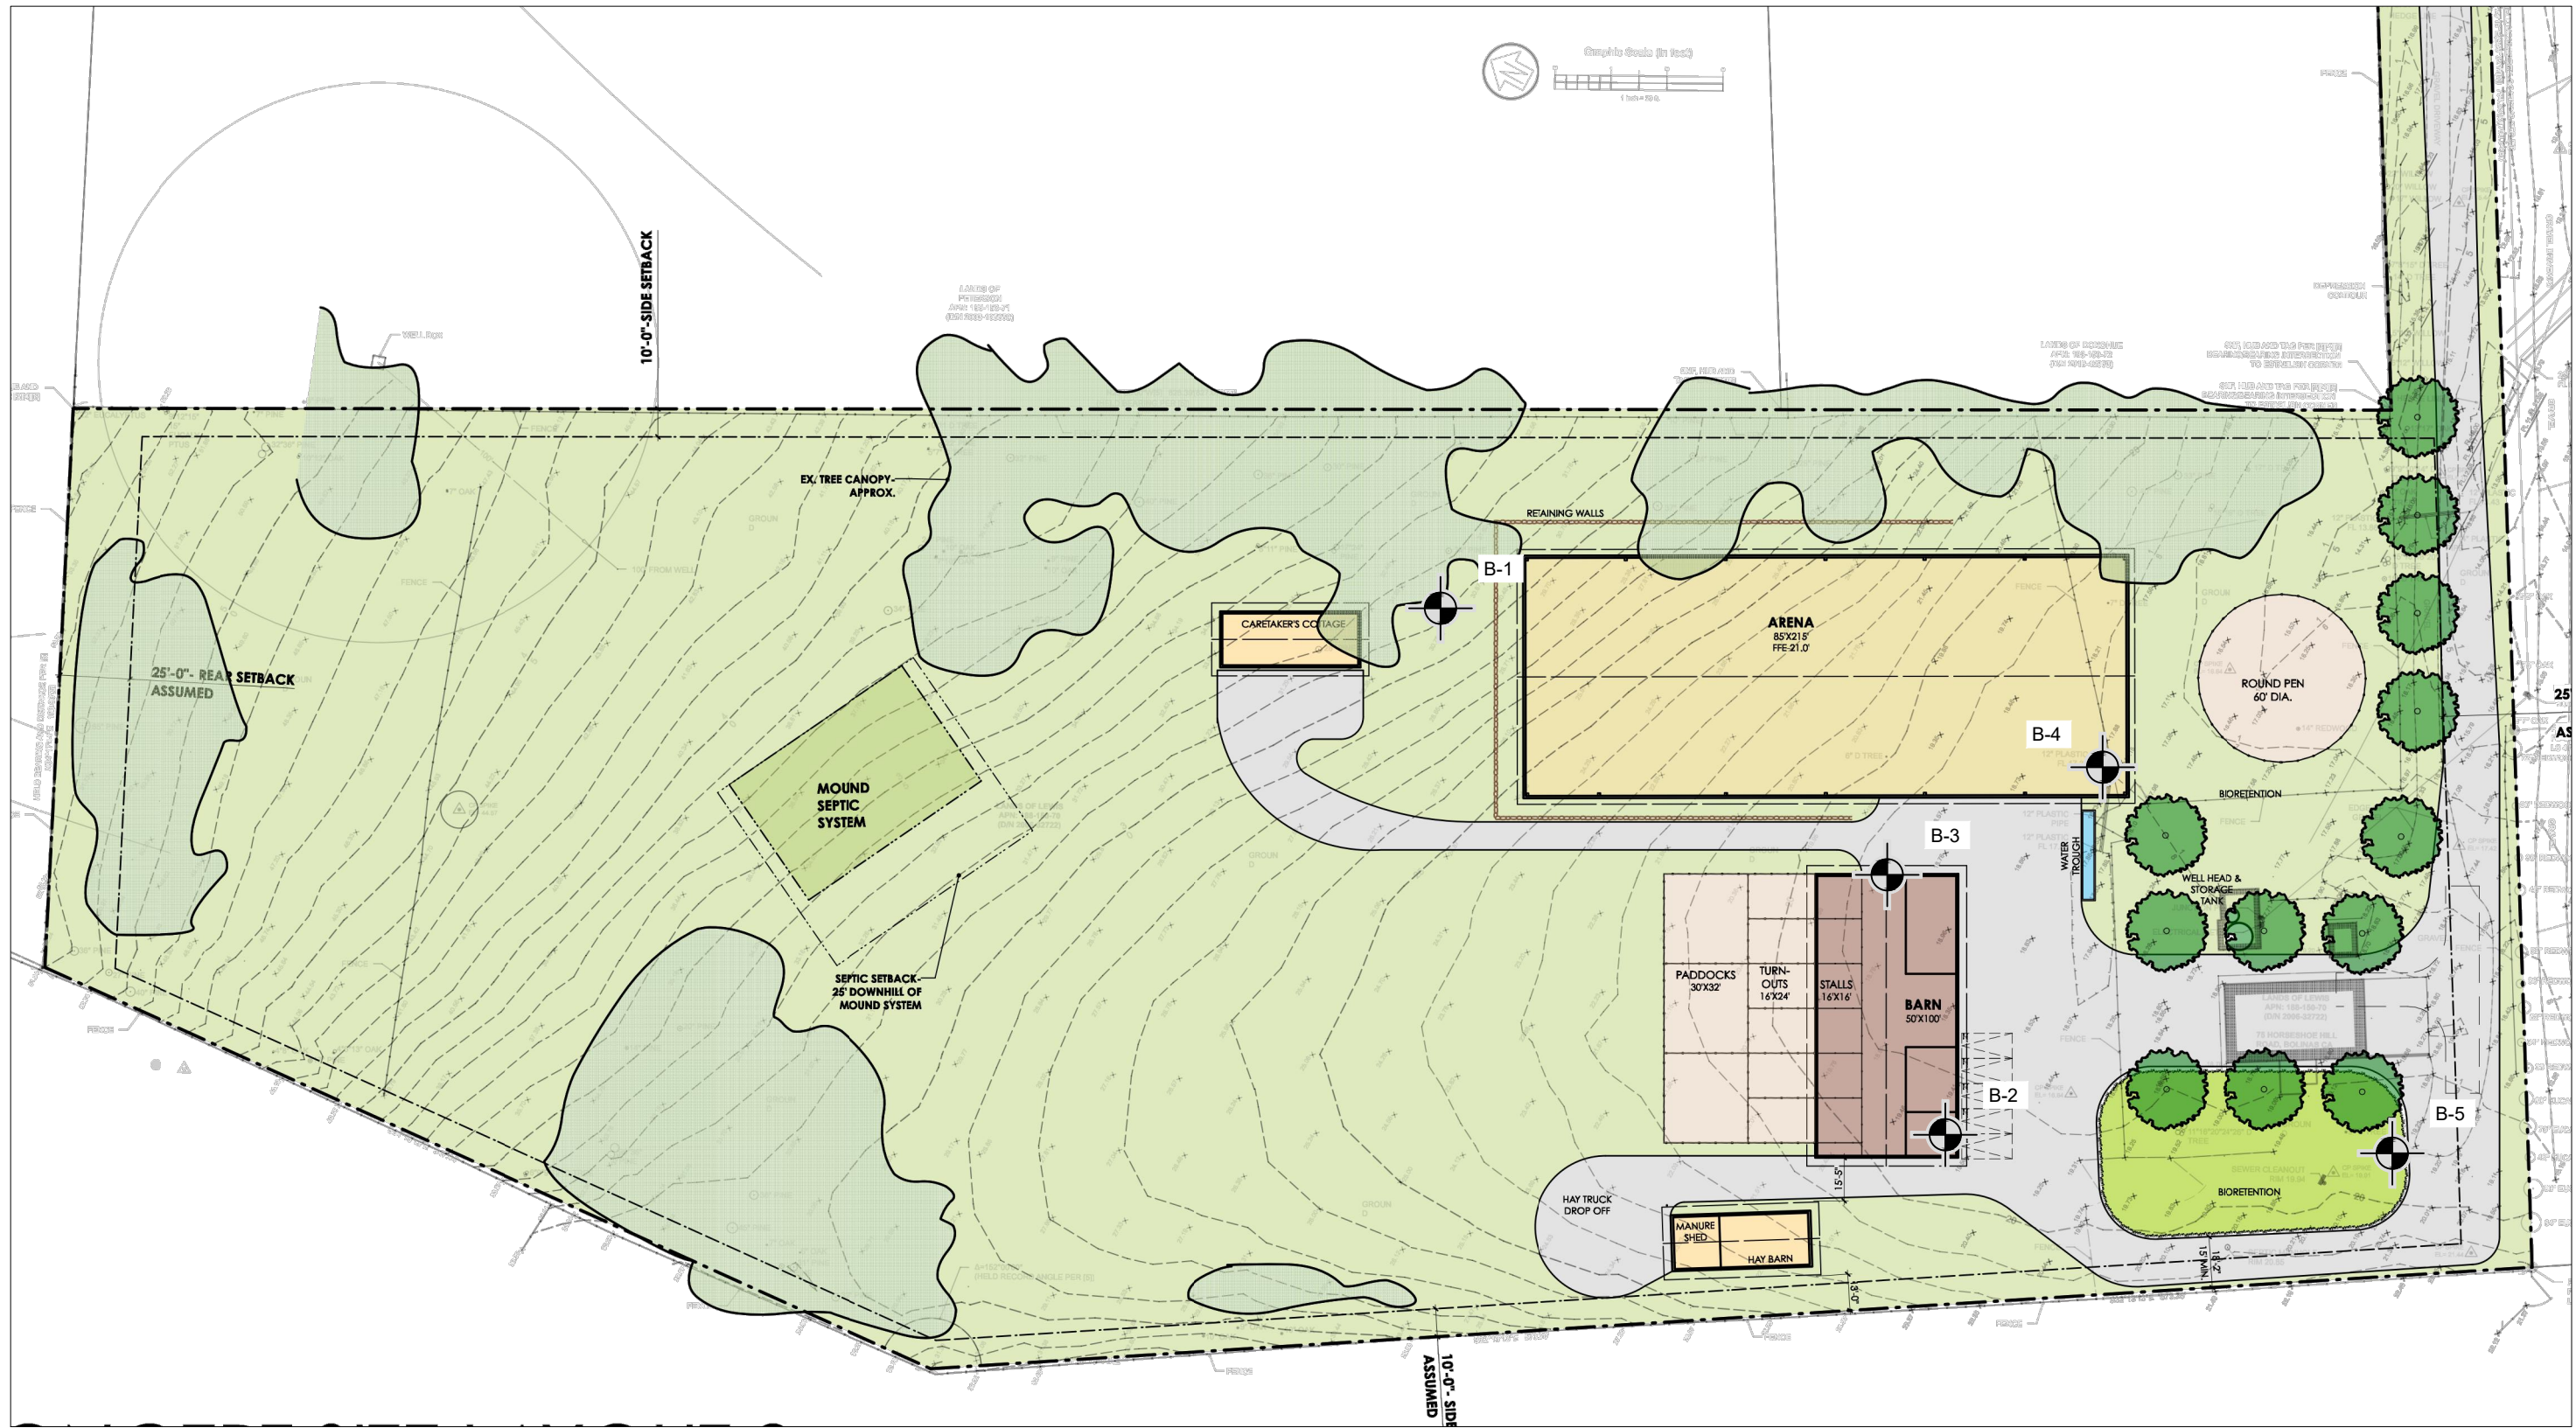
2
FIGURE

Approximate location of boring completed by MPEG, 2022

We explored subsurface conditions with 5 exploratory borings drilled with track-mounted drilling equipment on July 28, 2022, at the approximate locations shown on the Site Plan, Figure 2. The exploration was conducted under the technical supervision of our Field Geologist who examined and logged the soil materials encountered and obtained samples. Brief descriptions of the terms and methodology used in classifying earth materials are provided on the Soil and Rock Classification Charts, Figures A-1 and A-2, respectively, and the Boring Logs are shown on Figures A-3 through A-7.
