650 NORTH SAN PEDRO ROAD AMENDED FINAL EIR

STATE CLEARINGHOUSE NUMBER: 2004062004

County of Marin | October 22, 2010

DESIGN, COMMUNITY & ENVIRONMENT

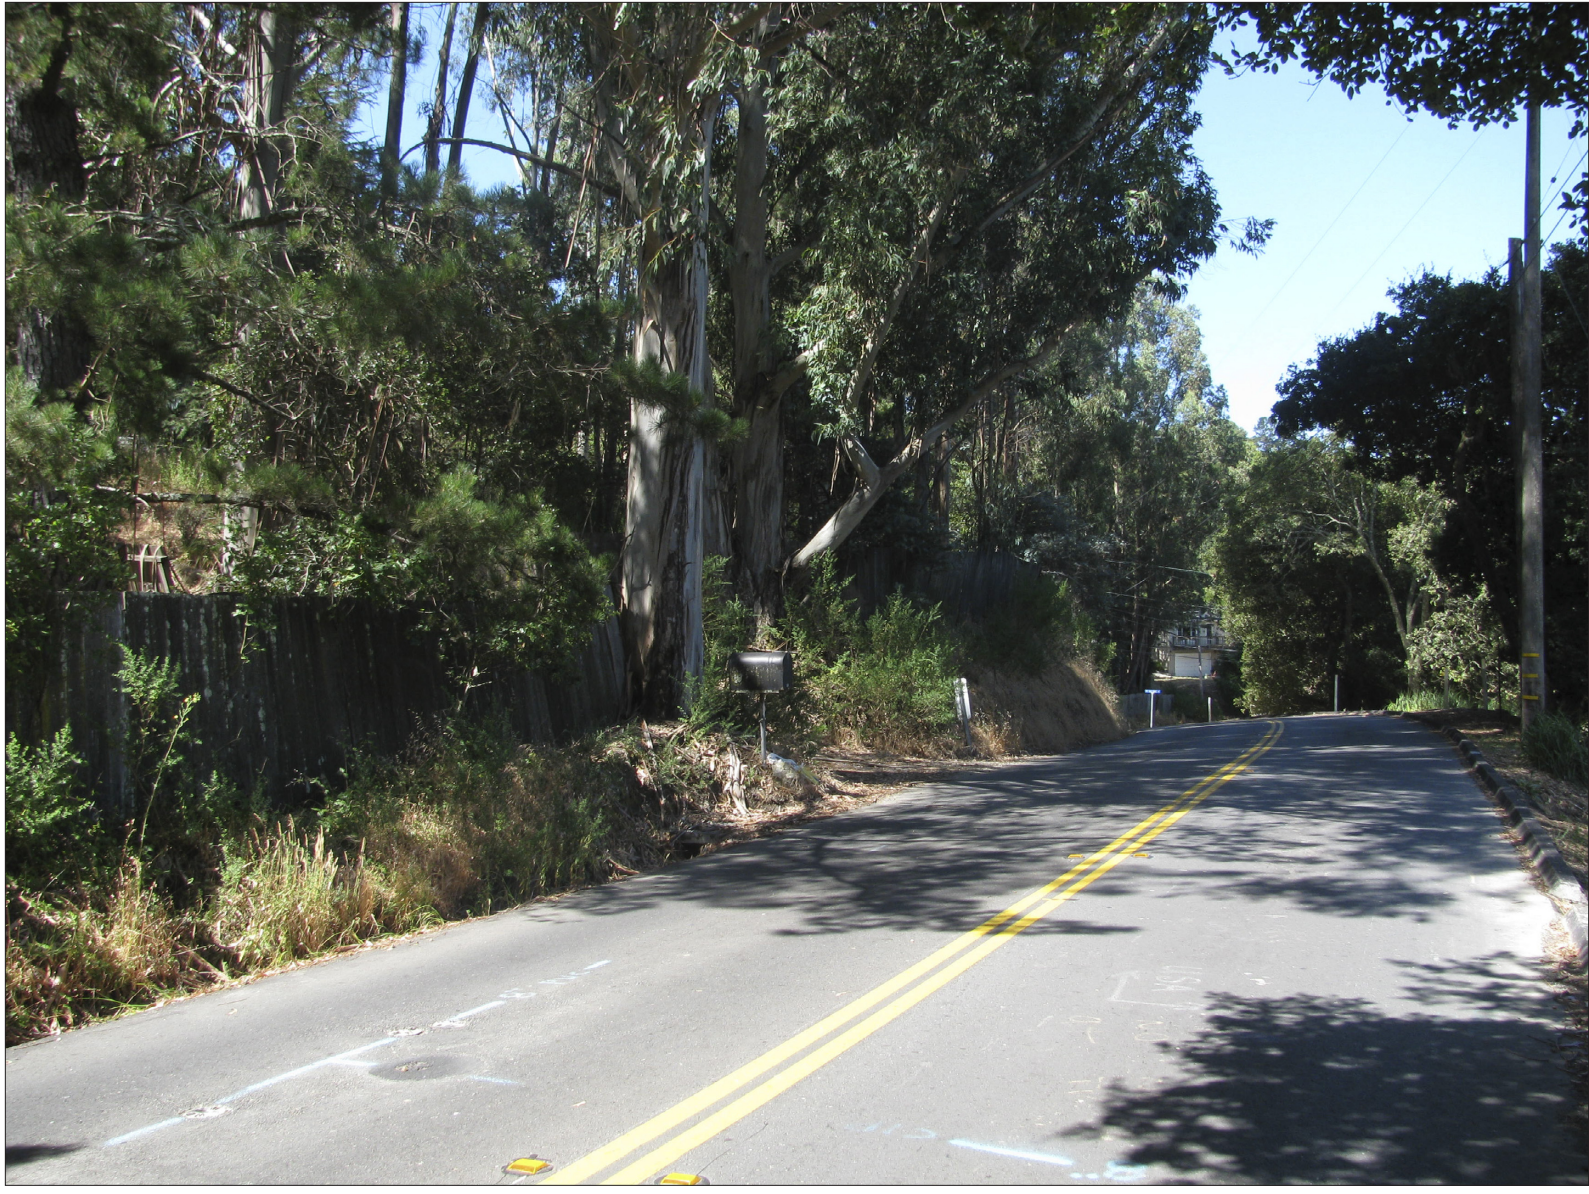
FIGURE 5-6

SOUTHWESTERN VIEW OF LOT I FROM NORTH SAN PEDRO ROAD

As discussed above, two figures have been added to Chapter 5, Alternatives, of the Final EIR. Figure 5-6 shows a photo of the existing condition of Lot 1 from a westbound approach on North San Pedro Road. Figure 5-7a shows a photo simulation of Lot 1 (at time of tree installation) that includes incorporation of Mitigation Measure 4.6-E.1 (sight-line enhancement). Figure 5-7b shows trees five years after installation. These photo simulations depict the grading on Lot 1 to provide for 250 feet of sight distance from Bay Creek Drive.

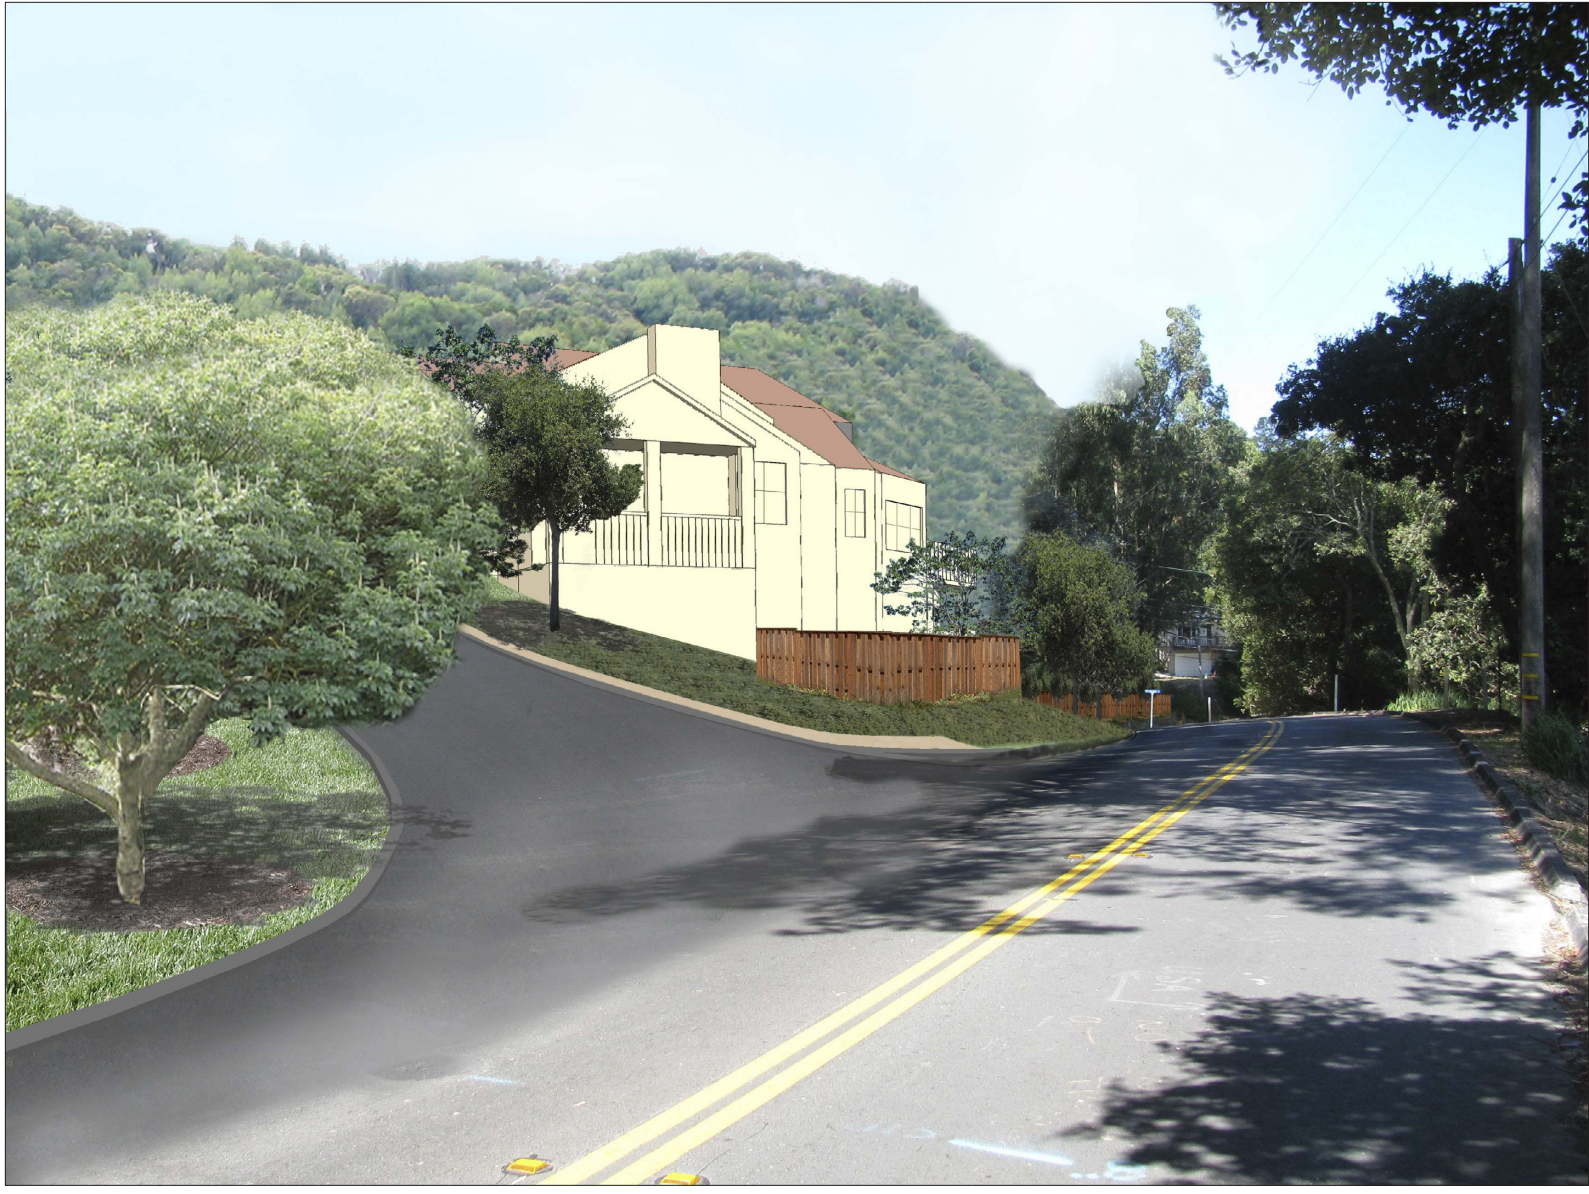
FIGURE 5-7B

SIMULATED VIEW OF LOT I FROM NORTH SAN PEDRO ROAD

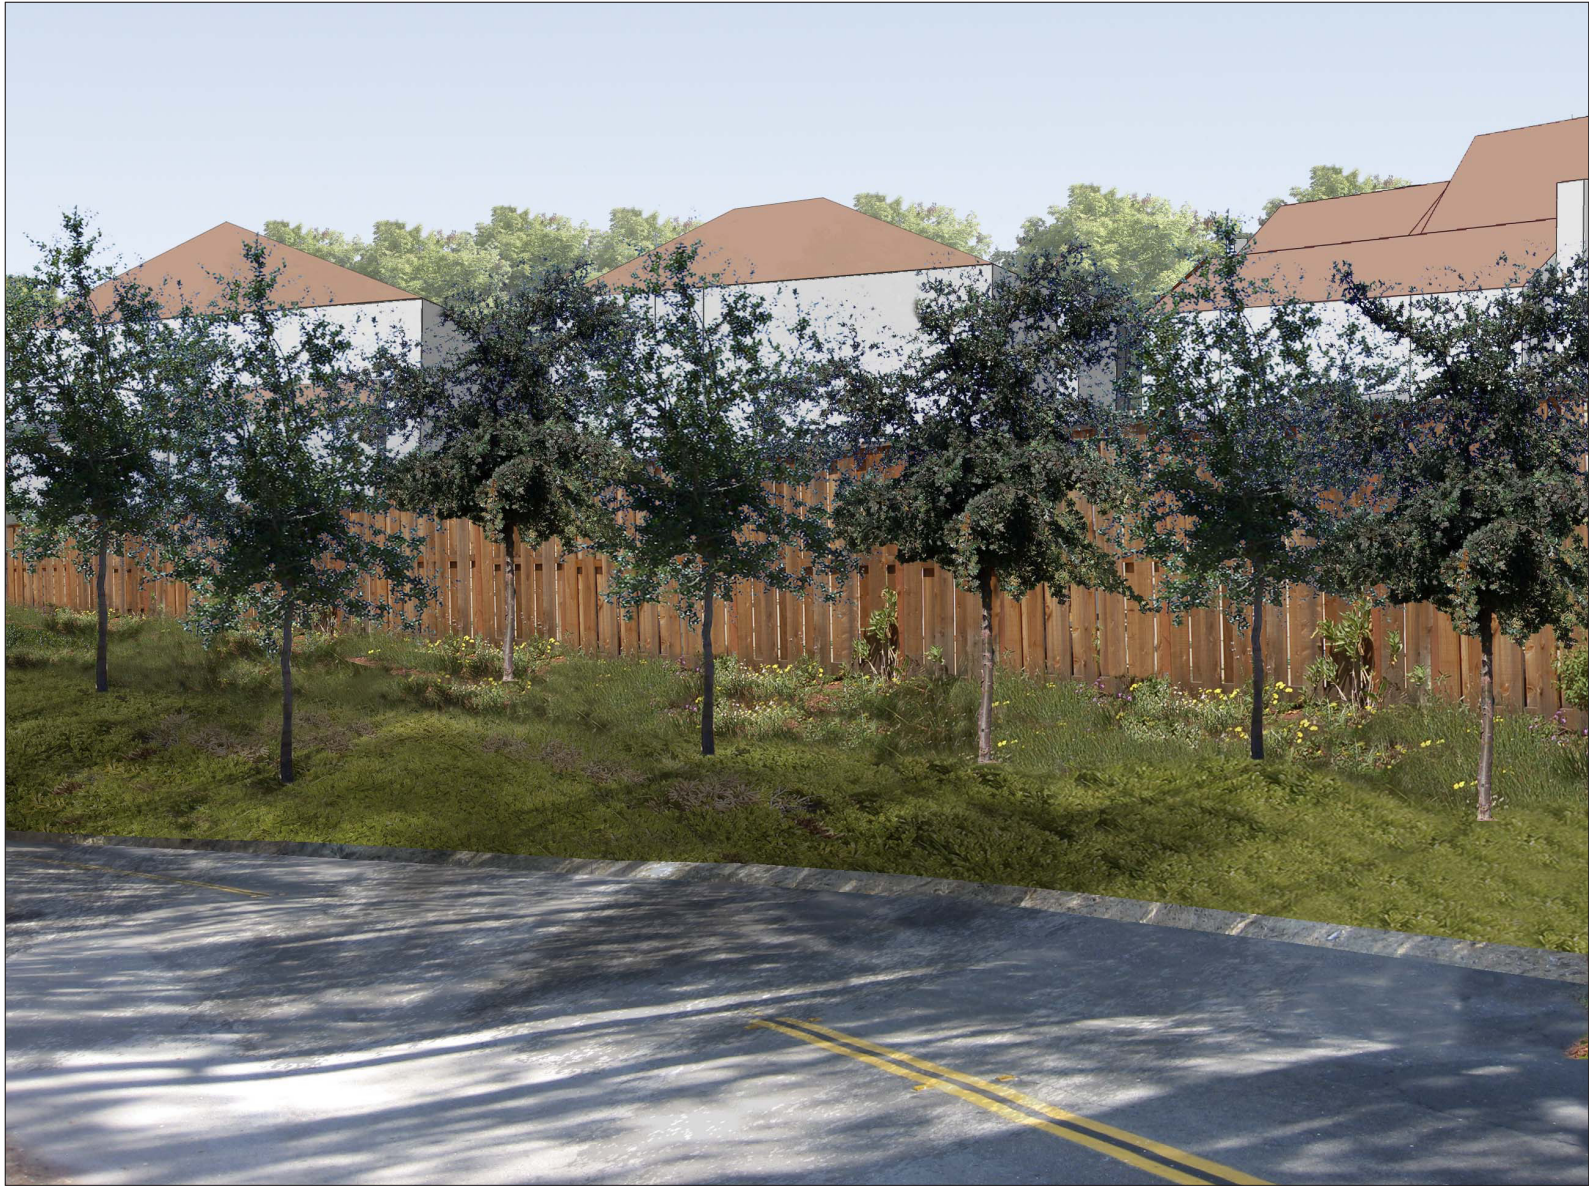
FIGURE 4.8-5A

SIMULATED VIEW OF SITE FROM PT. GALLINAS ROAD - 2ND REVISED

During the Public Hearing, it was requested that the photo simulations show trees at time of installation and at a time when the trees are not fully mature. Figures 4.8-5 through 4.8-7 have been revised to provide representations of the Proposed Project that are consistent with the Planting Plan, included in

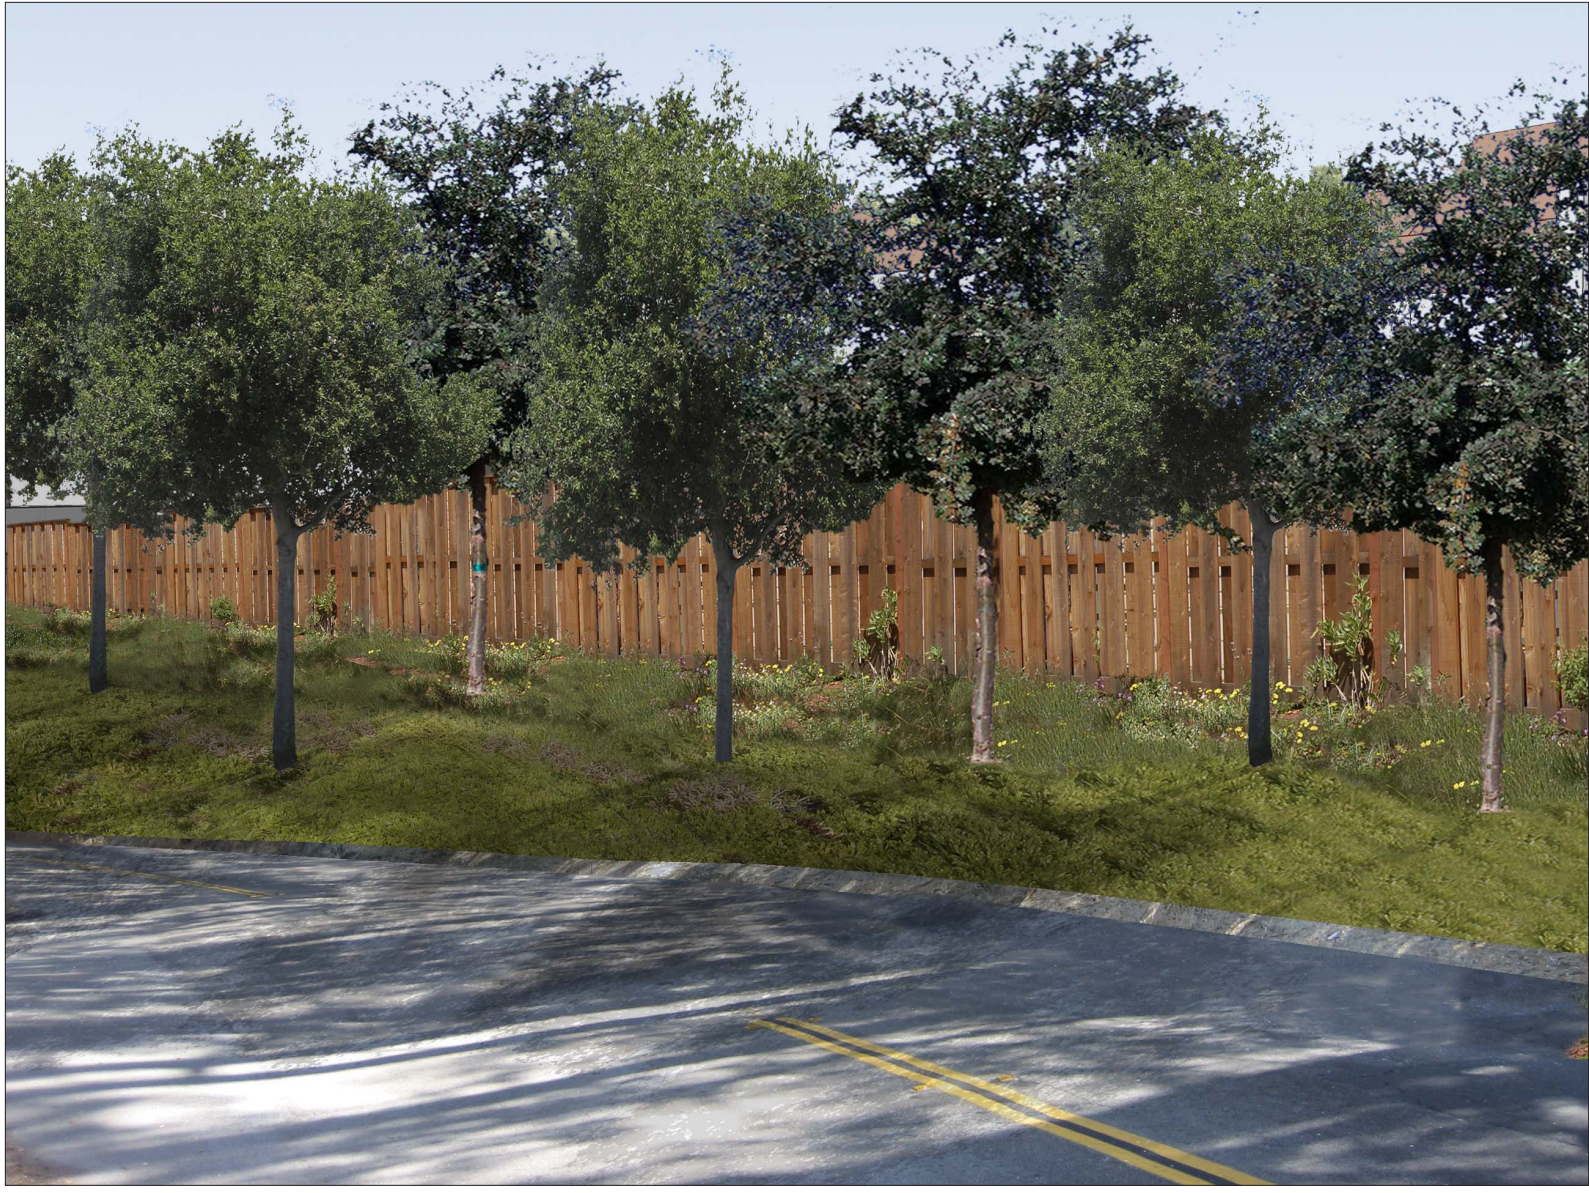
FIGURE 4.8-5B

SIMULATED VIEW OF SITE FROM PT. GALLINAS ROAD - 2ND REVISED

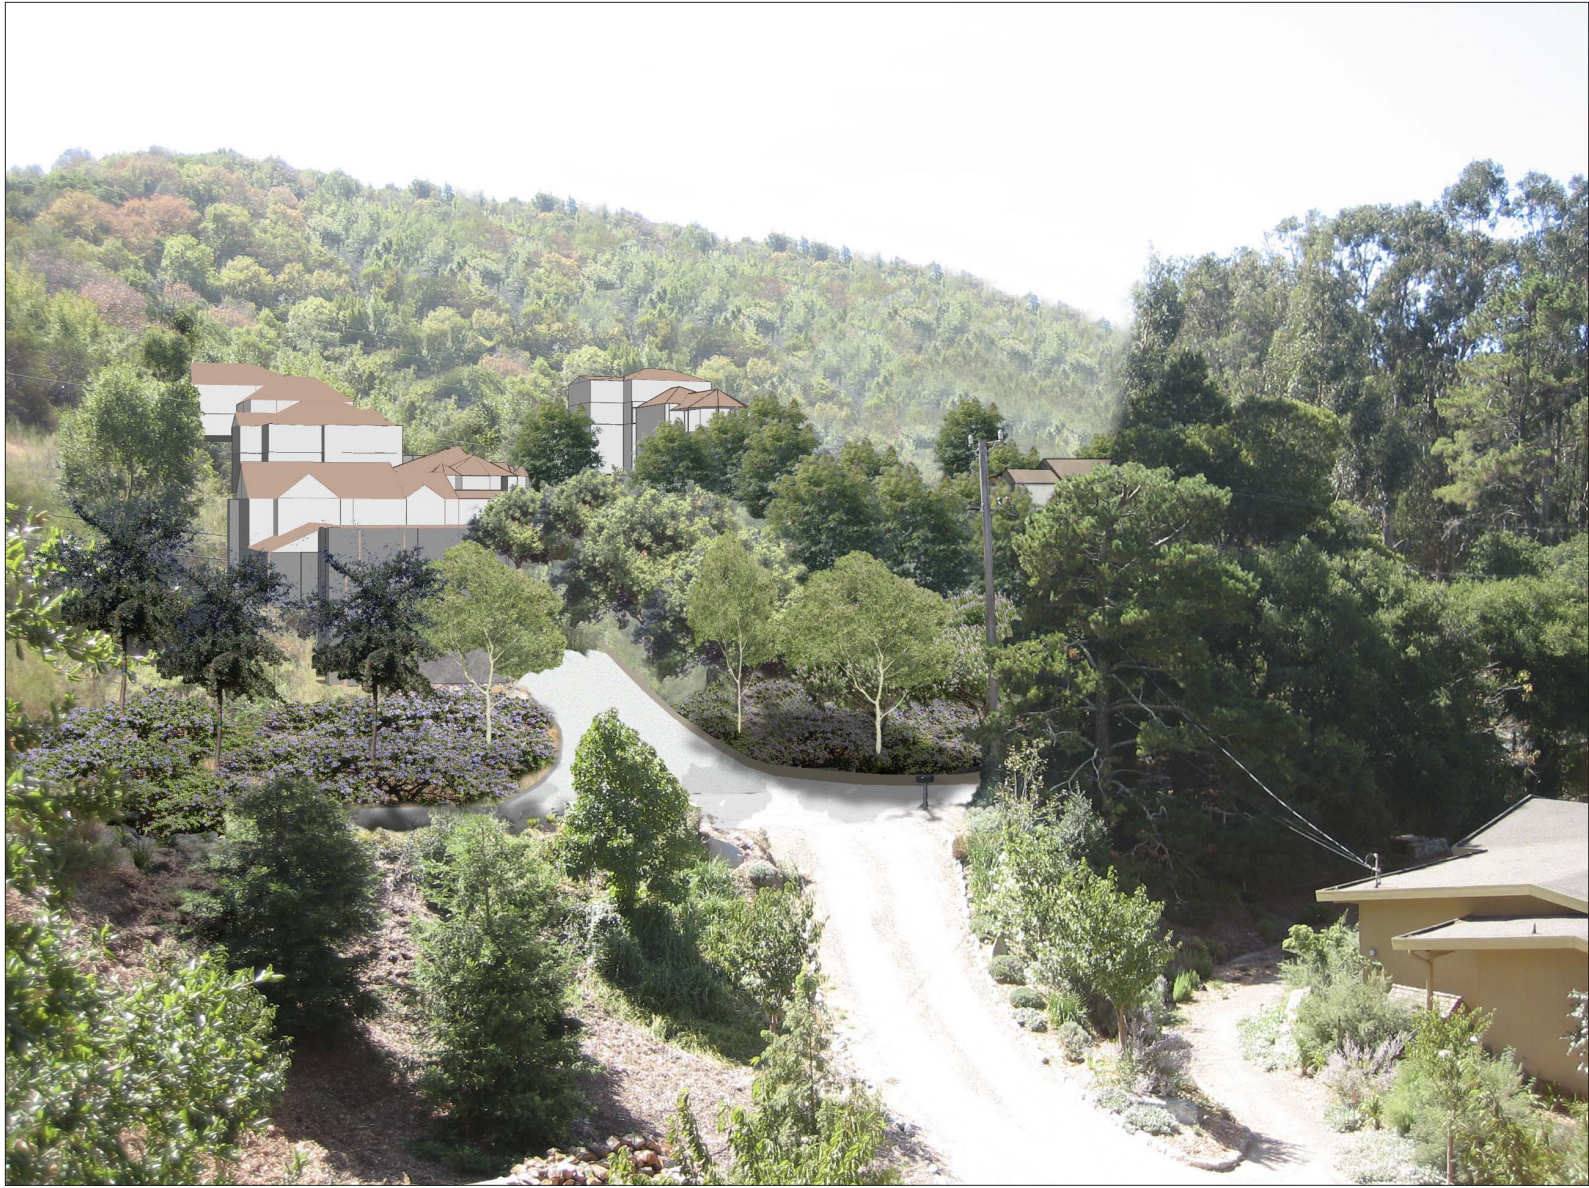
FIGURE 4.8-6A

SIMULATED VIEW OF SITE FROM UPPER ROAD LOOKING SOUTH - 2ND REVISED

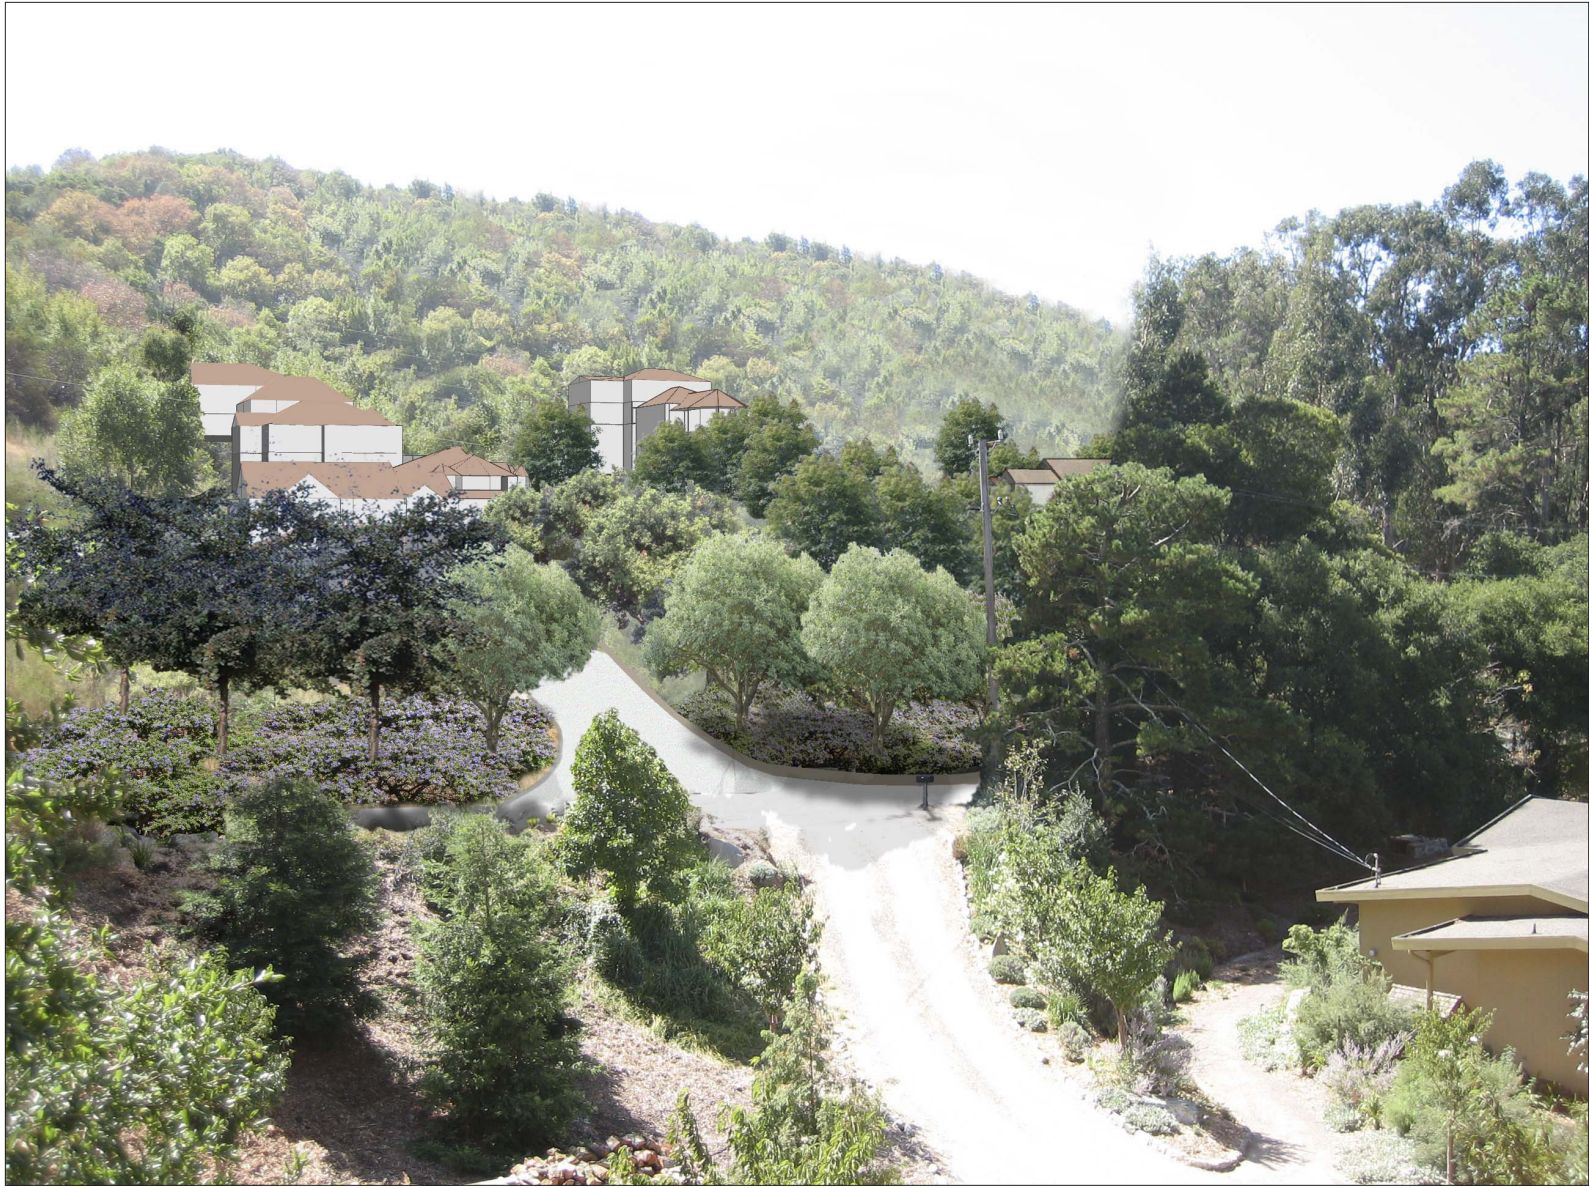
FIGURE 4.8-6B

SIMULATED VIEW OF SITE FROM UPPER ROAD LOOKING SOUTH - 2ND REVISED

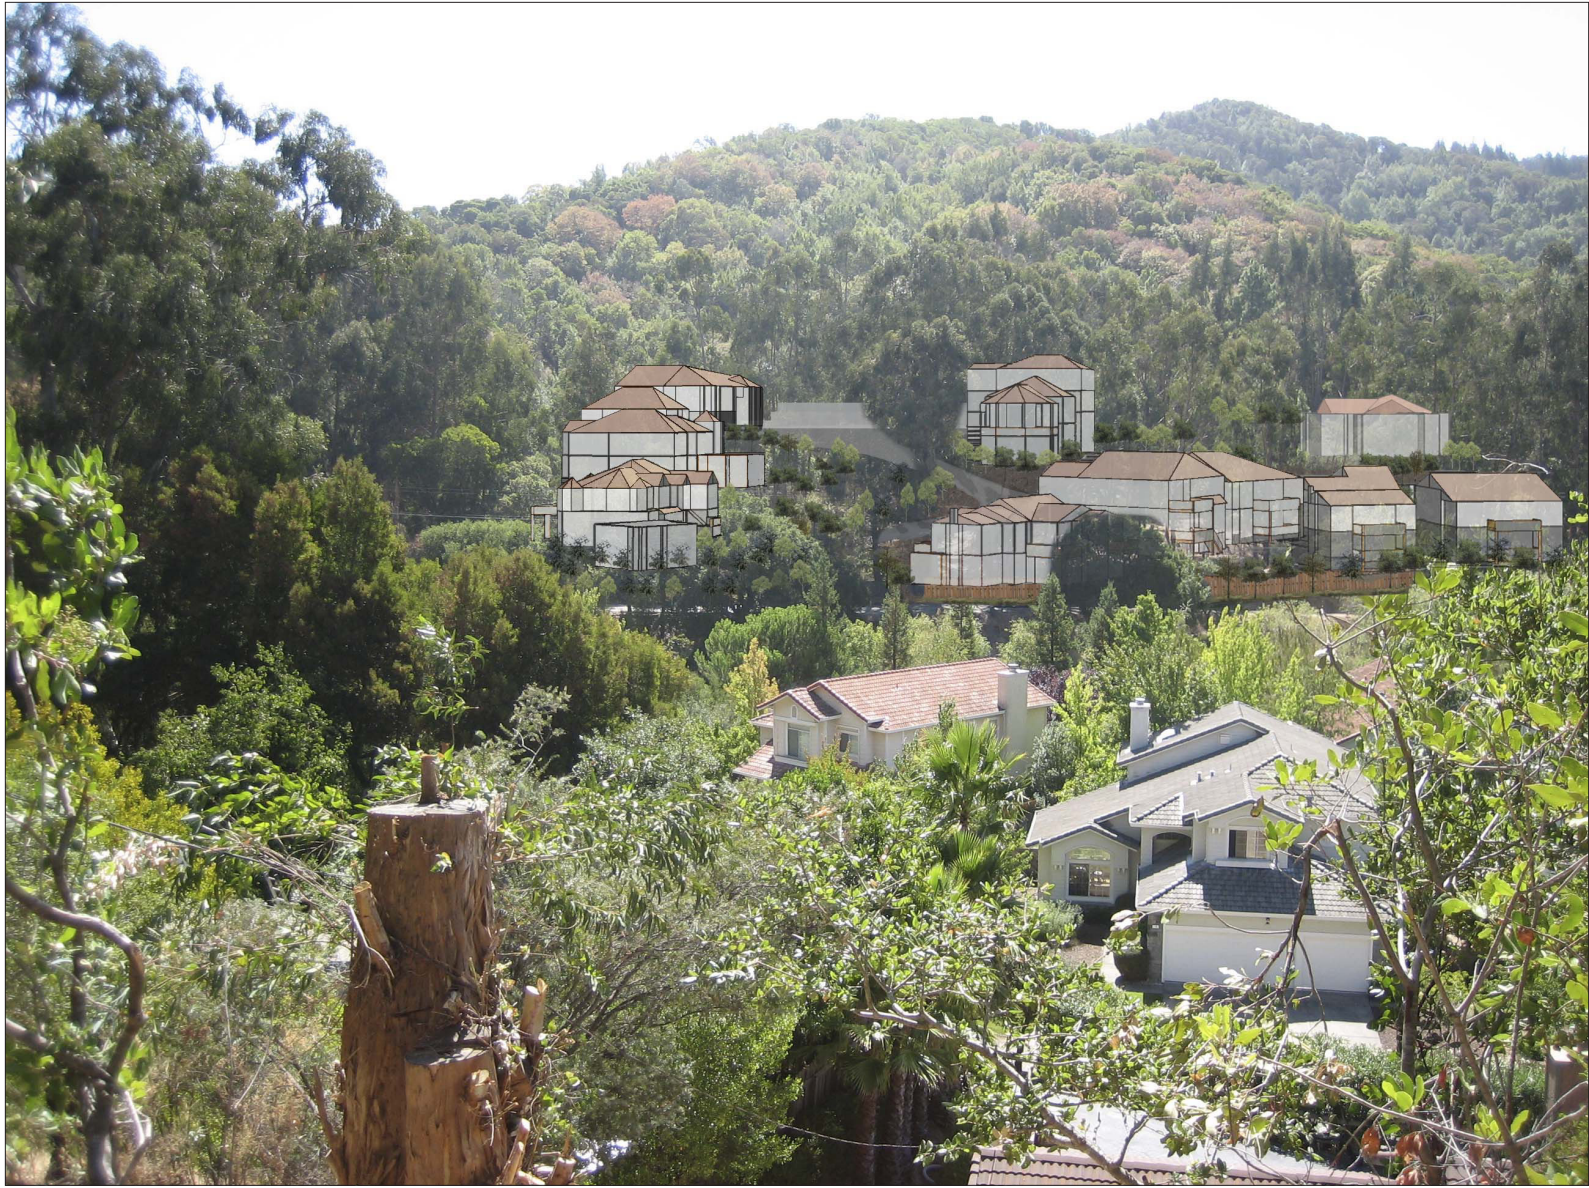
FIGURE 4.8-7A

SIMULATED VIEW OF SITE FROM UPPER ROAD LOOKING SOUTHWEST - 2ND REVISED

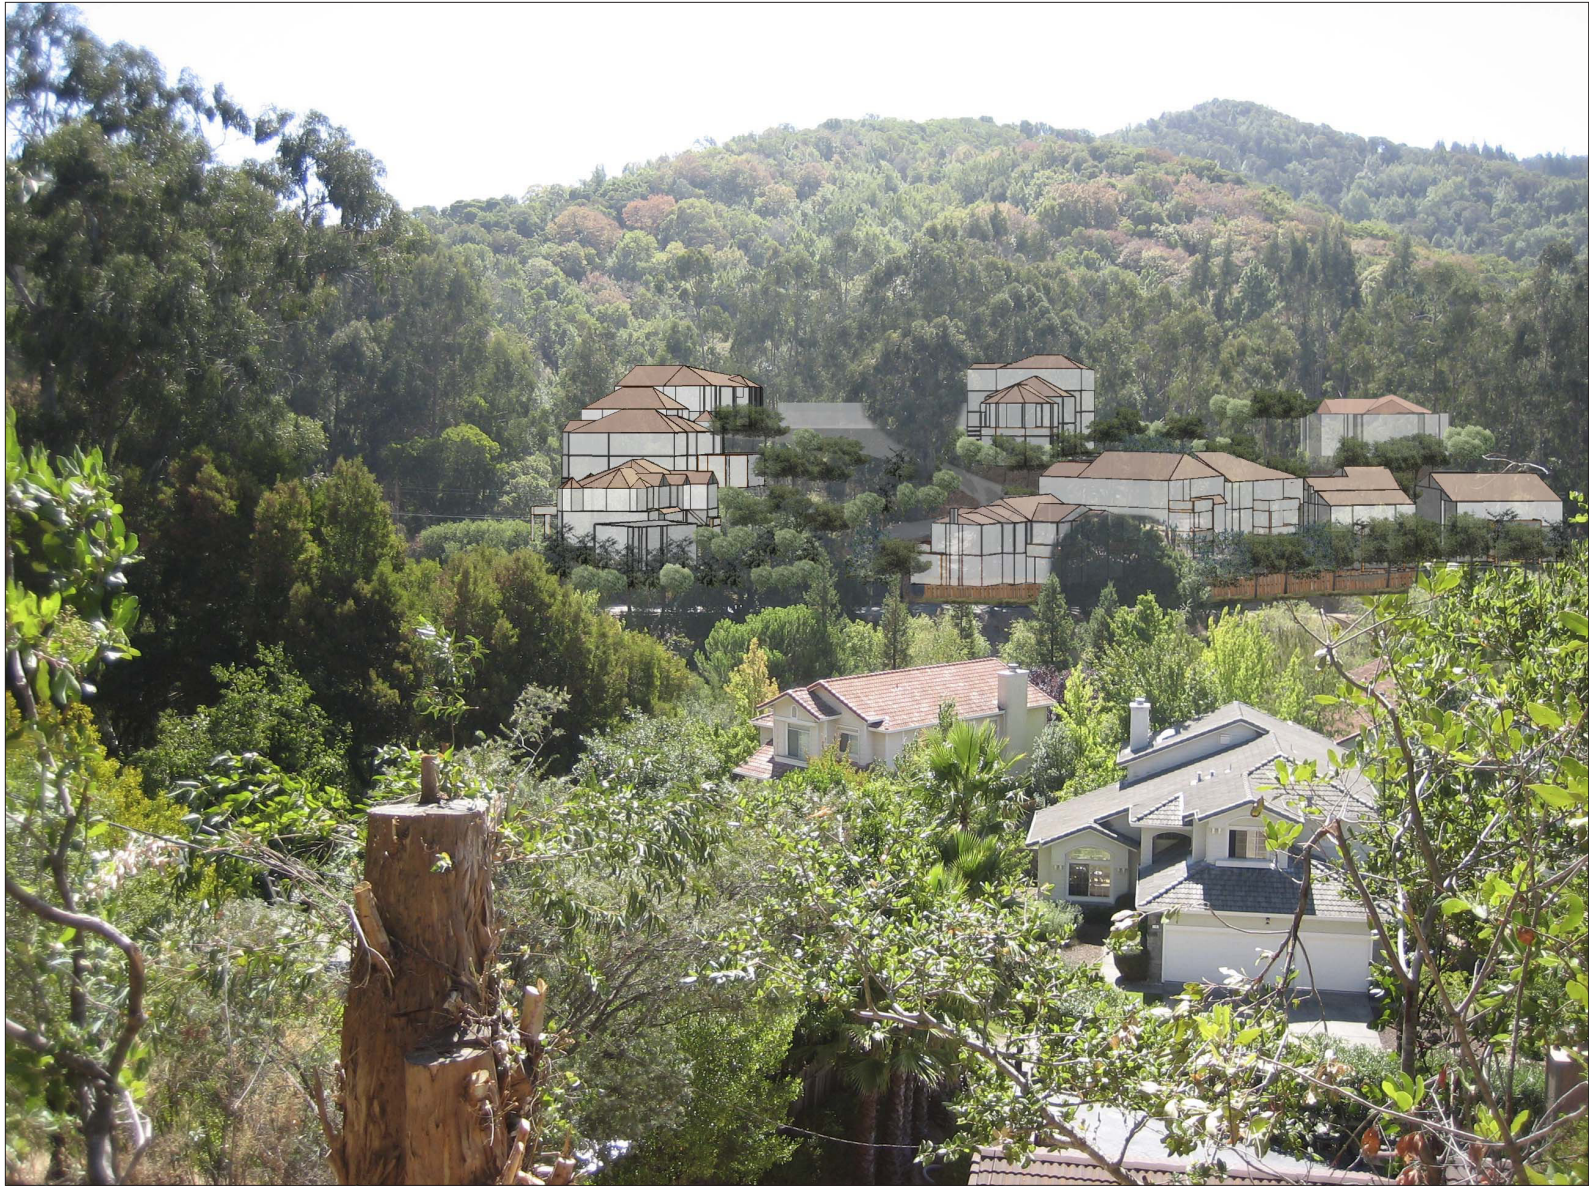
FIGURE 4.8-7B

SIMULATED VIEW OF SITE FROM UPPER ROAD LOOKING SOUTHWEST - 2ND REVISED

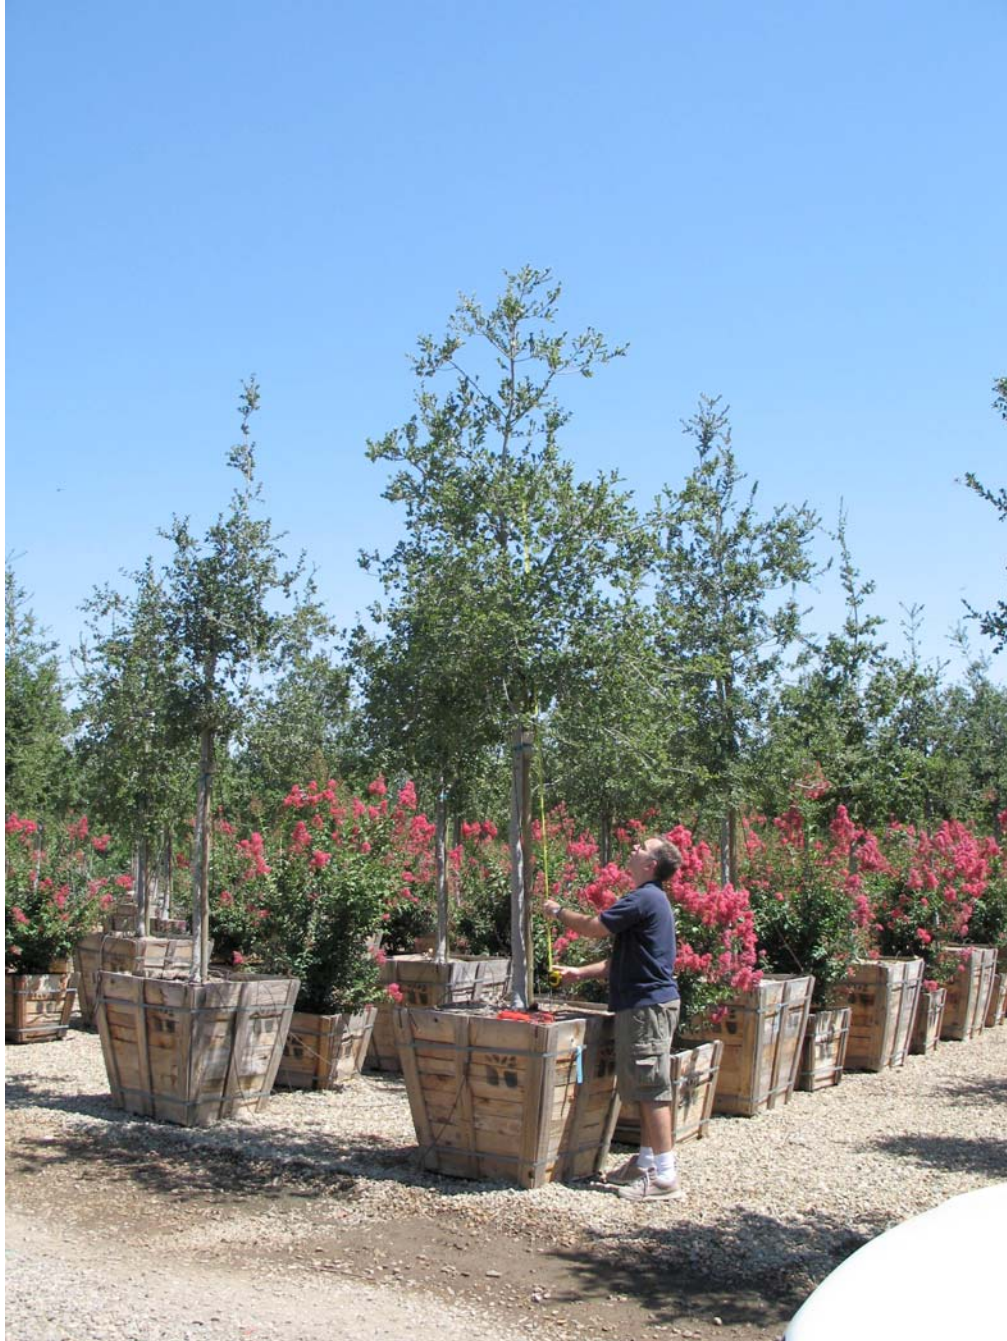
36" Box *Quercus agrifolia* (coast live oak)
(Photo 1)

Height:	12'-13'
Crown Spread:	4'-5'
Caliper (@6")	2.5"-2.75"

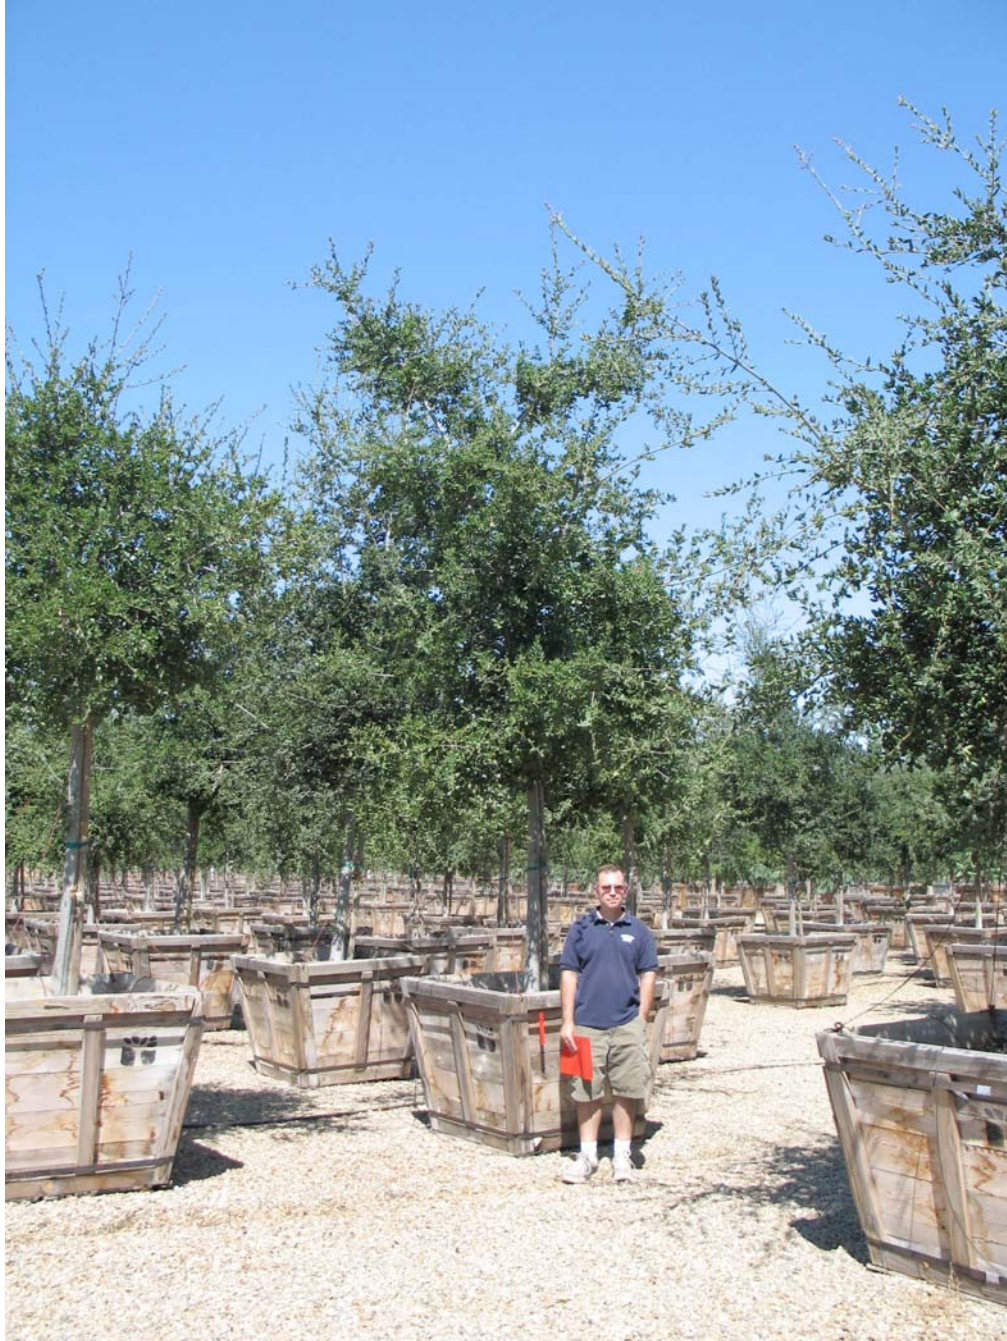
48" Box *Quercus agrifolia* (coast live oak)
(Photo 1)

Height:	14'-16'
Crown Spread:	5'-6"
Caliper (@6")	3.0"-3.5"

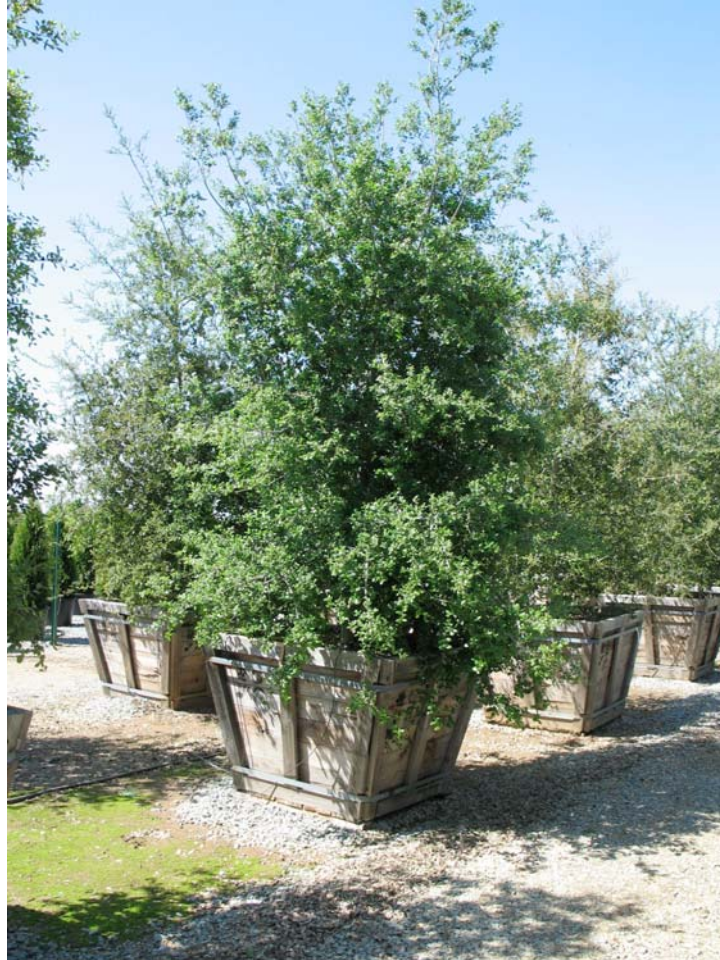
48" Box *Quercus agrifolia* (coast live oak) (natural form
(Photo 1)

Height:	10'-12'
Crown Spread:	6'-8'
Caliper (@6")	3.25"-4"

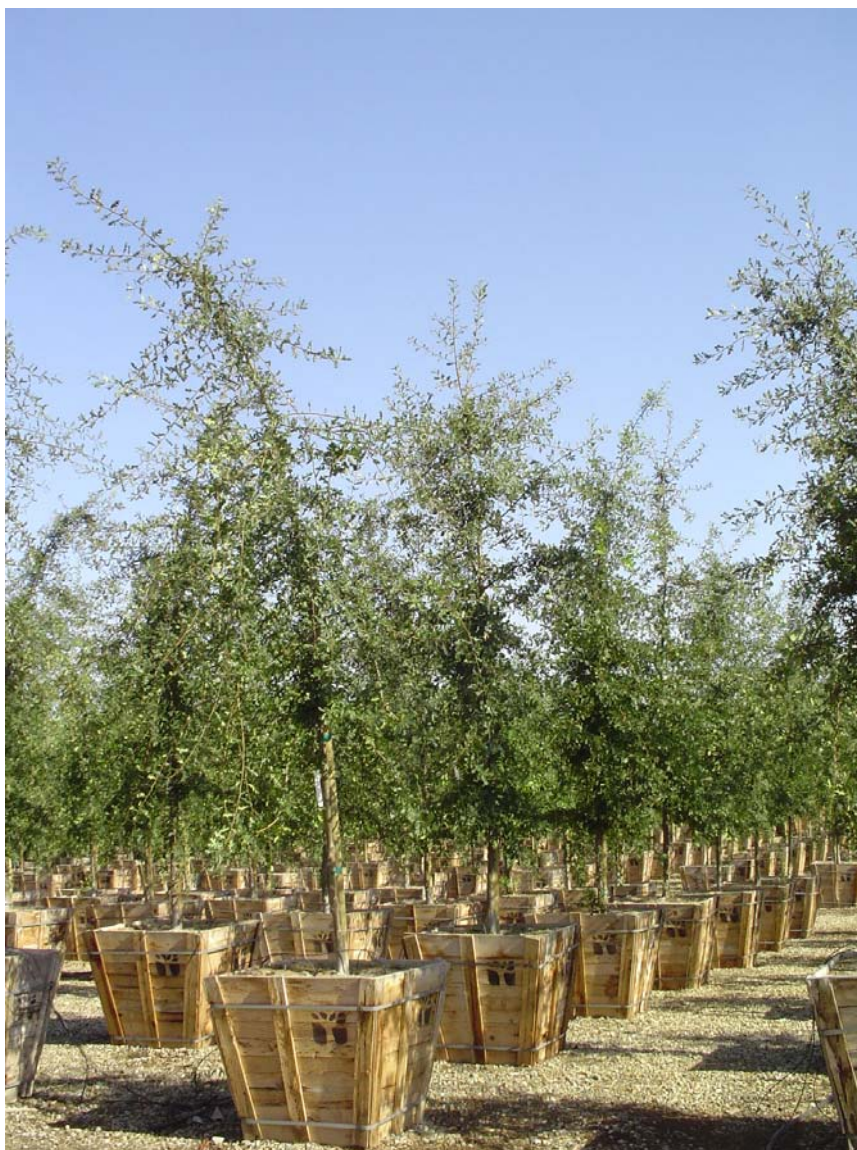
36" Quercus lobata 12-14' x 4-5' x 2.5-2.75"

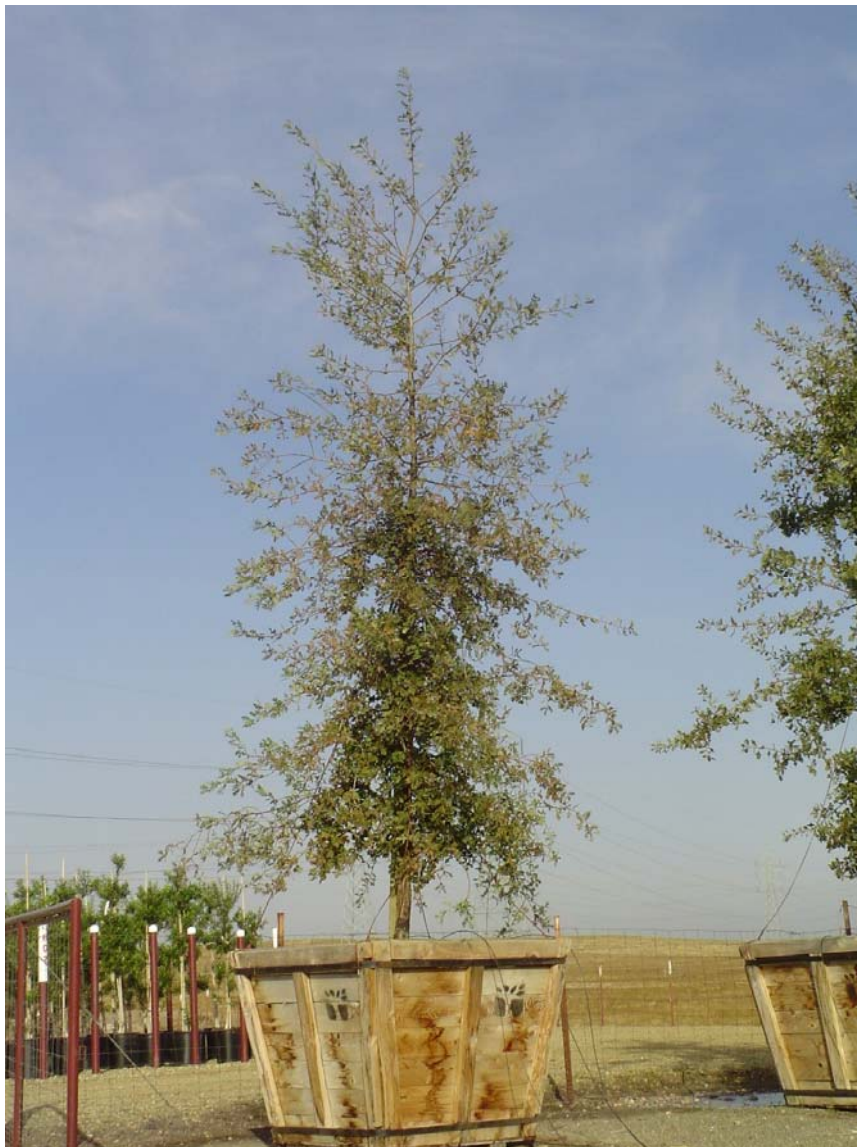
48" Quercus lobata 14-15'x5-6'x2.75-3"
